**PROBLEM DRYWALL ASSESSMENT AND  
INDOOR ENVIRONMENTAL QUALITY EVALUATION  
144 GROESBEEK STREET AND  
4 DARDEN STREET  
FORT BRAGG, NORTH CAROLINA**

**Dean W. Woodard  
Director, Defect Investigations  
Office of Compliance and Field Operations  
U.S. Consumer Product Safety Commission  
4330 East West Highway  
Bethesda, MD 20814**

**Environmental Health & Engineering, Inc.  
117 Fourth Avenue  
Needham, MA 02494-2725**

EH&E Report 17402

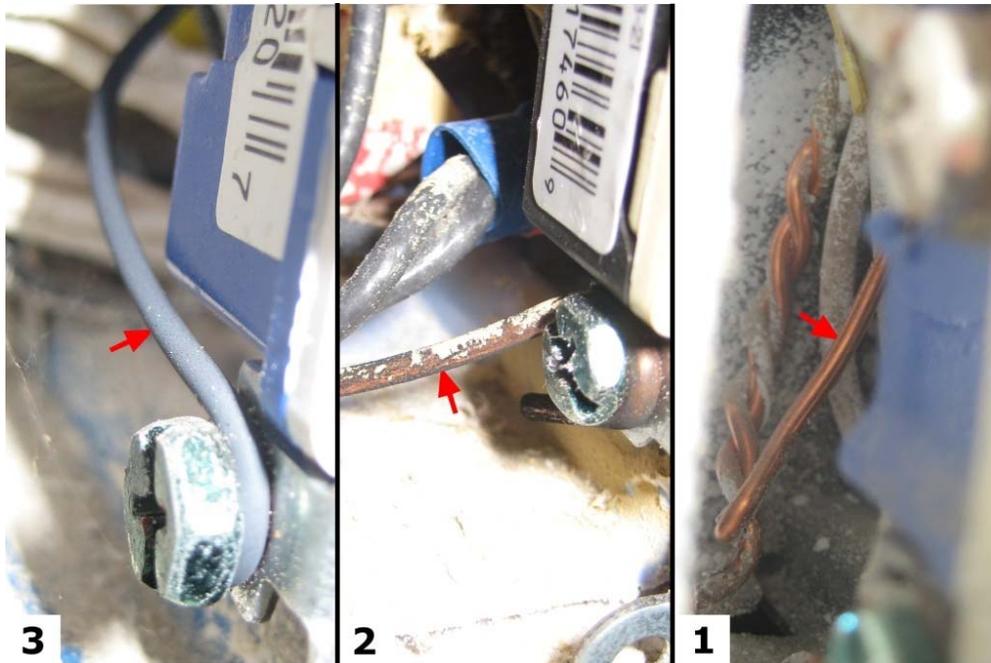
Grounding wires were evaluated on a three-point scale. A score of one indicated no visible corrosion; two indicated moderate visible corrosion; and three indicated significant visible corrosion. Examples of grounding wires and the associated rating are provided in Figure 4.1. Field team members performed cross-reference evaluations

**Figure 4.1** Example of Visual Corrosion Ratings, Electrical Ground Wire  
(3—Significant Visible Corrosion, 2—Moderate Visible Corrosion, 1—No Visible Corrosion)

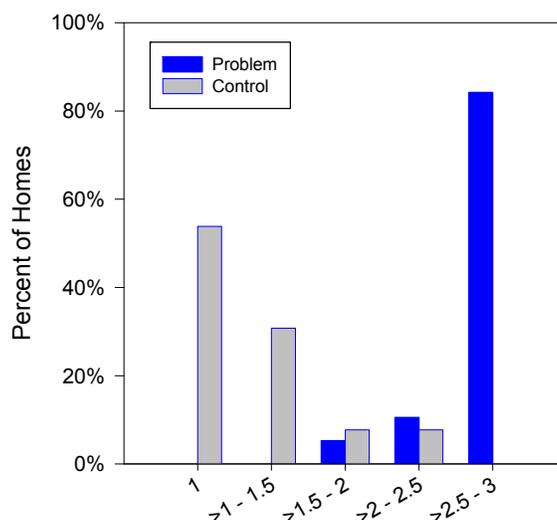
In 144 Groesbeek Street, all of the ground wires were rated the lowest score (i.e., no visible corrosion). In 4 Darden Street, 84% of the ground wires were rated the lowest score, and 16% were rated as “moderate visible corrosion.” Importantly, neither home had any copper ground wires that were rated the highest score (i.e., significant visible corrosion). This is in contrast to the results from the 51-Home Study, which found that every home in that study impacted by problem drywall had at least one ground wire rated the highest score, and in most cases the majority of ground wires were corroded significantly (i.e., heavily blackened) (Figure 5.1).

**Figure 5.1** Distribution of Mean Ground Wires Corrosion Rating in Homes from the 51-Home Study (Homes with Problem Drywall and Control Homes)

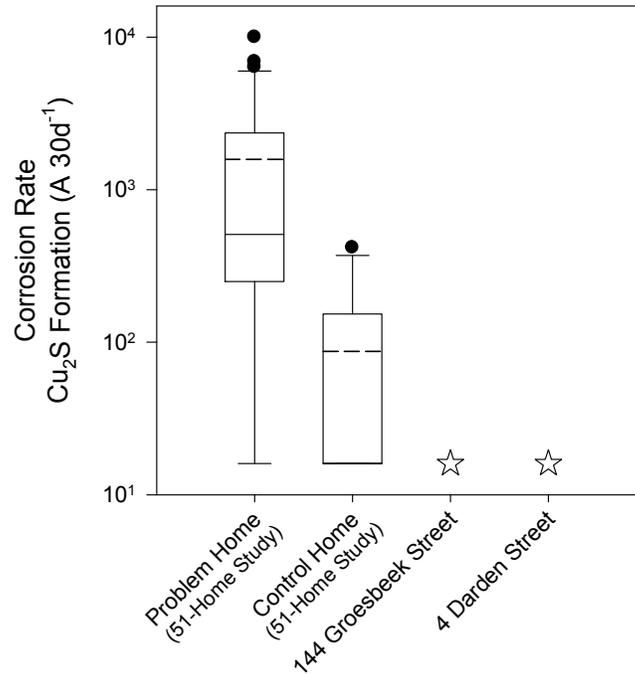
Copper corrosion classification coupons were deployed in multiple locations of each home for a 14-day period. Previous testing of homes with and without problem drywall identified significantly different rates of copper sulfide formation on classification coupons between problem and non-problem homes (CPSC/HUD 2010). For coupons placed in the air handler air supply stream, elevated rates of copper sulfide formation from homes with problem drywall are defined in this report as those with a corrosion rate greater than 300 angstroms per 30 days. For coupons placed in rooms within a home, elevated rates of copper sulfide formation are defined in this report as those greater than 100 angstroms per 30 days. The results of testing in the two Fort Bragg homes indicate that copper sulfide formation did not exceed those values in either home (Appendix A,

Table A.1). Figure 5.2 depicts the data from the Fort Bragg homes in comparison to results from the 51-Home Study.

**Figure 5.2** Comparison of  $\text{Cu}_2\text{S}$  Formation Rate ( $\text{A } 30\text{d}^{-1}$ ) at AHU Air Supply Register in Homes Impacted and Not Impacted by Problem Drywall from 51-Home Study and Fort Bragg Homes

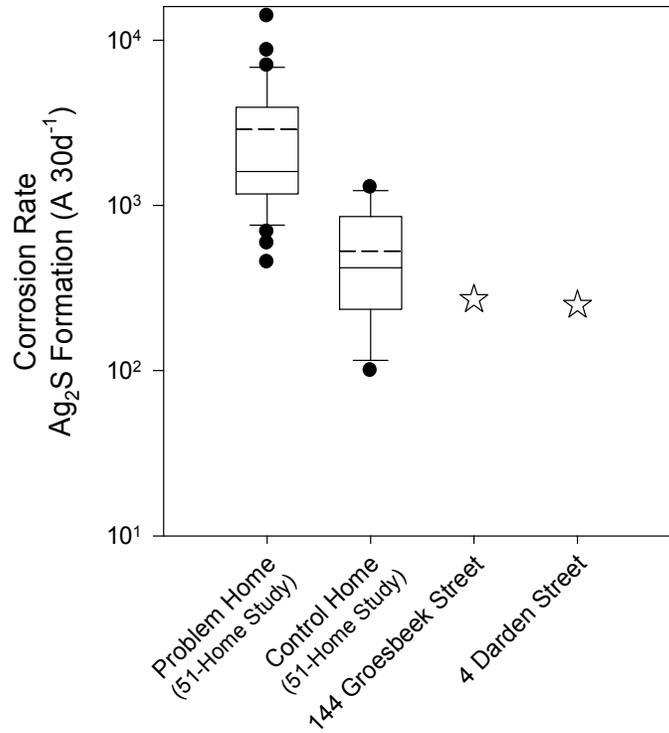
Silver classification coupons were deployed simultaneously with the copper classification coupons in the two Fort Bragg homes. Formation of silver sulfide on the silver coupons previously has been found to be a useful indicator of corrosive conditions in the homes containing problem drywall (EH&E 2010a). For silver coupons deployed in an air handler air supply stream, elevated silver sulfide formation rates are defined in this report as those greater than 1,000 angstroms per 30 days. For silver coupons deployed in rooms in the home, elevated silver sulfide formation rates are defined in this report as those

greater than 300 angstroms per 30 days. Results for the two Fort Bragg homes (Appendix A, Table A.1) demonstrate that elevated rates of silver sulfide formation were not observed in either home. The rate of silver sulfide formation was less than outdoor rates and consistent with background rates of silver sulfide formation in homes. Figure 5.3 depicts the data from the Fort Bragg homes in comparison to results from the 51-Home Study.

**Figure 5.3** Comparison of  $\text{Ag}_2\text{S}$  Formation Rate ( $\text{A } 30\text{d}^{-1}$ ) at AHU Air Supply Register in Homes Impacted and Not Impacted by Problem Drywall from 51-Home Study and Fort Bragg Homes

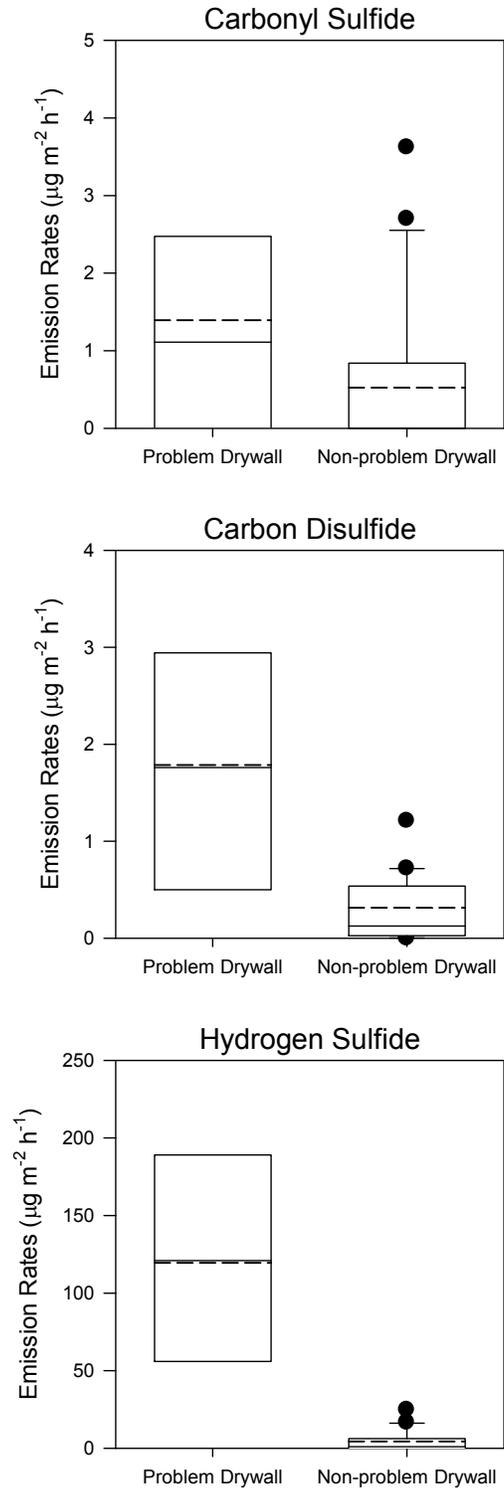
This initial testing was conducted at the early stages of public, governmental, academic, and commercial awareness surrounding the problem drywall issue. As such, sufficient testing establishing valid criteria for the identification of problem drywall had yet to be conducted. The comparison data used in the May 28, 2009, report was comprised of only one sample of known problem drywall and one control sample. This was inadequate reference data because it was not fully representative of the population of all problem or non-problem drywall. At this time, there is now a much larger and representative dataset of emission rates (i.e., off-gassing) from drywall with which to compare results against. Lawrence Berkley National Laboratory (LBNL) has conducted extensive off-gassing testing of a broad selection of both problem and non-problem drywall in the period of time following this EMSL Analytical, Inc. laboratory report from 4 Darden Street (LBNL 2010). Results from the LBNL testing demonstrate that while problem drywall has higher

emission rates than some sulfur compounds, this is only on average. For some volatile sulfide compounds, such as carbonyl sulfide and carbon disulfide, there is significant overlap in the distribution of sulfur off-gassing from problem and non-problem drywall (Figure 5.4). Although the conclusion that the drywall from 4 Darden Street is “Positive for off-gassing of sulfur compounds” may be correct, the result, in and of itself, is insufficient to indicate that this drywall is problem drywall; positive off-gassing of sulfur compounds is a sensitive, but not specific, marker of problem drywall (i.e., there is the potential for false positives).

**Figure 5.4** Emission Rate Data for Problem and Non-problem Drywall Samples, Defined as Drywall Samples With Elemental Sulfur Marker and Those Without (LBNL 2010)
