# FIXED-POSITION ELECTRIC HEATERS

FINAL REPORT ON FIXED-POSITION ELECTRIC HEATERS  
January, 2002

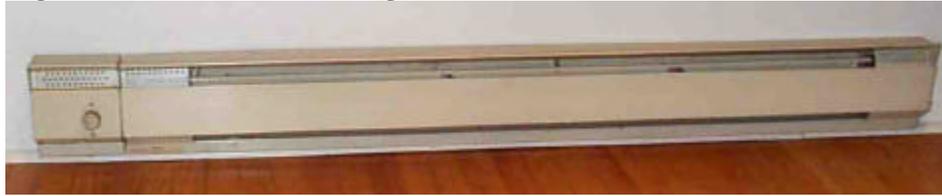
**Figure 3: Sheathed Heating Element Example**

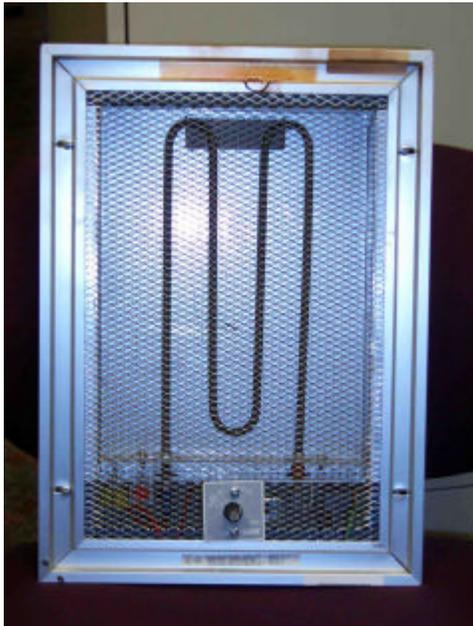
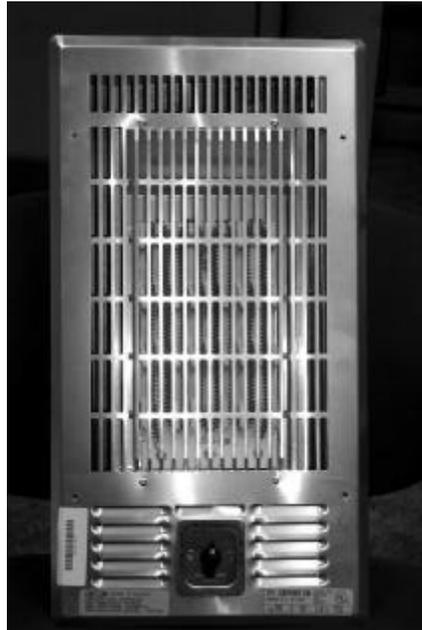
Without a failure of some type or a restriction of the airflow, an air-warming heater can never heat nearby combustibles above the temperature of the exhaust air, which is typically far below the combustion temperature of common household materials. However, radiant heater element surfaces are often well above the combustion temperature of many household materials. The line-of-sight construction requires that the elements present a large surface area to the front of the heater. Therefore, these heaters are capable of continuously adding thermal energy to the surface of an object until equilibrium is reached, perhaps at a temperature above the object's ignition point.

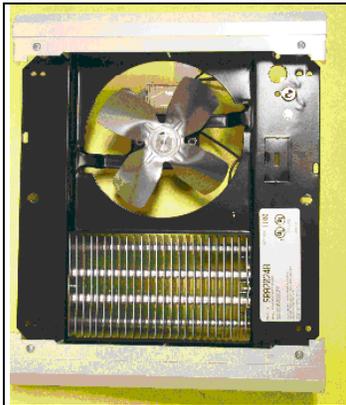
**FIGURE 1-1** HEATER #1  
(front, grill removed)

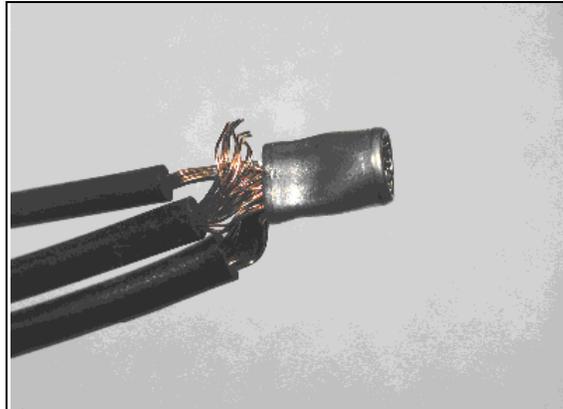
**FIGURE 3-1 - WIRE STRANDS NOT WITHIN THE CRIMP (Connector #10-B)**

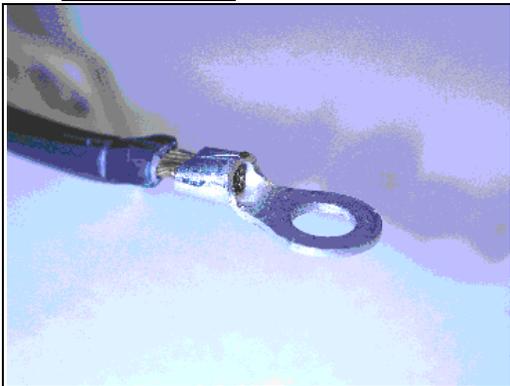
Ten percent (7 out of 71) of the crimp terminals examined had at least one strand of wire out of the crimp. All but one of these samples were pre-insulated type. Among the pre-insulated terminals the defect rate is 17% (6 out of 35). When the current in the wire and/or the number of misplaced strands is low, this defect may be innocuous. When a termination conducts relatively high current and the number of misplaced strands is high, as for instance the terminal illustrated in Figure 3-1 above, hazardous overheating failures may develop in service.

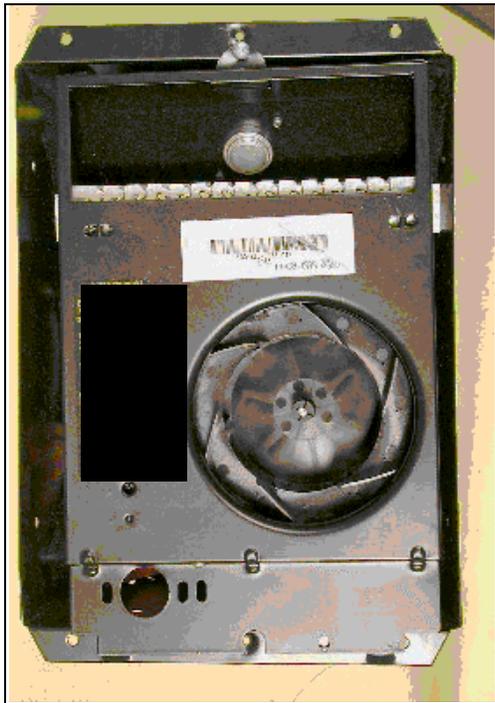
<b>HEATER #10</b>		<b>1500W@ 240V (6.2A)</b>		
<u>CRIMP #</u>	<u>TYPE</u>	<u>MARKING</u>	<u>WIRE SIZE &amp; COLOR</u>	<u>NOTES</u>
10-A	D	ETC 16-14	14 B	plated connector
10-B	E	ETC 03MX 16-10	14B+ 16B+ 20B	Plated connector, #20 pre-soldered,
10-C	C	ETC 12-10	16 B + 20 B	Plated connector, #20 pre-soldered, loose strands
