1. Task Number 080911HCC2010		2. Investigator's ID 8925		EPIDEMIOLOGIC INVESTIGATION REPORT
3. Office Code 810	4. Date of Accident YR MO DAY 2008 03 15	5. Date Initiated YR MO DAY 2008 09 15

6. Synopsis of Accident or Complaint UPC none The victim, a 33-year-old male was riding on a 4-wheeled utility vehicle in a wooded area and he was not wearing a helmet. He struck a brush pile of trees and he lost control. He was ejected and the utility vehicle overturned away from him. He sustained a head injury and he was taken to a hospital, where he died. The cause of death was traumatic brain injury due to blunt force trauma to the head. <u>MFR/PRVLBR NOTIFIED</u> COMMENTS: <input type="checkbox"/> YES <input checked="" type="checkbox"/> NO <input type="checkbox"/> OVERRULED; <input type="checkbox"/> ATTACHED <input checked="" type="checkbox"/> EXCISIONS/FOIA EXS <i>25c</i> ; <input checked="" type="checkbox"/> DO NOT RE-NOTIFY <input type="checkbox"/> RE-NOTIFY <i>for 5/18/09</i>

7. Location (Home, School, etc) 5 - OTHER PUBLIC PROPERTY		8. City PULASKI COUNTY		9. State KY
10A. First Product 5044 - Utility Vehicles		10B. Trade/Brand Name YAMAHA/RHINO		10C. Model Number UNKNOWN
10D. Manuf

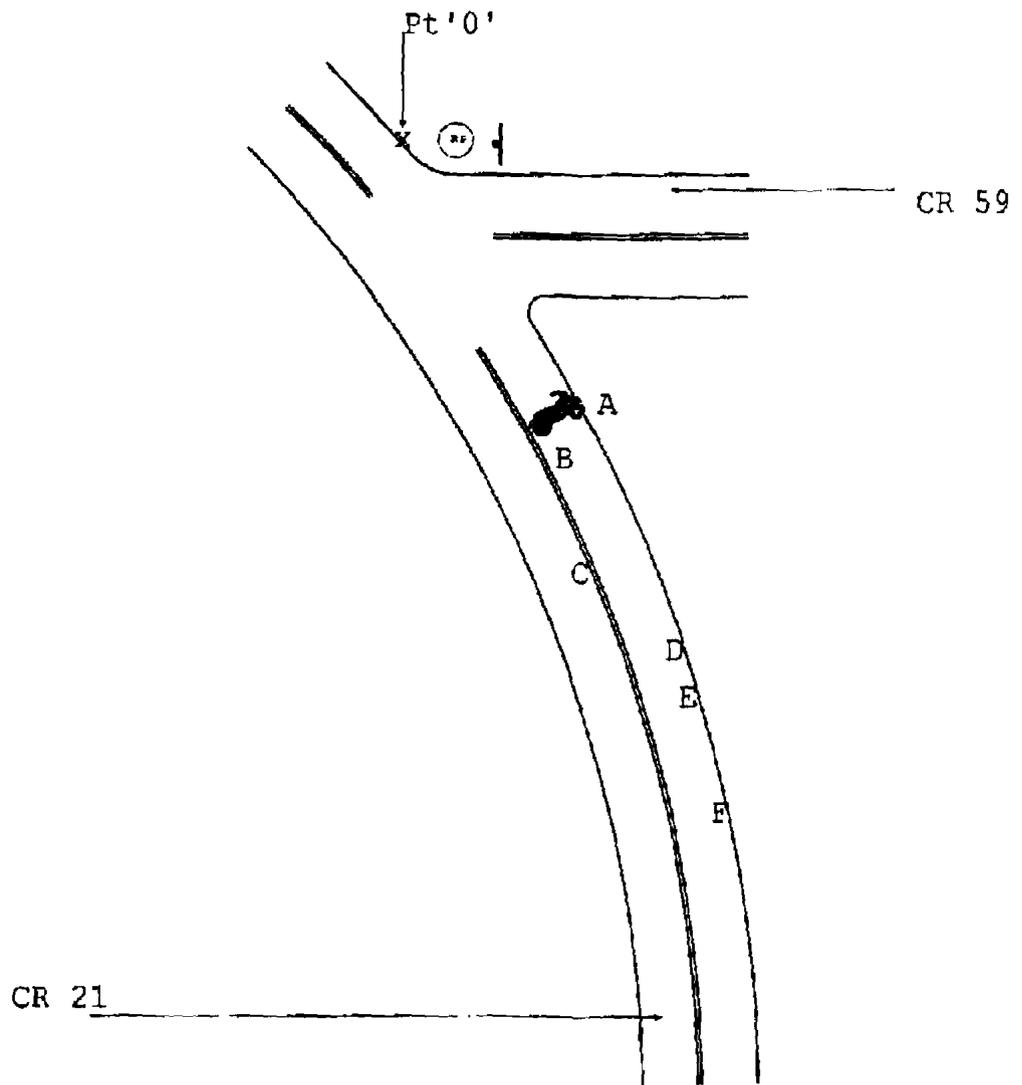
NOT TO SCALE

Unit 1 was traveling northbound on CR 21. Unit 1 failed to negotiate a curve to the left and drifted off the road to the right. Unit 1 overcorrected and overturned in the roadway.

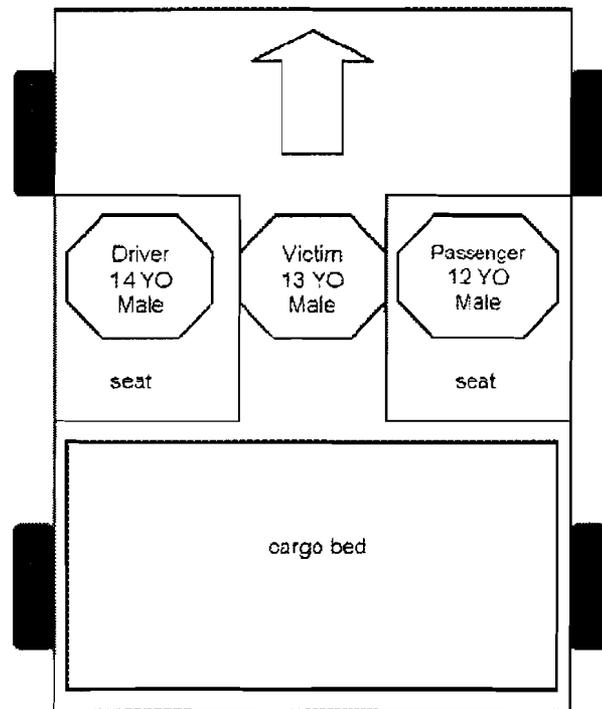
Seating Diagram (not to scale)

The victim was not wearing a seat belt (as he was not in a seat) nor was he wearing a helmet or any other safety equipment. He was only wearing blue jeans (no shirt and no shoes). The other occupants are not believed to have been wearing seat belts, helmets, or any other safety equipment.

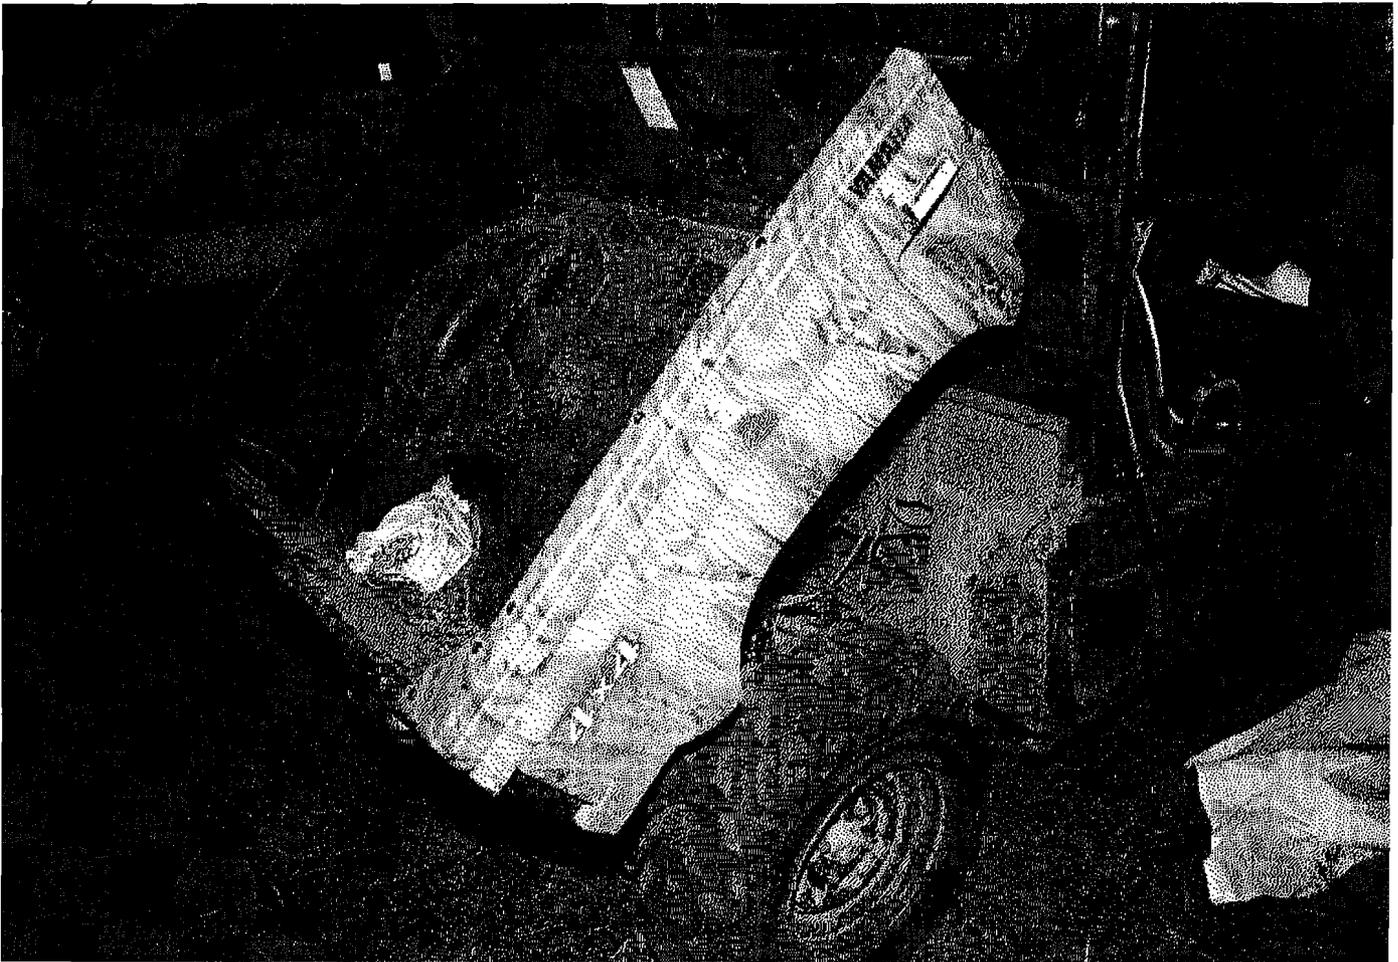
Photo 6: View of the incident utility vehicle (impact side). Photograph courtesy of the Effingham County Sheriff's Office.

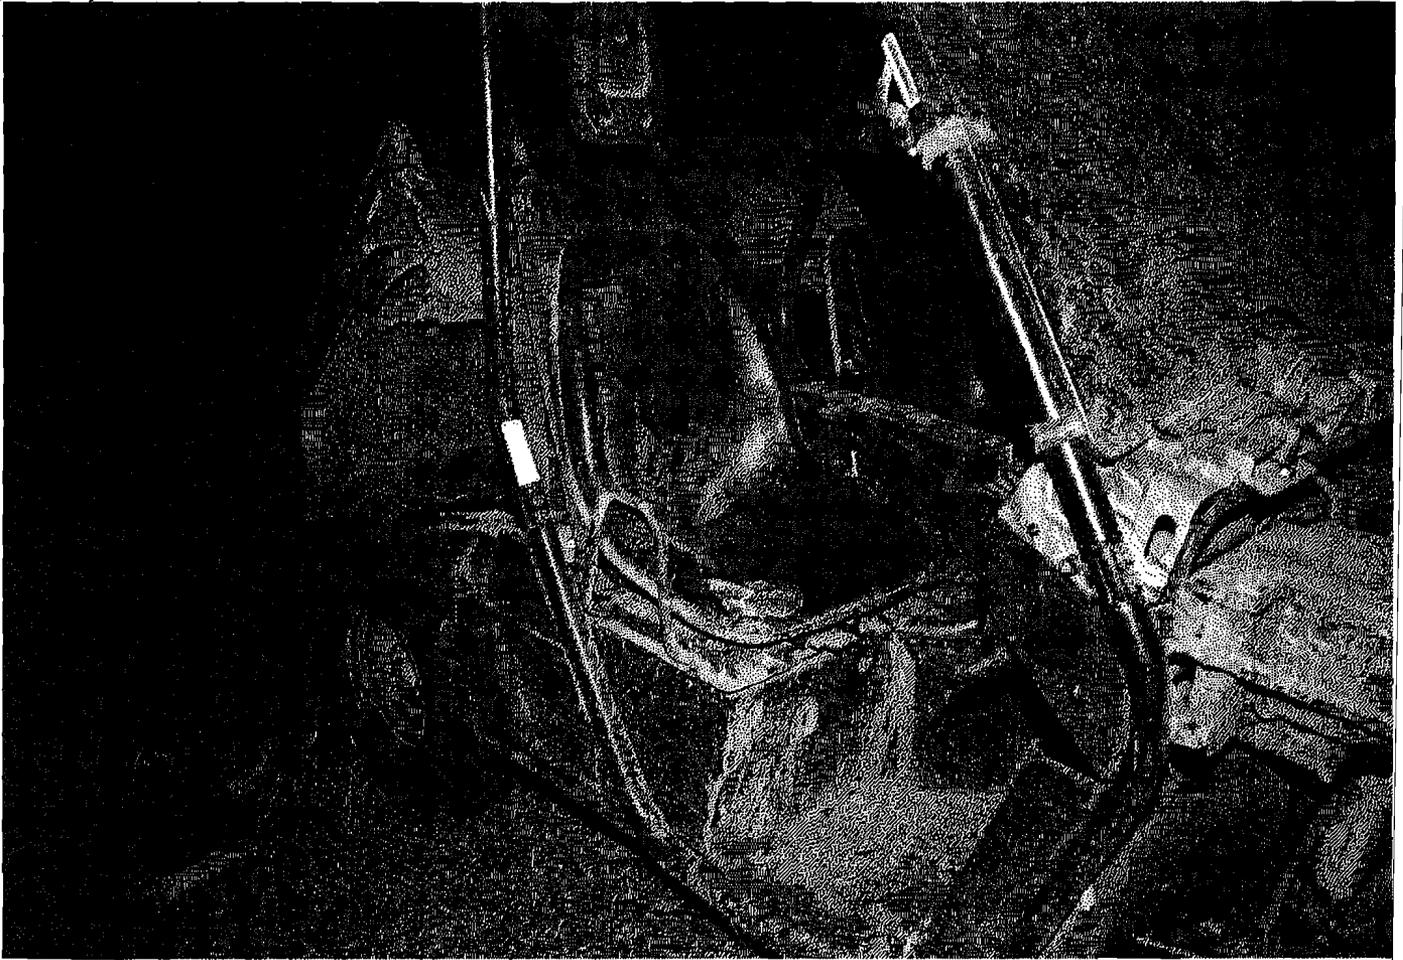
Photo 7: View of the incident utility vehicle (impact side). Photograph courtesy of the Effingham County Sheriff's Office.

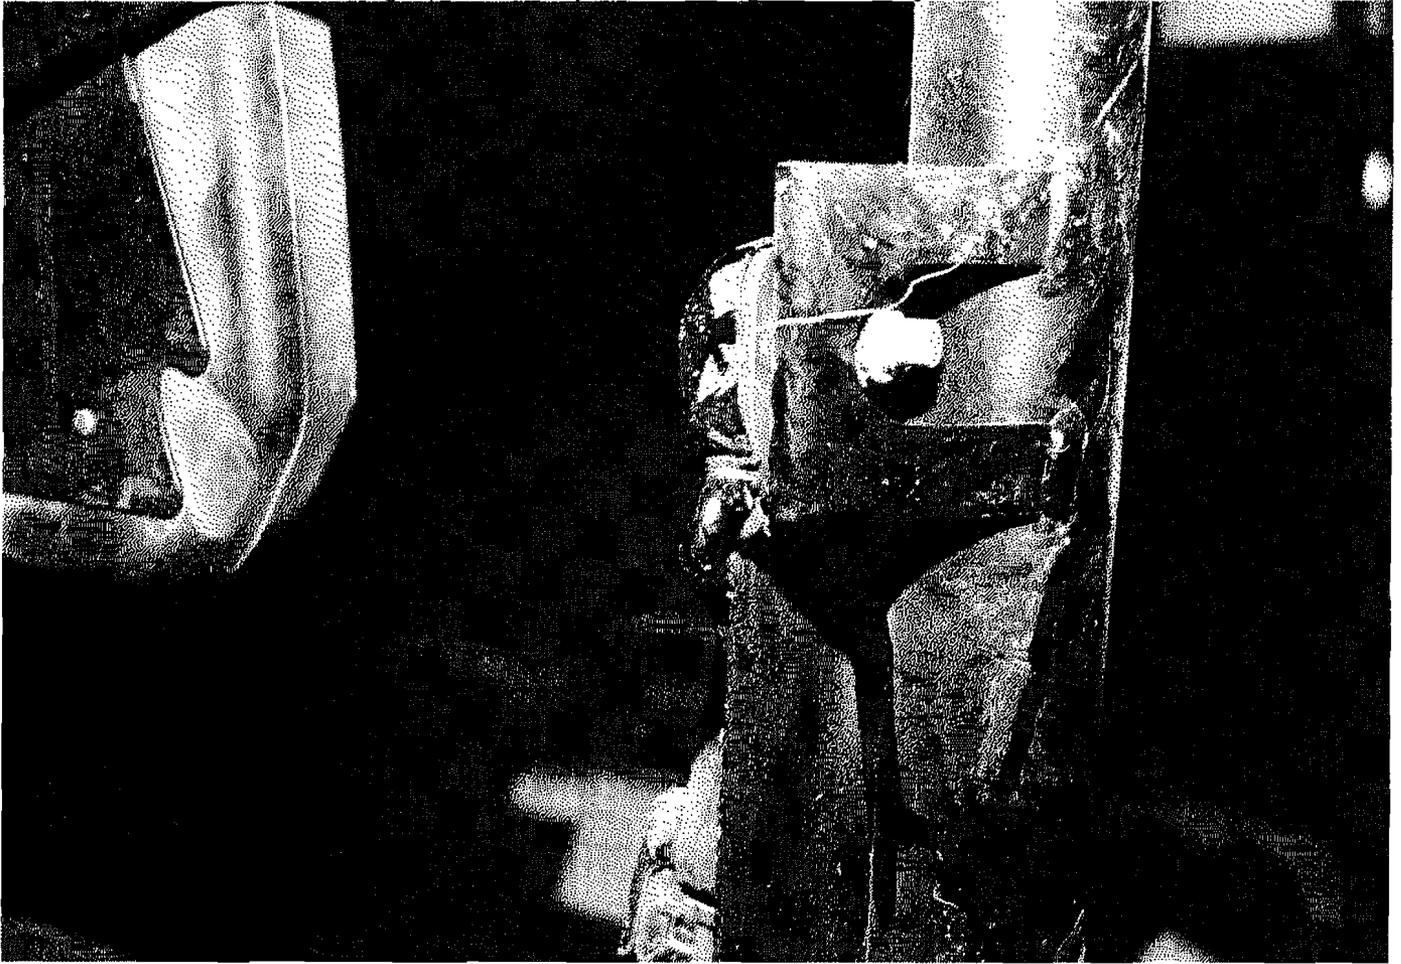
Area that struck
the victim (see
next two pages)

Photo 9: Close-up view of the passenger side roll bar / upper seat belt connection point in the area that struck the victim. Photograph courtesy of the Effingham County Sheriff's Office.

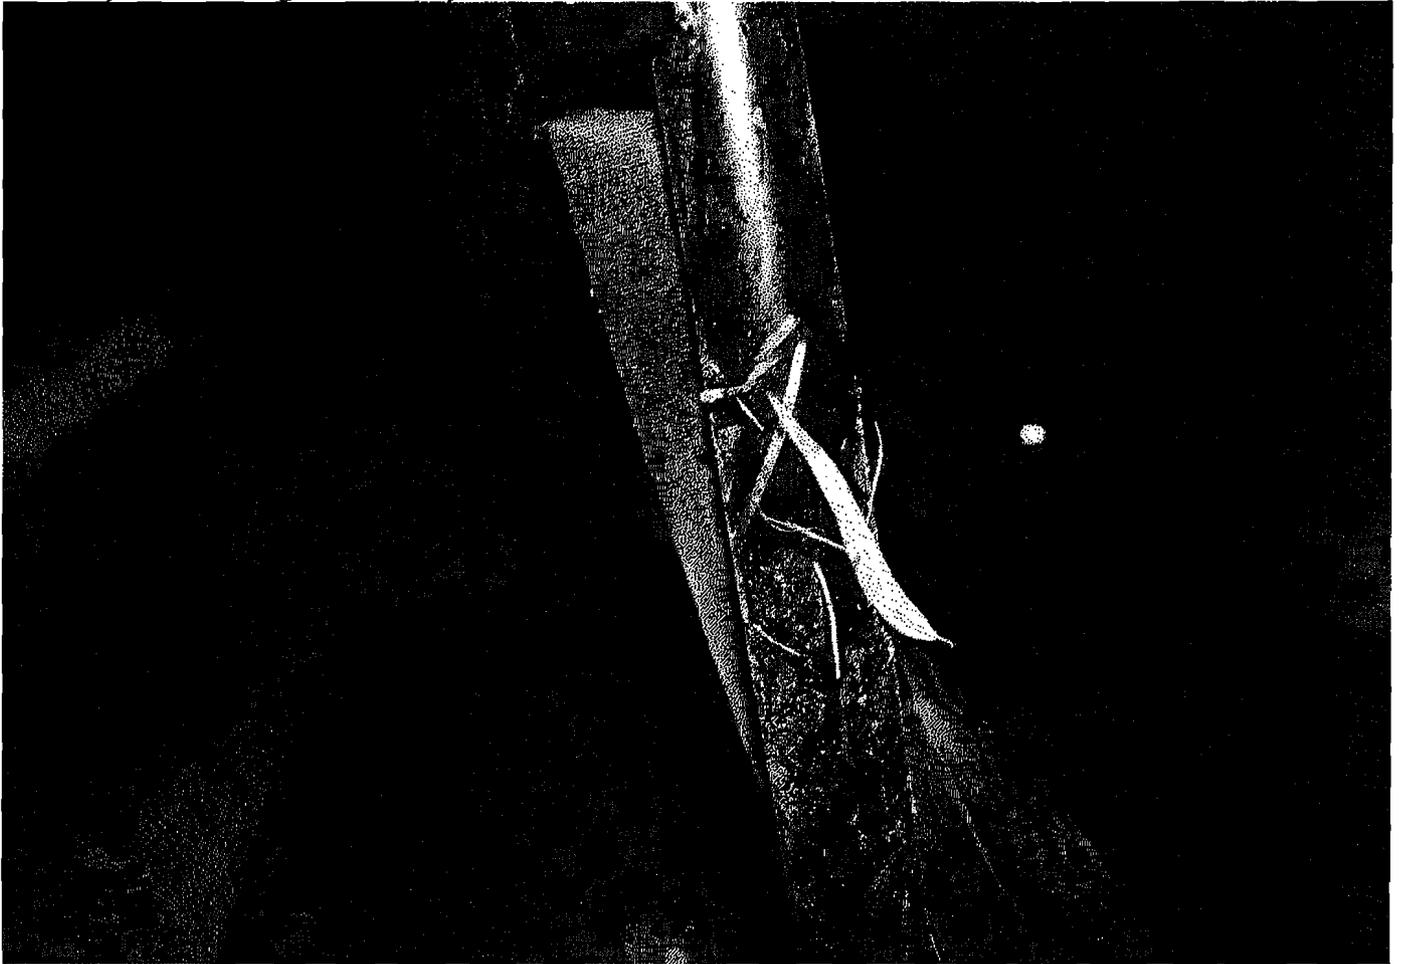
Photo 10: Close-up view of the passenger side roll bar in the area that struck the victim. Photograph courtesy of the Effingham County Sheriff's Office.

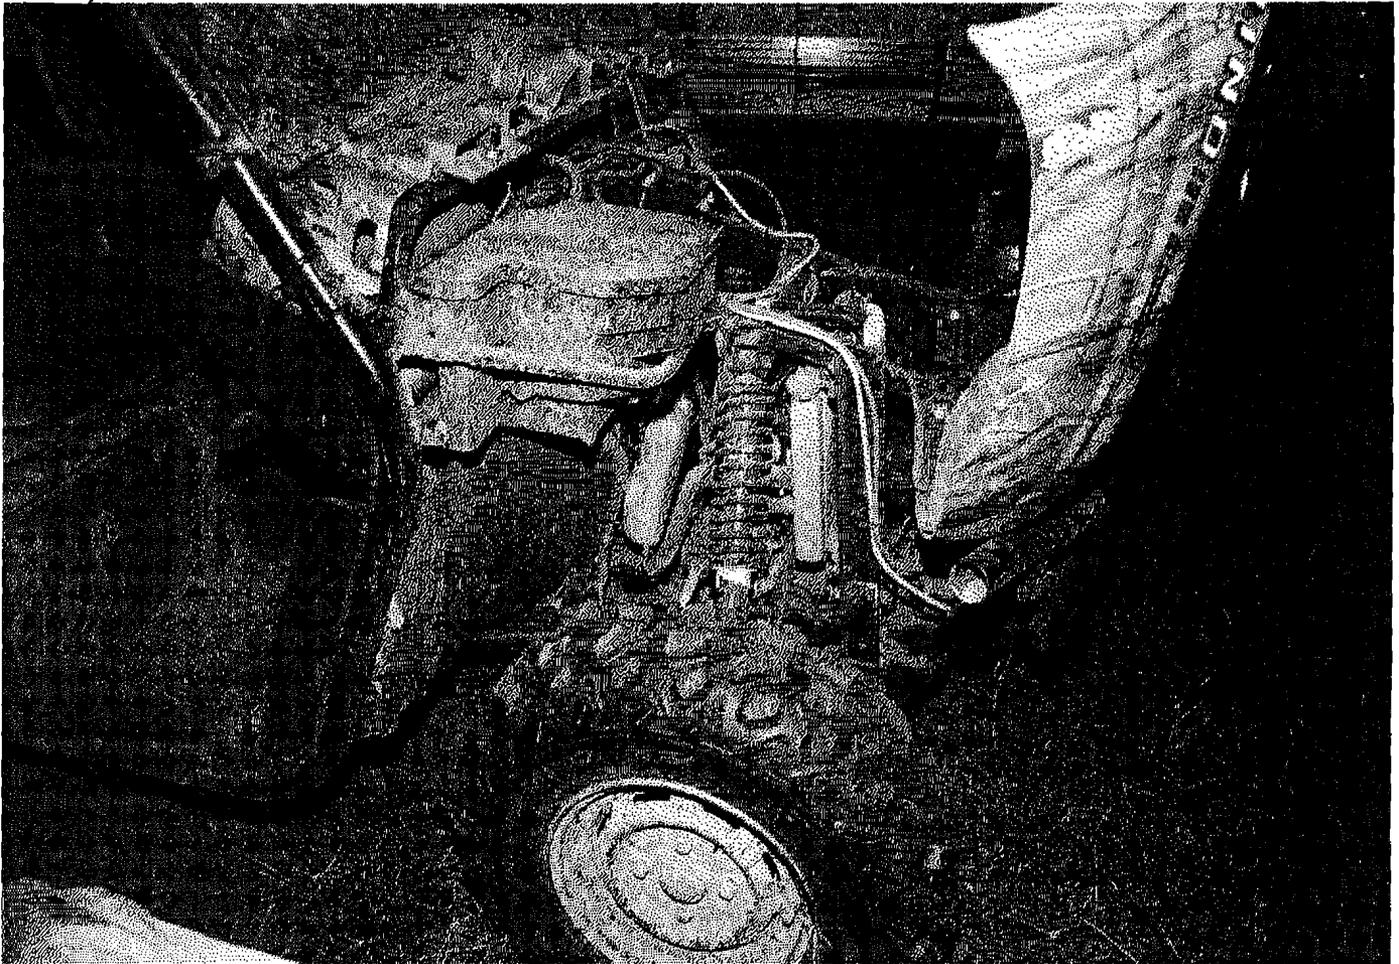
Photo 11: View of the incident utility vehicle (impact side). Photograph courtesy of the Effingham County Sheriff's Office.

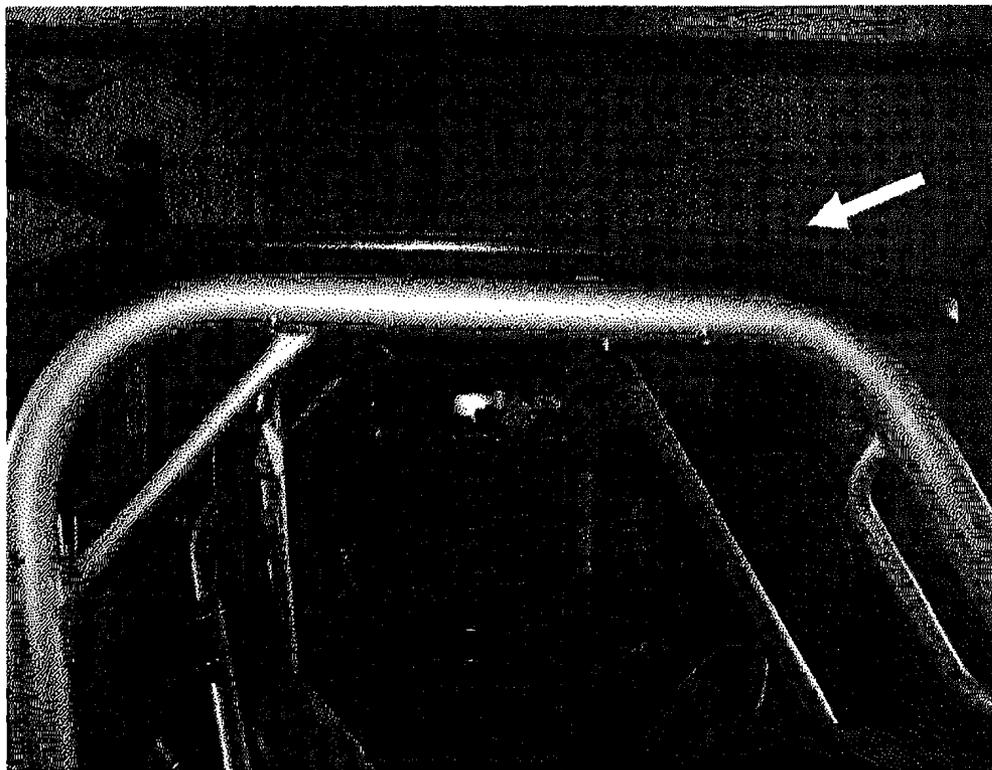
Photograph 15: Aftermarket modification to incident vehicle - View 1

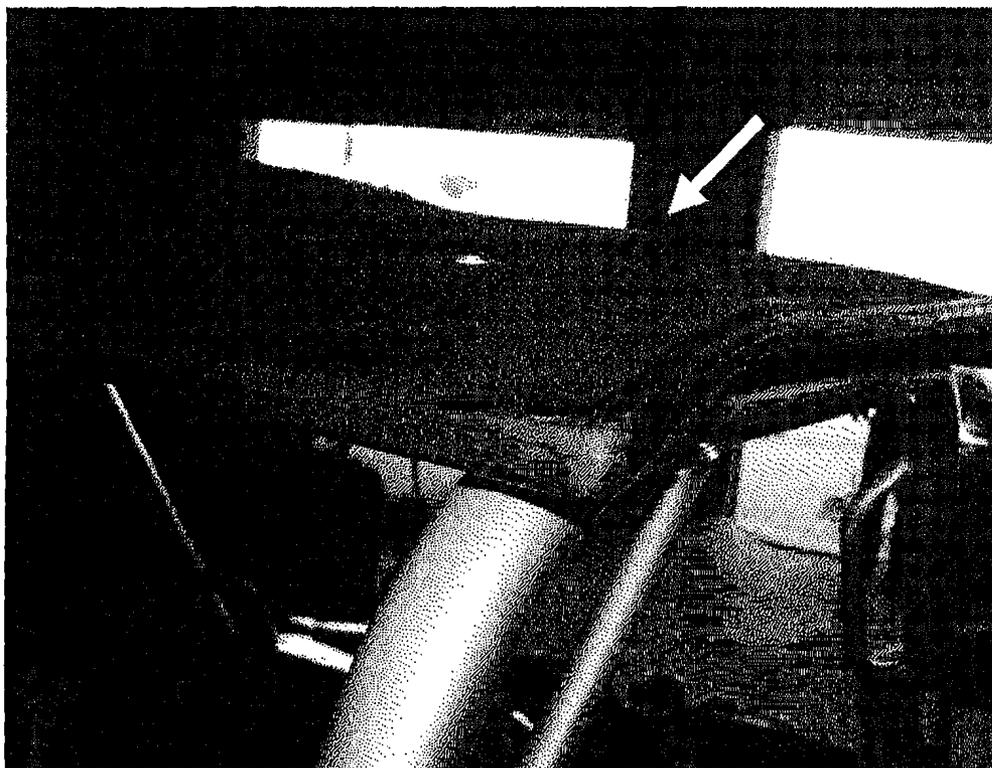
Photograph 16: Aftermarket modification to incident vehicle - View 2

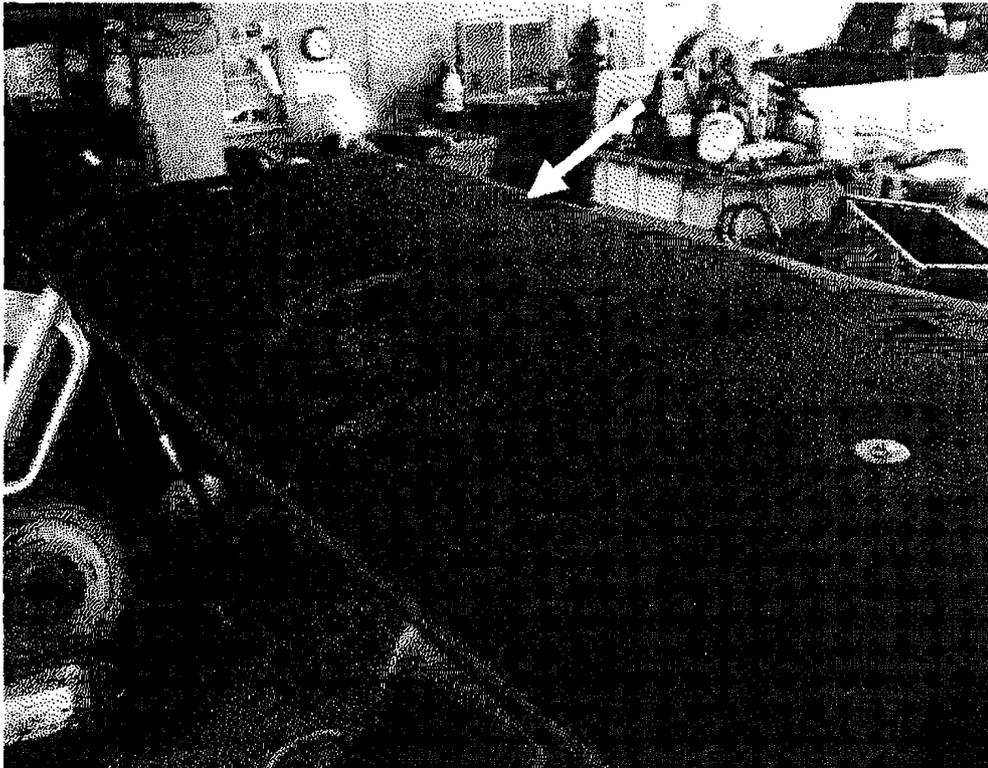
Photograph 17: Aftermarket modification to incident vehicle - View 3

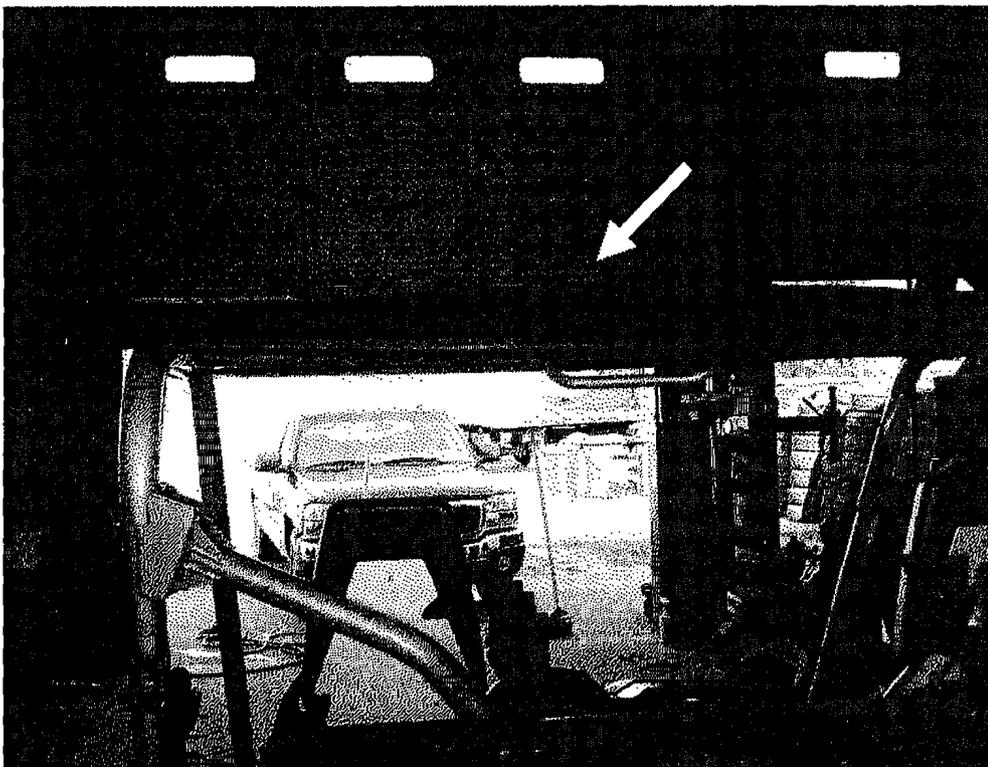
Photograph 18: Aftermarket modification to incident vehicle - View 4

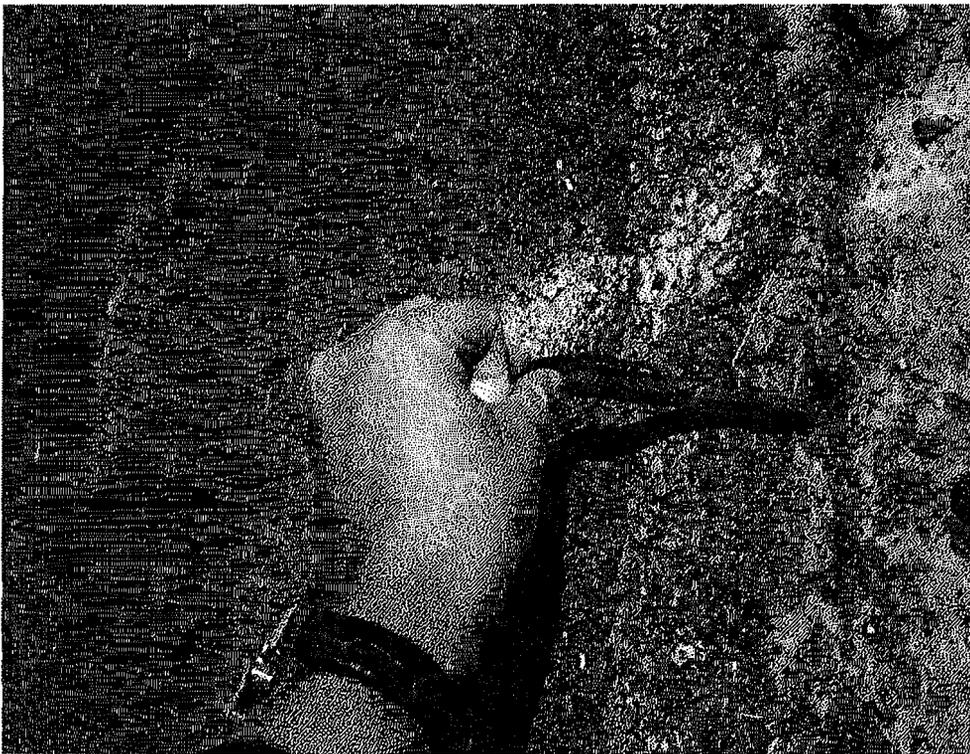
Photograph 26: Second view of shoulder where UTV left road prior to incident

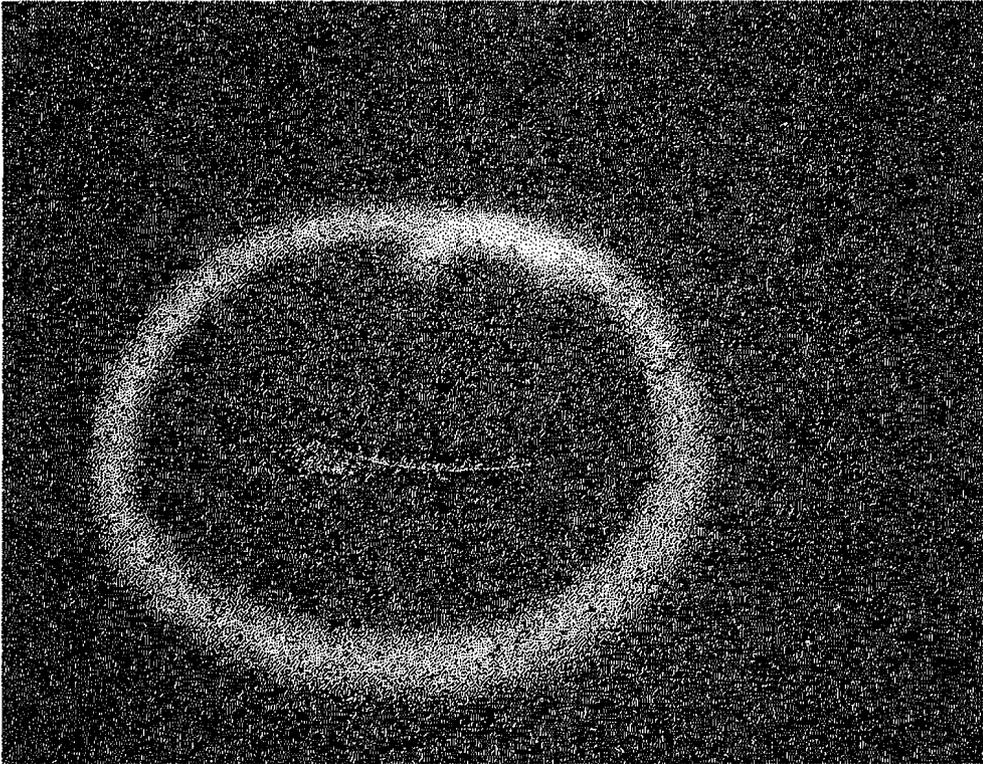
Photograph 27: Area of impact where UTV hit road during incident
