STUDY OF DETERIORATION OF SEPARABLE ELECTRICAL CONTRACTS IN SMOKE DETECTORS

Task III and IV Report
Critique and Recommendations
For Additions/Changes to UL217

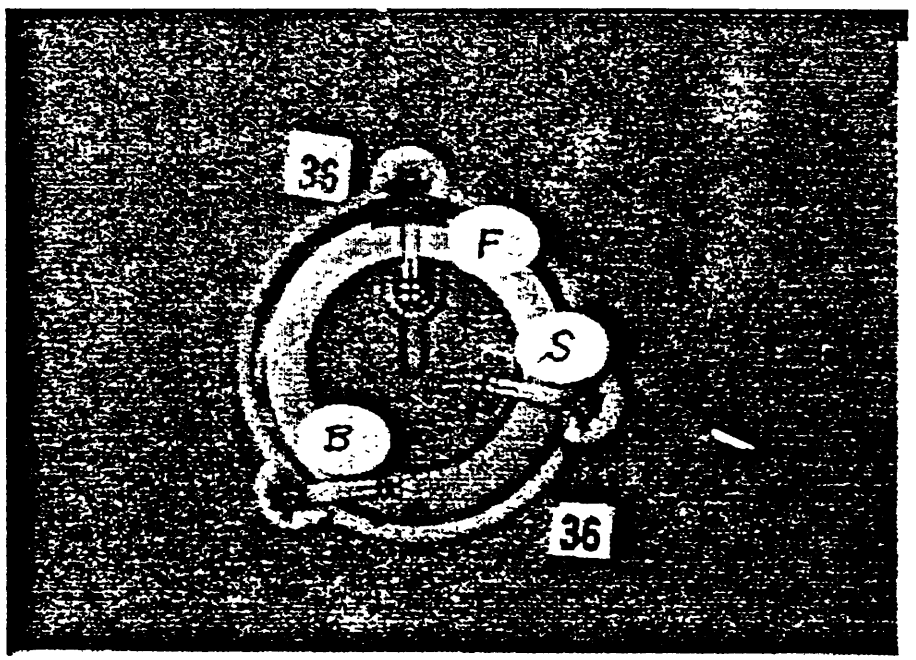
FIGURE 3: SEPARABLE CONTACTS ON A SMOKE DETECTOR HORN (1.25X)

Figure 3 shows the separable contacts on a typical smoke detector horn. The three contacts B, S and F are indicated on the photograph. Figure 4 is a conceptual cross-section of the horn disk and contacts. Figure 5 shows a close up of a bifurcated horn contact F from an older horn. All 6 of the smoke detectors in this phase of the test protocol that were reported as field failures had bifurcated contacts. Figure 6 shows a close up of a dimpled horn contact F on the newer horns. Both the new samples used in this phase were of this type. Figure 7 shows a close up of horn contact B on the older horn. To perform the auger (AES) surface analysis the contacts were removed from the horns. Figures 8 and 9 show the actual contact areas for the older and newer spring contact configurations. A rather heavy film was noted on the older contact shown in Figure 8. This film was detected visually on all three of the reported field failures tested in this section of the test protocol.

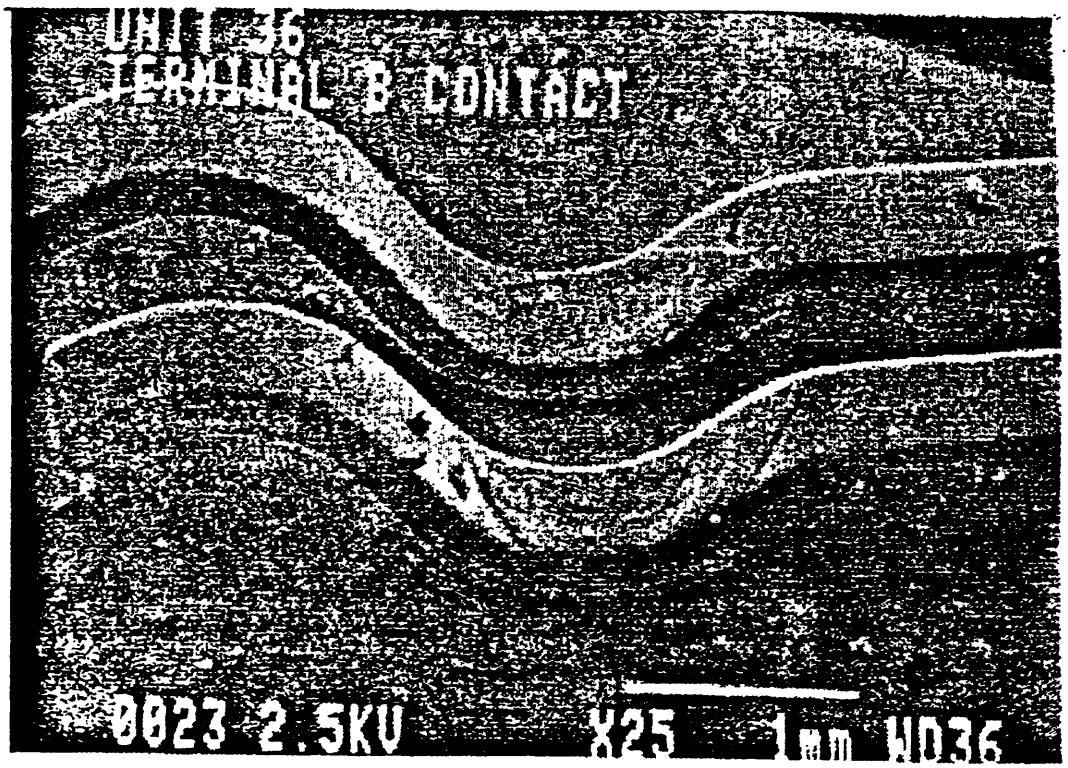
FIGURE 10: SEM PHOTOGRAPH OF A BIFURCATED CONTACT

Before the four horns used to document contact area materials were potted for cross-sectioning scanning electron microscope (SEM) photographs were taken of each contact area. Representative pictures of bifurcated and dimpled contacts appear in Figure 10 and 11, respectively. Energy Dispersive Analysis by X-Rays (EDAX) surface analyses were made on each of the four horns prior to potting. Table 1 summarizes the results of this analysis. Because of the relatively high beam voltages used by the SEM the depth of the surface analyses was about 1 micron. Even with this sensitivity both sulphur and chlorine are prominent on the older units and sulphur was also present on the newer units.

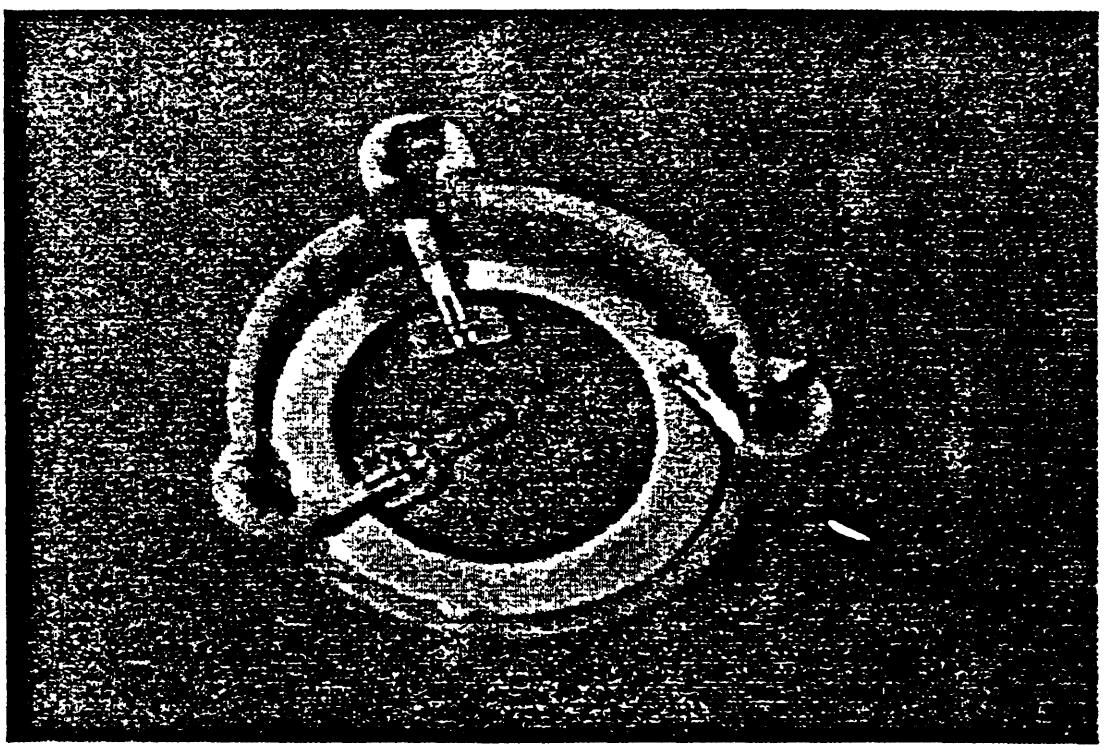
Seventeen of the 20 horns undergoing the accelerated testing of 1000 thermal cycles are of the type shown in Figures 13a and 13b. They are ruggedly constructed and the horns must be unsoldered to reveal the contacts. Also if the detector is disassembled it will probably be destroyed. For future discussion this style of horn will be referred to as

Type A. Three of the 20 horns were of the type shown in Figures 14a and 14b. This is basically a three-piece horn which can be easily disassembled and reassembled without a soldering operation. For future discussion this style of horn will be referred to as Type B. The fact that the critical contacts can be easily tampered with by curious people makes this horn less robust than the Type A horn. Also when reassembled the piezoelectric disc can be reversed making the smoke detector malfunction. Based on the 1000 cycle test the Type B horns appear significantly less reliable than the Type A horns. None of the Type A horns failed after 1000 thermal cycles while all three Type B horns failed.

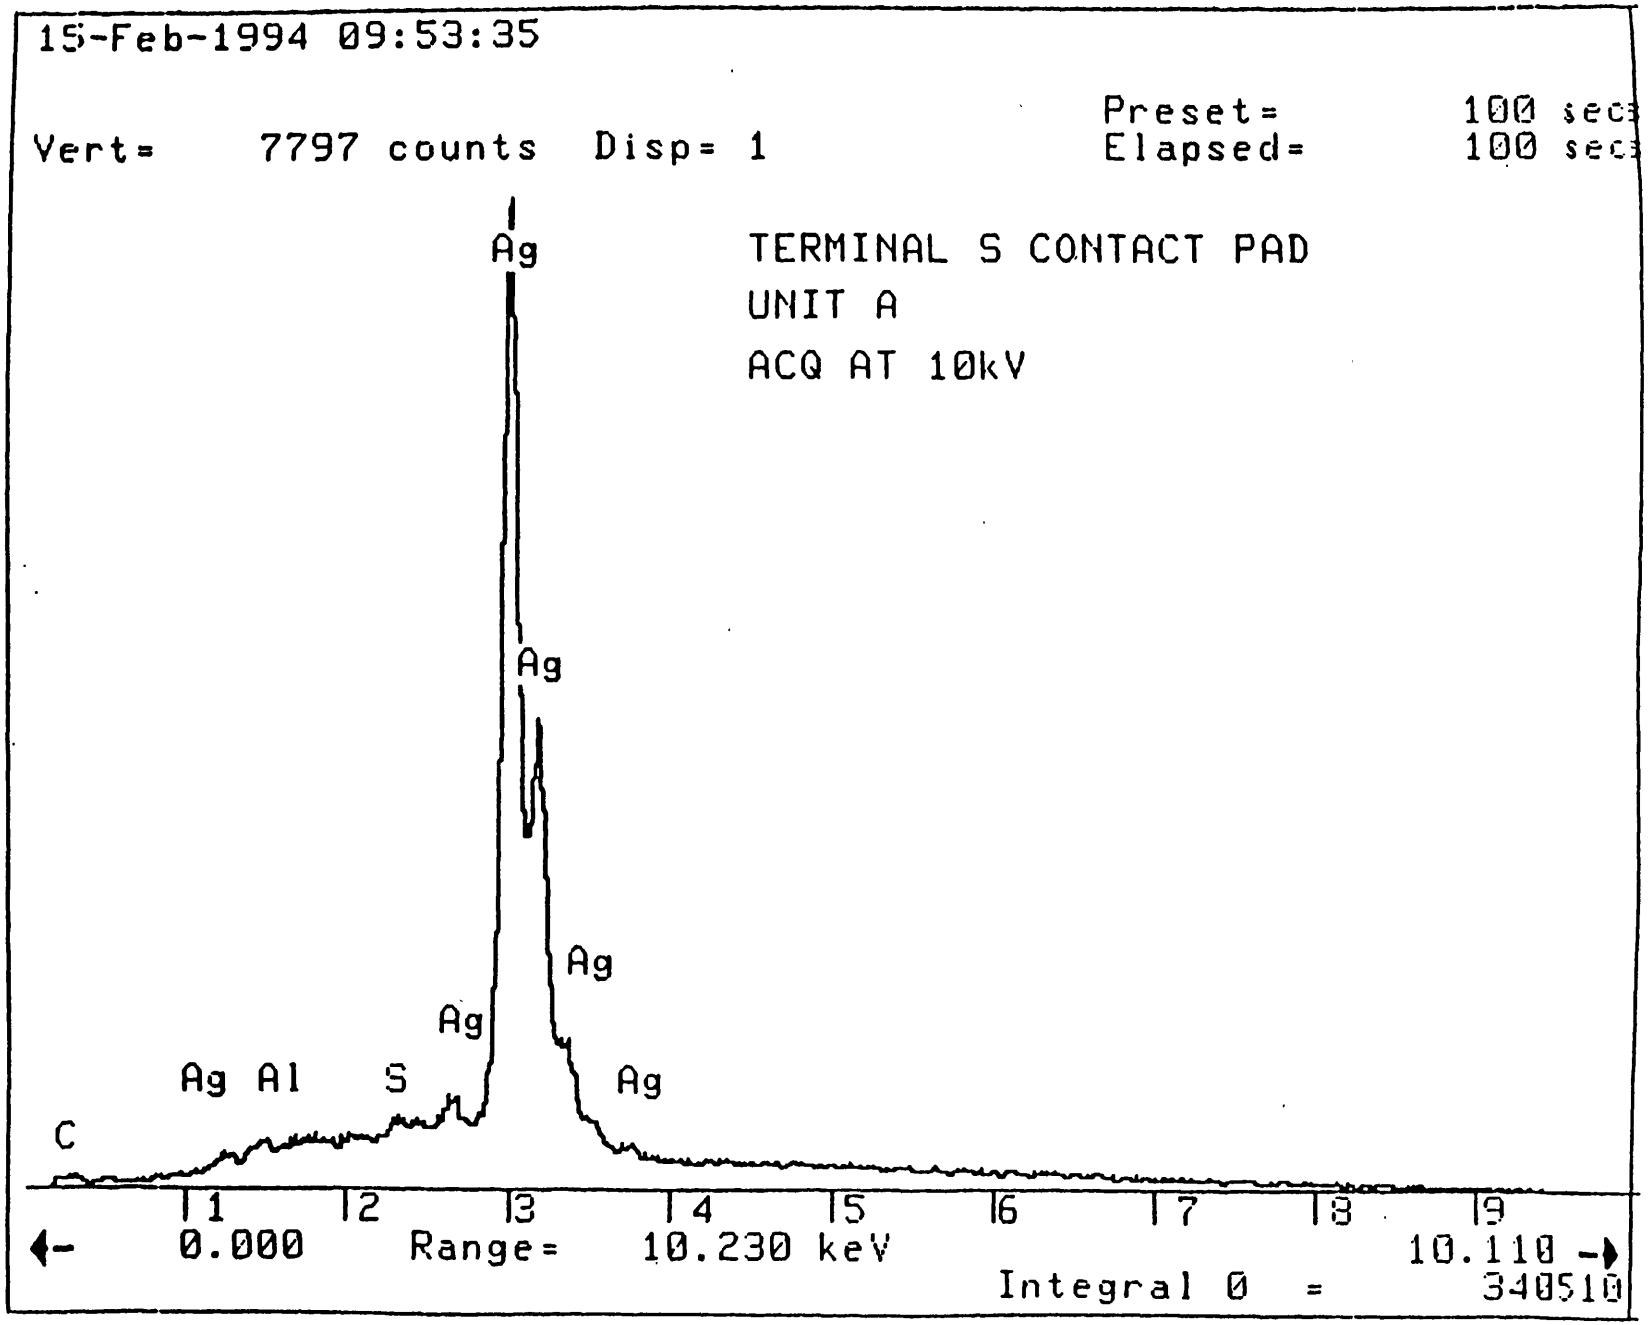
FIGURE 15: BEFORE CORROSION TEST - SO_2

Units A, B and C were investigated with SEM and EDAX before and after the corrosion testing. No noticeable visual difference could be found for any unit. However, the EDAX testing showed some differences. Figures 15 and 18 show the before and after tests of Unit A, Terminal S. The only difference is the increase in sulphur. Figures 16 and 19 show the before and after tests of Unit B, Terminal F. Again the only difference was an increase in the sulphur. Figures 17 and 20 show the before and after tests of Unit C, Terminal B. In this case there was no difference between the before and after plots. This testing again shows how benign the corrosion tests are concerning the horn contacts. The silver, which has an affinity for sulphur, did show an increase in sulphur, but the tin plated area did not show any significant amount of sulphur either before or after testing. A post corrosion EDAX test was run on the silver pad at contact F for Unit C. This plot (Figure 21) showed that the sulphur level was similar to the post corrosion EDAX tests on Units A and B.

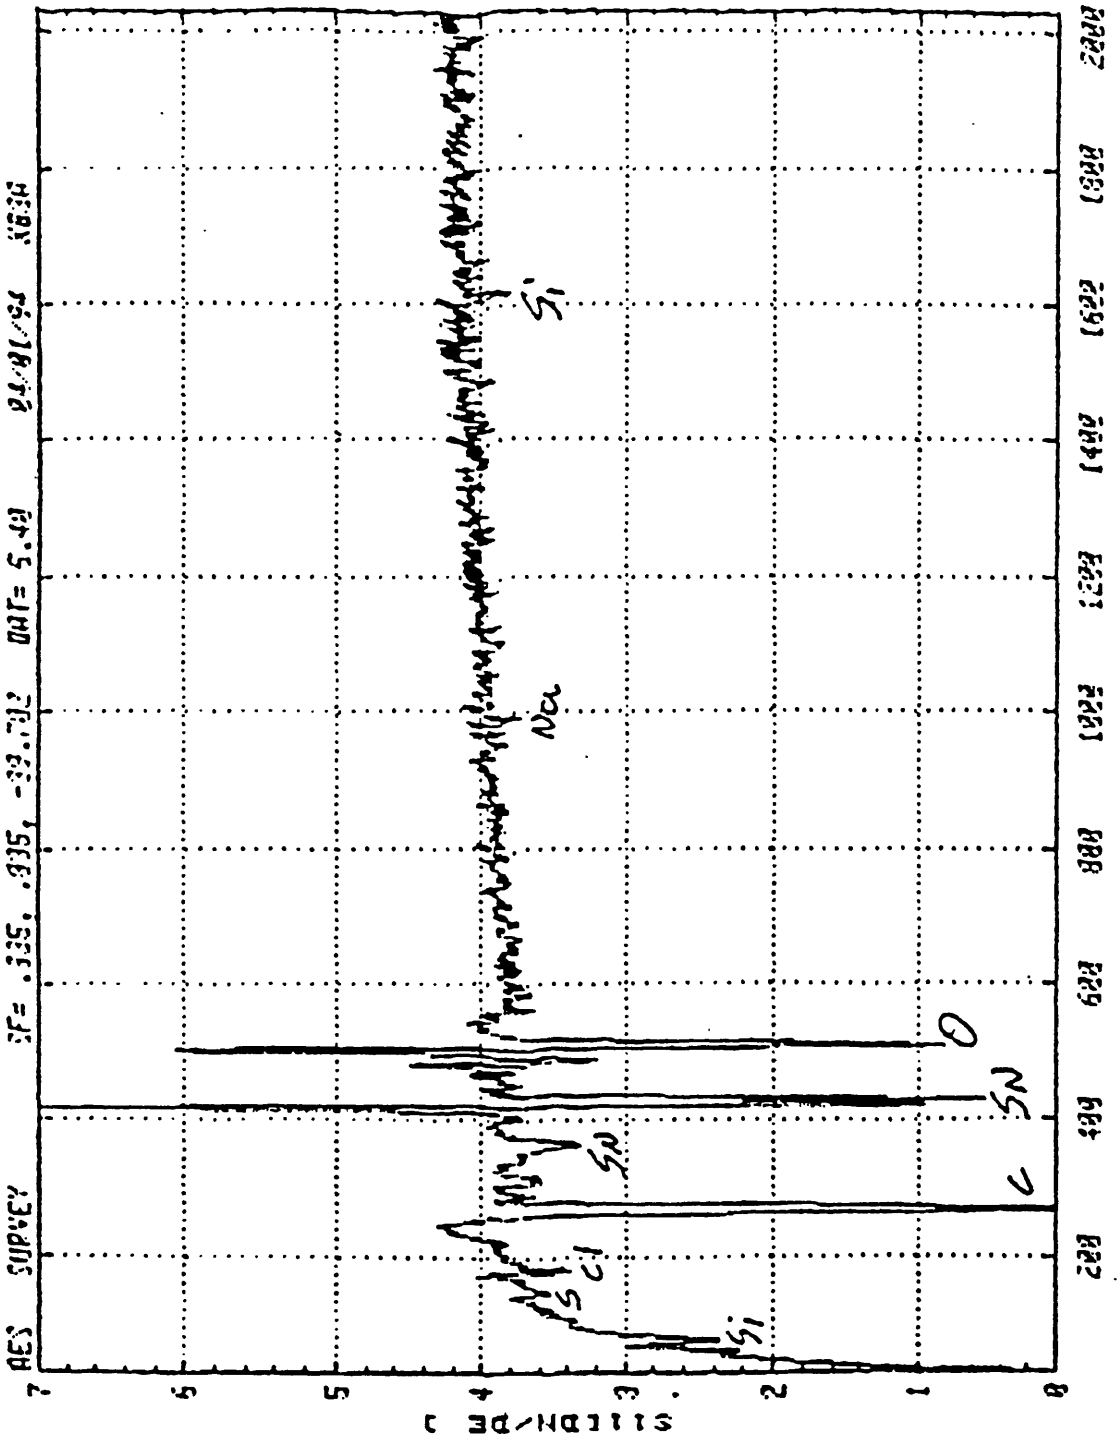
FIGURE 25

Figure 25, the pre-sputtering surface analysis on terminal B of horn X shows only a slight trace of sulphur. Both silicon and chlorine have higher levels than the sulphur. Horn X was selected for this testing because it should have had the thickest layer of contamination and confirms the EDAX surface analysis on horn C (Figure 20). This data also indicates that the UL 217 testing did not stress contact B (non-silver). Finally, based on the contact resistance measurements (see Table 10) it is apparent that the UL 217 corrosion testing provides minimal stressing of the horn contacts.

Auger elemental survey of Sample X, Terminal B

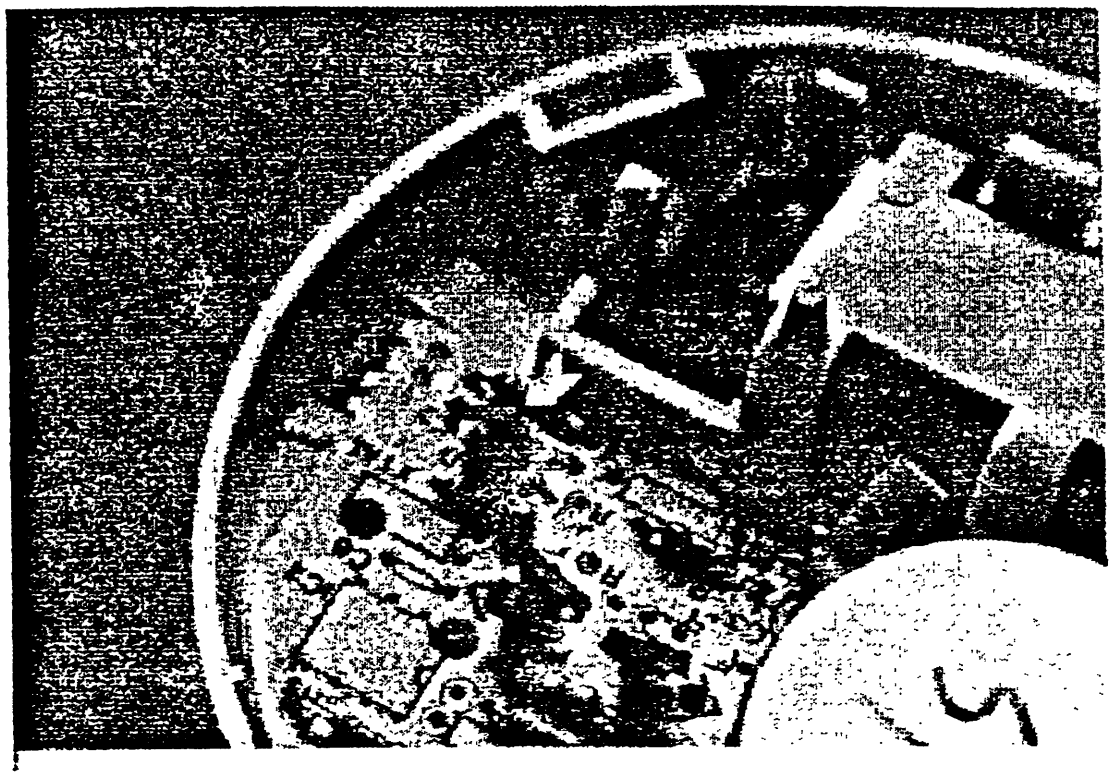
FIGURE 34: HORN CONTACTS ON SMOKE DETECTOR Z

Smoke detectors A, B, C, X and Y contain type A horns which are described earlier in the report. However, the horn from smoke detector Z is neither type A or B and, for future reference, will be called a type C horn. Figure 34 shows (see arrows) the three type C horn contacts which are easily accessible by removing the back of the detector. The horn element (shown in Figure 35) which is loosely contained by the front portion of the smoke detector housing can fall out during disassembly of the smoke detector if the back section is not carefully removed. When this happens, damage to the horn element and/or contacts is possible. Also an inexperienced person could reassemble the smoke detector with the horn in backwards. Since all of this can be accomplished simply and without a soldering operation this type of horn can be assumed to be less reliable than the type A horns. Figure 36 shows a close-up of contact F. The intent of this design is to have a sharp point contacting the horn element.

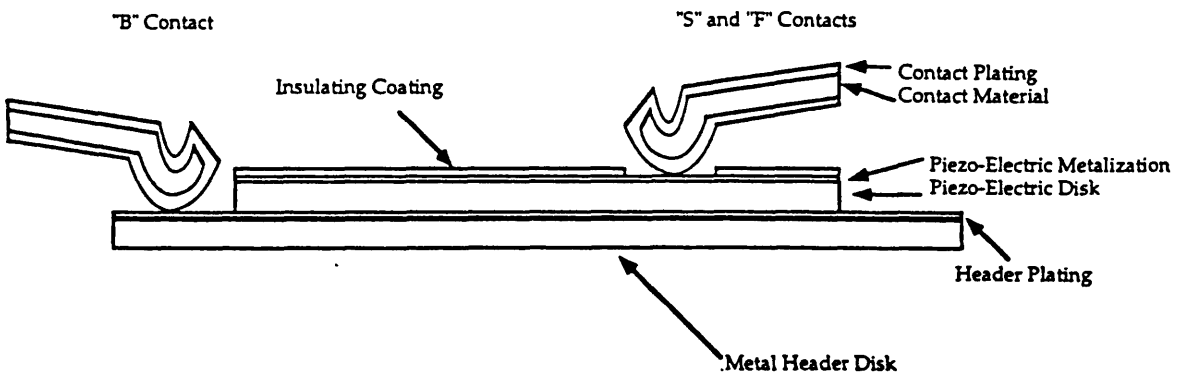
FIGURE 1: CONCEPTUAL CROSS-SECTION OF HORN DISK AND CONTACTS

After completion of the corrosion testing all six smoke detectors functioned properly. Surface analyses and depth profiles were then run on the contacts and contact pads. The horn configuration includes separable contacts B, F and S identified in a conceptual cross section drawing (Figure 1). Only the silver plated contact pads of terminals F&S showed any signs of sulfur. The depth of the sulfur layer ranged from 80Å (angstroms) on the units exposed to SO_2 to 400Å on units exposed to the combined gases. Units tested with H_2S only had a sulfur level of 180Å. On the basis of the above the SO_2 test is not needed. The H_2S or the combined testing would only be marginally useful for the silver plated contacts and useless for the non-silver contact pair (Terminal B).

However, the results of the analysis of smoke detectors submitted to standard corrosion testing does not agree with the SEM analysis of contaminants on the separable contact surfaces, selected from smoke detectors that failed in the field. The field results revealed that both sulfur and chlorine were prominent. Additionally, contact resistances measured after the corrosion testing were much lower than the measurements taken on contacts from smoke detectors that failed in the field.
