1. CASE NUMBER H5B0059	2. INVESTIGATOR'S ID	3. OFFICE CODE	EPIDEMIOLOGIC INVESTIGATION REPORT
951109CBB1168	8930	800	
4. INCIDENT DATE YR MO DAY	5. DATE IDI INITIATED YR MO DAY		
951031	951128

No injuries occurred when a fire started in a light switch and the circuit breaker failed to trip. The smoke detectors also failed to activate.

951109CBB1168
Att. #1

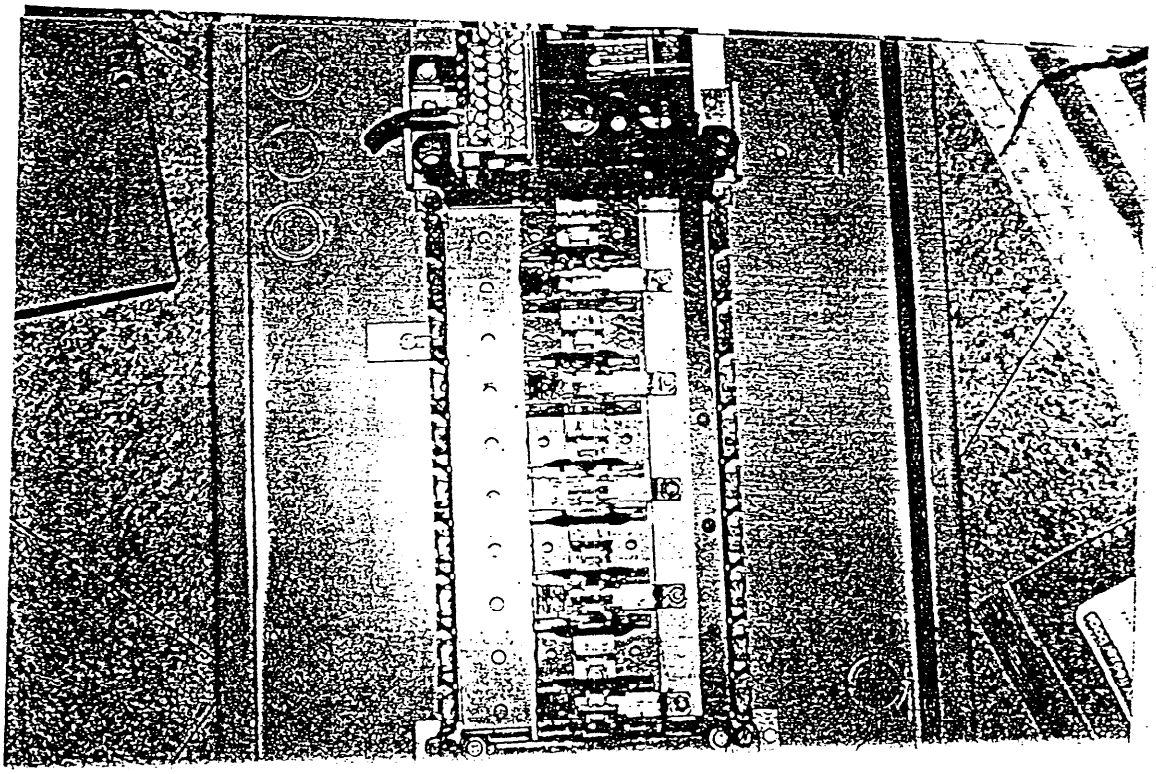
Fig. 5 - The circuit breaker box involved in the fire. It was replaced with a new one

Fig. 6 - Close-up of interior of box

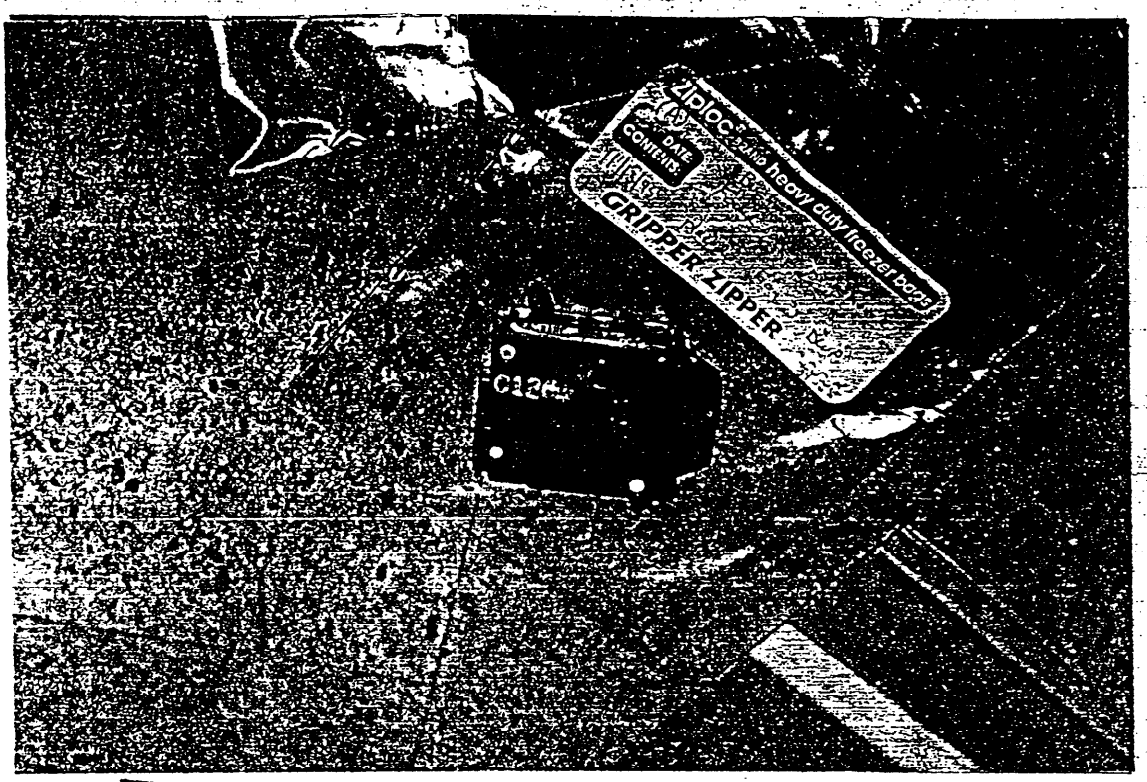
Fig. 9 & 10 - The breakers that were removed from box (front & back). Notice it melted from the heat

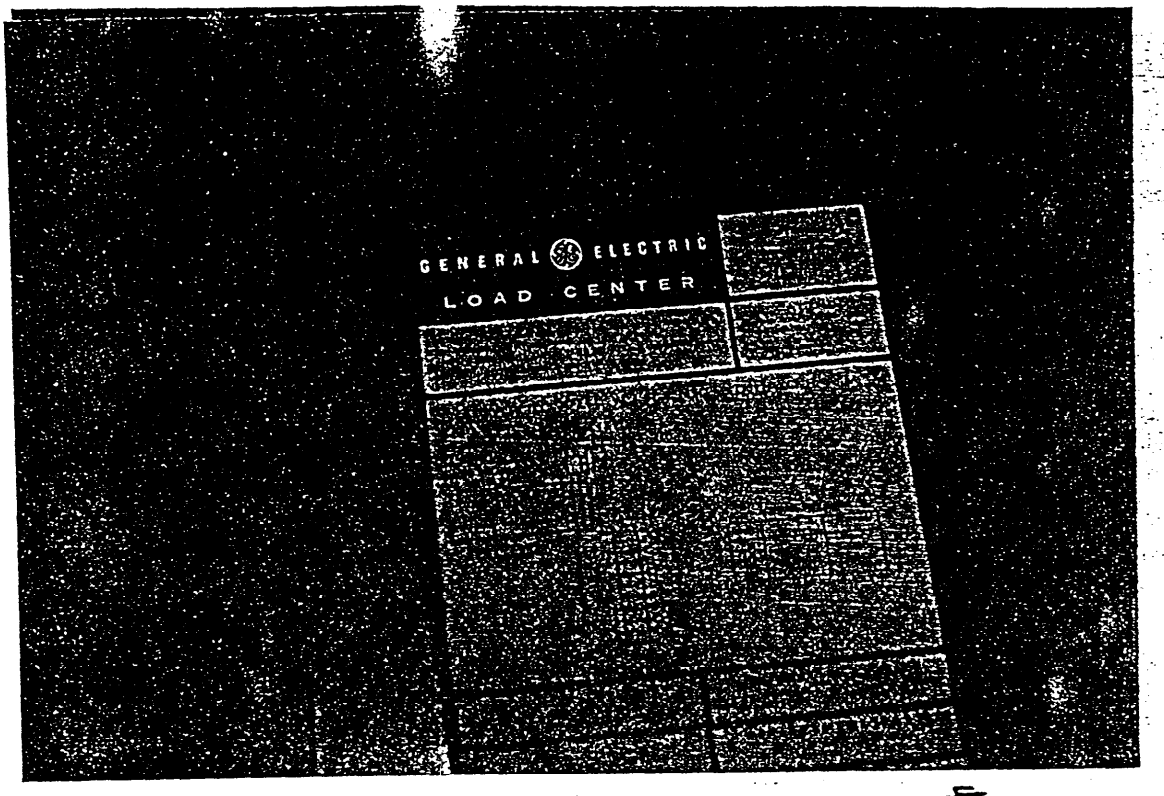
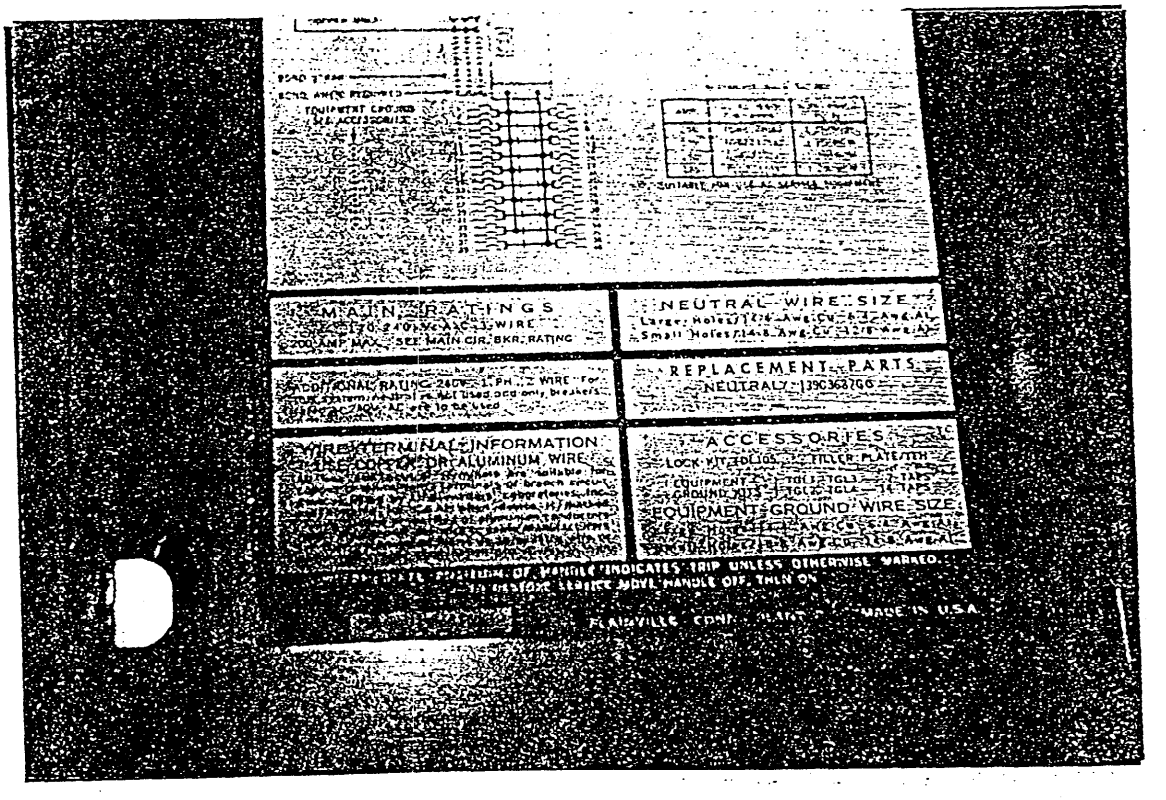
Fig. 11 & 12 - Label on inside of door of box

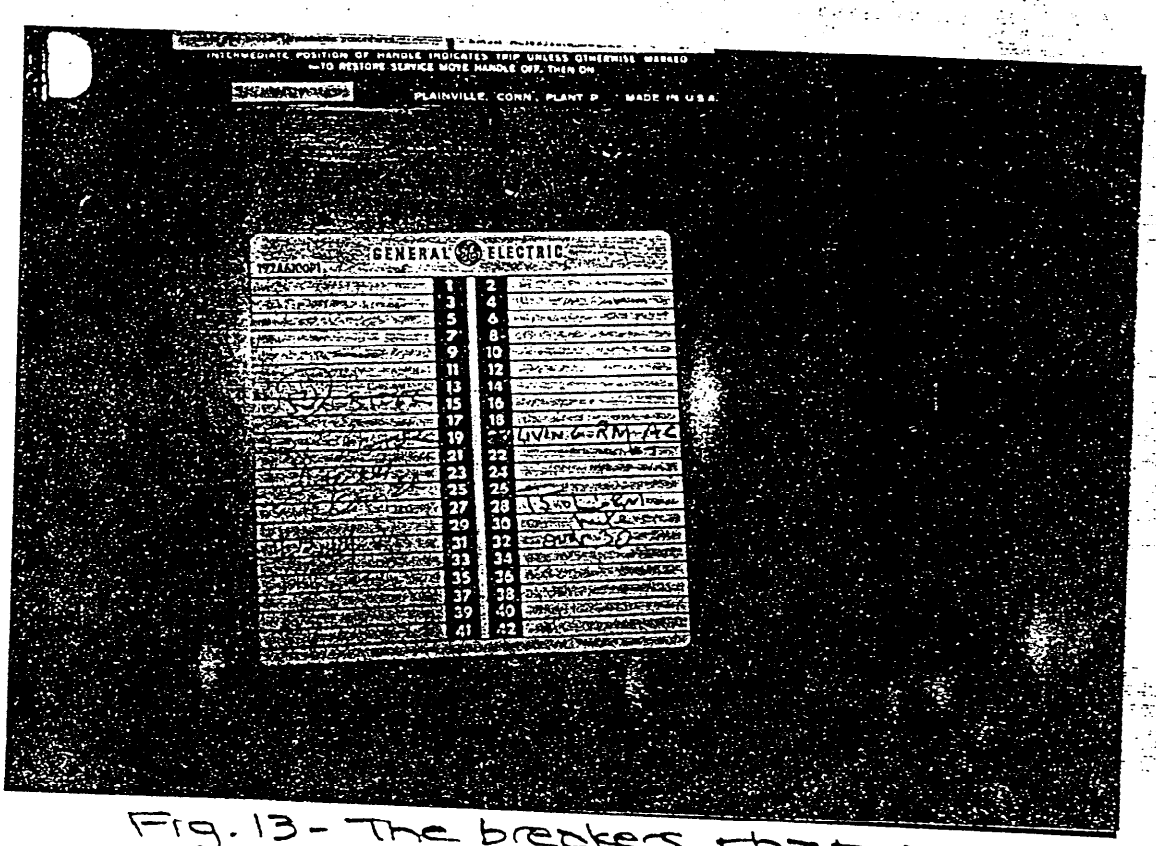
Fig. 13 - The breakers that are marked are incorrect

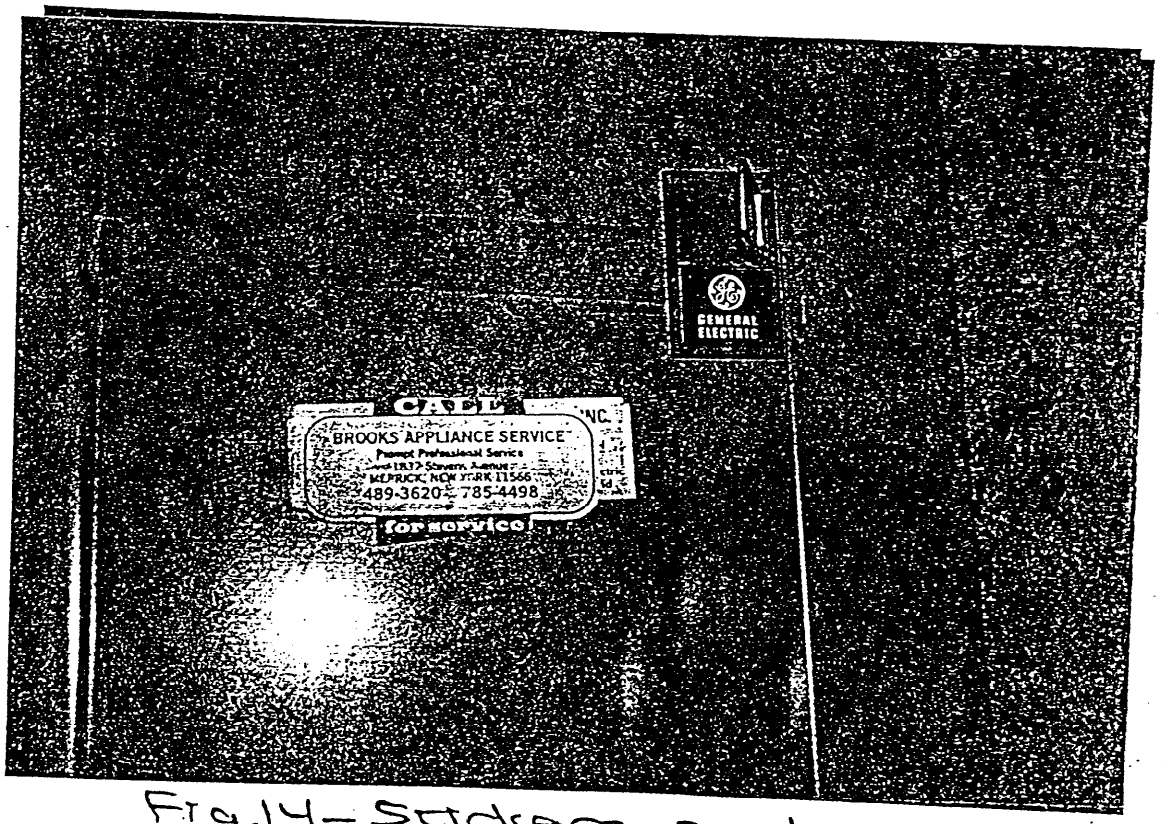
Fig. 14 - Stickers on door of box

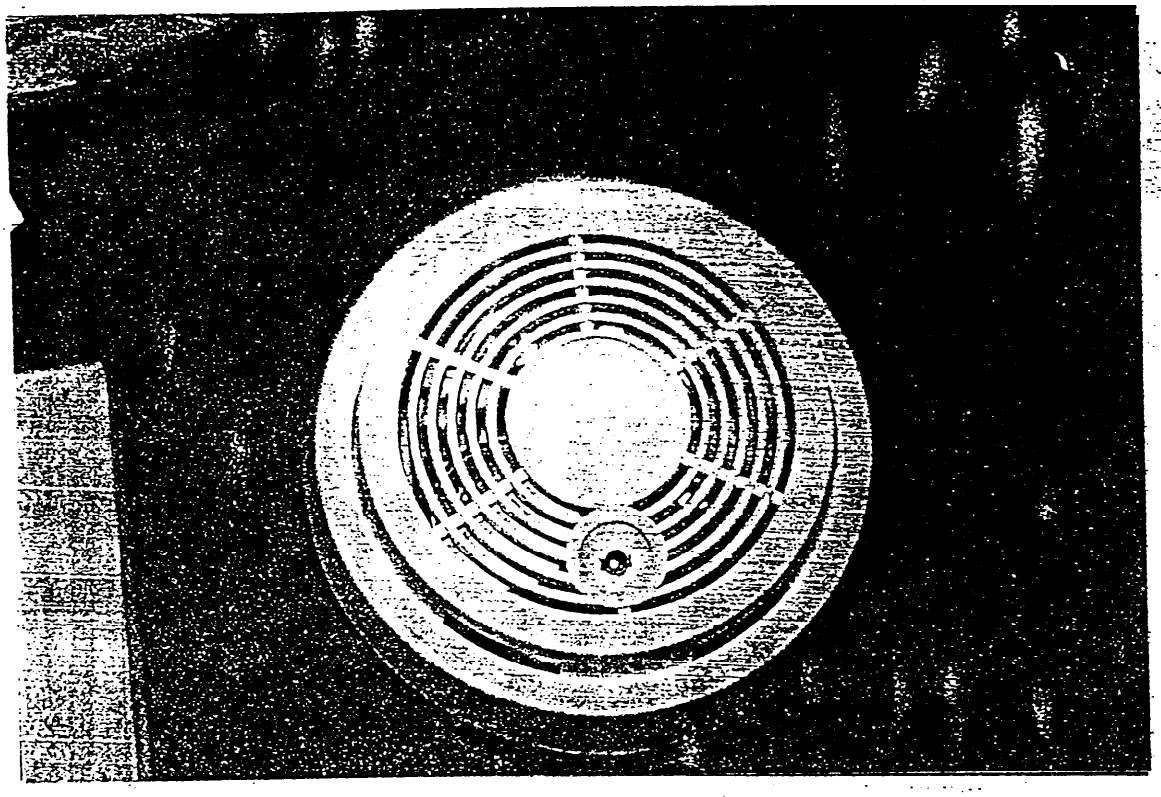
Fig-15 = Top of First Alert smoke detector

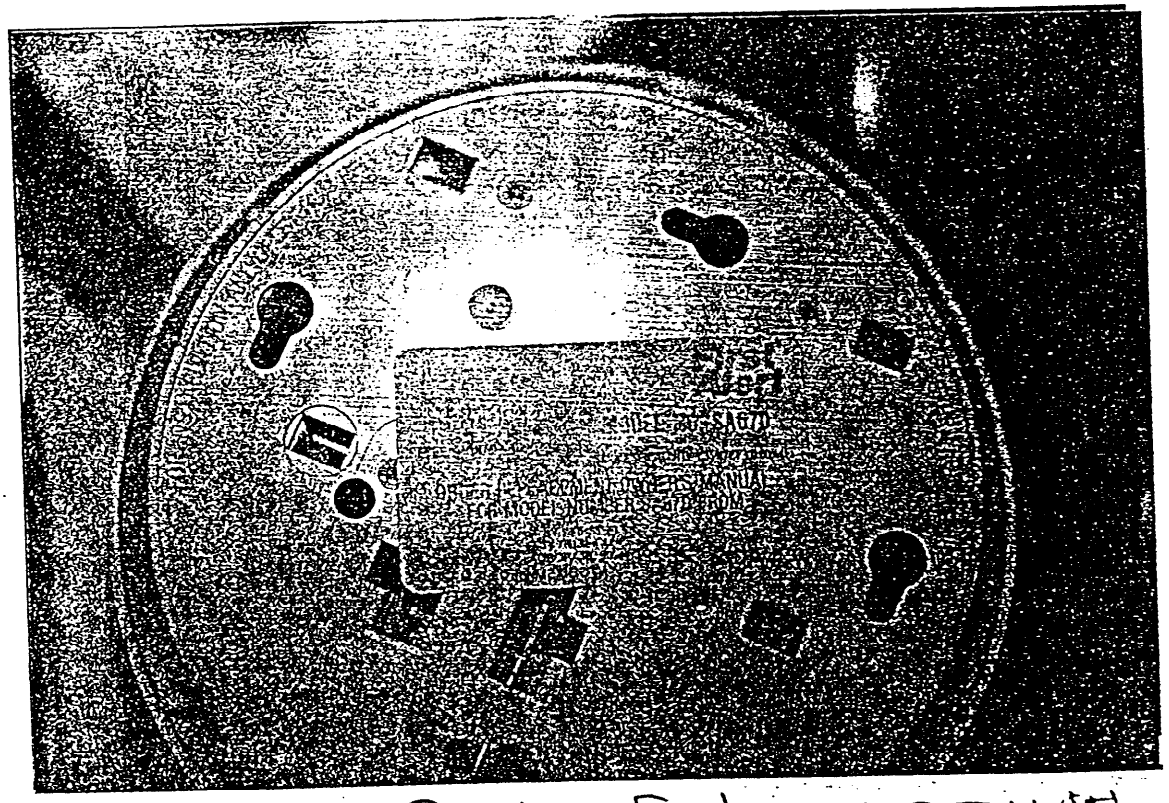
Fig. 16- Back of detector with label

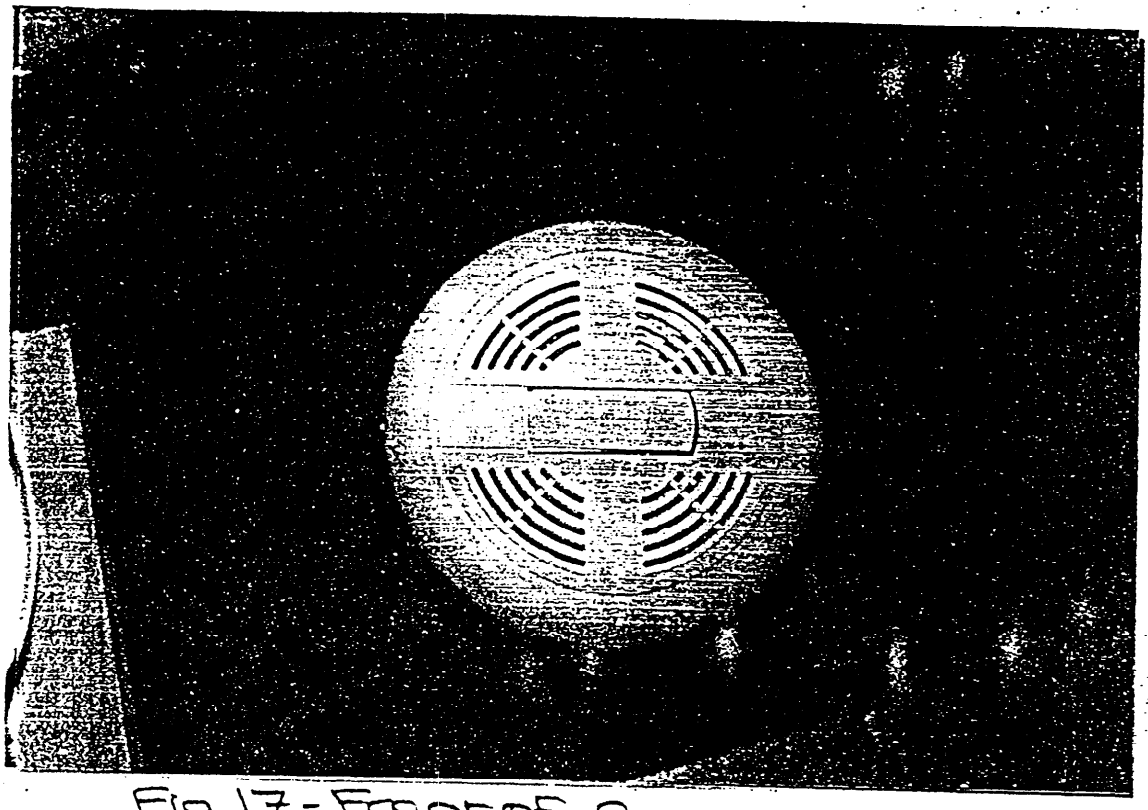
Fig. 17 - Front of American Sensors smoke detector

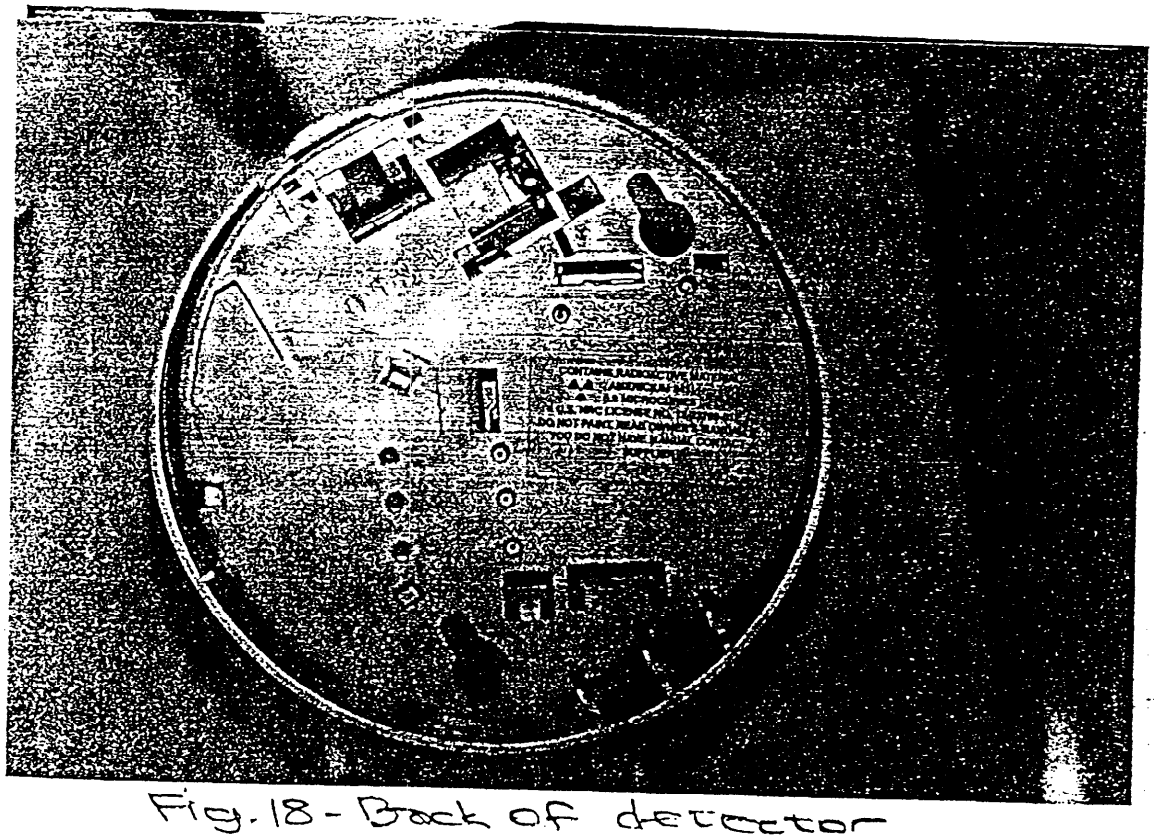
Fig. 18 - Back of detector
