1. CASE NO. G658127 '960521CCN1210	2. INVESTIGATOR'S ID 8029	3. OFFICE CODE 830	EPIDEMIOLOGIC INVESTIGATION REPORT
4. DATE OF ACCIDENT 960512	5. DATE INVESTIGATION INITIATED YR MO DAY 960522

6. SYNOPSIS OF ACCIDENT OR COMPLAINT A complainant stated heavy smoke and soot filled rooms in his home when he built a fire in his fireplace and forgot to open the damper. Neither of his 2 battery powered smoke alarms sounded when this occurred. No injuries were involved and no fire occurred.

10A. FIRST PRODUCT	11a. TRADE/BRAND NAME, MODEL
battery operated smoke detector 0702	Pittway Corporation 780 McClure Road Aurora, IL 60504-2495 model no. SA670
10B. SECOND PRODUCT none	11B. TRADE/BRAND NAME, MODEL none

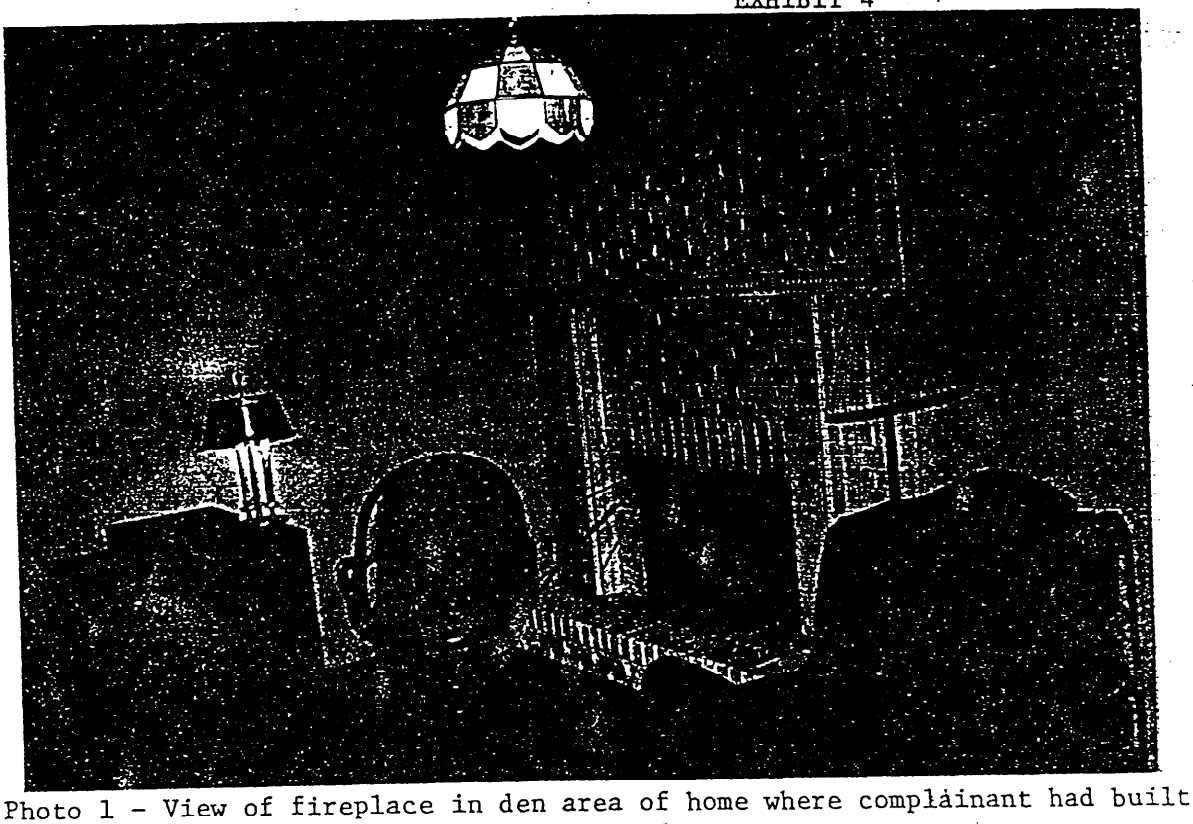
The complainant and his wife indicated their home is 22 years old and their fireplace is supplied with a natural gas line. The complainant stated he had already cleaned out his fireplace and was not planning to use it anymore this season. However, he stated on the day of this incident (5/12/96) it was a chilly day with the temperature being approximately 45 degrees so he decided to build a fire in the fireplace which has a gas starter. The complainant stated that after he build the fire, he and his wife were sitting in the den having coffee. He stated a few moments had elapsed (approximately 15 minutes or so) from the time he built the fire until the room started filling up with smoke. He stated that he had forgotten that he had closed the damper since he had not planned to use it anymore and he did not open it when he built the fire. The fireplace is located in the den portion of the complainant's home. For a view of the fireplace see the attached Exhibit 4 photographs 1 and 2.

Photo 1 - View of fireplace in den area of home where complainant had built a fire prior to smoke and soot damage.

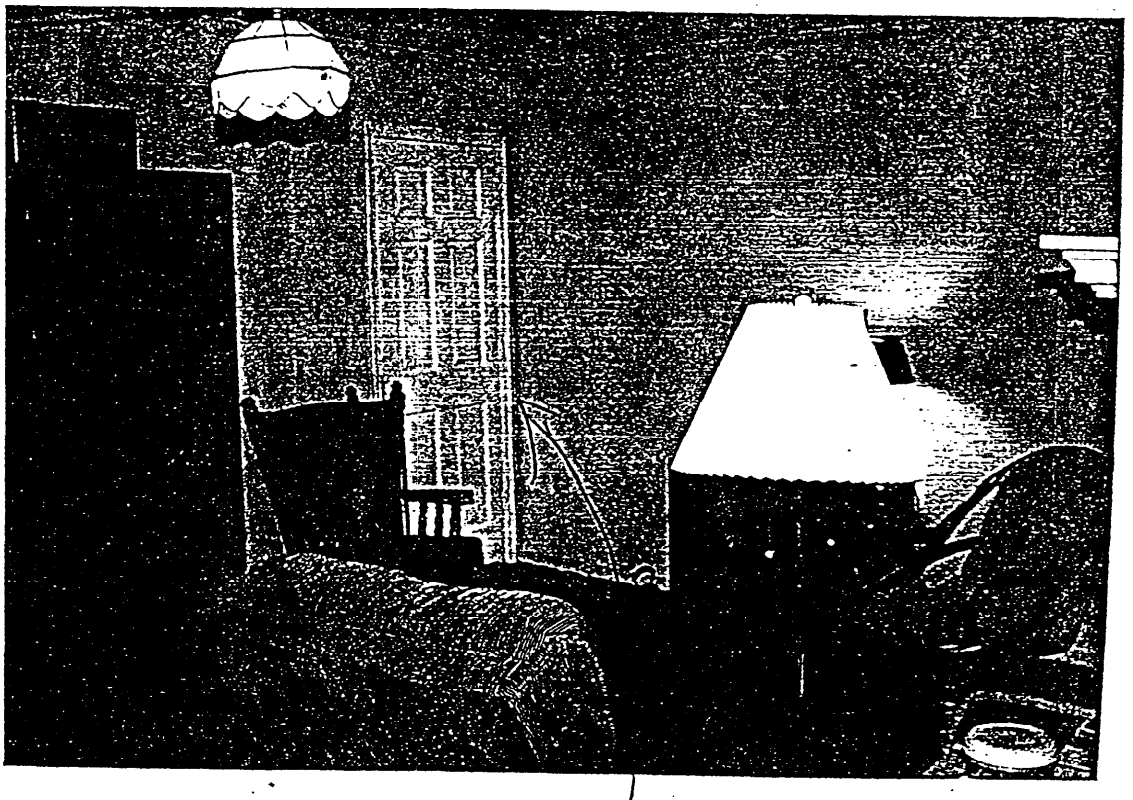
The complainant stated he had 2 smoke detectors (one located in the hallway and one located in the kitchen of his home). During the on-site investigation a ruler was used to measure the distance from the fireplace to the smoke detector located in the hallway and the distance measured approximately 15 feet. This smoke detector was still attached to the ceiling at the time of my on-site investigation. There is a doorway leading from the room where the fireplace was located into the hallway where the smoke detector was located (see attached Exhibit 4 photographs 1, 2 and 7). The complainant indicated that at the time of this incident, this doorway was closed and when the smoke filled the den where the fireplace is located they immediately opened the door but the smoke detector in the hallway did not go off.

Photo 4 - View of den area showing doorway leading to the hallway where one of the smoke detectors was located at the time of the incident. (NOTE: Complainant stated doorway was closed when smoke and soot first originated but was opened when smoke filled the room and the detector in the hallway did did alarm)

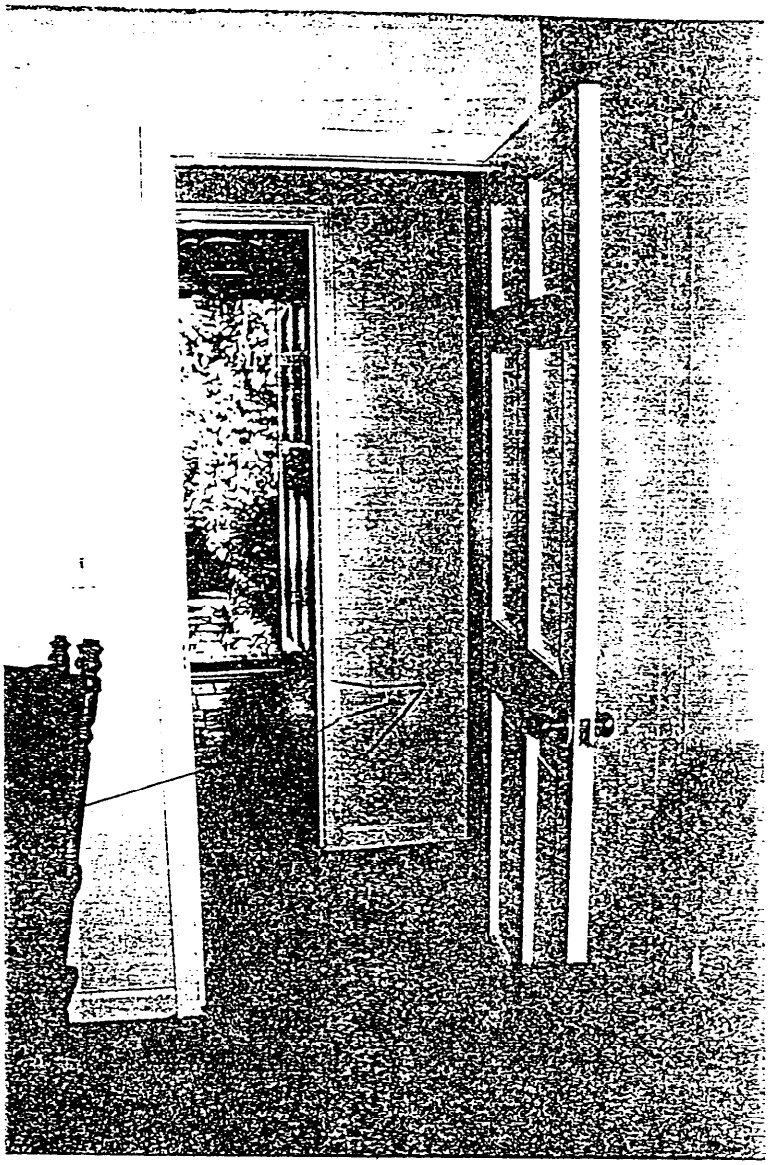
Photo 5 - View of doorway leading from the den into the hallway where one of the detectors was located. This is the same door shown in photo 4 which was in the closed position.

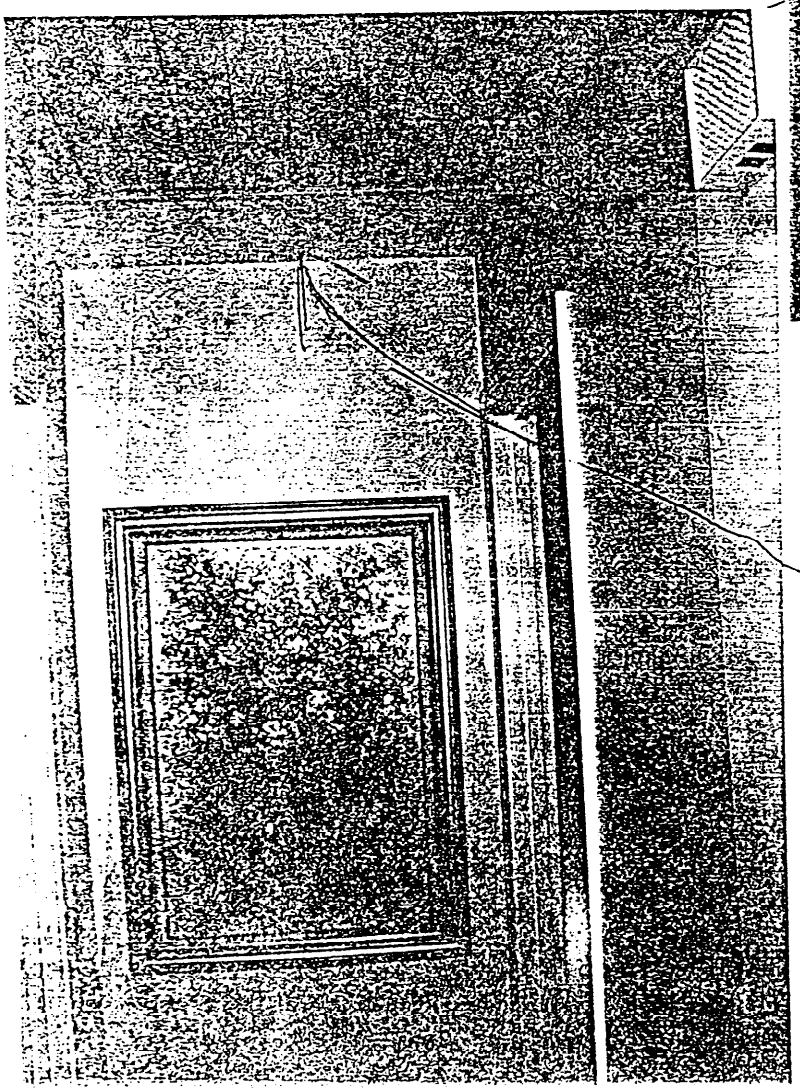
Photo 6 - View of hallway where one of the smoke detectors was located in the ceiling.

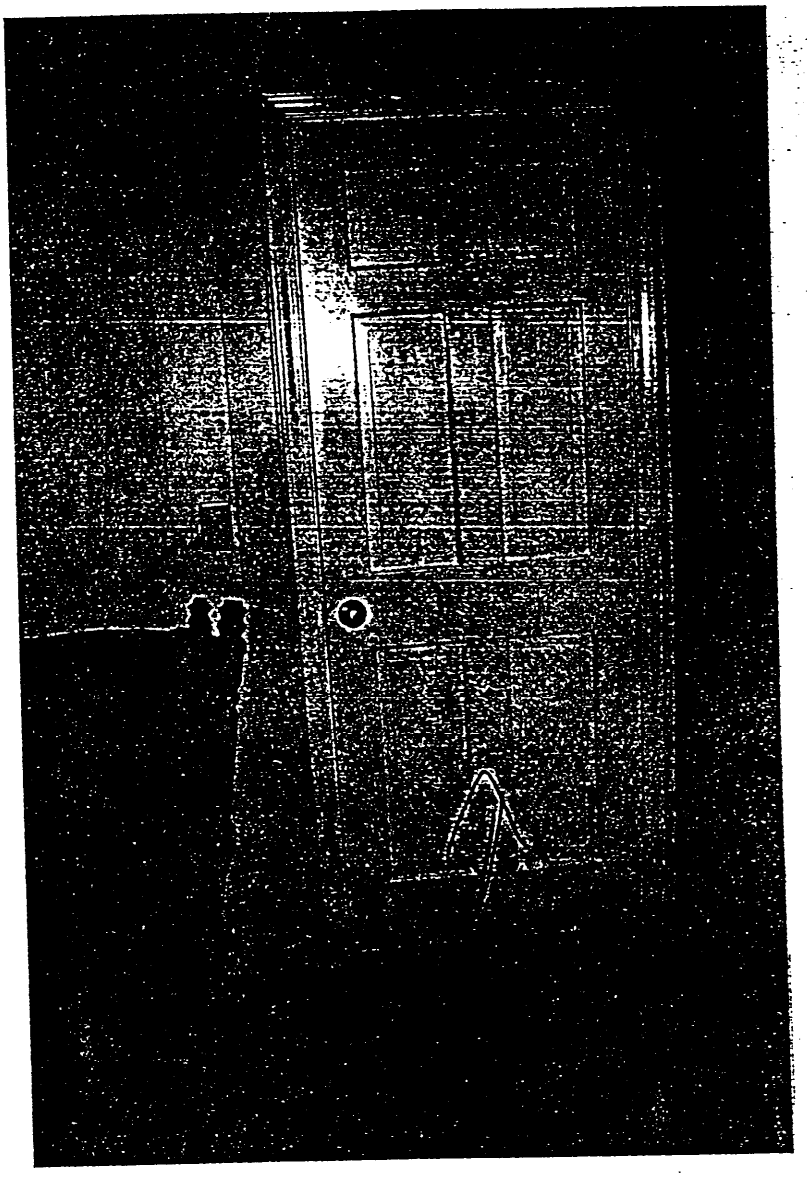
Photo 7 - View of doorway leading from the den into the hallway in the closed position.

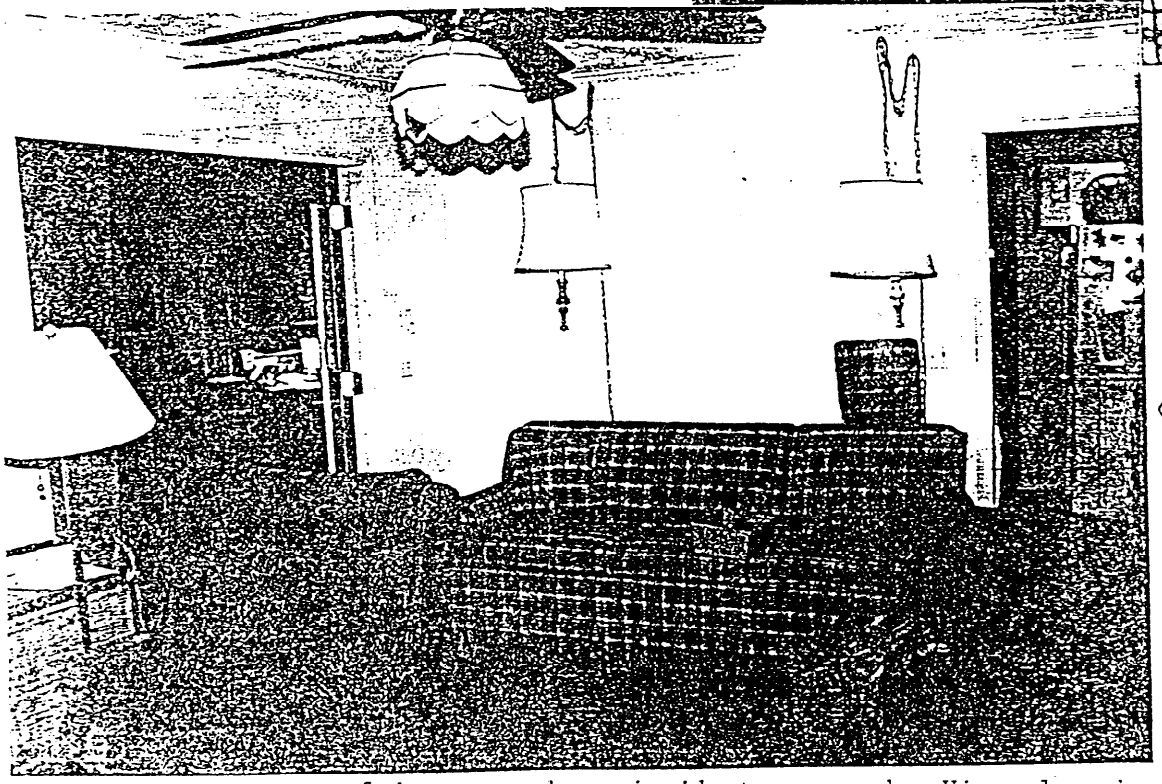
Photo 9 - View of den area where incident occurred. View also shows doorway leading to closed in porch area and doorway leading to the kitchen where [illegible]

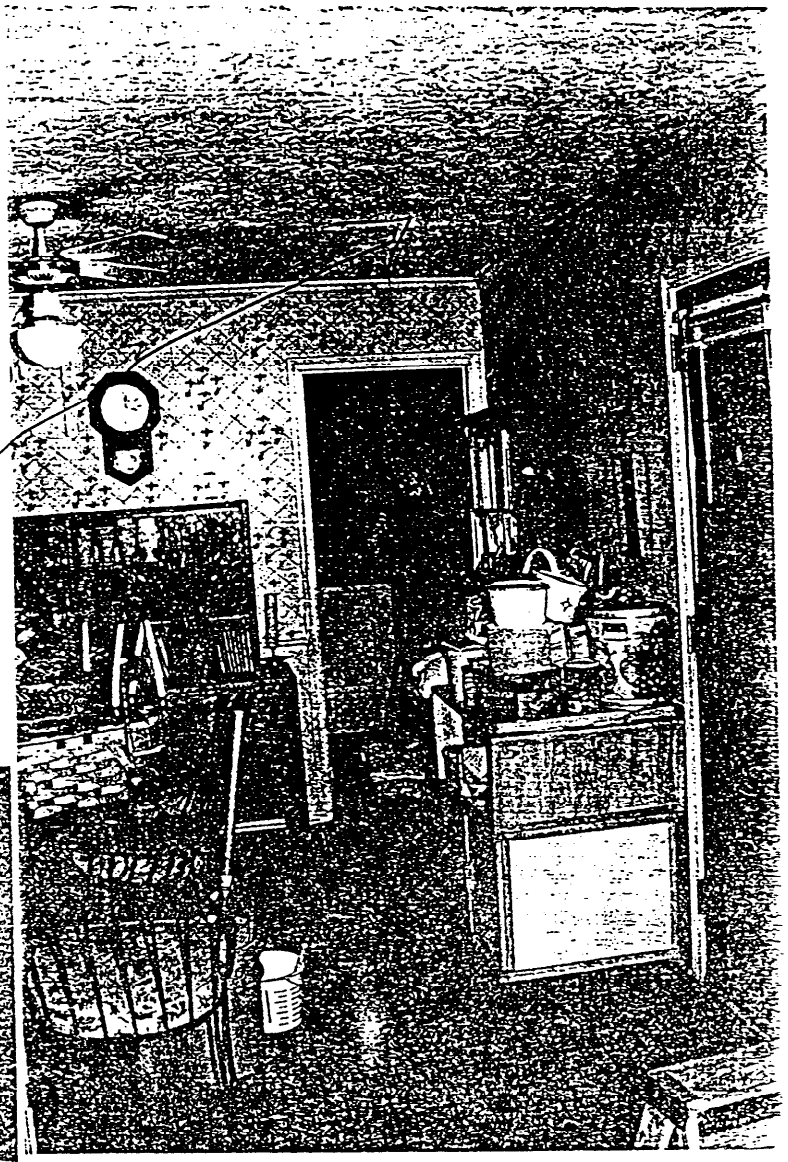
During the on-site investigation the distance from the fireplace in the den to the area in the kitchen where the other smoke detector was originally attached to the ceiling portion was measured and the distance measured approximately 39 feet (see attached Exhibit 4 photographs 4, 5, 9 and 10). The complainant had removed this smoke detector from the ceiling on the day of this on-site investigation. For a view of where the smoke detector was located in the kitchen see the attached Exhibit 4 photograph 10. For a view of the doorway leading into the hallway from the den where the other smoke detector was located see the attached Exhibit 4 photograph 5. In addition Exhibit 4 photograph 8 is a view showing the smoke detector located in the hallway.

Photo 10 - View showing kitchen area where one of the detectors was located. Distance from fireplace in den to area in kitchen where detector was located measures approximately 39 feet.

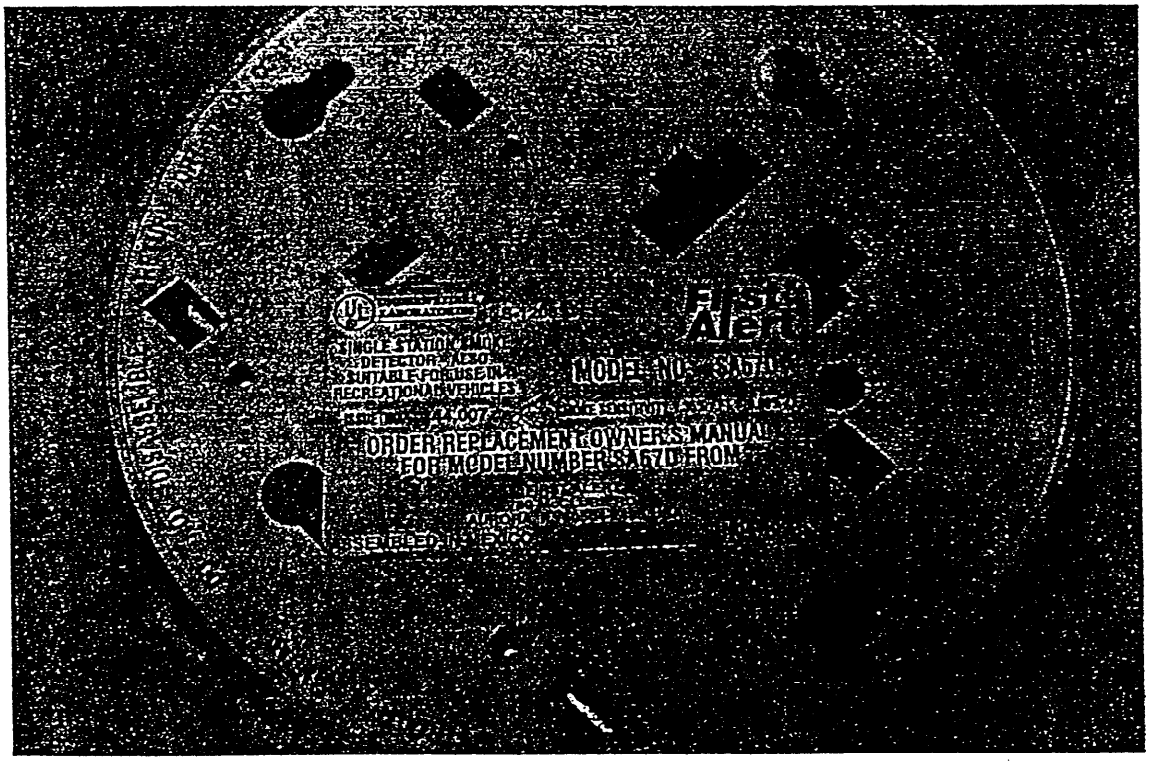
Photo 13 - View of labeling on back cover of detector that was located in the kitchen. Label states in part: "...MODEL NO. SA670..FIRST ALERT... AURORA, IL... ASSEMBLED IN MEXICO..."

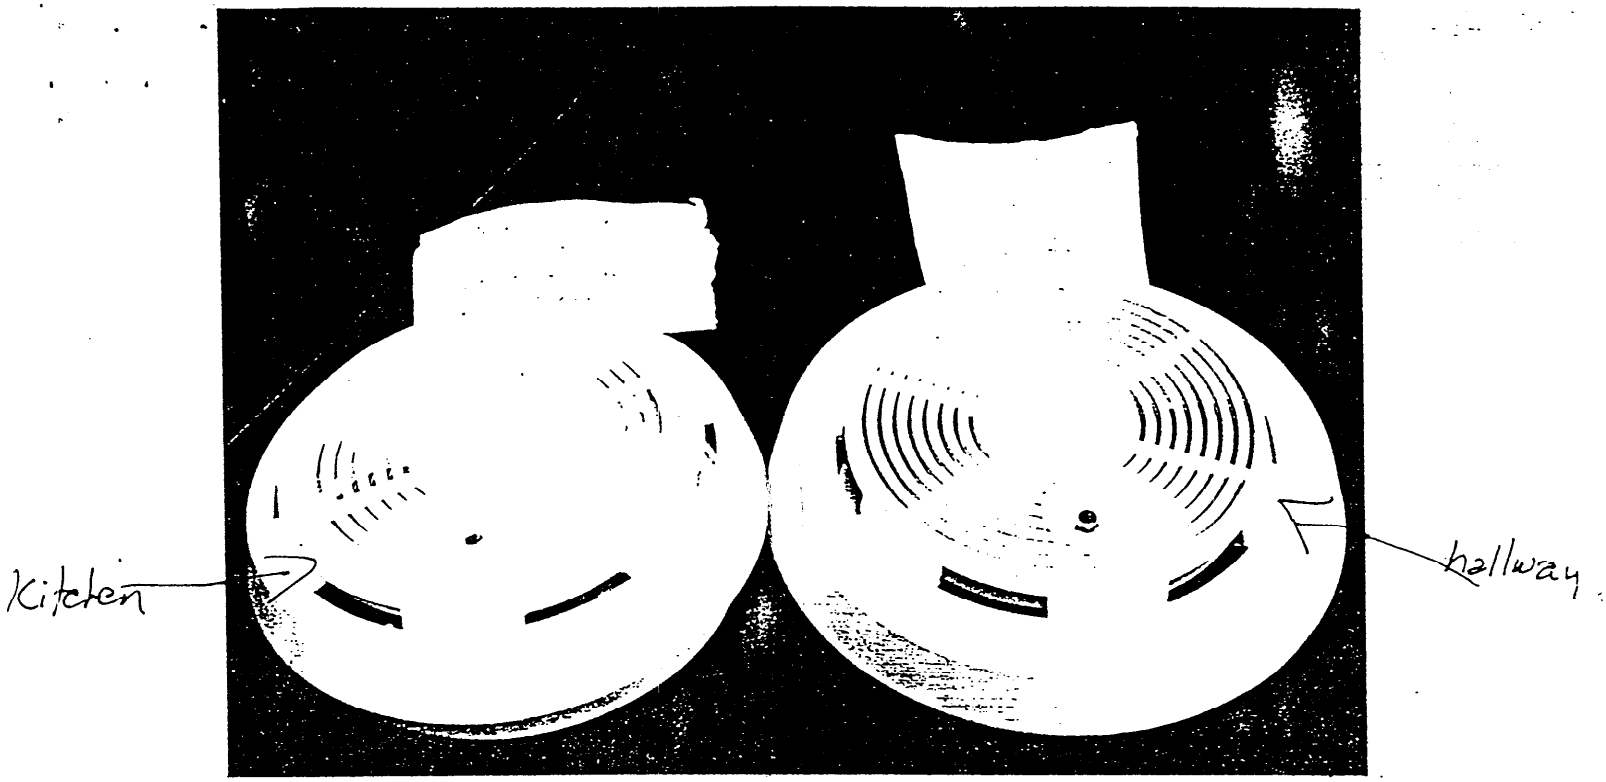
Photo 16 - Close view of detector that was located in the kitchen and hallway. The one in the kitchen was identified in SCR 96-830-4058 as Sub 2 and the one in the hallway was identified in SCR 96-830-4058 as Sub 1.

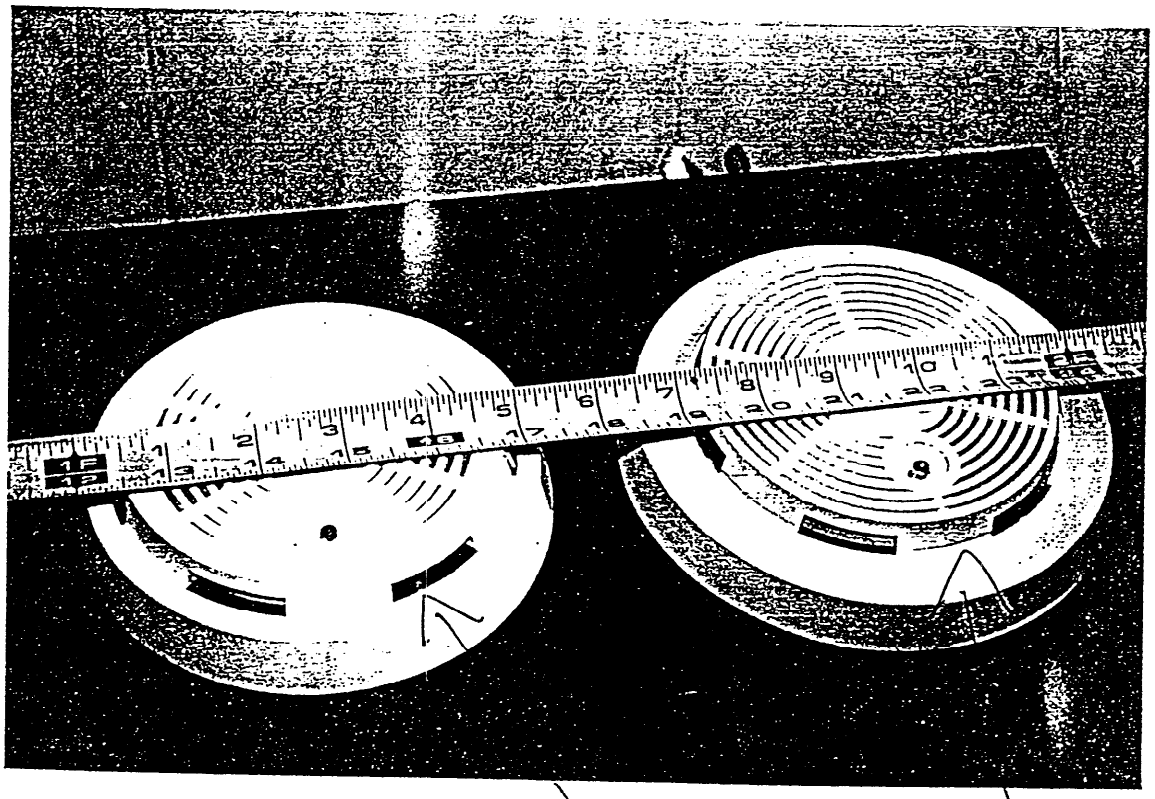
The diameter of the top portion of each of these was measured and the diameter of the one located in the hallway which is identified as Sub 1 measures approximately 6-1/4" in diameter. The detector identified as Sub 2 was located in the kitchen and the top cover portion measures approximately 5-1/4" in diameter. This measurement can be seen in the attached Exhibit 4 photograph 17 with a ruler being used to show the measurement. The base portion of each of these detectors measures the same which is approximately 5" as shown in the attached Exhibit 4 photograph 18.

Photo 17 - View using ruler to demonstrate the approximate diameter of the detectors. The one located in the kitchen is slightly smaller. It measures approximately 5-1/4" in diameter and the one in the hallway measures approximately 6-1/4" in diameter on the top cover portion.

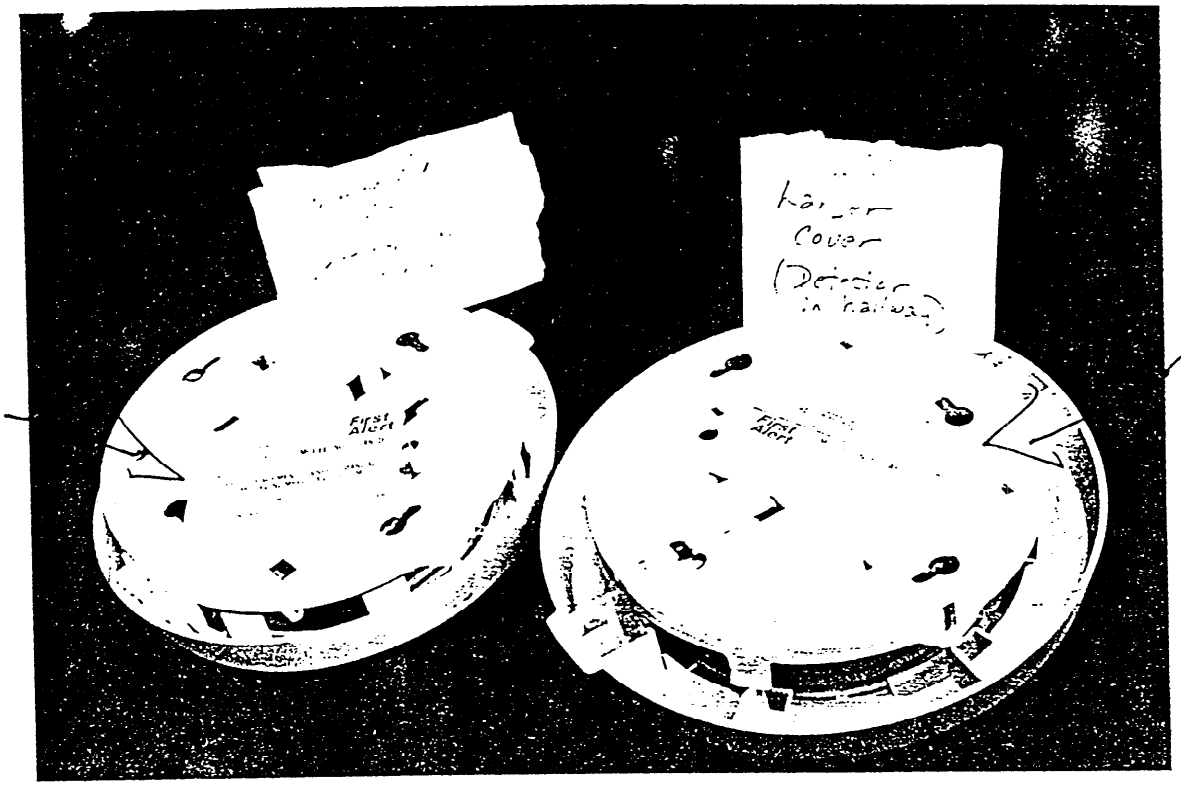
Photo 18 - Close view of bottom portion of both detectors involved in incident.

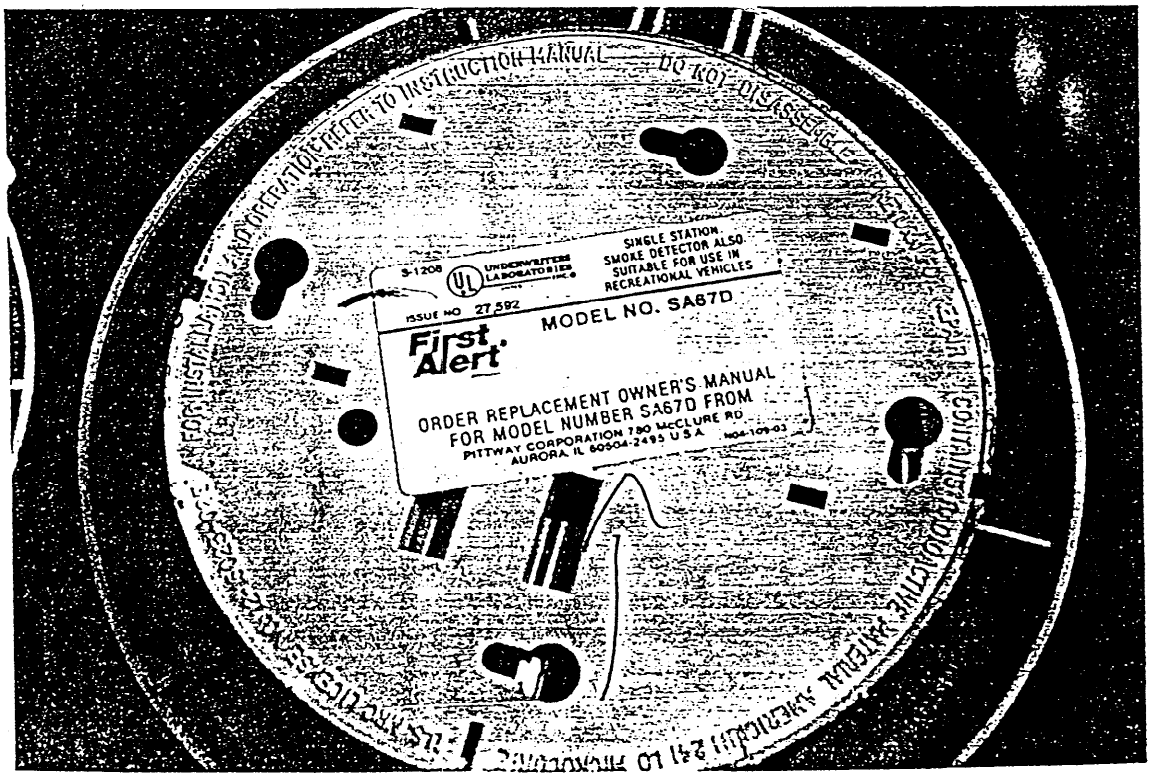
Photo 19 - View of labeling on back cover of detector in hallway indicating in part:

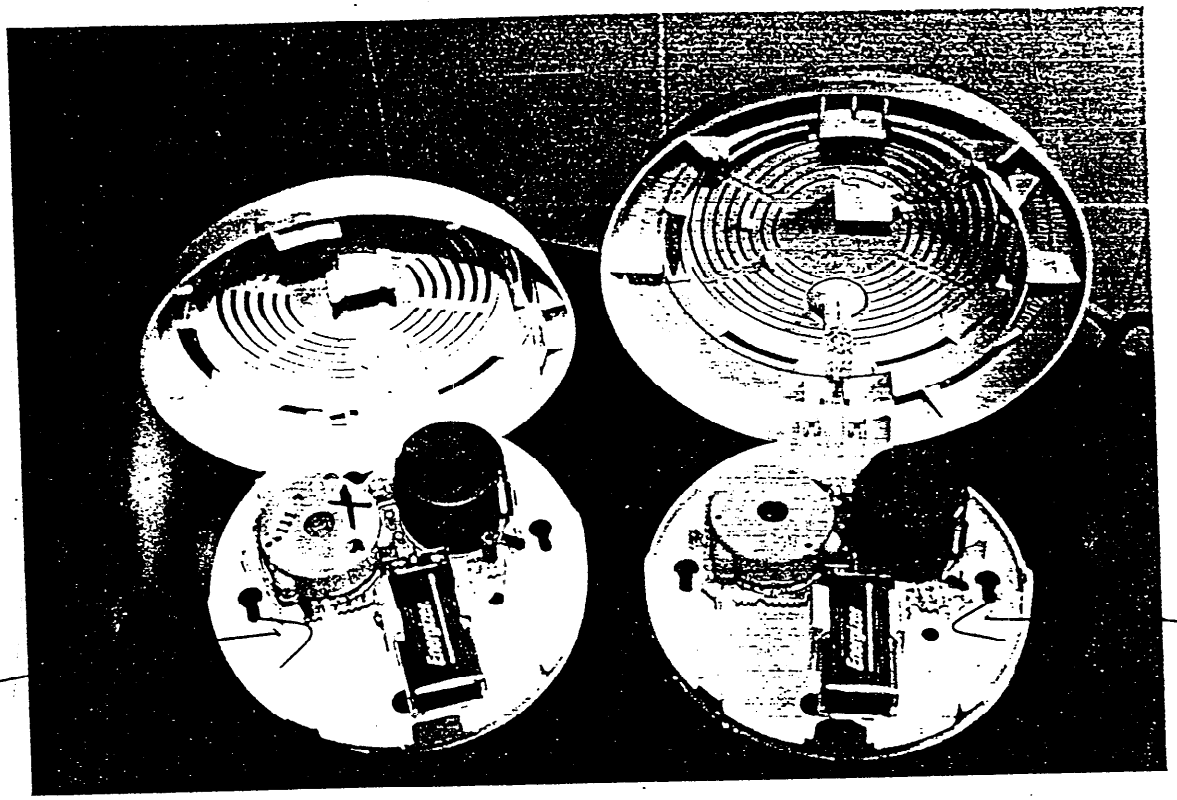
The complainant had a 9 volt "EVEREADY Energizer ALKALINE BATTERY" in each of the 2 smoke detector as shown in the attached Exhibit 4 photograph 20. The complainant and his wife indicated to the best of their memory the smoke detectors were purchased approximately 2 years prior to the time of this incident from Home Depot, Atlanta, Georgia. According to the complainant and his wife, the batteries were purchased approximately April 96 from Wal-mart, Johnson Ferry-Shallowford Road, Roswell, Georgia. The complainant indicated he checks these batteries at least once a week and he had checked both batteries right before the incident happened and each of the batteries was working properly.

Photo 20 - Close view of inside components of detector in kitchen and hallway. Both detectors use the same type battery.

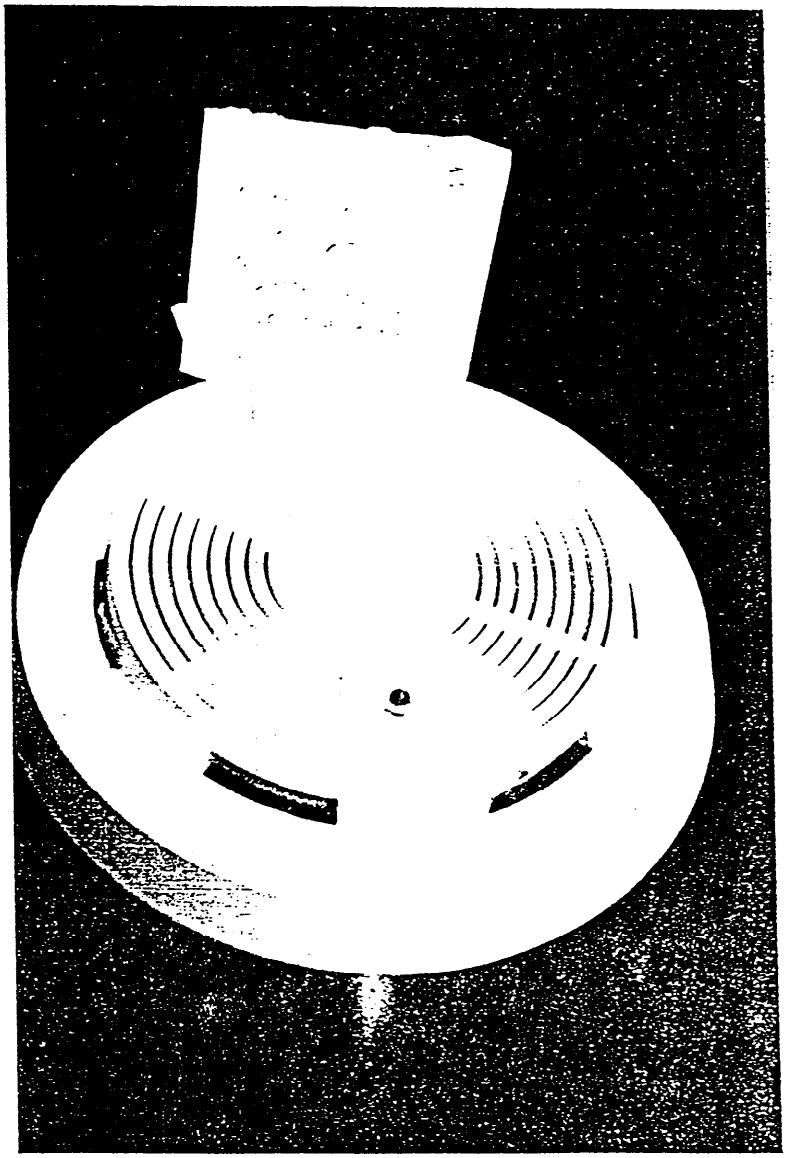
Photo 24 - Close view of battery that was located in hallway.

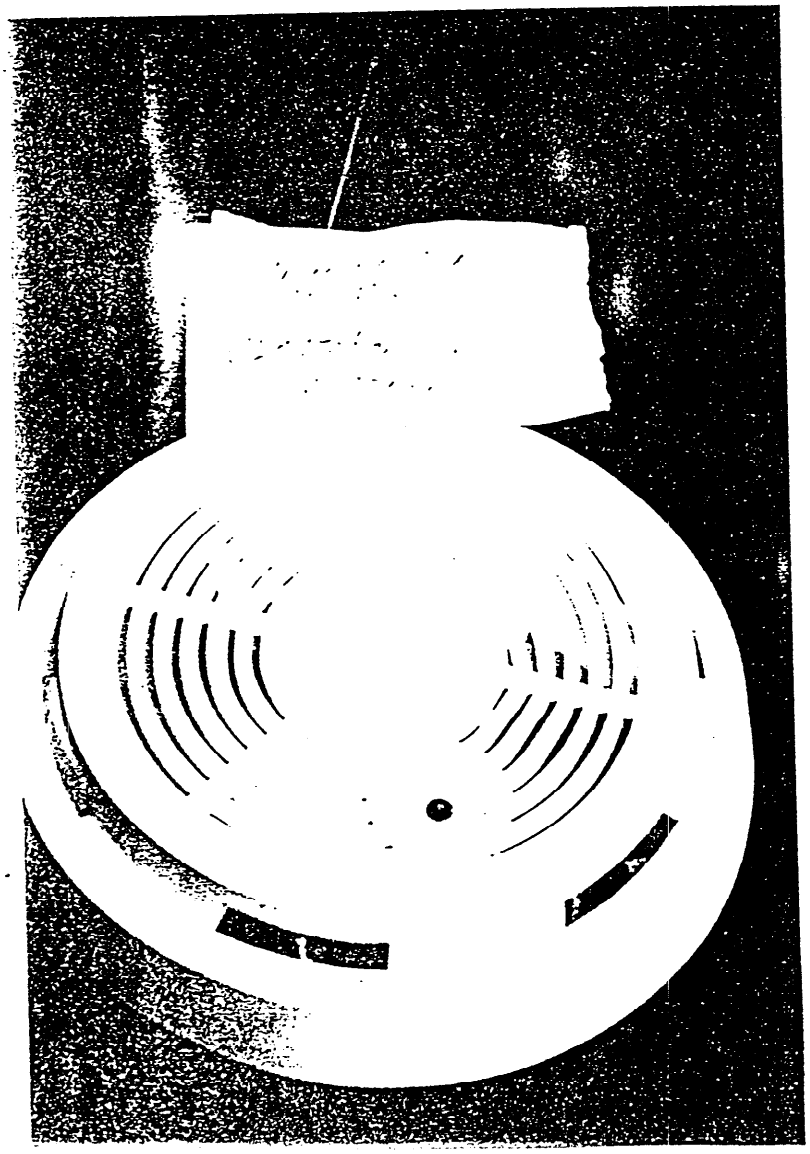
Photo 25 - Close view of battery that was located in kitchen.
