Report on Lead in Vinyl Miniblinds

LEAD POISONING HAZARD FROM IMPORTED VINYL MINIBLINDS

2. September 19, 1996, *REPORT ON LEAD IN VINYL MINIBLINDS*

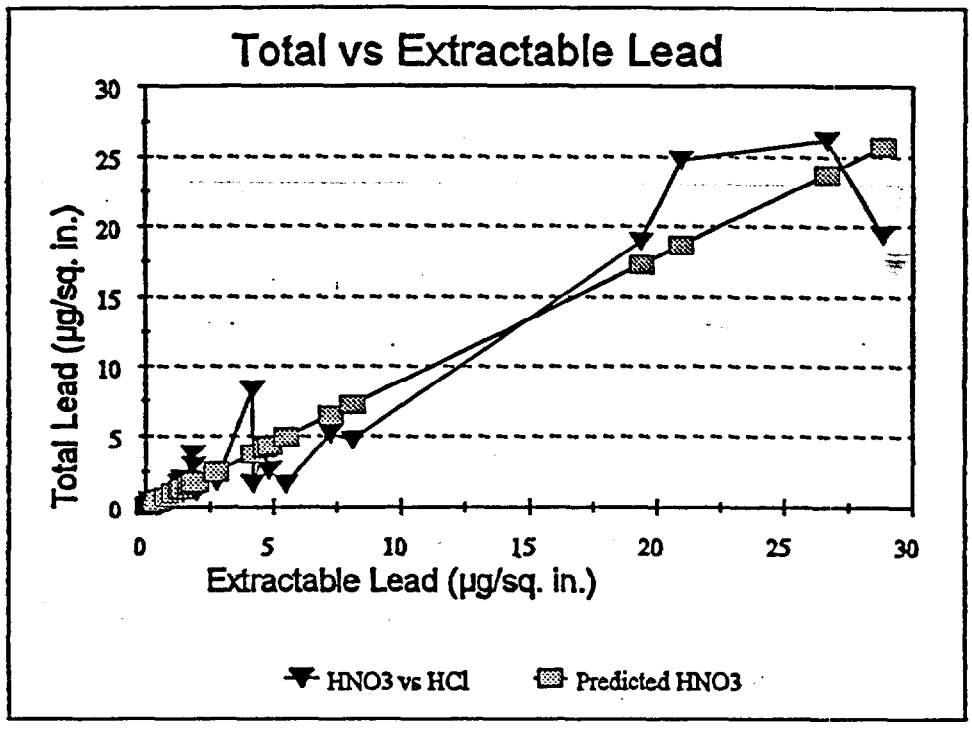
Figure 1. Surface Lead; HNO_3 digestion vs 0.07 N HCl extraction.

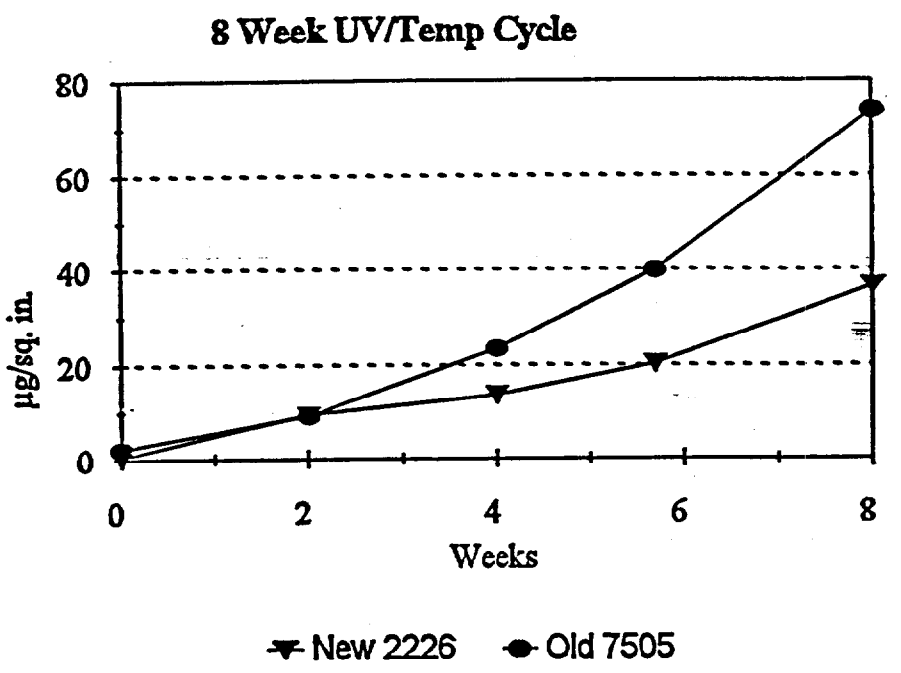
The Laboratory Sciences staff conducted additional experiments to more firmly establish the surface lead as being a result of the deterioration of the blind with the lead stabilizers becoming available on the surface. The duration of the exposure was eight weeks with samples removed for analysis about every two weeks. Thus, one new and one used blind were initially

Figure 2. Accelerated Aging of New and Used Miniblinds

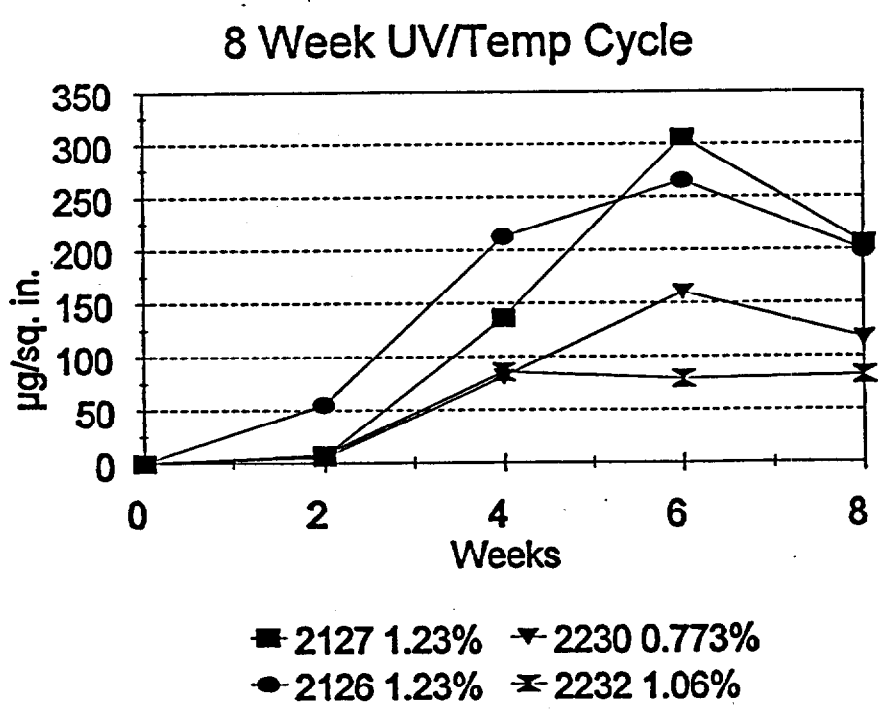
Table 7. Four New Blinds with Different Total Lead Concentrations, 8 Weeks Accelerated Aging.

Figure 3. Accelerated aging of four new blinds with different concentrations of lead.
