STUDY OF DETERIORATION OF SEPARABLE ELECTRICAL CONTACTS IN SMOKE DETECTORS

Contract No. CPSC-C-93-1139

IITRI Project No. A06393

Final Report

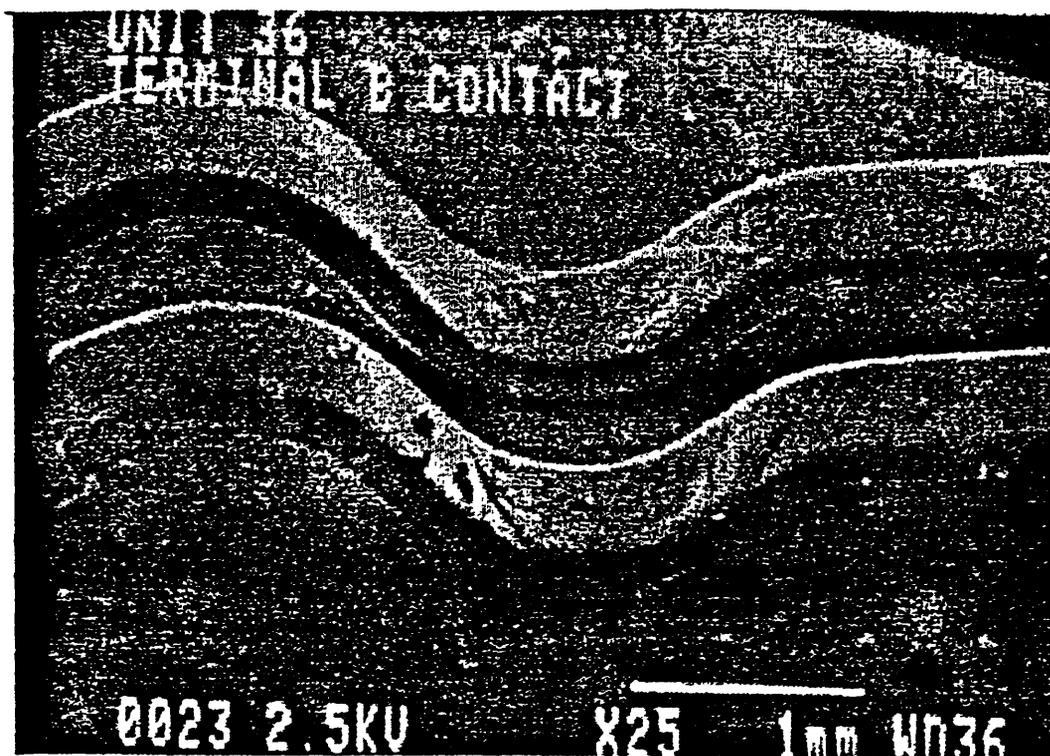
FIGURE 8: SEM PHOTOGRAPH OF A BIFURCATED CONTACT

Before the four horns used to document contact area materials were encapsulated for cross-sectioning, scanning electron microscope (SEM) photographs were taken of each contact area. Representative pictures of bifurcated and dimpled contacts appear in Figures 8 and 9, respectively. Energy Dispersive Analysis by X-Rays (EDAX) surface analyses were made on each of the four horns prior to encapsulation. Table 5 summarizes the results of these analyses. Because of the relatively high beam voltages used by the SEM, the depth of the surface analyses was about 1 micron. Even with this sensitivity, both sulphur and chlorine are prominent on the units collected in the study. Sulphur was also present on the new control sample units.

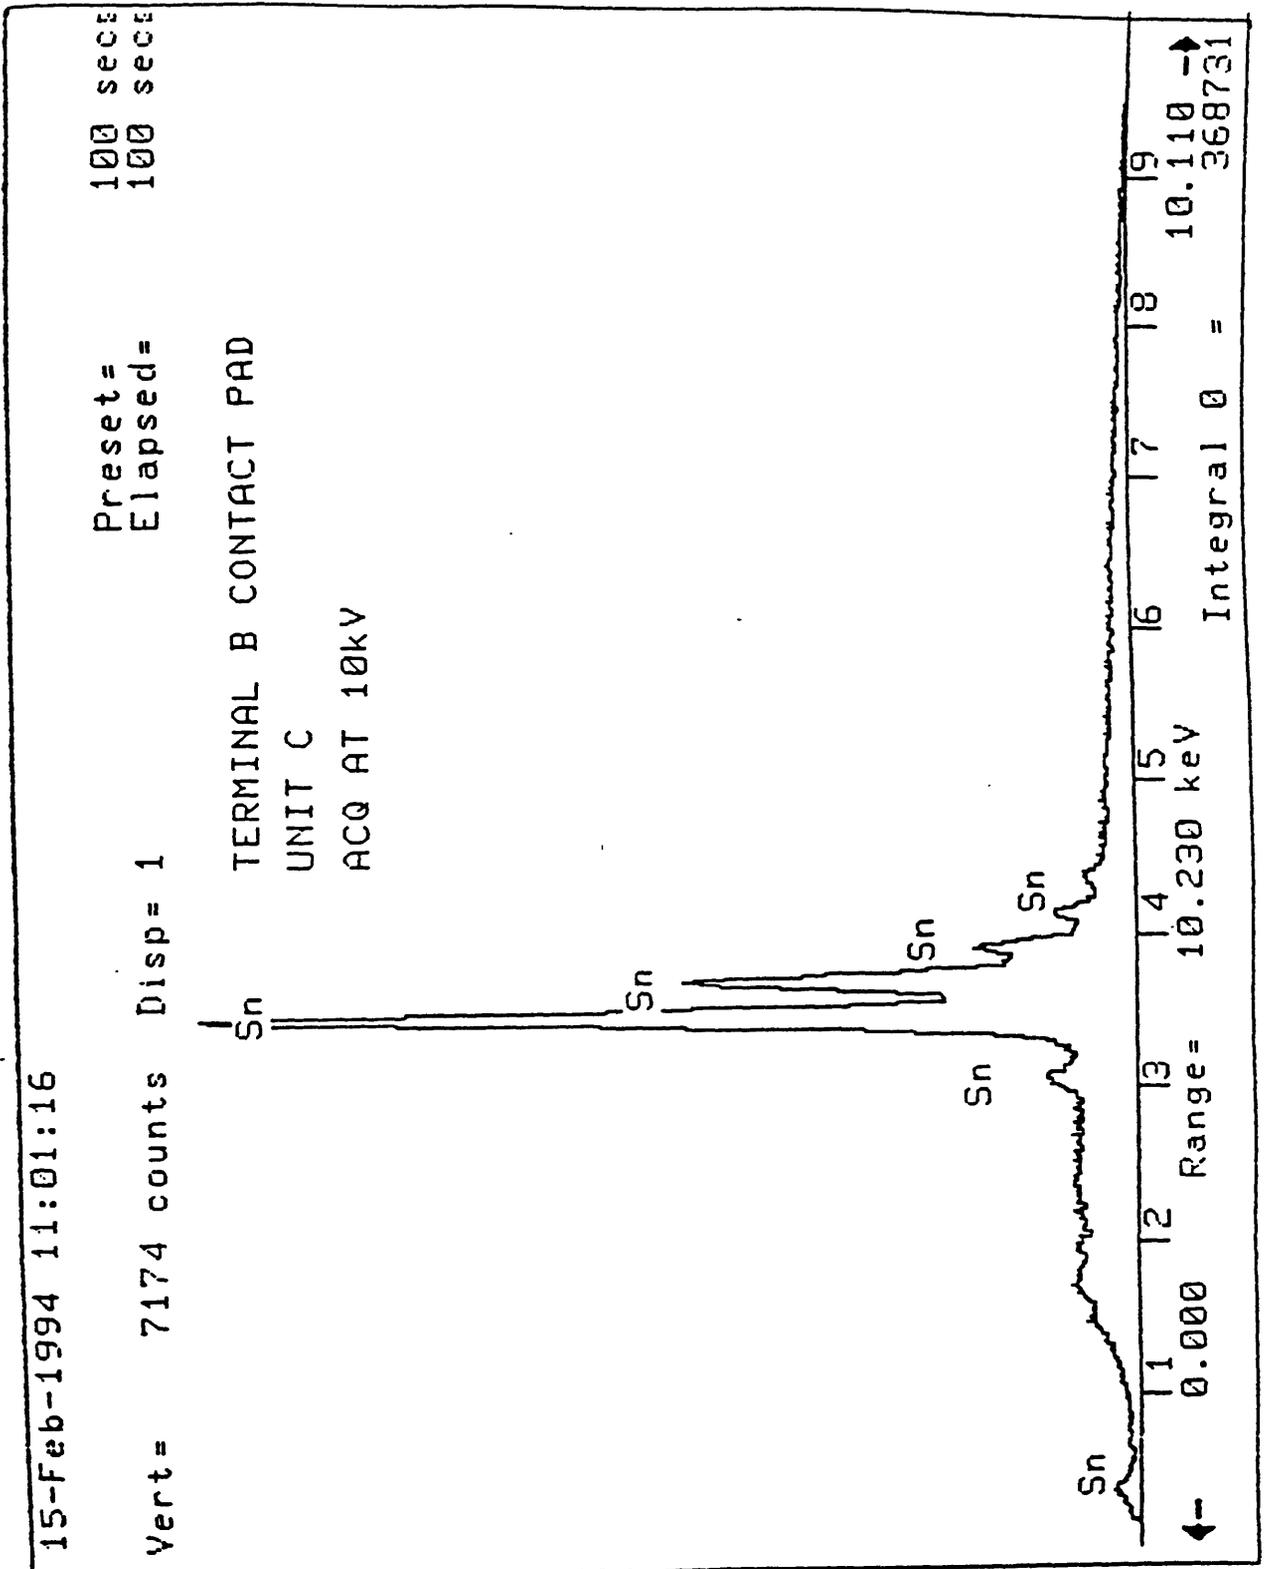
FIGURE 18: BEFORE CORROSION TEST - H₂S/SO₂

Units A, B and C were investigated with SEM and EDAX before and after the corrosion testing. No noticeable visual difference could be found for any unit. However, the EDAX testing showed some differences. Figures 16 and 19 show the before and after tests of Unit A, Terminal S. The only difference is the increase in sulphur. Figures 17 and 20 show the before and after tests of Unit B, Terminal F. Again, the only difference was an increase in the sulphur. Figures 18 and 21 show the before and after tests of Unit C, Terminal B. In this case there was no difference between the before and after plots. This testing again shows how benign the corrosion tests are concerning the horn contacts. The silver, which has an affinity for sulphur, did show an increase in sulphur, but the tin plated area did not show any significant amount of sulphur either before or after testing. A post corrosion EDAX test was run on the silver pad at contact F for Unit C. This plot (Figure 22) showed that the sulphur level was similar to the post corrosion EDAX tests on Units A and B.

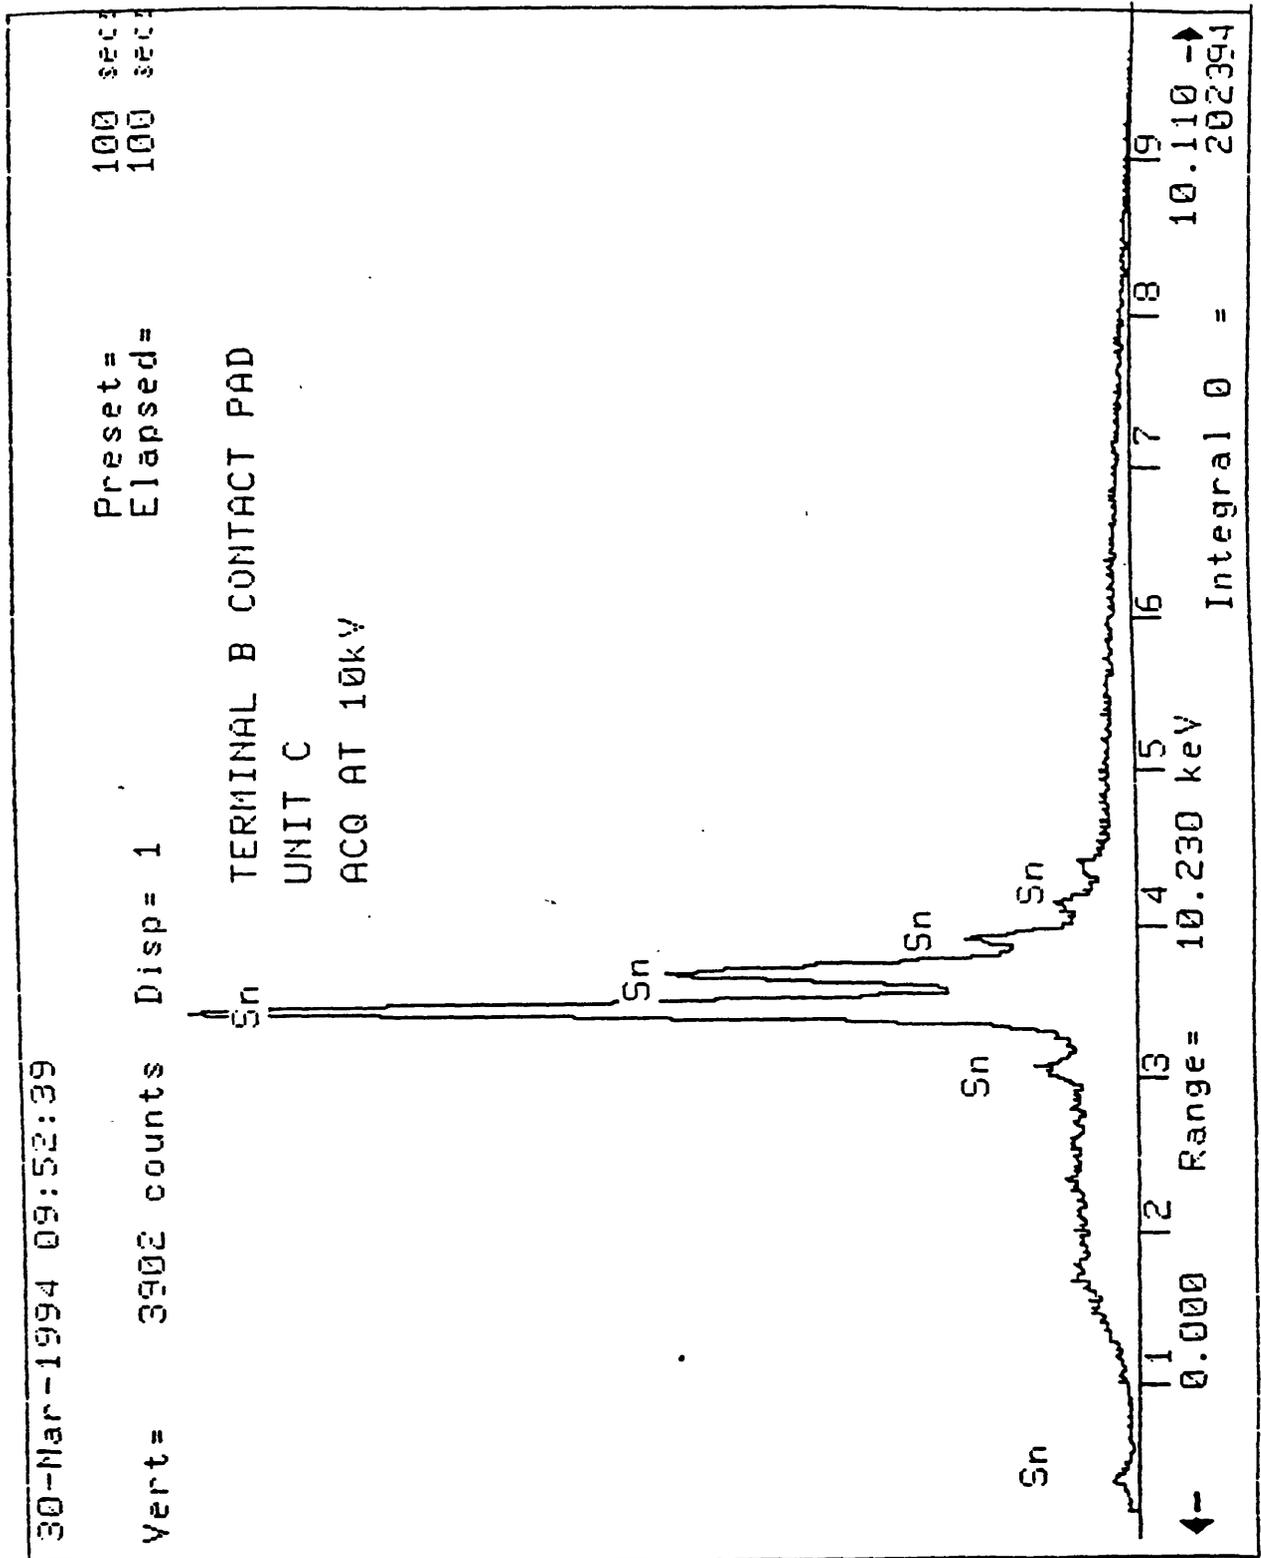
FIGURE 21: AFTER CORROSION TEST - H₂S/SO₂

Each horn was then documented photographically and delivered to ORS for surface analyses. The horns subjected to SO₂ had less film deposits than the H₂S testing, while those exposed to the combination of H₂S and SO₂ had the most deposits.

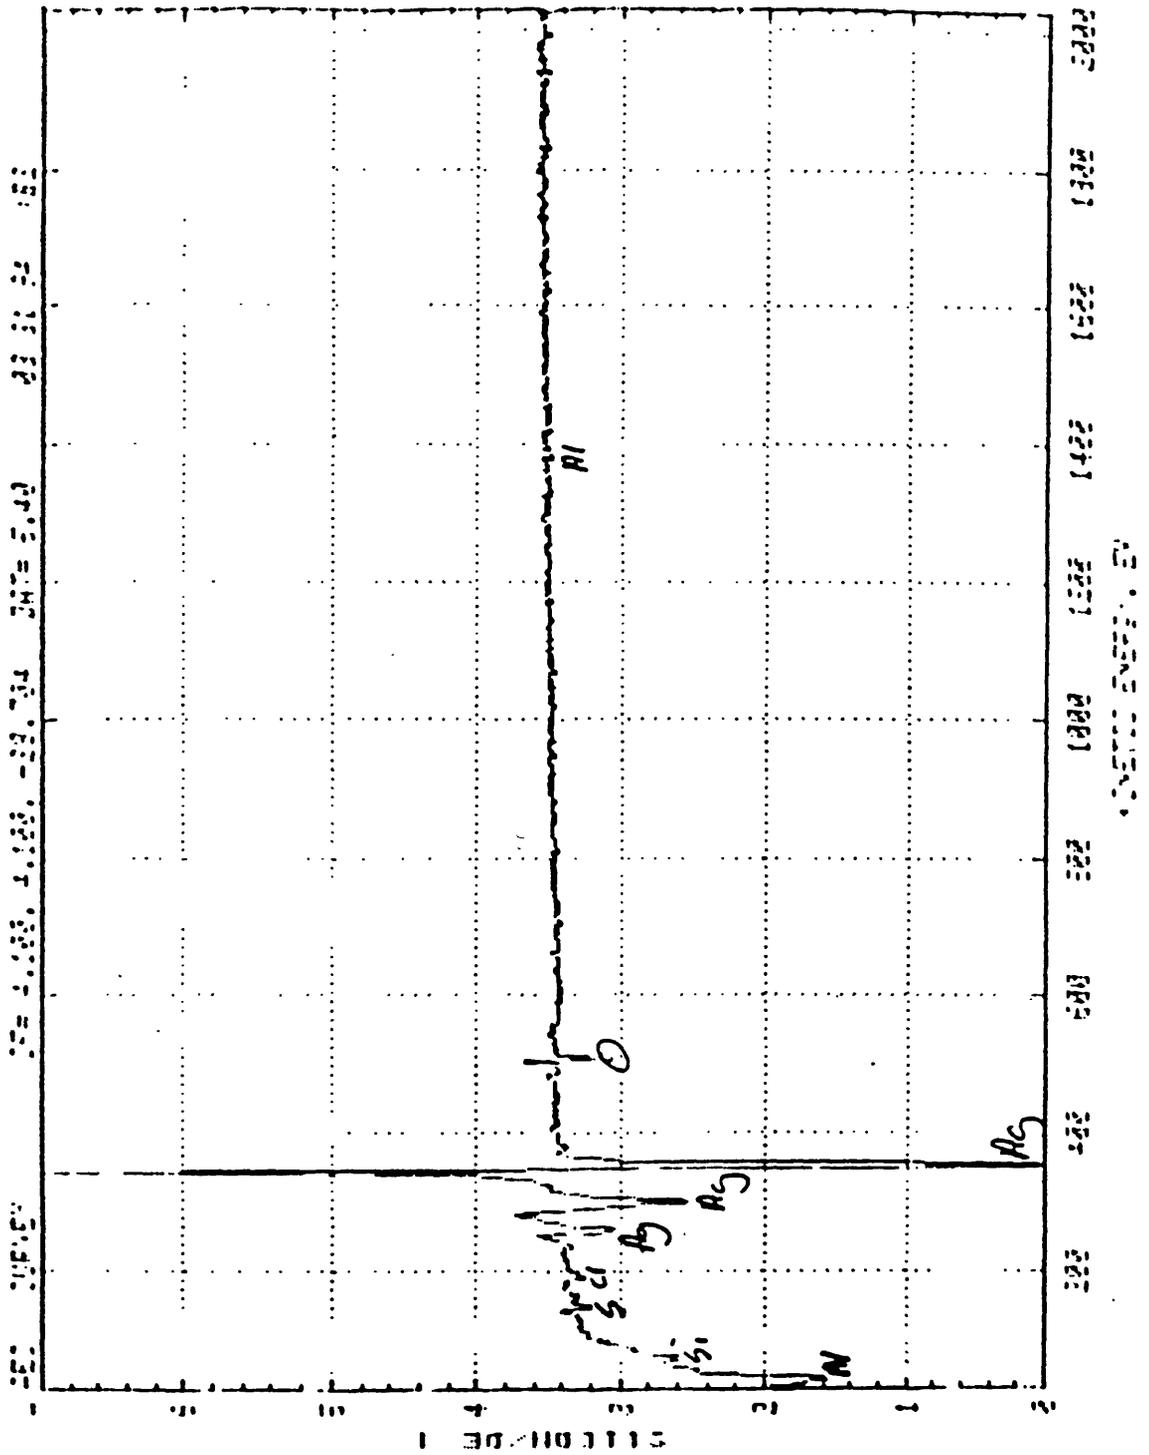
FIGURE 24: AUGER DEPTH PROFILE OF SAMPLE X, TERMINAL S

Figures 23, 24, and 25 are typical pre- and post-sputter surface analyses, and the depth profiles for the four samples tested, respectively.

As shown in Figure 23, the pre-sputtering surface analysis on terminal S of horn X shows only a slight trace of sulphur. Both silicon and chlorine have higher levels than the sulphur. Horn X which was exposed to both gases was selected for this testing because it should have had the thickest layer of contamination and to confirm the EDAX surface analysis on horn C (Figure 21). Comparison of this data with the Table 5 EDAX test results of field units, which identified significant levels of sulphur, shows that the UL 217 test environment does not represent field conditions.
