FIRE INCIDENT STUDY
NATIONAL SMOKE DETECTOR
PROJECT

JANUARY 1995

LINDA E. SMITH, EPHA
DIRECTORATE FOR EPIDEMIOLOGY
U.S. CONSUMER PRODUCT SAFETY COMMISSION
4330 EAST WEST HIGHWAY
BETHESDA, MD 20814

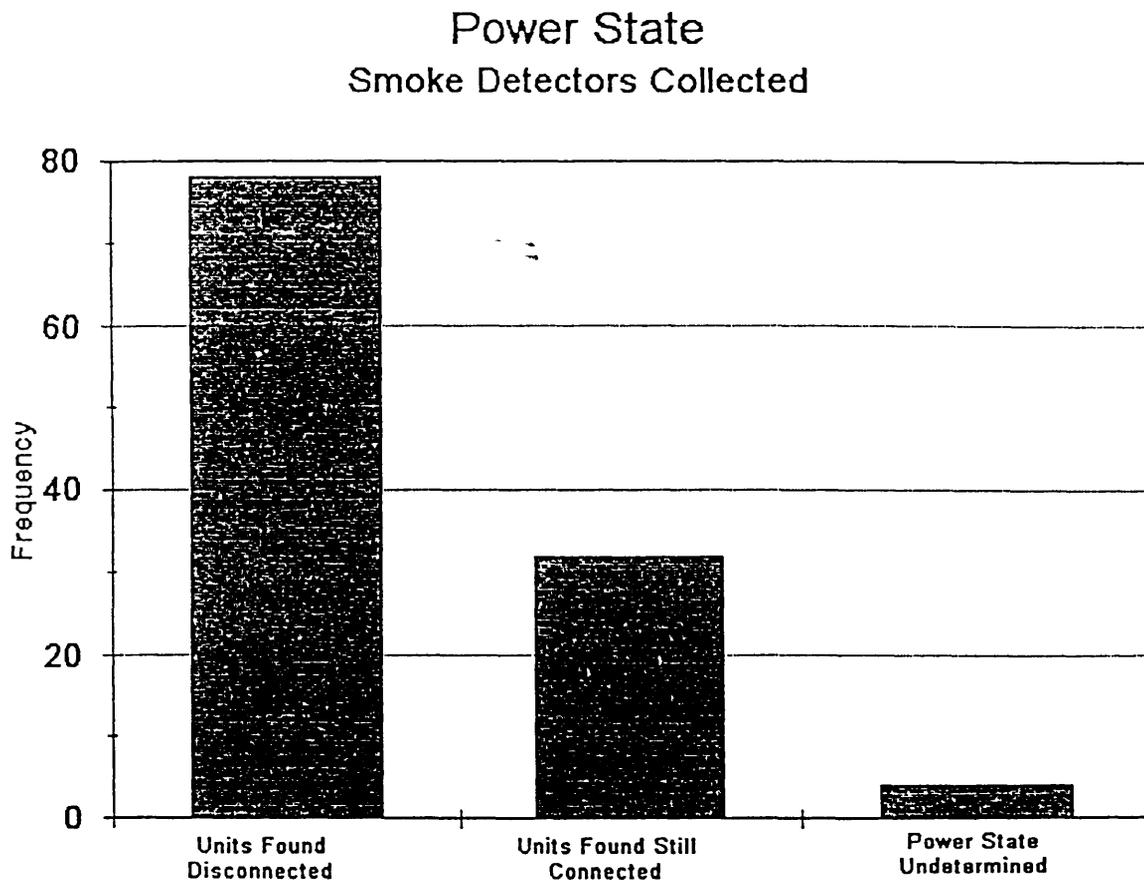
Figure 1. Power state of smoke detectors.

The results of the laboratory testing are divided by the detector's power state: units that were found disconnected after the fire, units that were found still connected after the fire, and units for which the power state at the time of the fire could not be determined. These categories are displayed in Figure 1.
