U.S. CONSUMER PRODUCT SAFETY COMMISSION  
5 RESEARCH PLACE  
ROCKVILLE, MD 20850

January 8, 2018

# CPSC Staff Assessment on Eutectic-Type Thermal-Cutoff Fuse Failures in Shaded-Pole Motors Used in Exhaust Fans

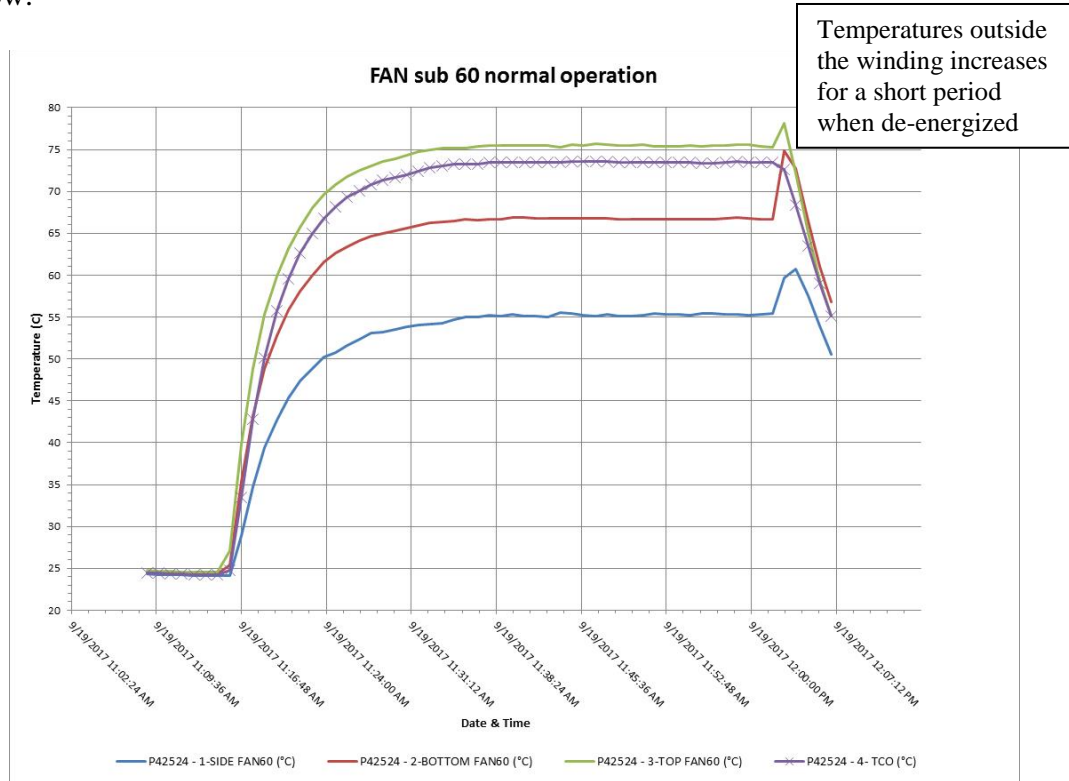
Figure 11. Temperature measurements on the winding and within the TCO (Fan 60)

The testing showed that the TCO's internal temperature for this freely spinning motor with impeller is about 73°C. The thermocouple at the top of the winding measured slightly higher, at 76°C, than the TCO temperature as shown in Figure 11. When the fan was de-energized, the thermocouples located on the winding wrap measured an increase in the winding temperature because of the lack of airflow over the thermocouples when the

impeller stopped spinning. The temperature within the TCO did not measure the same increase in temperature when the fan was de-energized. This is most likely caused by the TCO being located below the wrap, which caused the TCO not to be affected by the airflow.

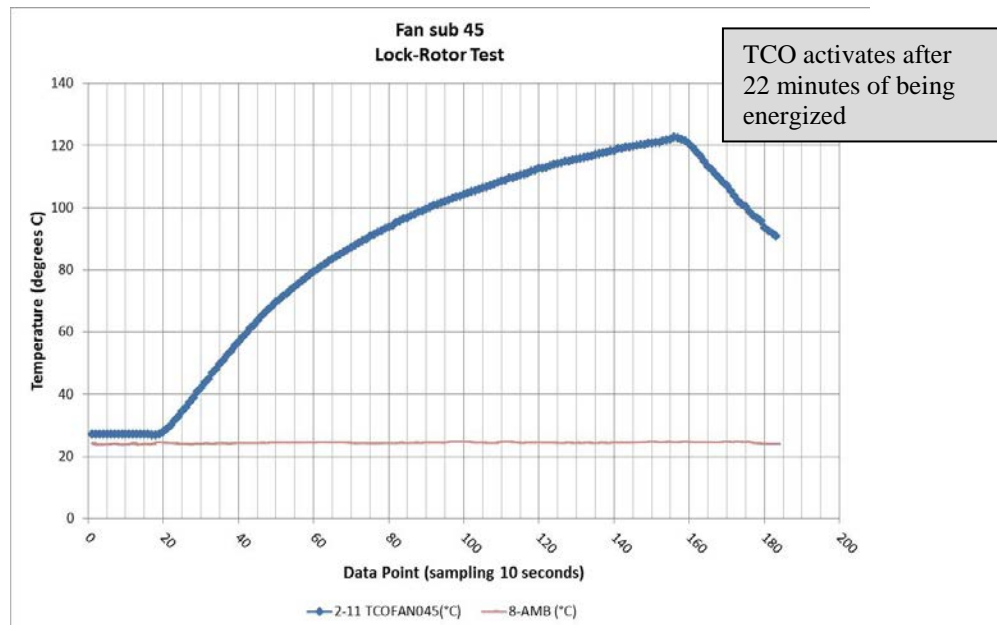
Figure 13. Sub 45 temperature measurement outside the winding

The fan was tested in its as-received condition, *i.e.*, locked-rotor condition. A single thermocouple was placed on the side of the winding, on the outside of the wrap, adjacent to the TCO location. After being energized, the TCO activated after 22 minutes, as shown by the temperature traces in Figure 13. For the location of this thermocouple, the temperature shows a maximum of 120°C, but this location is about 20°C cooler than the actual TCO or at the top of the winding. The actual TCO functioning temperature ( $T_f$ ) was calculated to be about 140°C (120°C + 20°C), which corresponds closely to the  $T_f$  of 136°C. This testing in lock-rotor condition also verified that the side thermocouple measurements on the paper wrap were about 20°C lower than the actual TCO or the top of the windings. Figure 14 shows the radiographs of the TCO’s fusible link after lock-rotor testing, which shows the thermal linkage melted or open.

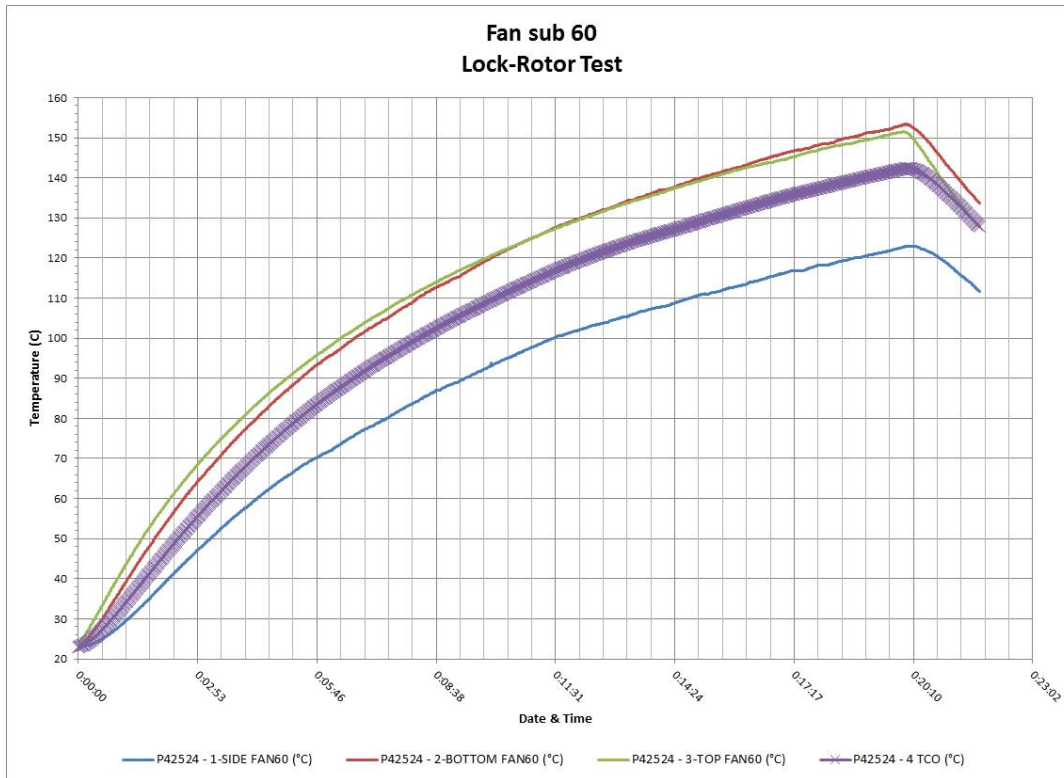
Figure 17. Temperature on the winding and within the TCO during a lock-rotor test

The same fan sub 60 that was instrumented with a thermocouple inside a TCO was used to measure the temperatures during lock-rotor conditions. Similar to the normal operation test, fan sub 60 had the three thermocouples on the paper wrap exterior of the winding and thermocoupled TCO. The lock-rotor condition was operated for 20 minutes to simulate the TCO tripping after 20 minutes in lock-rotor testing, as seen in Sub 45. After 9 minutes 12 seconds, the TCO temperature reached 105°C, as shown in Figure 17. At 15 minutes, the TCO temperatures reached 130°C. Shortly before 20 minutes, the TCO temperature reached 140°C. The TCO temperature measured approximately 142°C at 20 minutes or the manual trip time. The measurements in this test closely correspond to the sub 45 locked-rotor test. As mentioned previously, the TCO in sub 45 tripped at a measured temperature on the side of the winding around 120°C, and the temperature measured on the side of the winding in the test after 20 minutes of operation was about 123°C.

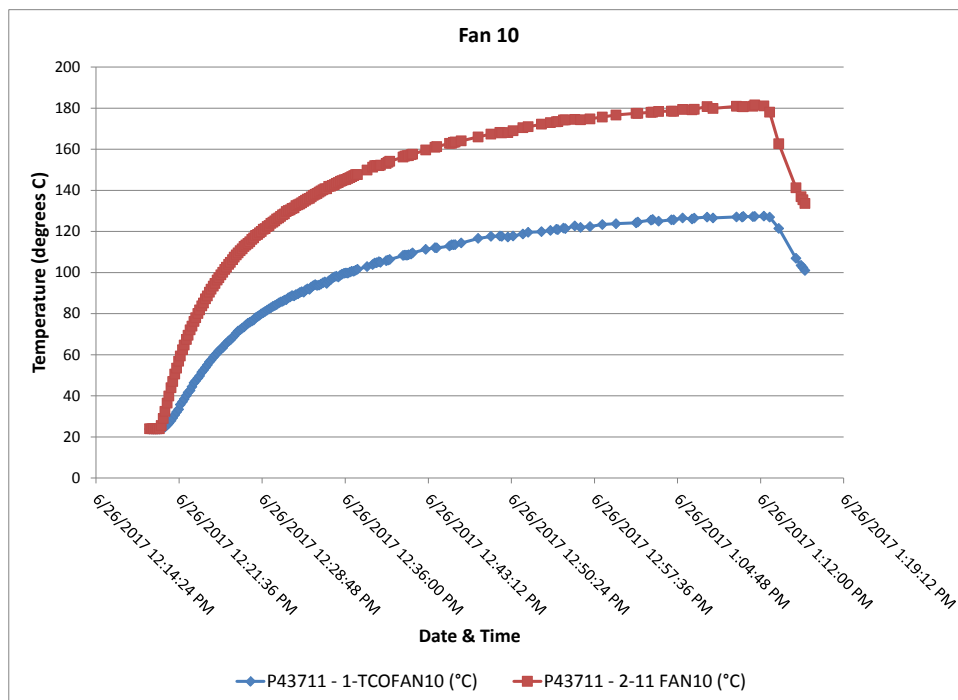
Figure 23. Temperature traces for Sub 10 Test Group 3 - Lock-Rotor Test

Staff conditioned the fan (sub 10) for 64 hours 30 minutes. During the locked-rotor testing, the TCO activated. The TCO activated approximately 52 minutes after the rotor was locked. The activation time was about 30 minutes longer than seen during typical lock-rotor testing, which activated around 20 minutes within the testing. Figure 23 shows the temperature traces for the thermocouples during the lock-rotor test.

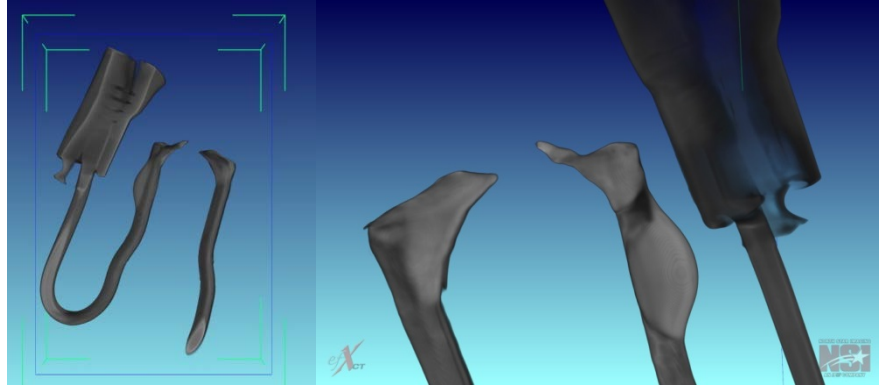
Figure 24. CT scan of the fusible link after lock-rotor testing (sub 10)

Figure 24 shows the CT scan of the fusible link after the lock-rotor test. As seen in prior testing when the trip time is longer than average, the fusible link melts at the center of the link. The figure does show a partial wetting of the electrodes occurred, which allowed the solder link to bead.

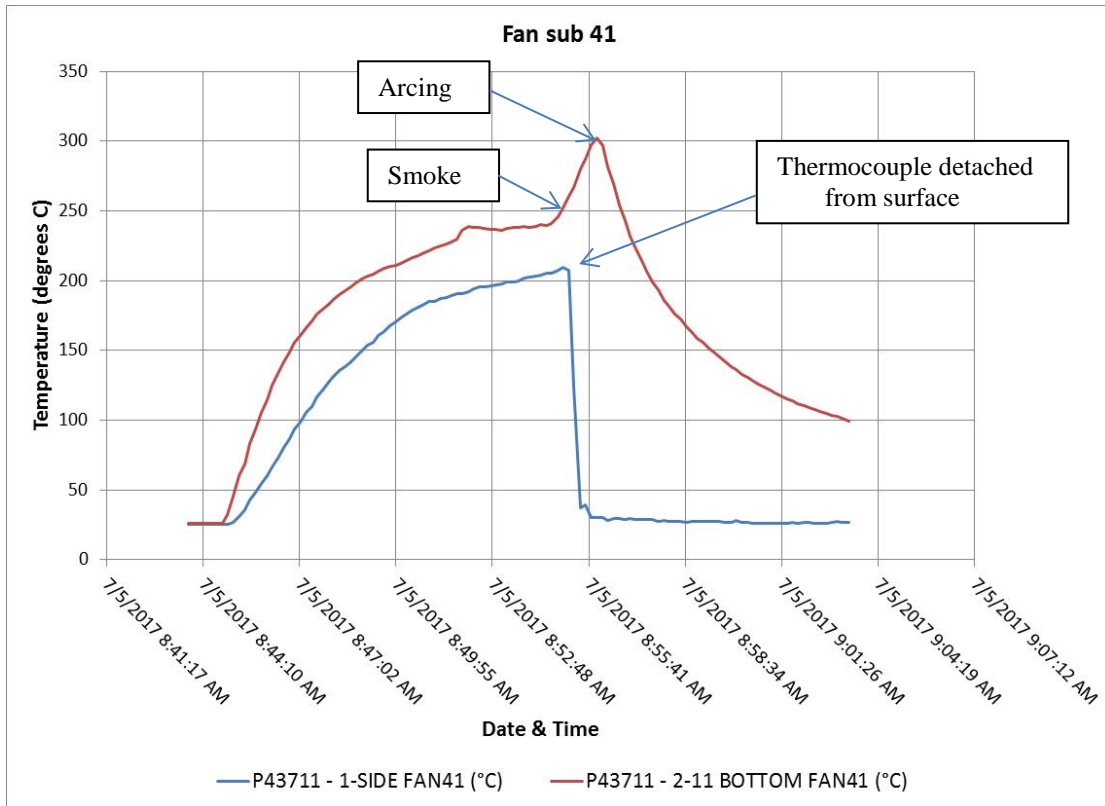
Figure 26. Temperature traces for Sub 41 Test Group 3 - Lock-Rotor Test on July 5, 2017

Staff allowed the fan to cool to room temperature before retesting. During the second lock-rotor test, the temperatures increased rapidly, and the unit began to smoke. The temperature suddenly increased and arcing could be heard. Suddenly the arcing ceased, and the temperature began to decrease. Figure 26 shows the temperature traces for the thermocouples during the lock-rotor test on July 5, 2017. The thermocouple located at the

TCO (blue trace) detached from the surface of the winding when the unit began to smoke, which resulted in a sudden drop in temperature. The elapsed time to maximum temperature was about 9 minutes, 50 seconds.

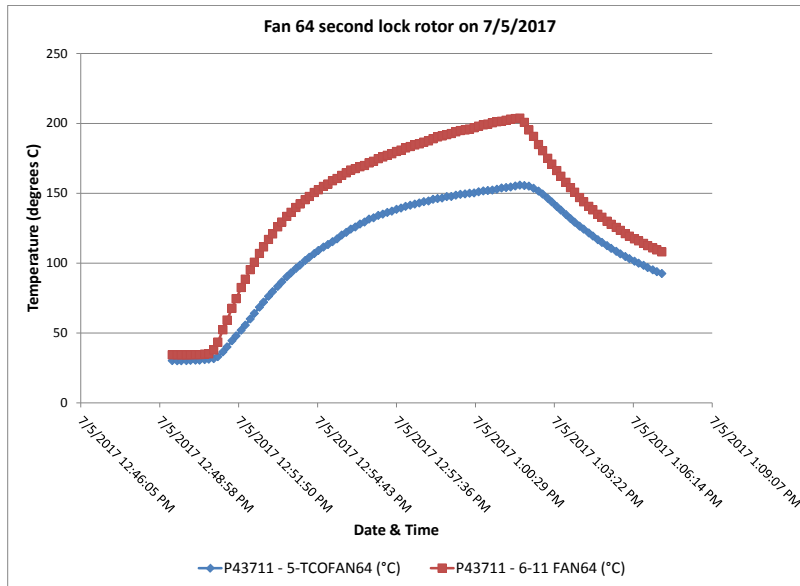
Figure 29. Temperature for Sub 64 Test Group 3 during Second Lock-Rotor Test

Staff allowed the fan to cool for 45 minutes (to approximately room temperature) before retesting. During the second lock-rotor test, the TCO activated. Figure 29 shows the temperature traces for the thermocouples during the second lock-rotor test. The TCO tripped after approximately 11 minutes during the second lock-rotor test.

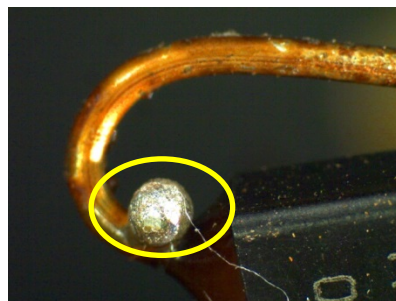
Post examination revealed a solder bead external to the TCO casing, as highlighted by the yellow circle shown in Figure 30. Microscopic images of the TCO show that the solder bead originated from inside the TCO because solder was located in cracks between the epoxy seal and the lead wire, as shown in Figure 31. Figure 32 shows the CT scans with the partially melted fusible link after the testing, thus, indicating the TCO did activate, but abnormally. Visible in the CT scan is the solder bead, highlighted by the yellow circles.

Solder bead

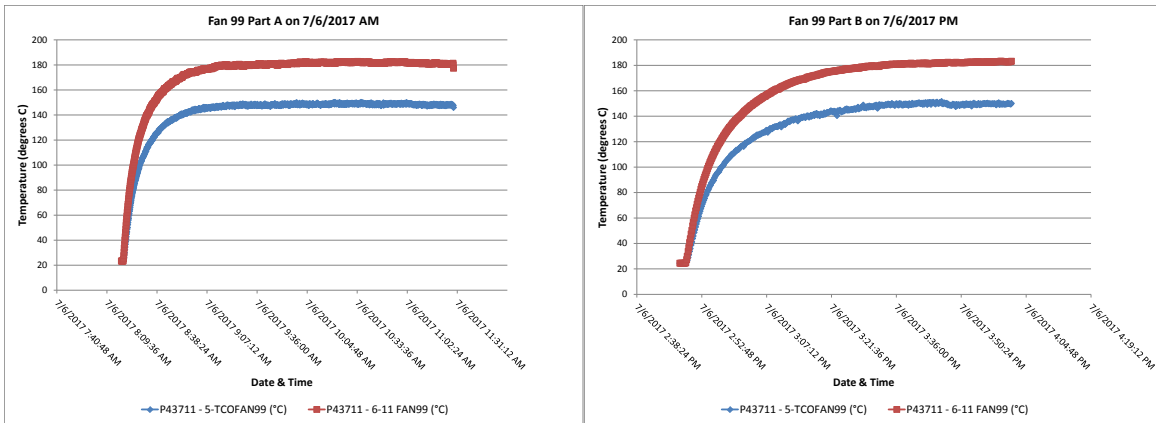
Figure 33. Segment Part A and B temperatures for Sub 99 Test Group 3 - Lock-Rotor Test

Staff conditioned the fan (sub 99) for 288 hours before being subjected to three lock-rotor test periods as summarized in Table 7. During the initial lock-rotor test (segment A), the TCO did not activate. During the second lock-rotor test (segment B), the TCO did not activate. The TCO activated during the third lock-rotor test (segment C). Figures 33 and 34 show the temperature traces for the thermocouples during the three segments of lock-rotor test. The TCO tripped after approximately 30 minutes during the third lock-rotor test, but after almost 5 hours of combined lock-rotor testing (sum of the test duration for all of the segments up to the activation).

Testing Segment	Test Duration (hh:mm:ss)	Maximum temperature at Side Windings (C)	Calculated TCO Temperature (C)	Maximum temperature at Bottom Windings (C)	Notes
PART A	3:09:36	150	~170	182.6	Manually terminated
PART B	1:12:06	151.6	~172	183.2	Manually terminated
PART C	0:29:42	140.9	~161	173.3	TCO tripped

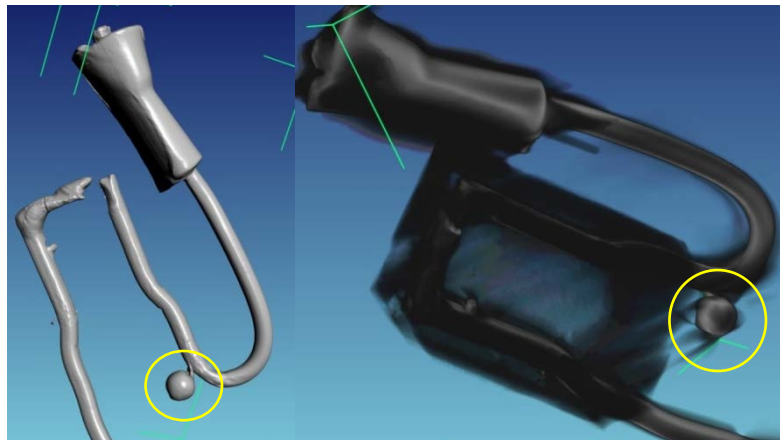
Figure 35. CT scans of the TCO showing the solder bead (Sub 99)

Post examination revealed the TCO had a solder bead external to the TCO casing. Figure 35 shows the CT scans with the partially melted fusible link after the testing, thus, indicating the TCO did activate, but abnormally. Microscopic images show that the solder originated from inside the TCO because of solder located within the cracks between the epoxy seal and the lead wires. Figure 36 shows the microscope images of the solder bead and solder in the cracks.

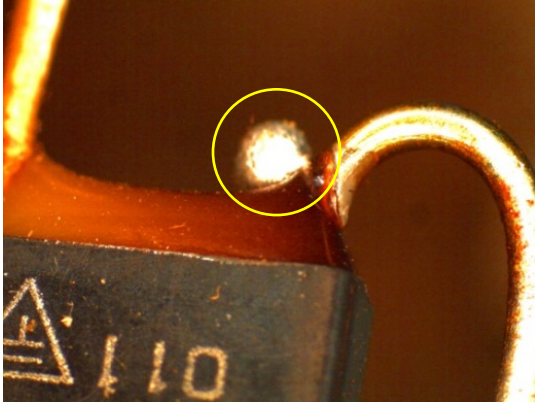
Solder bead

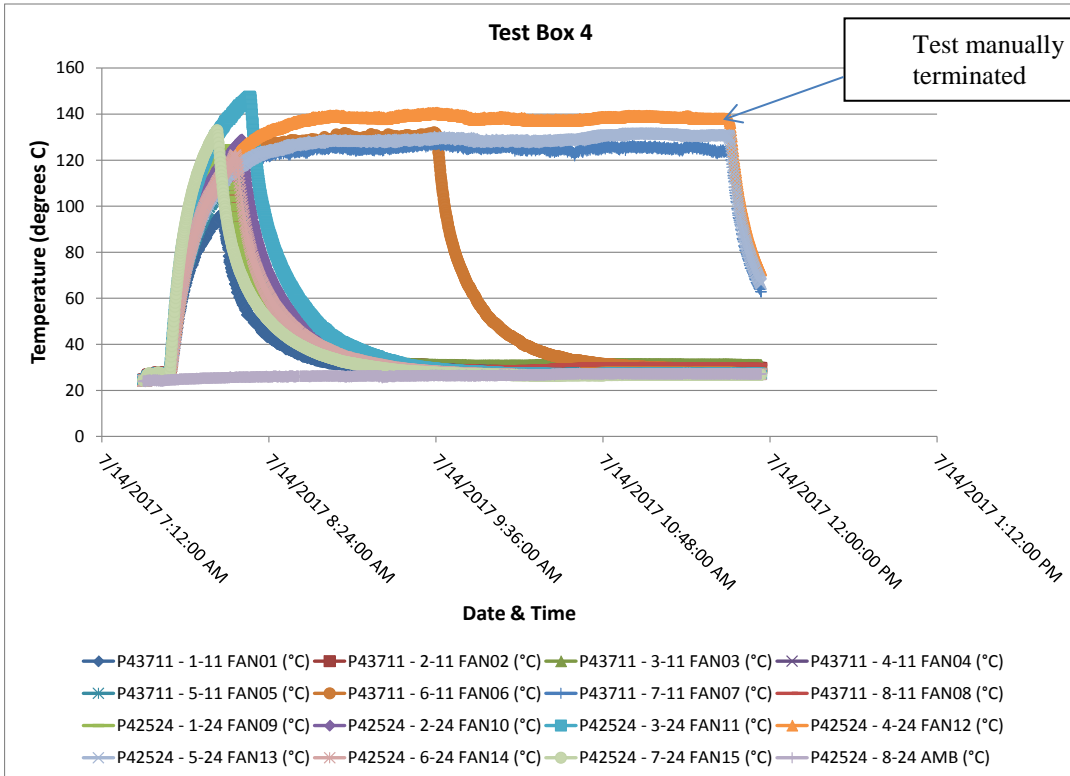
Figure 37. Temperature traces for Test Group 4 - Lock-Rotor Test

Test Group 4 had 15 fans. Staff placed the 15 fans in the conditioning oven at 2:30 p.m. on July 6, 2017. Staff set the conditioning oven at 105°C. After 165 hours (July 13, 2017 at 11:30 am), all 15 units were removed from the conditioning oven and installed in the large test frame. The fans were allowed to cool to room temperature before testing. A single thermocouple was placed on the side of the winding for each fan sample. The fans were tested in a lock-rotor condition on July 14, 2017. Figure 37 shows the temperature traces for Test Group 4 – Lock-Rotor Test.

Test Group 4			TCO		
Test Frame Location Number	Fan Sub No.	Thermocouple id	Tripped	Elapsed Time	TCO Failed to Activate Normally
1	81	P43711-1-11FAN01	Yes	32 m 35 s	No
2	45	P43711-2-11FAN02	Yes	32 m 35 s	No
3	11	P43711-3-11FAN03	Yes	33 m 34 s	No
4	28	P43711-4-11FAN04	Yes	37 m 24 s	No
5	67	P43711-1-11FAN05	Yes	40 m 15 s	No
6	58	P43711-6-11FAN06	Yes	2 h 3 m 43 s	Yes
7	66	P43711-7-11FAN07	No	Over 4 hours	Yes
8	9	P43711-8-11FAN08	Yes	34 m 54 s	No
9	17	P42524-1-11FAN09	Yes	35 m 53 s	No
10	84	P42524-2-24FAN10	Yes	40 m 52 s	No
11	1	P42524-3-24FAN11	Yes	44 m 12 s	No

12	51	P42524-4-24FAN12	No	Over 4 hours	Yes
13	6	P42524-5-24FAN13	No	Over 4 hours	Yes
14	93	P42524-6-24FAN14	Yes	38 m 1 s	No
15	43	P42524-7-24FAN15	Yes	30 m 11 s	No
Ambient		P42524-8-24Amb

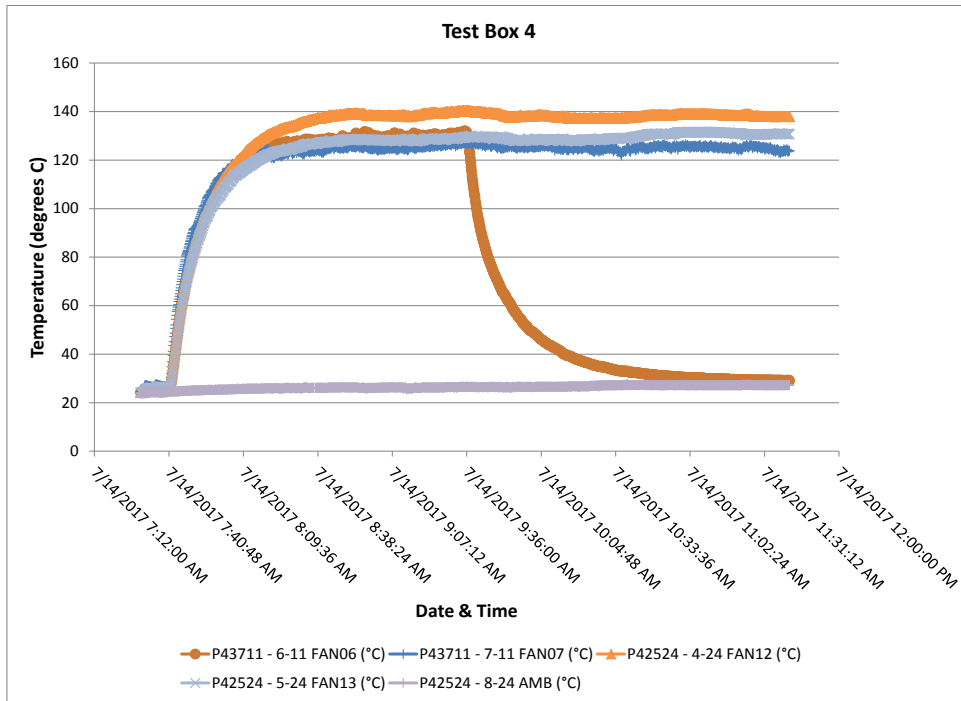
Figure 38. Temperature traces for Subs 6, 7, 12 and 13 (Test Group 4 - Lock-Rotor Test)

Figure 38 shows fan subs 6, 51, 58 and 66 temperature traces for Test Group 4 – Lock-rotor Test. These subs had a TCO that had activation trip times that were long or never tripped. The TCOs were x-rayed and CT scanned.

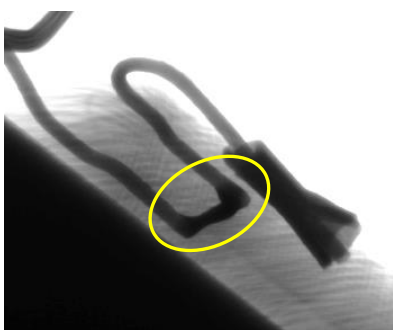
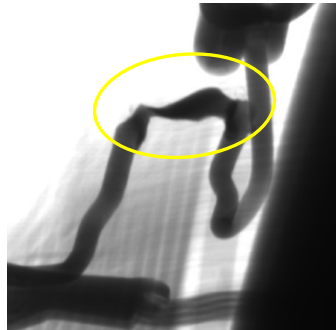
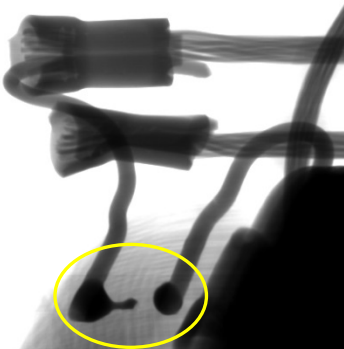
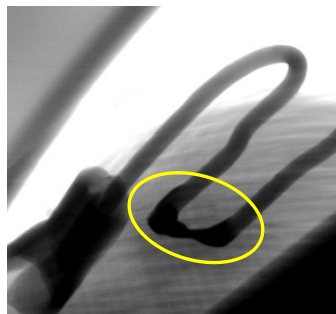
Figure 39. Radiograph of subs 6, 51, 58 and 66 after Lock-Rotor test

Figure 39 shows the TCO from sub 58, which tripped but took more than 2 hours. As seen in previous TCOs that had a long trip time, the melted linkage would bead to both wire leads; but in this case, the radiograph shows a thin portion of the fusible link still present.

Sub 06 (intact)

Sub 51 (intact)

Sub 58 (open)

Sub 66 (intact)

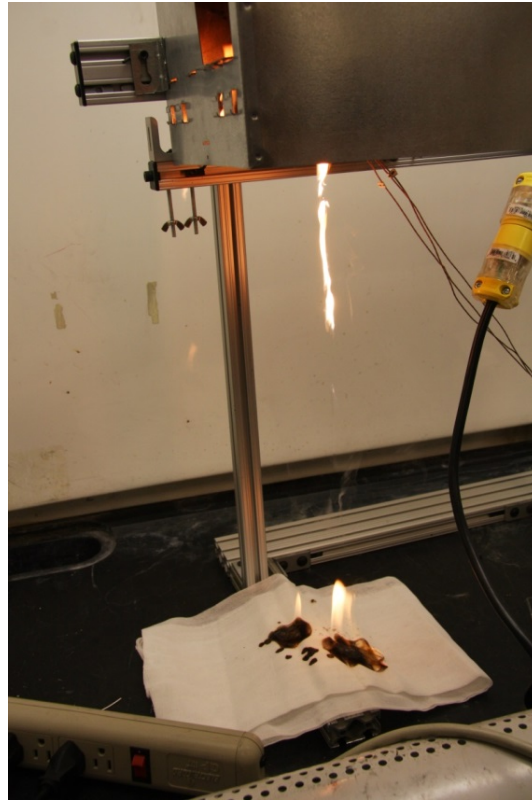
Figure 41. Fan sub 73 during lock-rotor test

Dripping flaming plastic ignites the cheesecloth ignition indicator

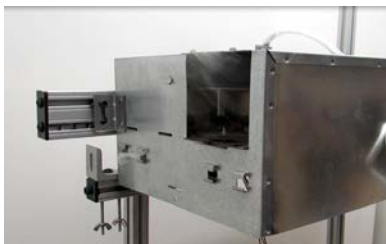
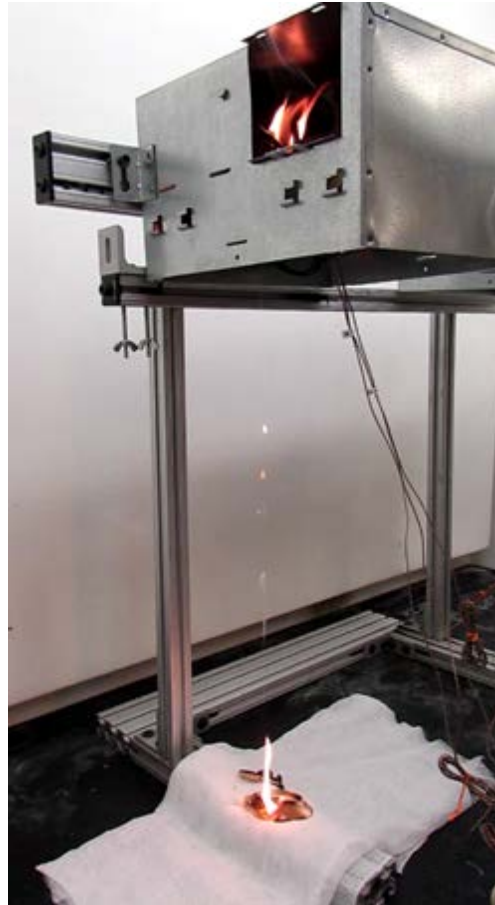
Figure 45. Fan sub 23 during lock-rotor test

Fan sub 23 was in lock-rotor for about 2 hours and 40 minutes before the unit ignited, as shown in Figure 44. The fan's winding temperature,  $\sim 186^{\circ}\text{C}$ , was at steady state, above the TCO specified activation temperature, until the winding temperature began to increase rapidly. This rapid increase in temperature indicates shorting in the winding, which reduces the winding resistance. Before ignition, at about  $\sim 292^{\circ}\text{C}$ , the unit was producing visible white smoke. Similar to Fan sub 73, when the unit ignited at  $\sim 340^{\circ}\text{C}$ , it produced a large flash and flames for a brief moment. The large flames subsided slightly, until the flames ignited more of the wrap around the winding and/or the coating of the winding. The flames impinged on and ignited the plastic impeller. The burning impeller and bobbin resulted in dripping flaming plastic. Four layers of cheesecloth were placed under the fan to be used as an ignition indicator. The dripping flaming plastic ignited the cheesecloth, which indicates that the fan's plastic grill could also ignite in this type of situation. Figure 45 is a sequence of photographs during lock-rotor testing for sub 23.

At around 292°C, the fan begins producing white smoke

The large flames subside and the winding wrap and/or the winding coating appears to be burning

More of the winding wrap and the coating on the winding burns, thus creating a larger flame

The impeller has ignited and begins to sag onto the motor

Dripping flaming plastic ignites the cheesecloth ignition indicator

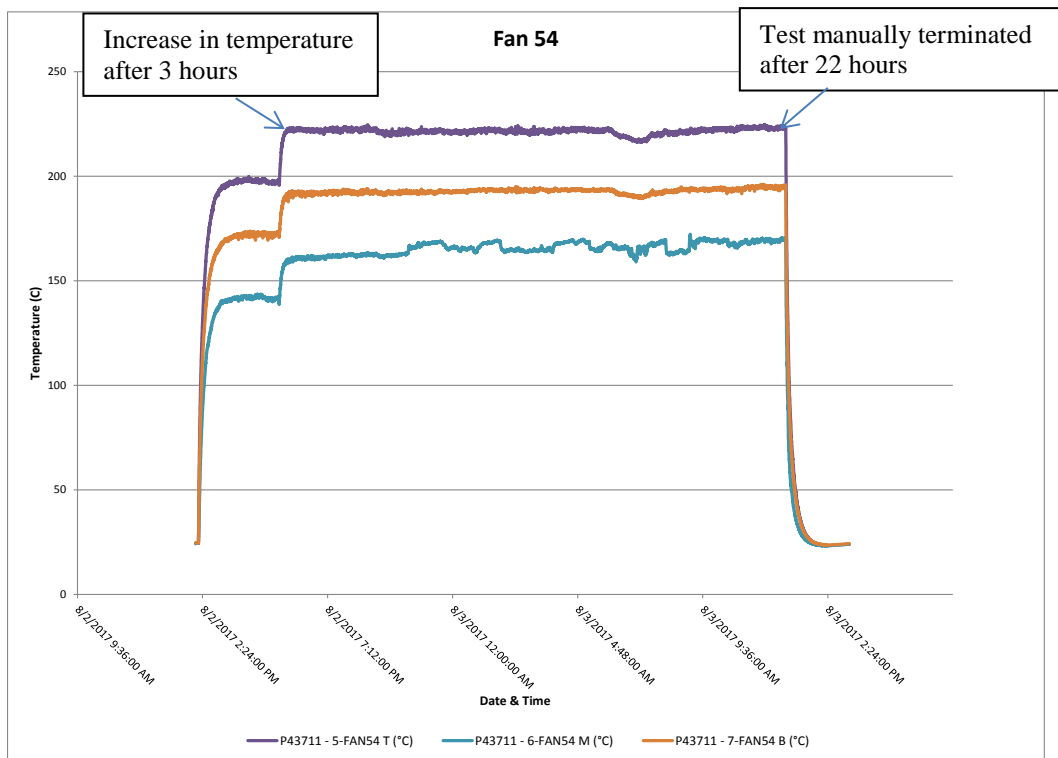
Figure 48. Winding temperatures during lock-rotor test for Fan sub 54

As previously indicated, fan sub 54 was tested in lock-rotor condition for 22 hours. After the initial 3 hours, the temperature increased and then leveled off. The fan maintained a steady temperature that was well above the TCO activation temperature for the majority of the testing, as shown in Figure 48. The TCO did not activate, and staff manually terminated the test after 22 hours. Figure 49 shows radiographs of the TCO after the test. The linkage appears to have thinned out, but is still intact. The figure shows a bead had formed outside the TCO casing.

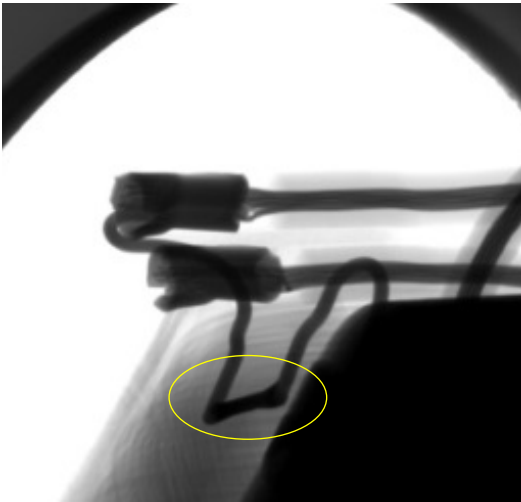
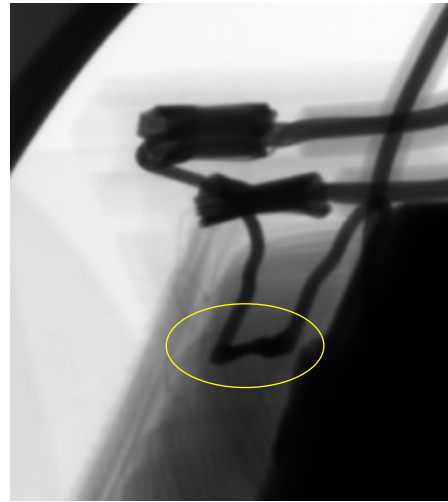
Figure 50. Radiograph of the TCO before and after the test (sub 54)

Figure 50 shows radiographs of the TCO before and after the test. From these angles, the thermal linkage appears not to have changed shape significantly, but depending on the viewing angle, the thermal linkage is thicker or thinner.

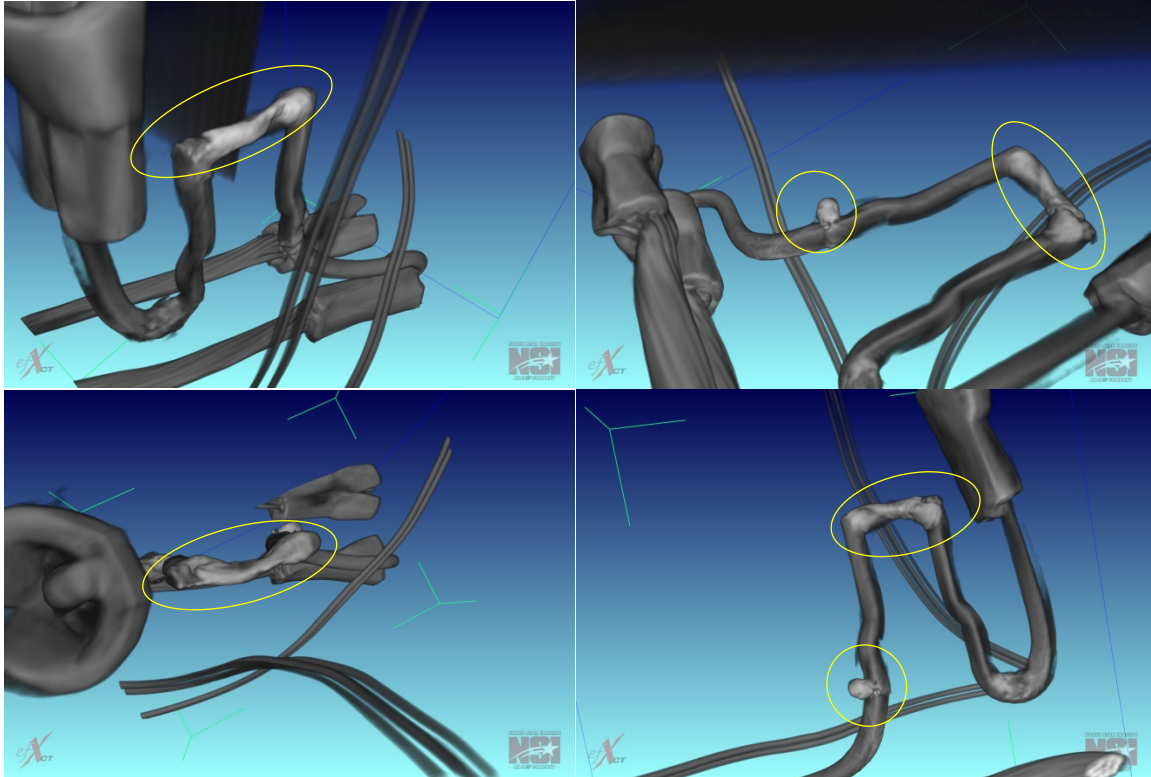
Figure 51. CT scans of the TCO after the test (sub 54)

Figure 51 shows CT scans of the TCO after the test. CT scans of the TCO confirm the solder link within the TCO is intact. The radiographs and CT scans show a solder bead has formed outside the TCO casing. This would suggest that the TCO is no longer hermetically sealed when thermally aged or placed under thermal stress. The reason that the windings were operating at such an elevated temperature for so long without eventually breaking down is not known, but it can be surmised that the winding coating would eventually deteriorate and cause shorts within the winding because the eutectic temperature has changed from  $T_f$ .

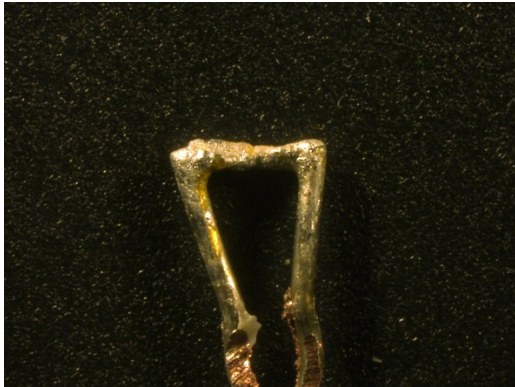
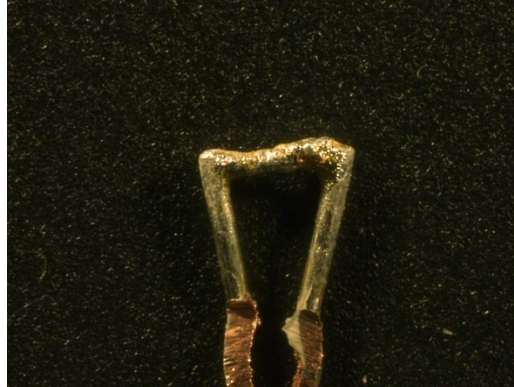
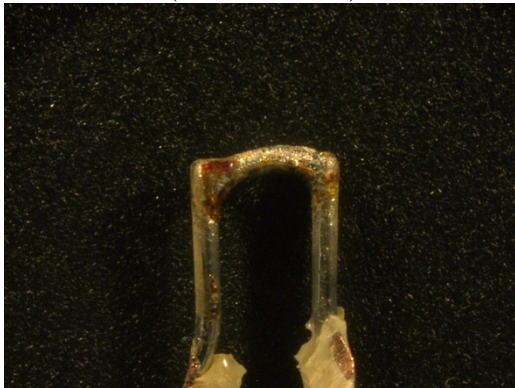
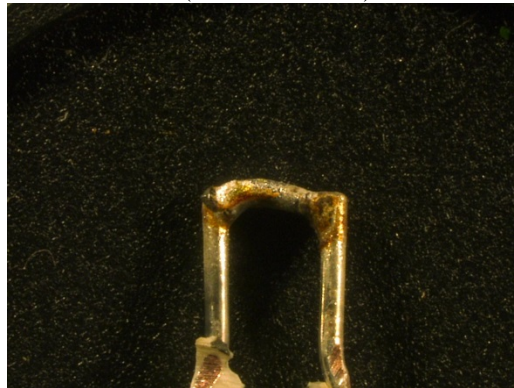
Figure 52. TCO solder link from Fan subs 22 and 59 (conditioned 330 hours @ 105°C)

Subs 22 and 59 (conditioned for 330 hours at 105°C) from Test Group 5 were reserved for analysis of the solder link within the TCO. The TCO casing was opened and the internal components were removed. For comparison, two TCOs, sub 74 and 85 (no conditioning), from Test Group 7 were also reserved for TCO analysis where the TCO casing was opened and the internal components removed. Figure 52 shows the solder links from Fan subs 22 and 59, which have been conditioned 330 hours at 105°C. Figure 53 shows the solder links from Fan subs 74 and 85, which have not been conditioned. Sub 85 shows some deformation in the solder link, where part of the solder link has flattened and formed to the interior of the TCO casing, but this was already present before any conditioning of the TCO. The mechanical structure of the solder linkage appeared unchanged as a result of the conditioning, when the before and after radiographs were compared.

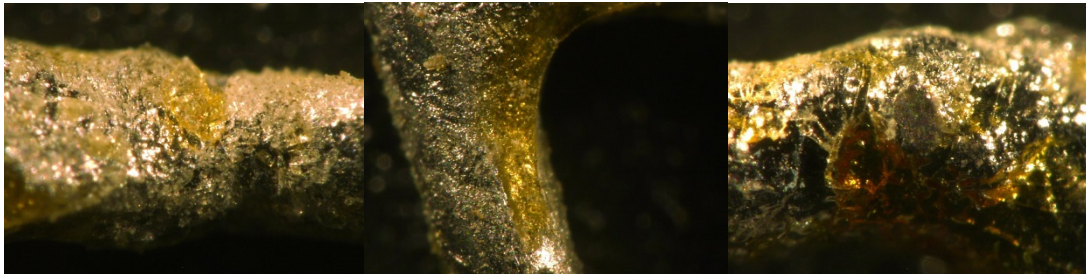
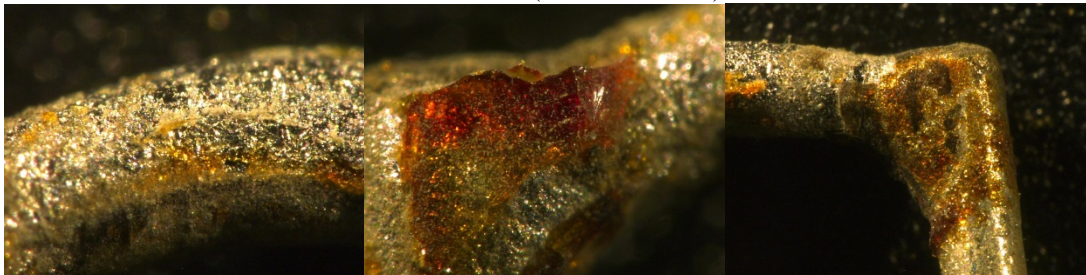
Figure 54. Close-up images of the TCO solder link (conditioned 330 hours @ 105°C)

Staff observed under a microscope that a yellowish substance was on the solder link, as shown in Figures 54 and 55. This was thought to be the special coating or flux material. Staff also observed that the conditioned TCOs appeared to have less of the yellowish substance than the TCOs that were unconditioned, but staff did not measure an actual mass content or volume of the substance for each sample.

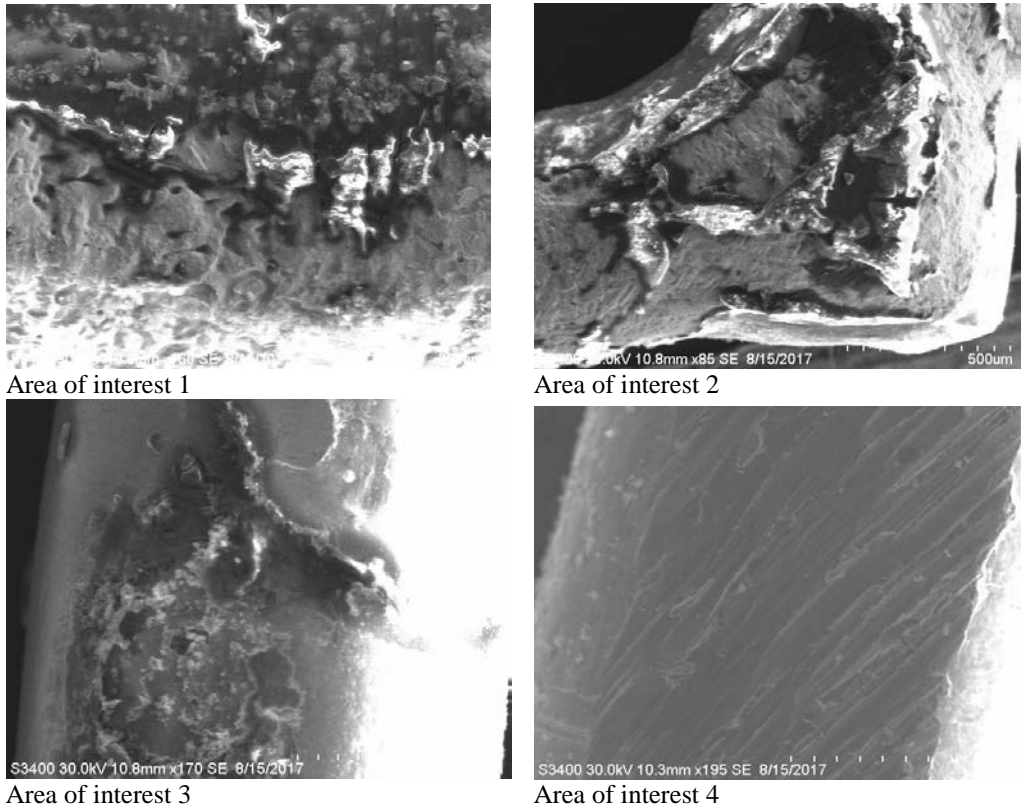
Figure 56. SEM scans for Sub 59

characterization. XRD is used to study nature of phases/microstructure and their crystal structure. Figure 56 shows SEM scans of the solder link and terminals. SEM and XRD analysis for sub 59, which was conditioned at 105°C, show that the wire leads are copper and the thermal linkage is comprised of mainly tin, indium, and lead.

Area of interest 2 is the solder link connection to the copper terminal. This is mainly comprised of C, O, In, Sn and Pb. There is a trace amount of silicon (Si) and copper (Cu). Copper shows up because it is the bulk material of the terminal.

Areas of interest 3 and 4 are the copper terminals. This is mainly comprised of Cu and Sn. There are lower amounts of C and O.

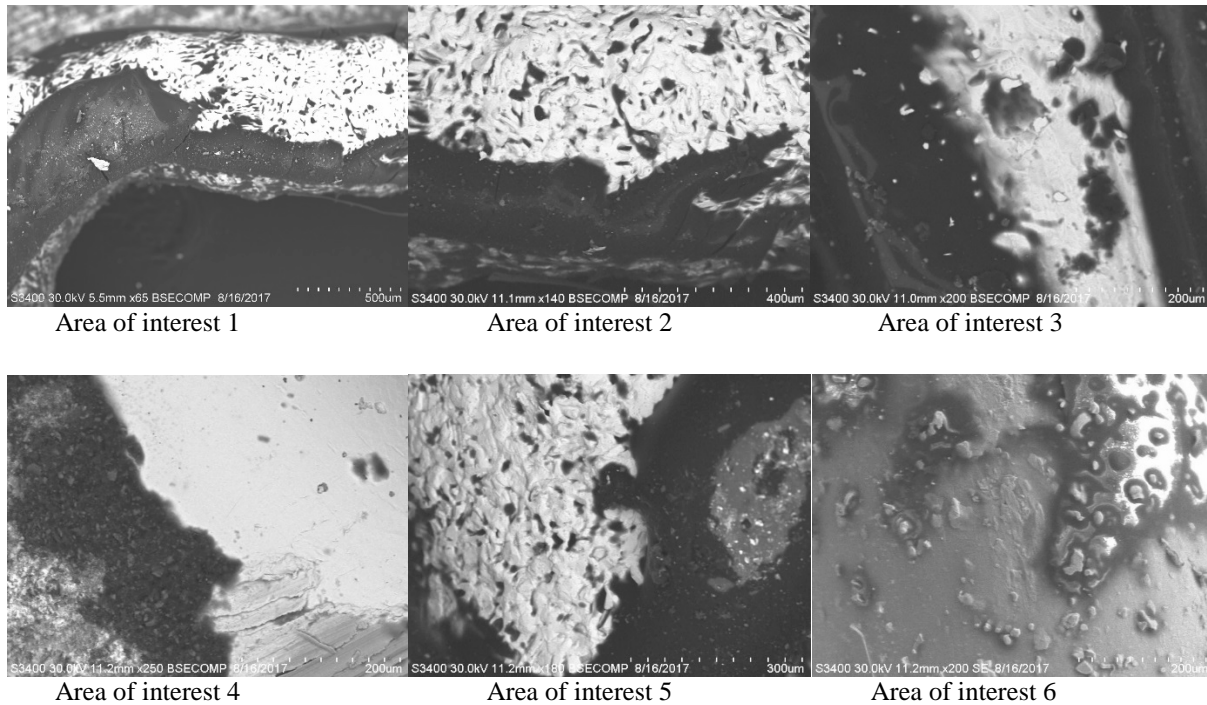
Figure 57. SEM scans for Sub 74

SEM analysis for sub 74, which was not conditioned, is shown in Figure 57. Area of interest 1 is the solder link. This is mainly comprised of C, In, Sn, and Pb. The Indium, Tin, and Lead are most likely the elements that make up the solder linkage. Carbon and Oxygen are most likely the elements that make up the special coating. Area of interest 2 is a close-up of an area from area interest 1. This is mainly comprised of C, O, In, Sn, and Pb. There is a trace amount of Si.

Areas of interest 3, 4, 5, and 6 are areas that had coating on the terminals or solder link.

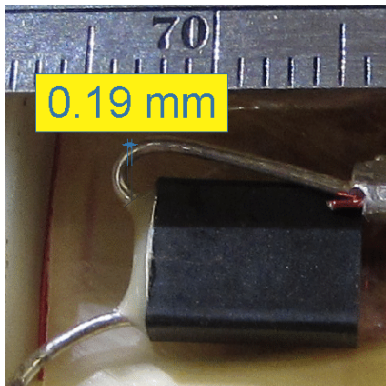
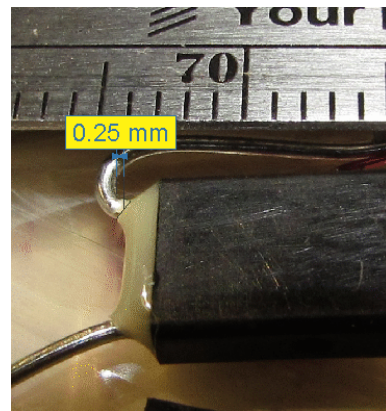
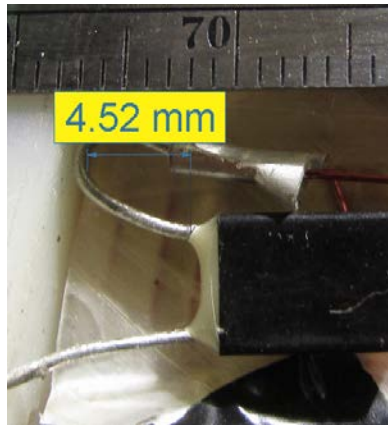
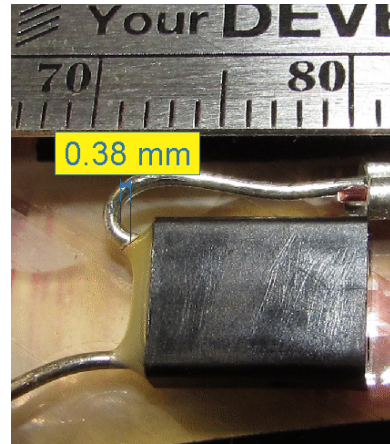
Figure 58. Wire bend lengths vary between TCOs in the Fan samples

Figure 58 shows the TCO wire lead bends can vary between fan motors. Even though sub 27 shows the wire lead bend greater than 3 mm, it appears that the base of the wire lead near the seal was not secured when the wire lead was bent, which is evident by the outward angle of the wire lead.

Wire lead with 0.19 mm length between the seal and bend (Sub 98)

Wire lead with 0.25 mm length between the seal and bend (Sub 26)

Wire lead with 4.52 mm length between the seal and bend (Sub 27)

Wire lead with 0.38 mm length between the seal and bend (Sub 79)

Improper bending of the wire lead may result in cracking of the epoxy seal, thus allowing solder to flow out and oxygen to enter the TCO and alter the functioning temperature of the TCO. Oxygen along with heat and time may also be a combination that could be accelerating the changes in the properties for the thermal linkage and the special compound.

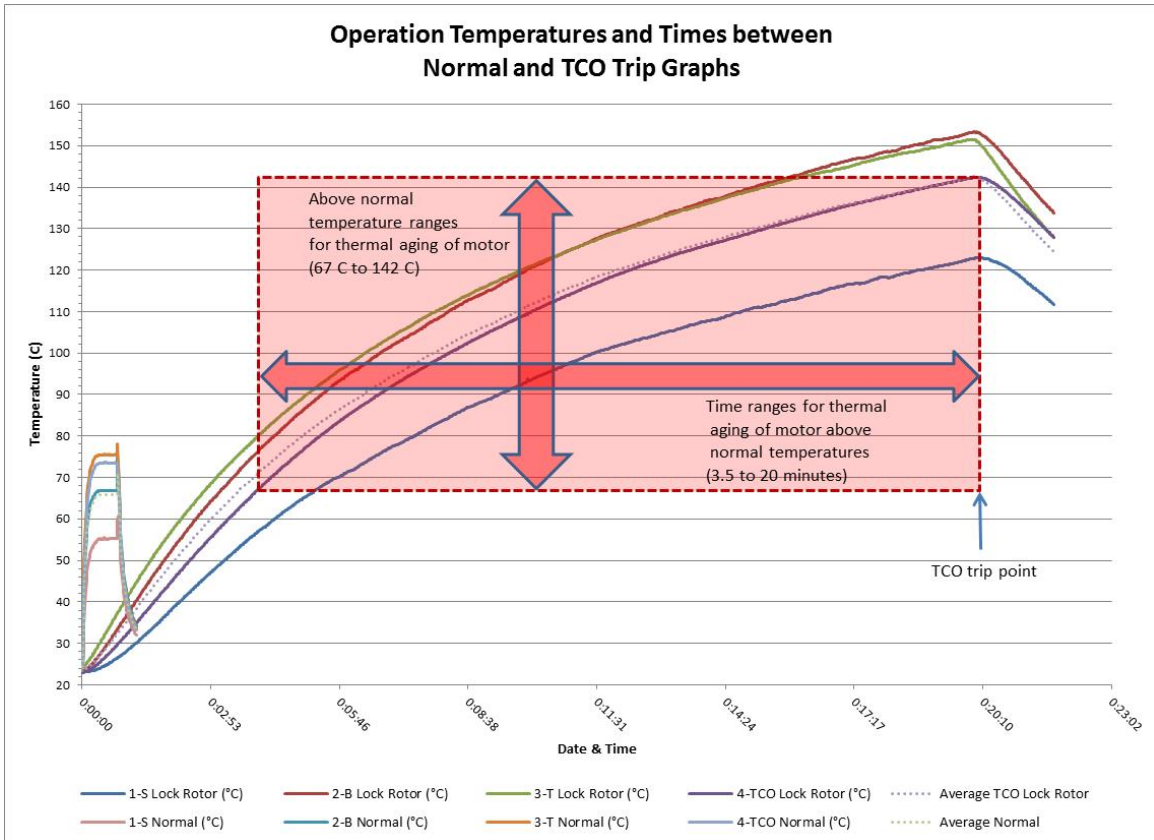
Figure 59. Potential thermal aging of the motor between normal and TCO trip conditions

Figure 59 shows Fan sub 60 temperatures for normal and lock-rotor operation. In normal operations, the TCO temperature stabilizes at around 68°C. For lock-rotor condition, the TCO activates at a TCO temperature around 142°C after 20 minutes. This would suggest that an exhaust fan that is in lock-rotor condition, but is operated for less than 20 minutes, can have the TCO heated to temperatures up to 142°C. If the exhaust fan is operated for more than 3 minutes, the TCO is experiencing temperatures above normal operation.
