CPSC Staff's Statement on SEA Ltd.'s (SEA's) Report, "Study of Debris Penetration of Recreational Off-Highway Vehicle (ROV) Floorboards"
December 2021

*Study of Debris Penetration of Recreational
Off-highway Vehicle (ROV) Floorboards*

for:
Consumer Product Safety Commission

December 2021

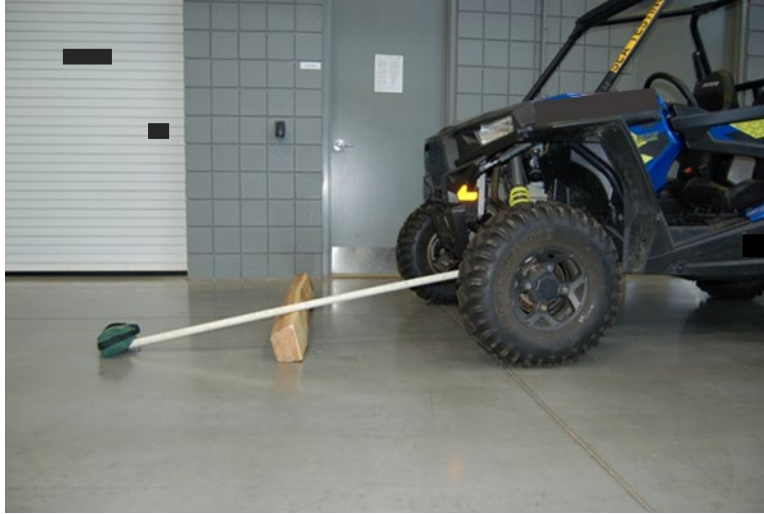
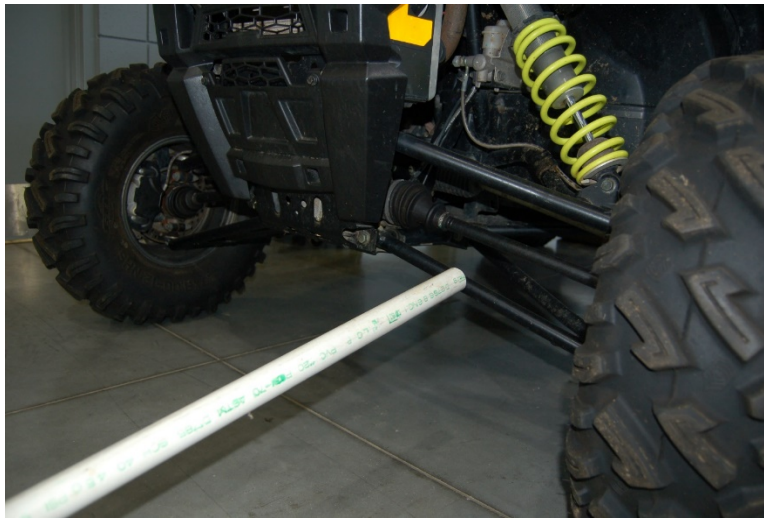
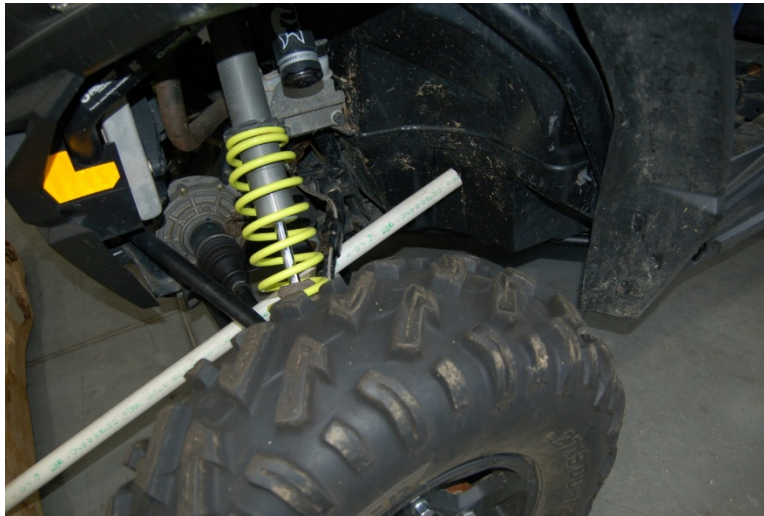
Figure 1: Simulated Stick at an Angle Where it Could Get Caught up in Suspension of Vehicle A.

The outdoor tests were designed to simulate the more serious accidents. A popular type of vehicle, which is called Vehicle A in the sled test sequence, was examined for the possibility of this type of accident, as seen in the photos of Figure 1. The middle photo of Figure 1 shows that with the end of the stick positioned where it is, if the vehicle were moving forward, the stick would pass between or above the suspension components. The angle of the simulated stick and the height of the tip of the stick in the middle photo were measured. These two factors together set the preliminary length and angle of the above-ground portion of the stick in the outdoor testing. The final angles for the sticks in the outdoor testing were adjusted somewhat from these initial values, as will be described later.

The bottom photo of Figure 1 shows the same stick with the vehicle moved forward, showing that a straight stick can find its way between the suspension components and strike the floorboard or firewall, similar to how sticks struck vehicles in the severe accidents. The angle of the stick may potentially change as the vehicle moves; however, it was determined that a straight stick could pass through the suspension components. During the final set up of the outdoor test, it was decided to use two stick penetration zones, one between the lower and upper suspension A-arms like Figure 1, as indicated by the rectangle in Figure 2. The other penetration zone was with a higher impact point above the suspension upper A-arm and below the spring/shock strut as indicated by the triangle in Figure 2. The test using the triangular impact zone is referred to as Run 1 and the test using the rectangular impact zone is Run 2.

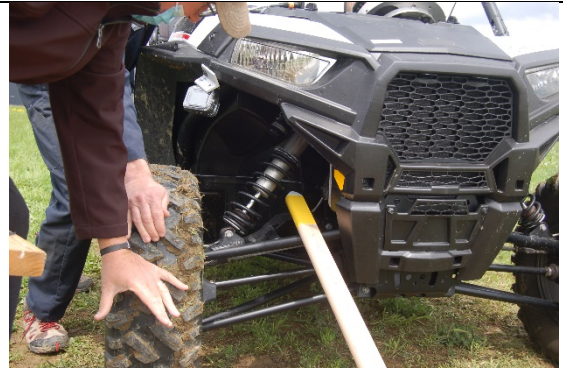
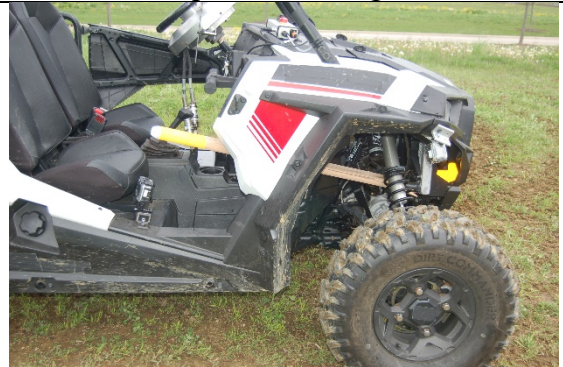
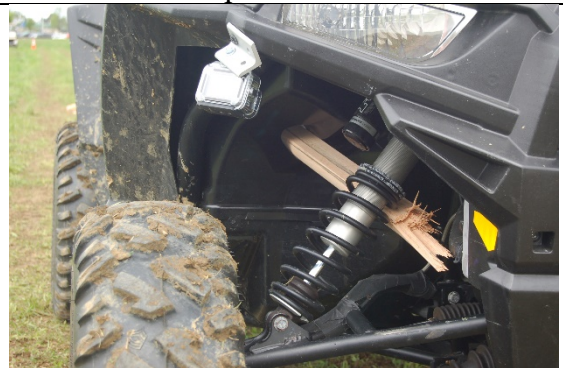
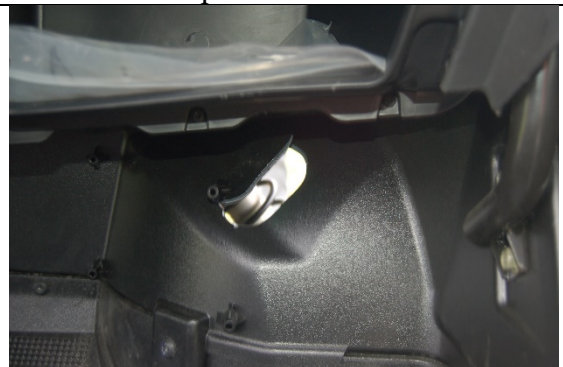
Table 1: Full Scale, Autonomously Driven ROV (Vehicle A) Impact Run #1

Complete stick penetration through firewall section.

After penetrating the firewall and becoming engaged with suspension components, the stick broke as the vehicle moved past the fixture holding the base of the stick.

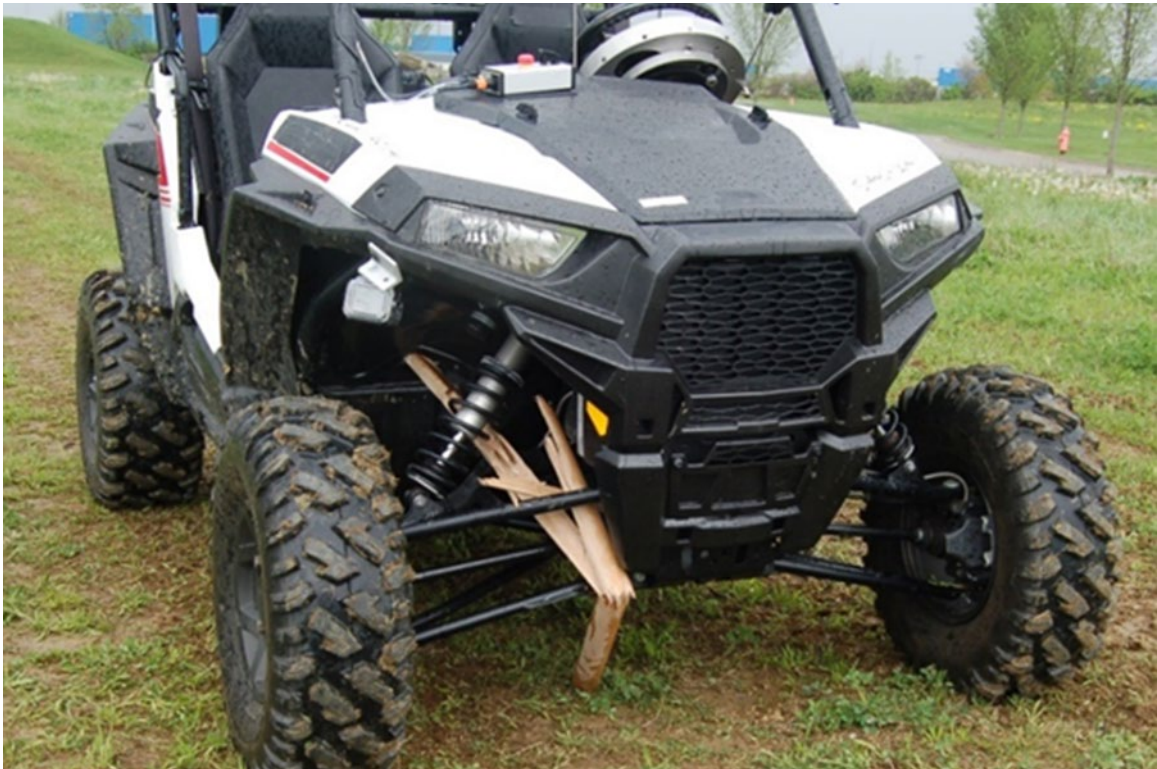
Figure 16: Run 2 Post-Impact Front View

The pre-impact stick alignment for Run 2 is shown on Figure 15, with the end of the stick positioned to go between the upper and lower control arms. Figure 16 shows a post-impact front view of the vehicle. The stick was guided between the control arms and into the upper floorboard / lower firewall area. The stick penetrated the floorboard/firewall seam, became intertwined in the suspension components, and broke off as the vehicle passed over the wooden box holding the far end of the stick.

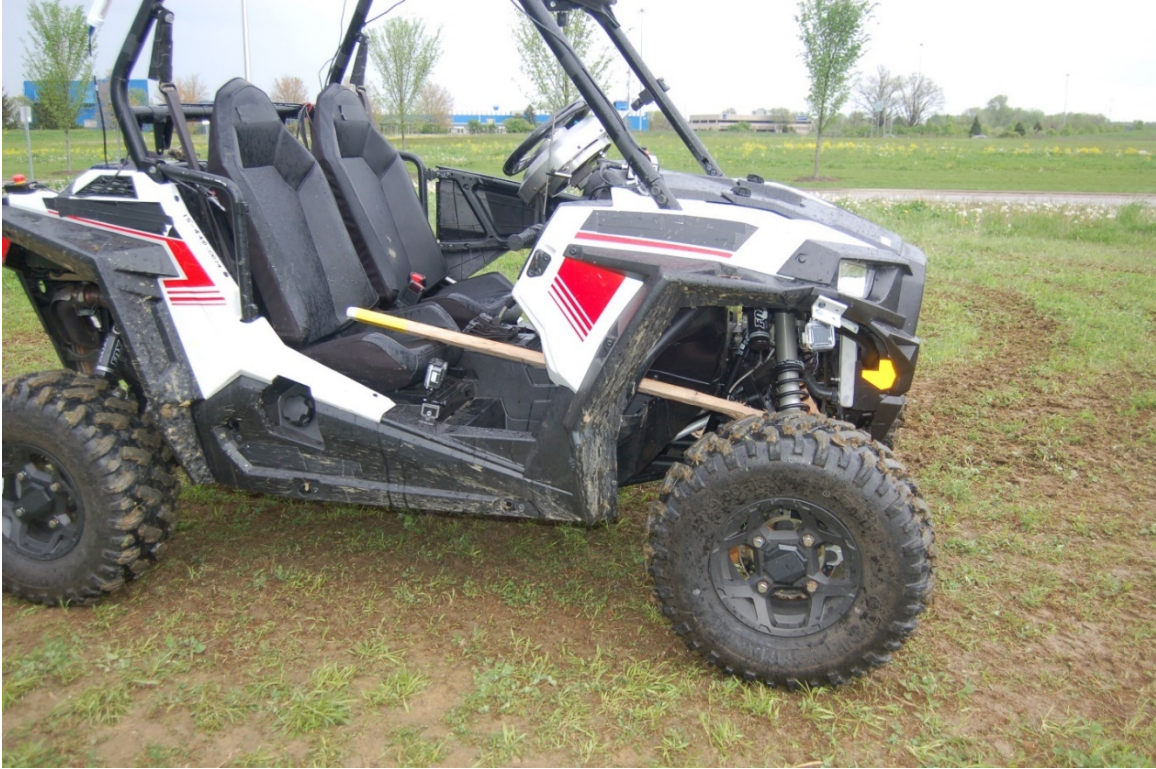
Figure 17: Run 2 Post-Impact Side View

Figure 17 is a side view showing how the stick entered the occupant compartment above the passenger's seat. Interior and exterior views showing how the stick penetrated between the floorboard and firewall seam are shown in Figure 18 and 19, respectively.

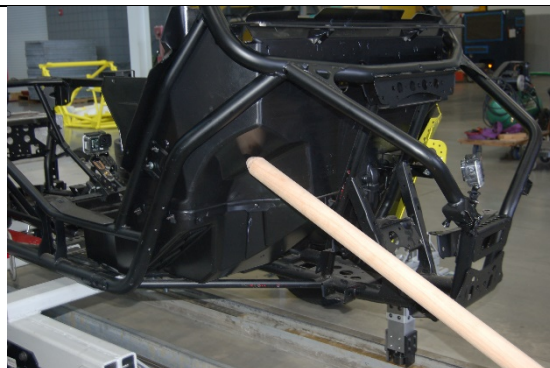
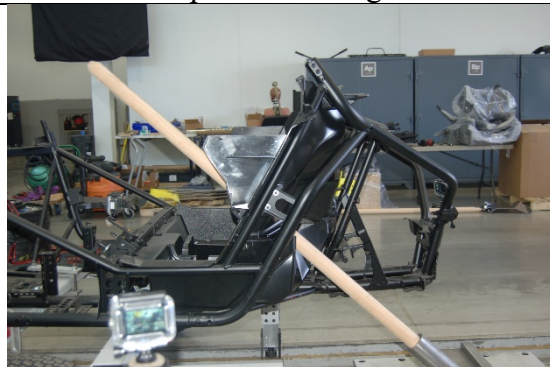
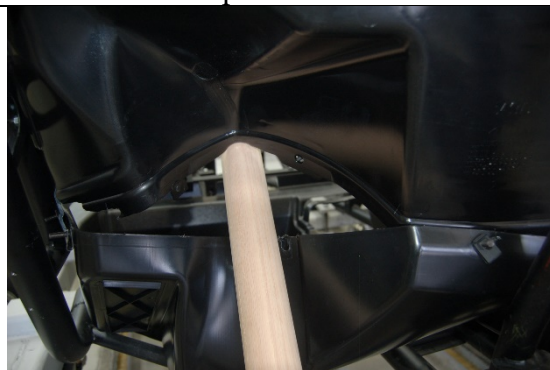
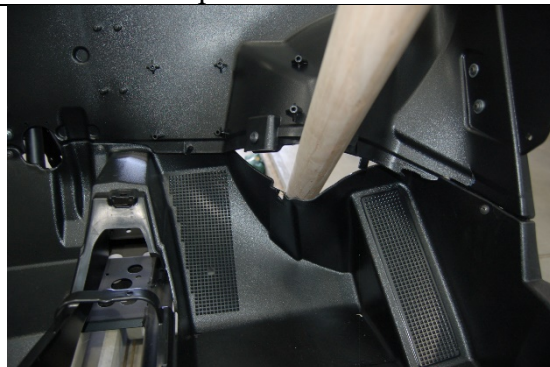
Table 6: Vehicle A – Sled Impact Run #2

Complete stick penetration through seam area between floorboard and firewall sections.

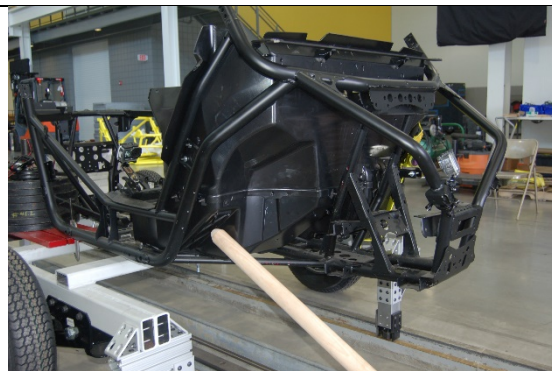
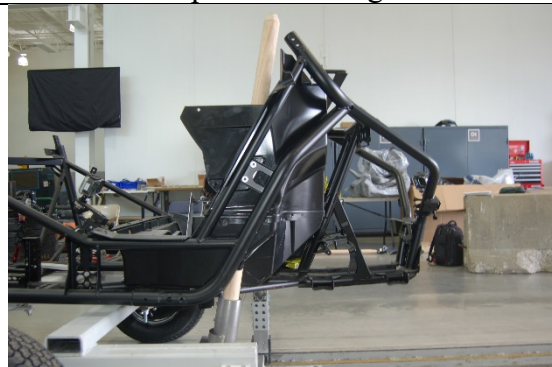
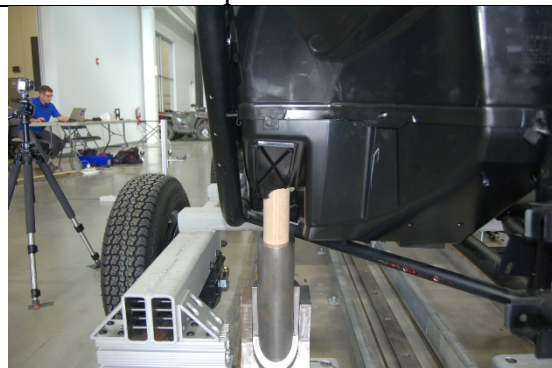
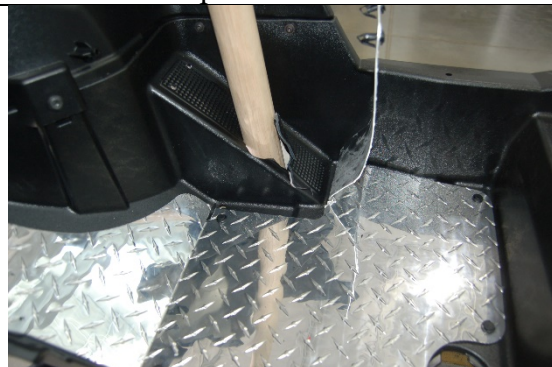
Table 6 (Continued): Vehicle A – Sled Impact Run #2 – Aftermarket Guard A1

Complete stick penetration through floorboard section and past Aftermarket Guard A1.

Fasteners securing top portion of guard on to footrest failed.

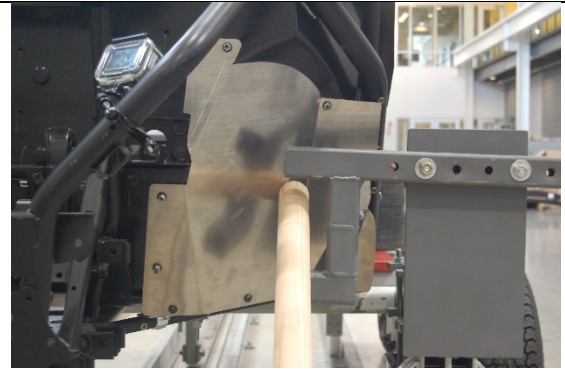
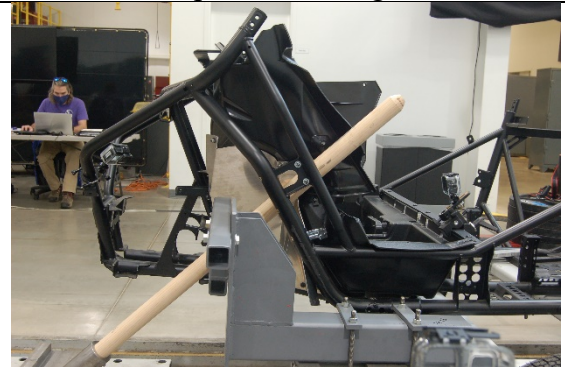
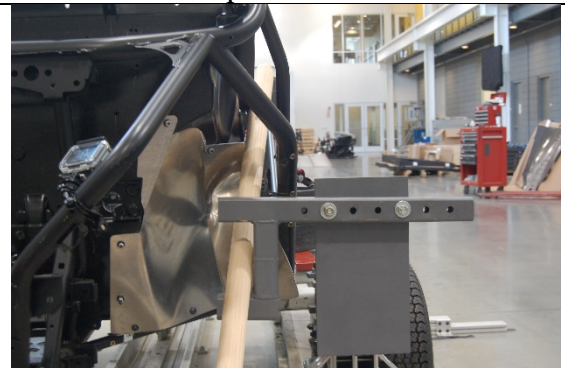
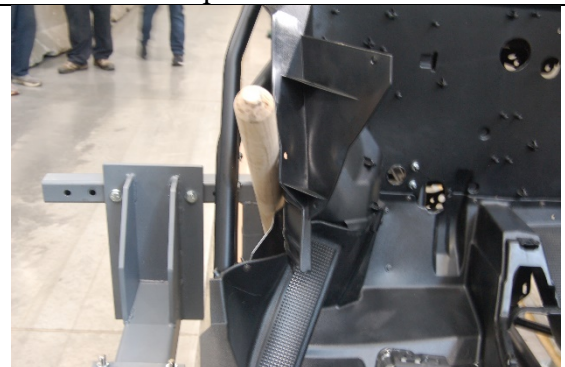
Table 7 (Continued): Vehicle A – Sled Impact Run #3 – Aftermarket Guard A2

The guard deformed and the C-hook securing the outside edge of the guard became disconnected from the frame of the vehicle. The stick moved up and outward, past the outside of the deformed guard, then penetrated between the vehicle frame and floorboard/firewall sections.

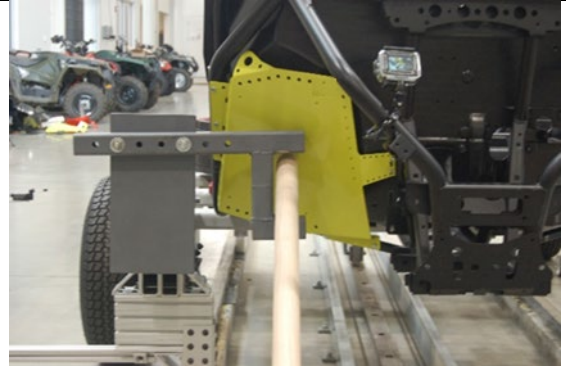
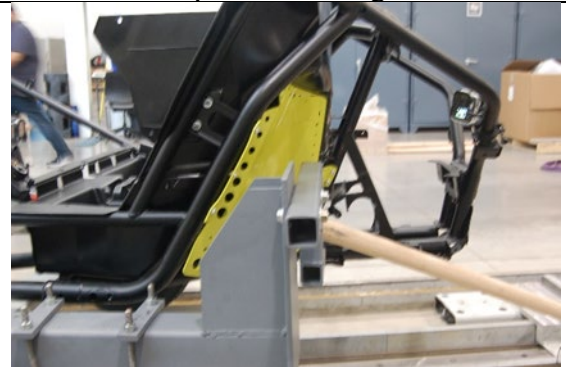
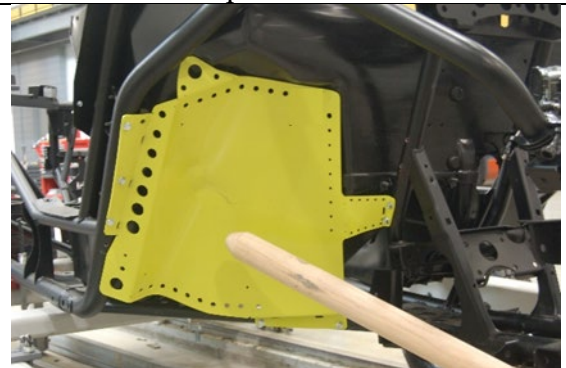
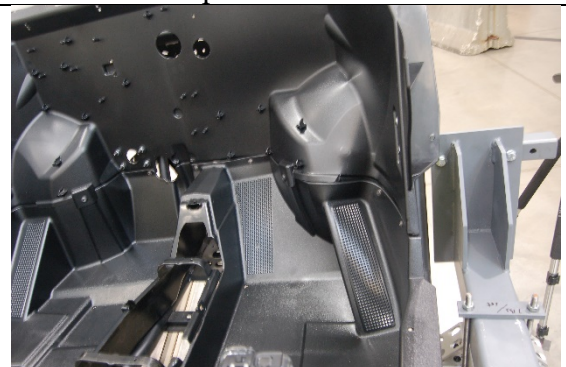
Table 8 (Continued): Vehicle A – Sled Impact Run #4 – Aftermarket Guard A3

The guard deformed and pushed into the area of the seam between the floorboard and firewall. The post-impact maximum deflection of the floorboard/firewall was 2 ¼".

During the impact, the sled cart with vehicle chassis lifted over 10" and yawed clockwise about 10 degrees.

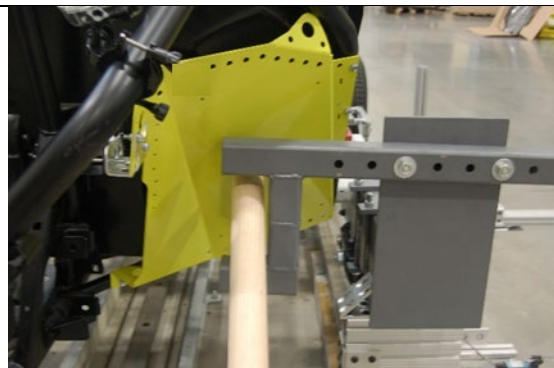
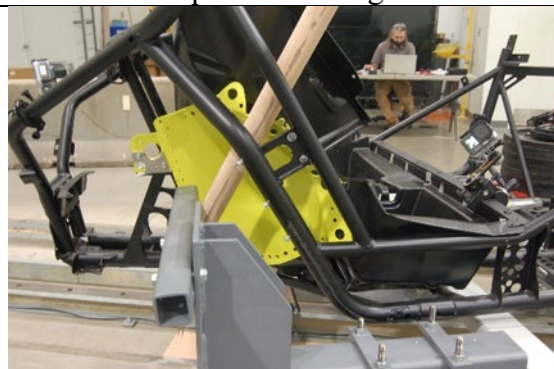
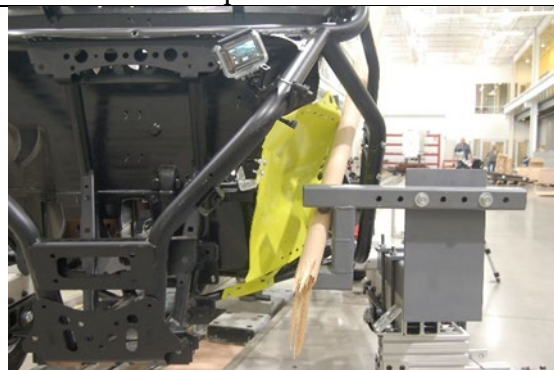
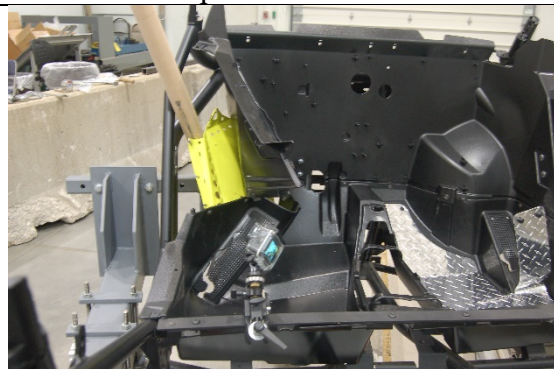
Table 9 (Continued): Vehicle A – Sled Impact Run #5 – Aftermarket Guard A3

The guard deformed and the guard material around the holes for the three outside guard fasteners failed, allowing the guard to release from the outside fasteners. The fasteners themselves did not fail.

The stick moved outward and up, past the outside of the deformed guard, then the stick and guard penetrated between the vehicle frame and floorboard/firewall sections.

After penetrating the occupant compartment and becoming engaged with the C-Brace, the stick broke as the vehicle chassis moved past the fixture holding the base of the stick.

The bottom left photo shows the failed guard material around the holes for the three outside guard fasteners. The bottom right photo shows the maximum deflection in the middle of the part, about 3 3/8 inches.

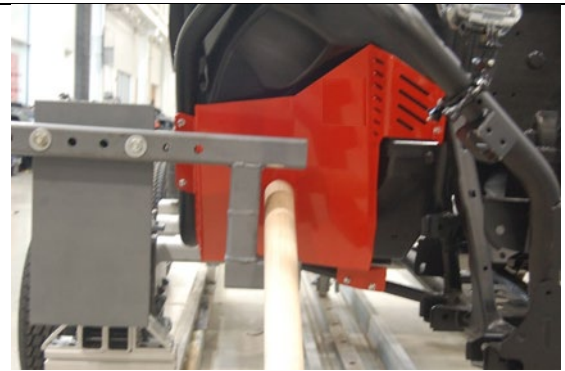
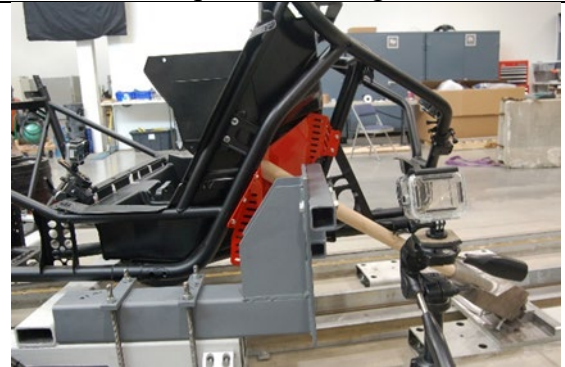
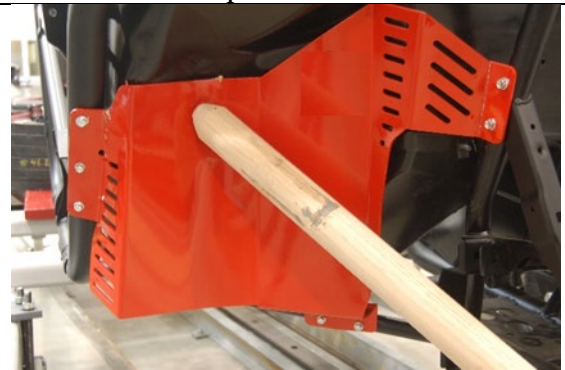
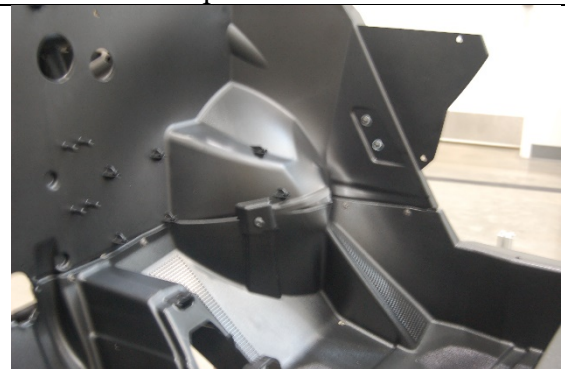
Table 10: (Continued) Vehicle A – Sled Impact Run #6 – Aftermarket Guard A4

The guard deformed and pushed into the area of the seam between the floorboard and firewall. The post-impact maximum deflection of the floorboard/firewall was 2 ¾".

During the impact, the sled cart with vehicle chassis lifted over 8" and yawed clockwise about 11 degrees.

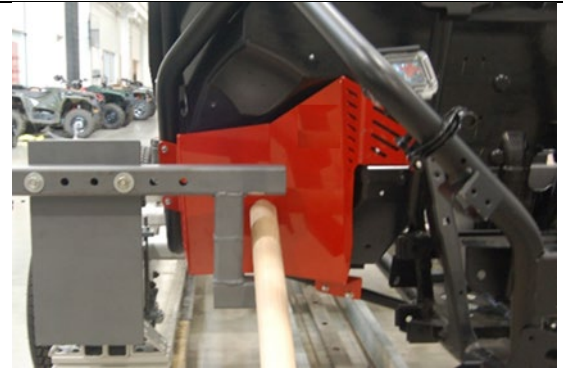
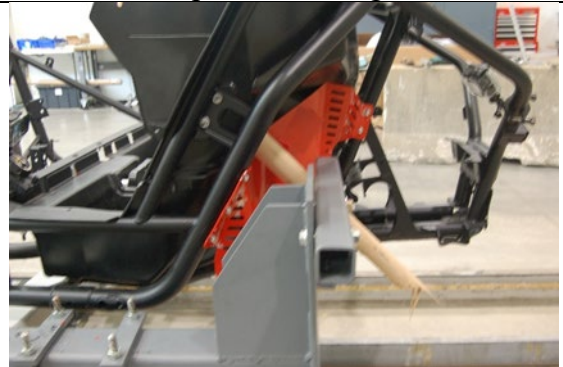
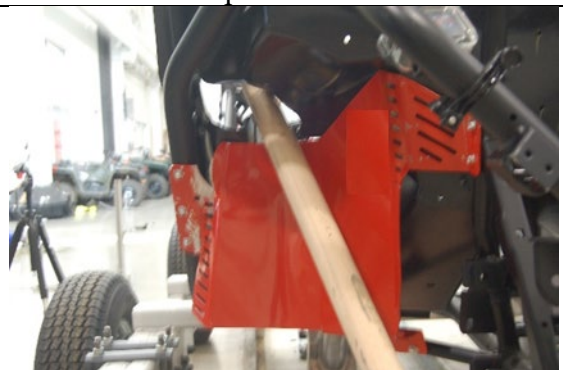
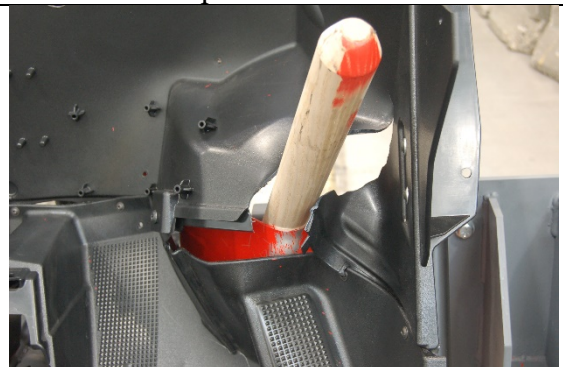
Table 11 (Continued): Vehicle A – Sled Impact Run #7 – Aftermarket Guard A4

The guard deformed and the guard material ripped near the top outer edge of the guard. None of the guard fasteners failed.

The stick rode up the guard, after significant guard deformation, and penetrated the firewall above the floorboard/firewall seam.

After penetrating the floorboard/firewall and becoming engaged with the C-Brace, the stick broke as the vehicle chassis moved past the fixture holding the base of the stick.

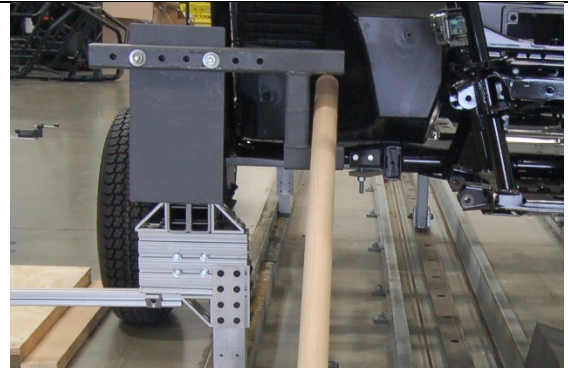
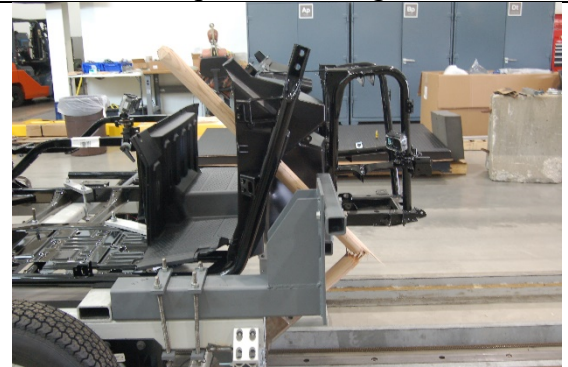
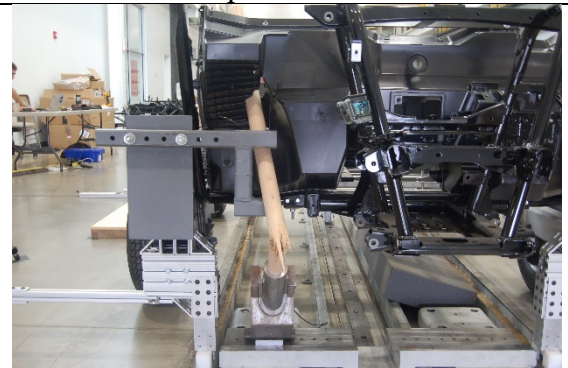
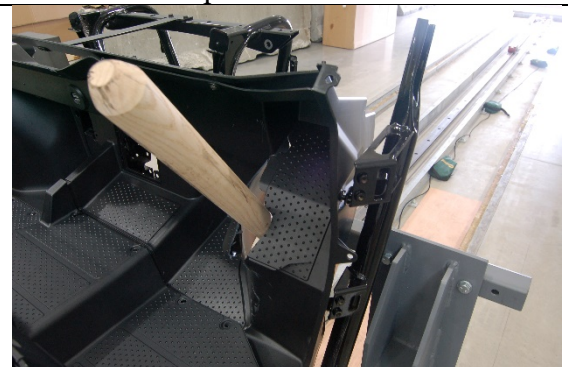
Complete stick penetration through floorboard/firewall.

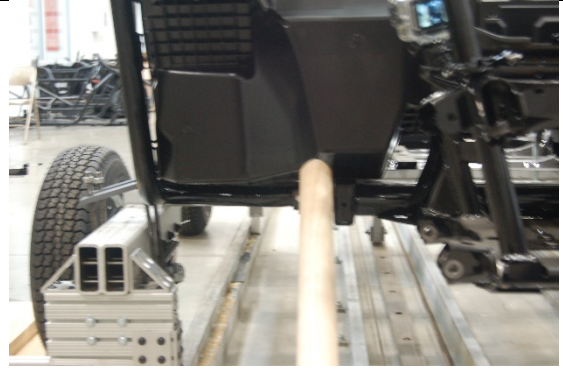
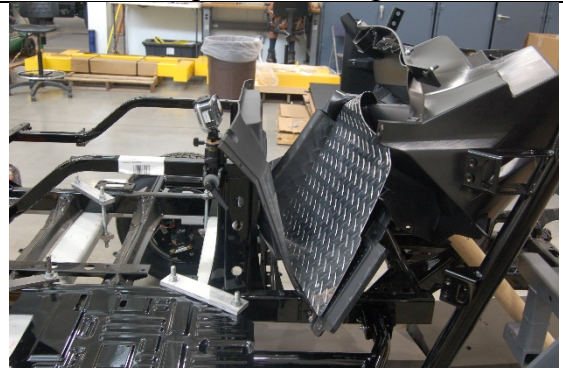
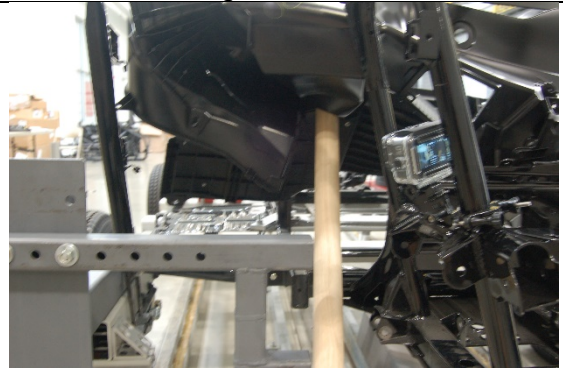
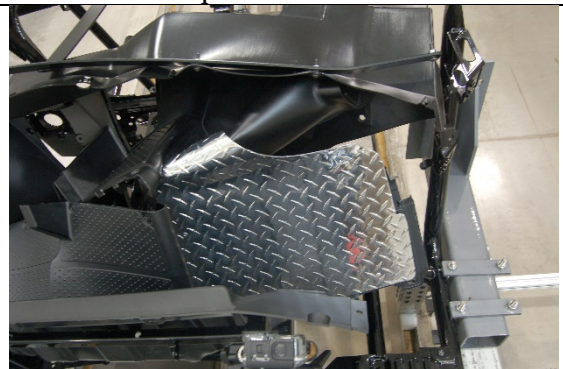
Table 13 (Continued): Vehicle B – Sled Impact Run #2 – Aftermarket Guard B1

The floorboard and guard deformed together. One rivet connection of the guard failed, but the two rivets nearest the impact did not fail. The guard deflected about one inch more than floorboard.

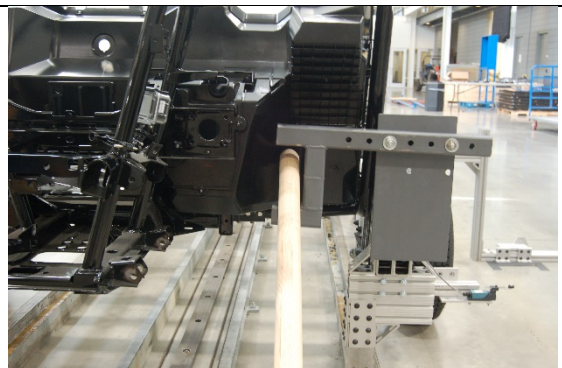
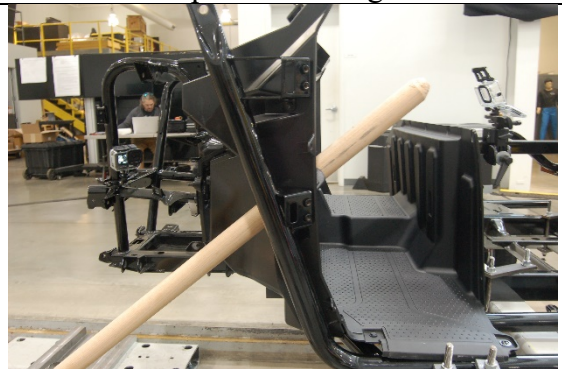
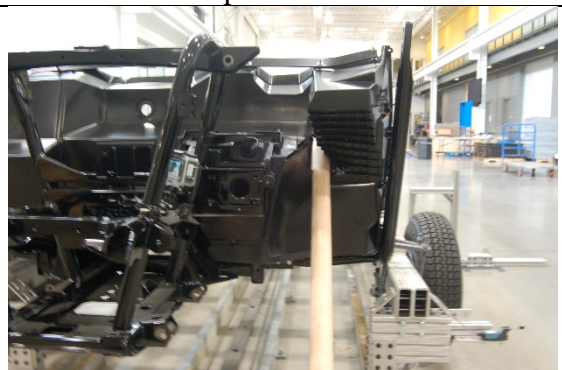
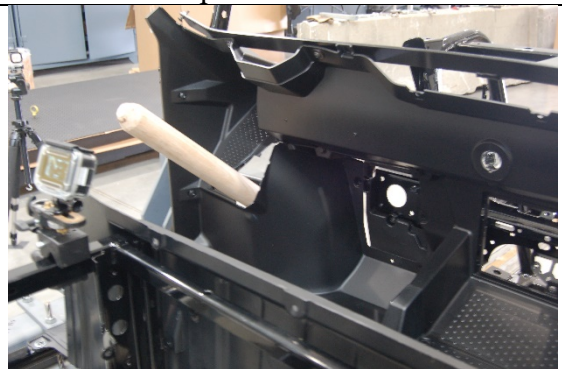
Complete stick penetration through floorboard/firewall.

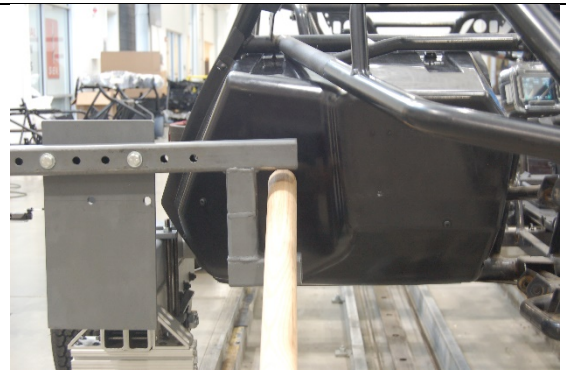
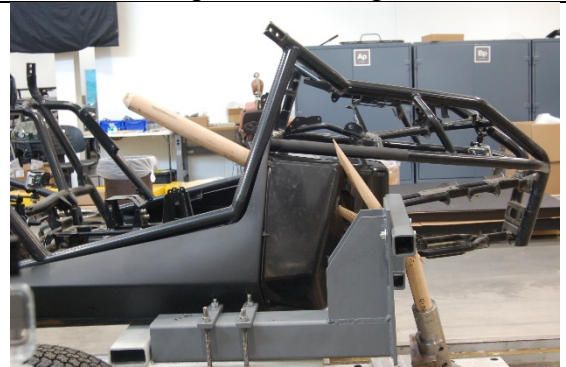
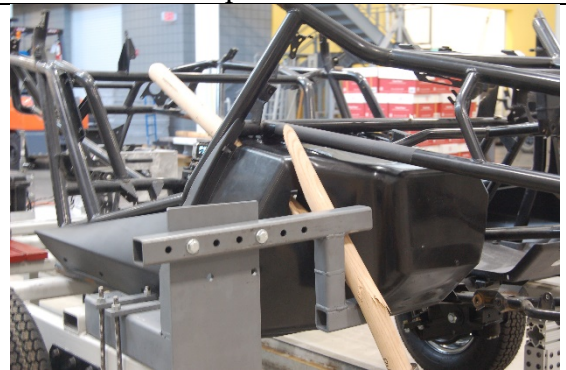
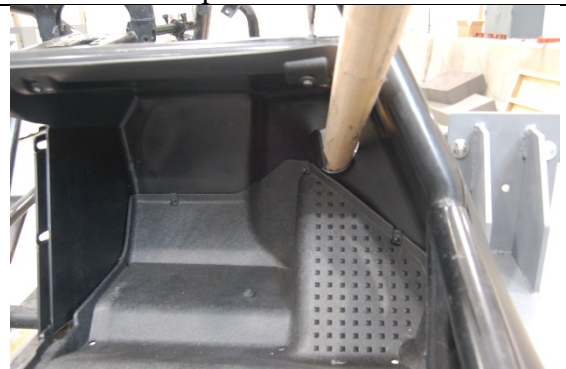
Complete stick penetration through firewall, above footwell section. Tip of stick contacted and went below upper frame member.

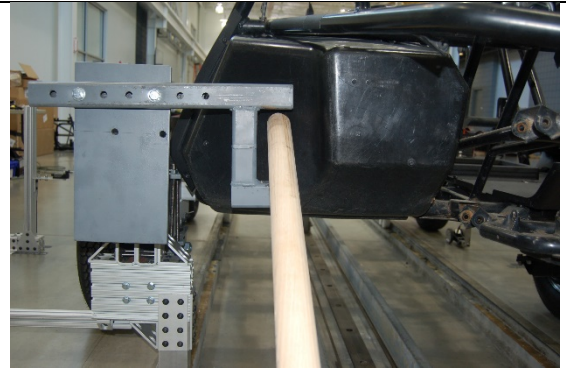
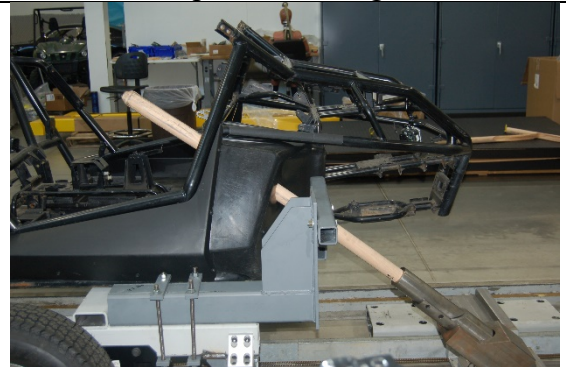
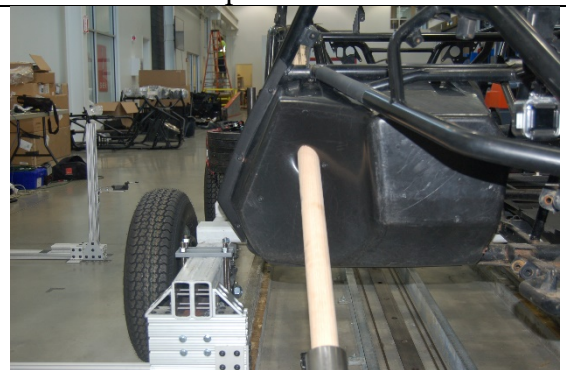
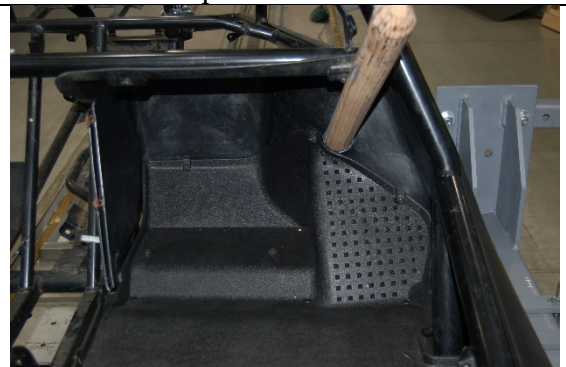
Complete stick penetration through firewall, above footwell section. Tip of stick contacted and went below upper frame member.

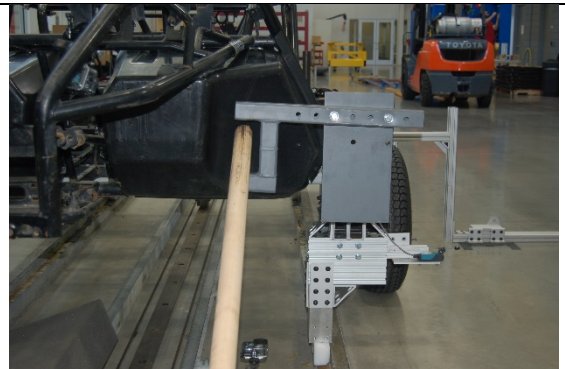
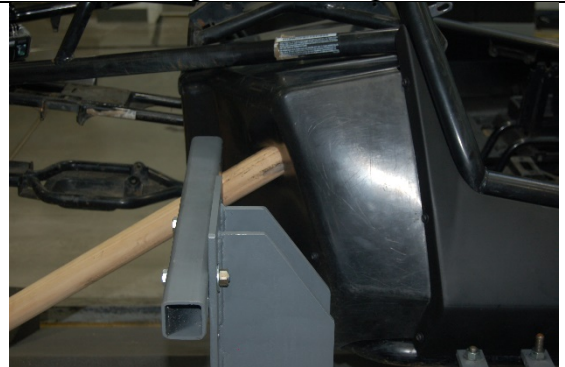
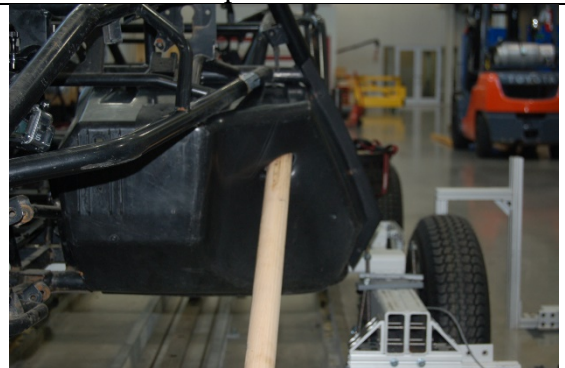
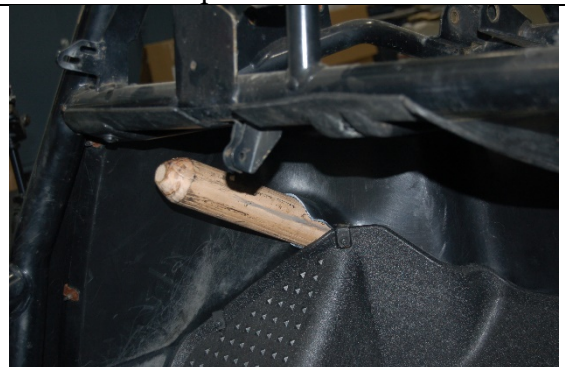
Table 17: Vehicle C – Sled Impact Run #3

Complete stick penetration through firewall, above footwell section. Penetration not far enough for tip of stick to contact upper frame member.

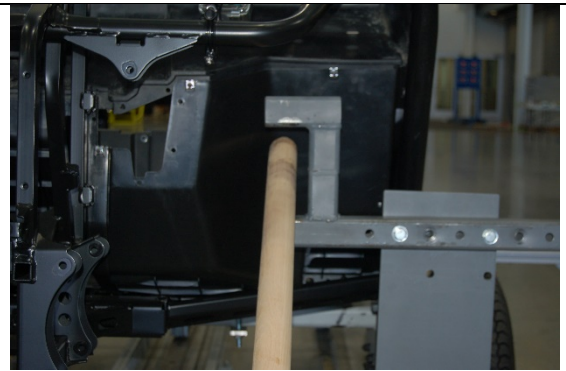
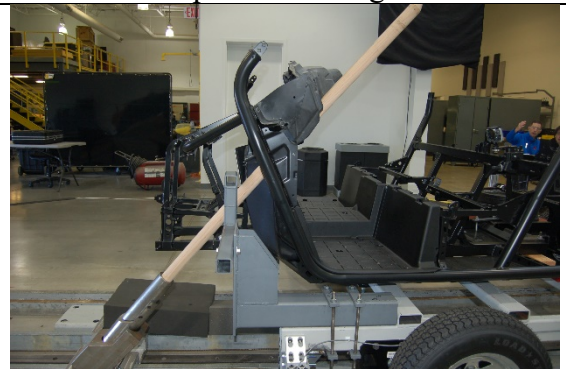
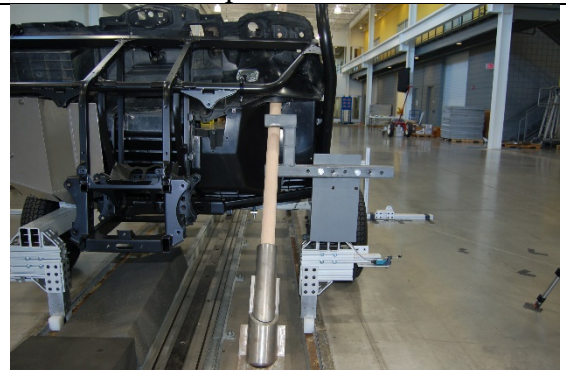
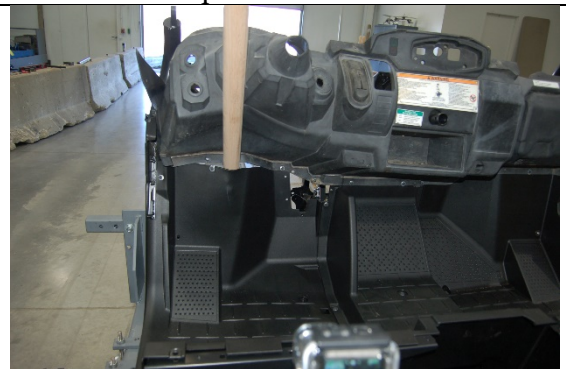
Table 18: Vehicle D – Sled Impact Run #1

Complete stick penetration in seam where firewall section meets dash section.

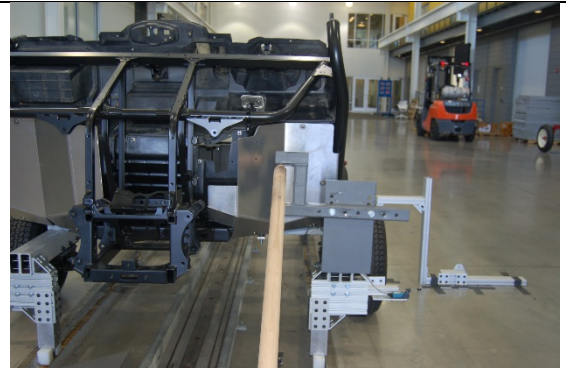
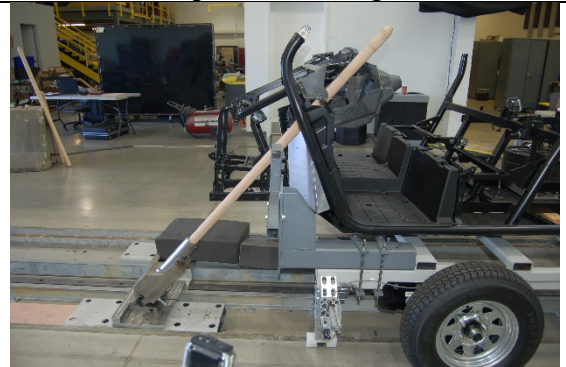
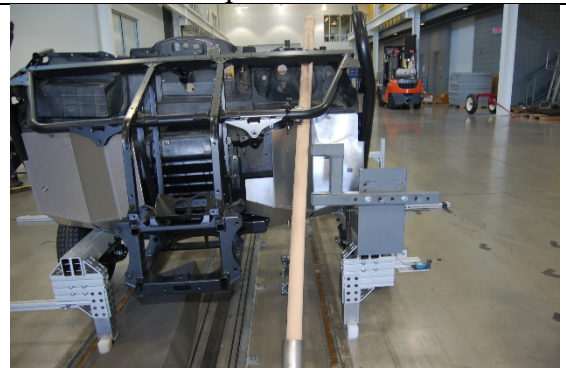
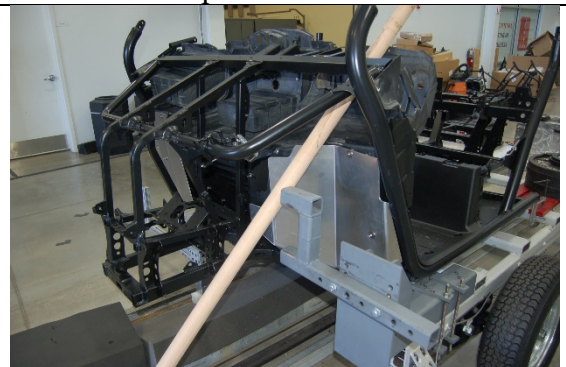
Table 19: Vehicle D – Sled Impact Run #2

Complete stick penetration in the dashboard section, above firewall. The guard deflected about 5/8". The stick moved outside of the C-Brace and upward above guard and into the dashboard.

The guard has a natural bend, which was increased in the test. After this run, the dimension was 3 1/8 inches, as seen in the bottom photo. On an undamaged guard the same measurement was 2 1/2 inches, therefore the deflection caused by this run was 5/8 inch.

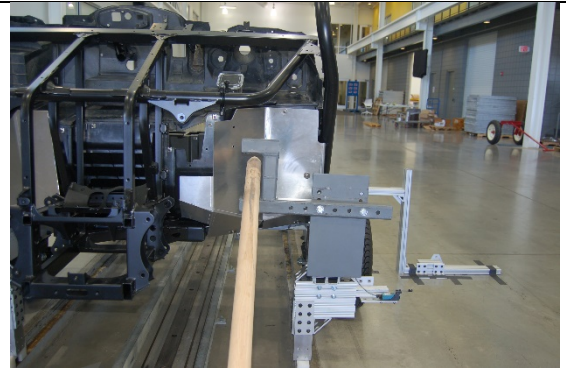
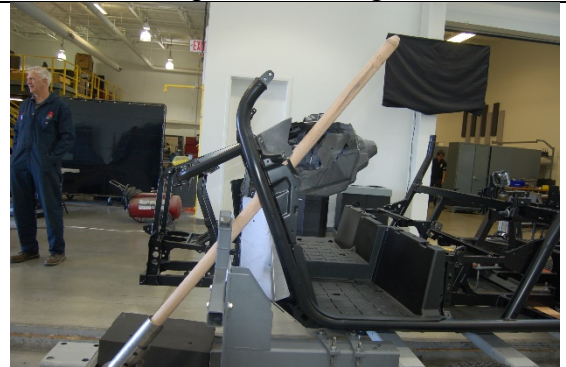
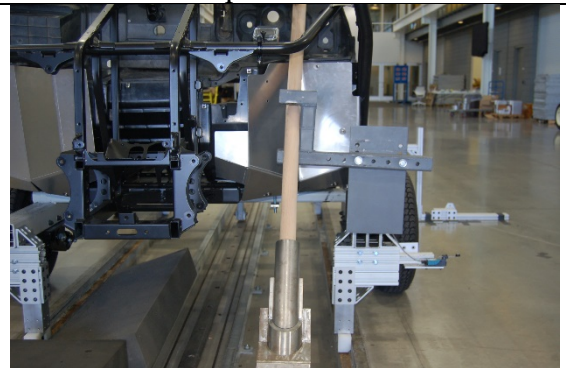
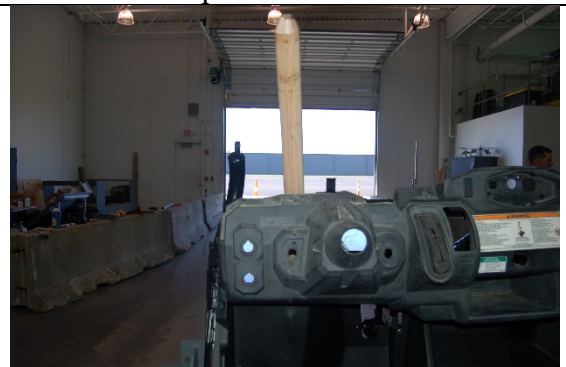
Complete stick penetration in the dashboard section, above firewall. The guard deflection was about 5/8". The stick remained in the C-Brace, and again moved upward above guard and into the dashboard.

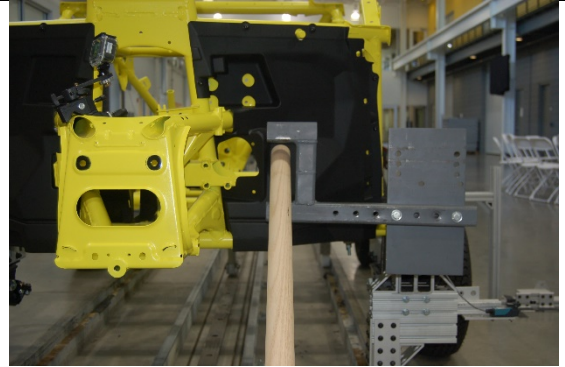
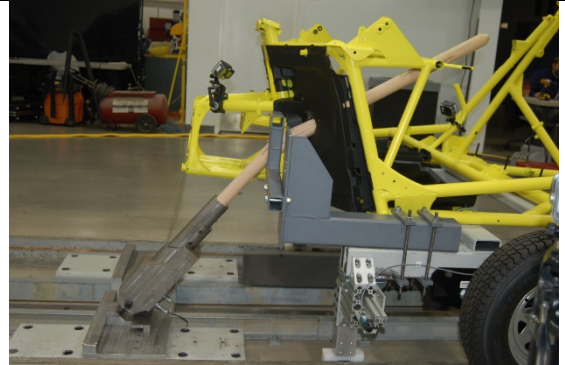
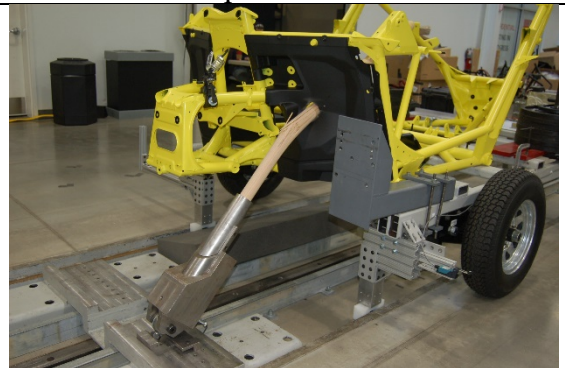
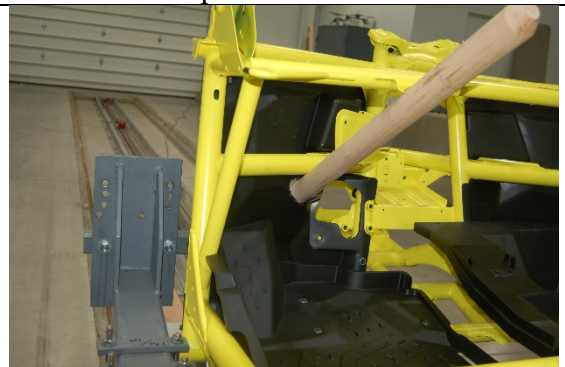
Complete stick penetration into firewall section.

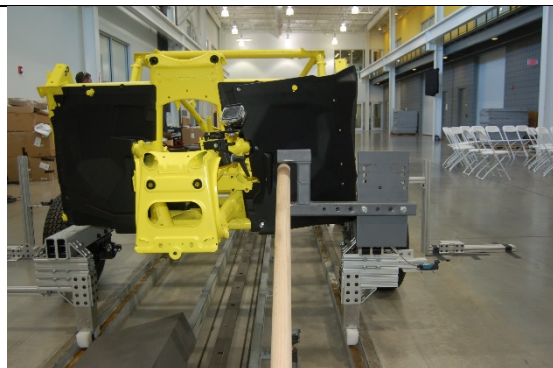
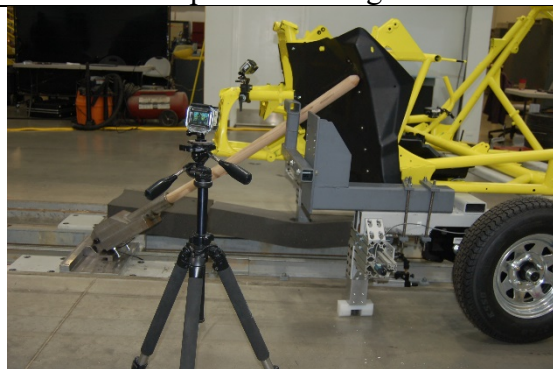
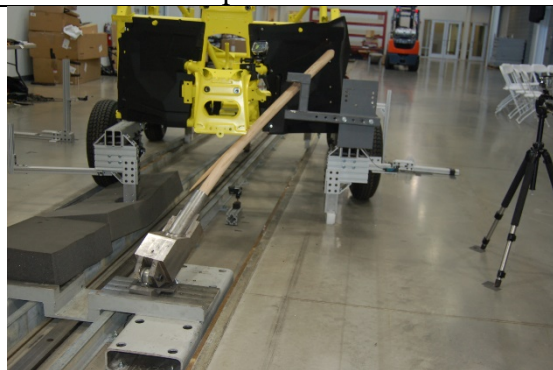
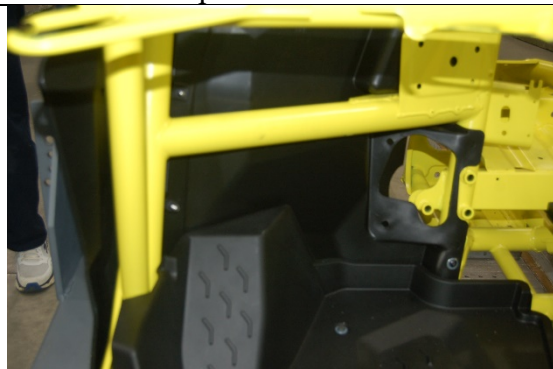
Table 22: Vehicle E – Sled Impact Run #2

Small dent, about 1/2", in plastic guard. No damage to OEM firewall or fasteners.

During the impact, the sled cart with vehicle chassis lifted over 8" and yawed counterclockwise about 8 degrees.

The forming process for this guard allows for making complex curves, and the guard shape is not a series of planes. This makes the deflection more difficult to measure. However, the maximum depth of damage was estimated at $\frac{1}{2}$ inch, as shown in the bottom photo.

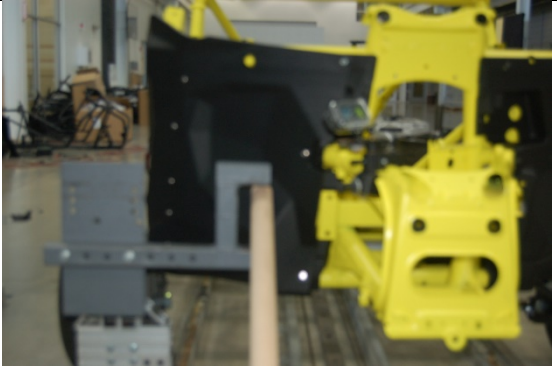
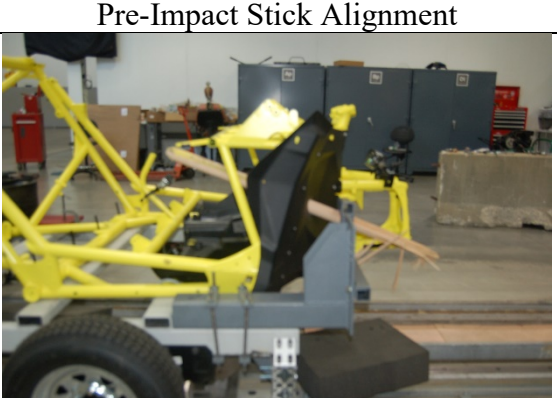
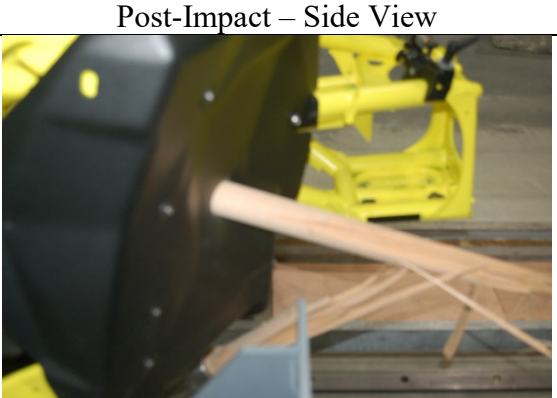
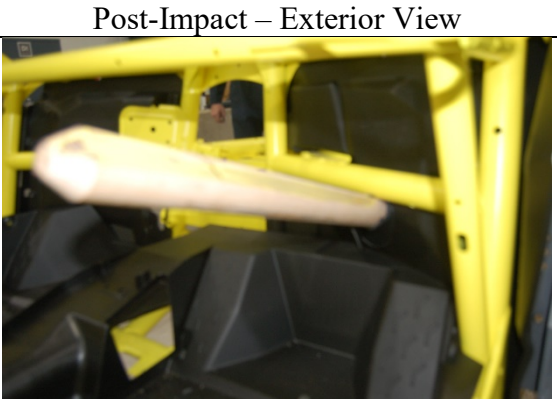
Table 23: Vehicle E – Sled Impact Run #3

<p>Configuration: Aftermarket Guard E1</p> <p>Nominal Impact Speed: 10 mph</p> <p>Actual Impact Speed: ~10 mph (No Speed Data)</p> <p>Primary Impact Location: Stick aligned to impact center of the guard</p> <p>9" Above Bottom of Floorboard 13 ¾" Right of Vehicle Centerline</p> <p>Stick Length: 53"</p> <p>Stick Penetration: Yes</p> <p>Peak Force at Base of Stick: 9,392 lbs</p> <p>Run Outcome Narrative: Complete stick penetration through guard and OEM firewall section.</p>

This is a black plastic guard made of High Molecular Weight Polyethylene (HMWPE). Per the manufacturer of this guard, its starting thickness is 0.30 inches and after forming/stretching it into shape it will be less in some areas. Its thickness varies somewhat but averages about 0.270 inches. It covers an area of about 24 inches laterally and 27 inches vertically. The top photo shows the passenger's side guard tested in this run. The slightly greater than 2 inch diameter through hole in the guard was caused by the 2 inch diameter stick penetration.

The depth of maximum damage at the point of maximum damage, near but not at the penetration, is shown in the bottom photo. This is 9/16 inch.

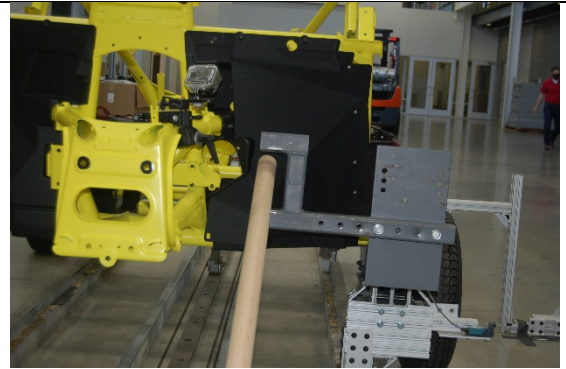
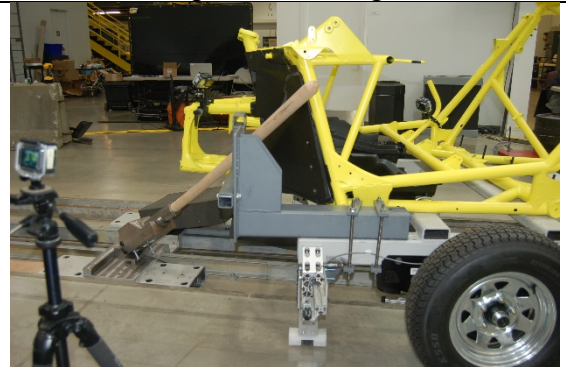
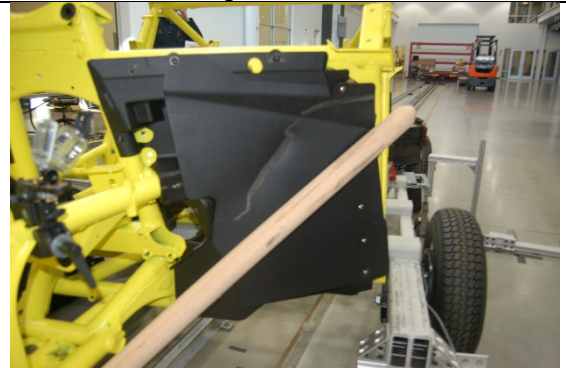
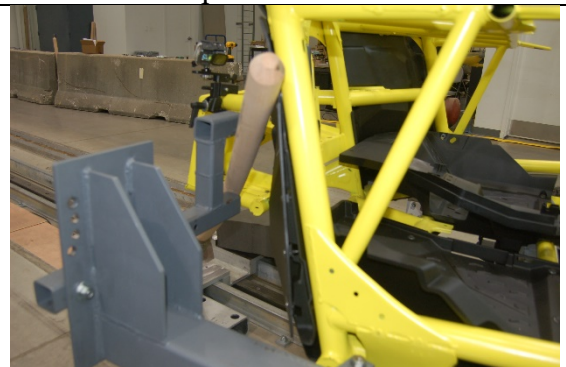
Table 24: Vehicle E – Sled Impact Run #4 – Aftermarket Guard E2

Indentation in guard of about one inch. No damage to OEM firewall or fasteners.

During the impact, the sled cart with vehicle chassis lifted over 8" and yawed counterclockwise about 9 degrees.

The depth of maximum damage at its deepest point is about 1 inch, as shown in the bottom photo.
