CPSC Staff's Statement on SEA Ltd.'s (SEA's) Report, "Study of Debris Penetration of Recreational Off-Highway Vehicle (ROV) Floorboards"
December 2021

*Study of Debris Penetration of Recreational
Off-highway Vehicle (ROV) Floorboards*

for:
Consumer Product Safety Commission

December 2021

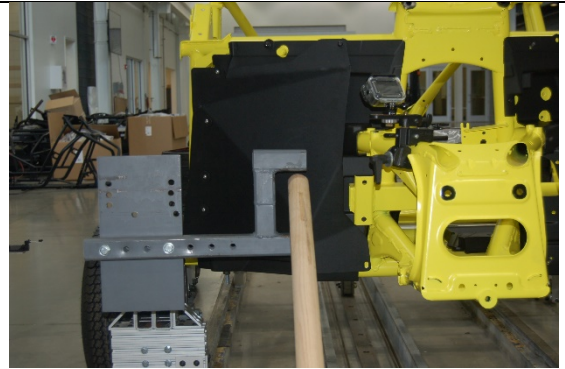
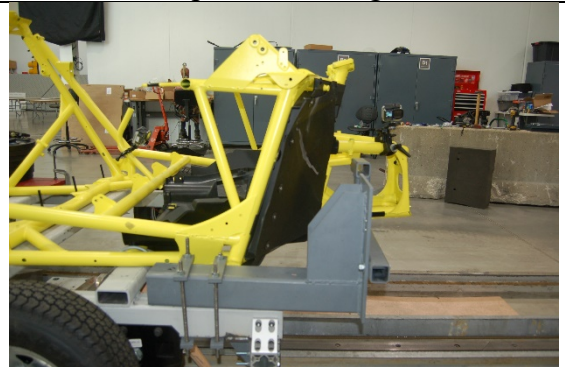
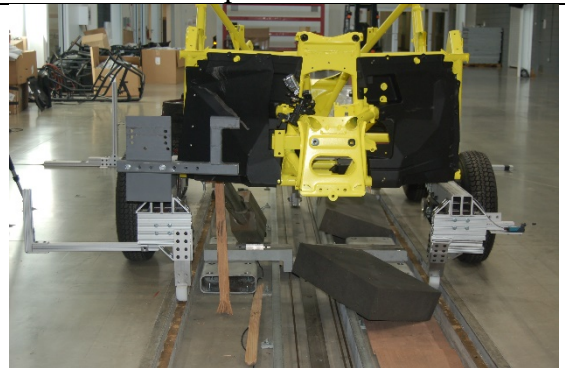
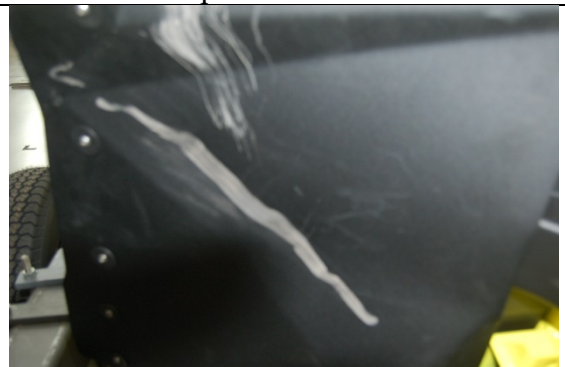
Table 25 (Continued): Vehicle E – Sled Impact Run #5 – Aftermarket Guard E2

Guard E2 (Table 25) passed the run at 10 mph, it prevented the stick from penetrating the occupant compartment. During this impact, the tip of the stick was forced upward and outward along the guard, and eventually the stick shattered. The guard covered an area extending beyond the outside frame of the vehicle, and there was no failure of the guard material or guard fasteners.

Stick shattered. Indentation in guard of about 1 3/16". The guard covered an area extending beyond the outside frame of the vehicle, and there was no failure of the guard material or guard fasteners. No damage to OEM firewall or fasteners.

The depth of maximum damage at its deepest point is about 1 3/16 inch, as shown in the bottom photo.
