U.S. CONSUMER PRODUCT SAFETY COMMISSION
5 RESEARCH PLACE
ROCKVILLE, MD 20850

January 8, 2018

CPSC Staff Assessment on Eutectic-Type Thermal-Cutoff Fuse Failures in Shaded-Pole Motors Used in Exhaust Fans

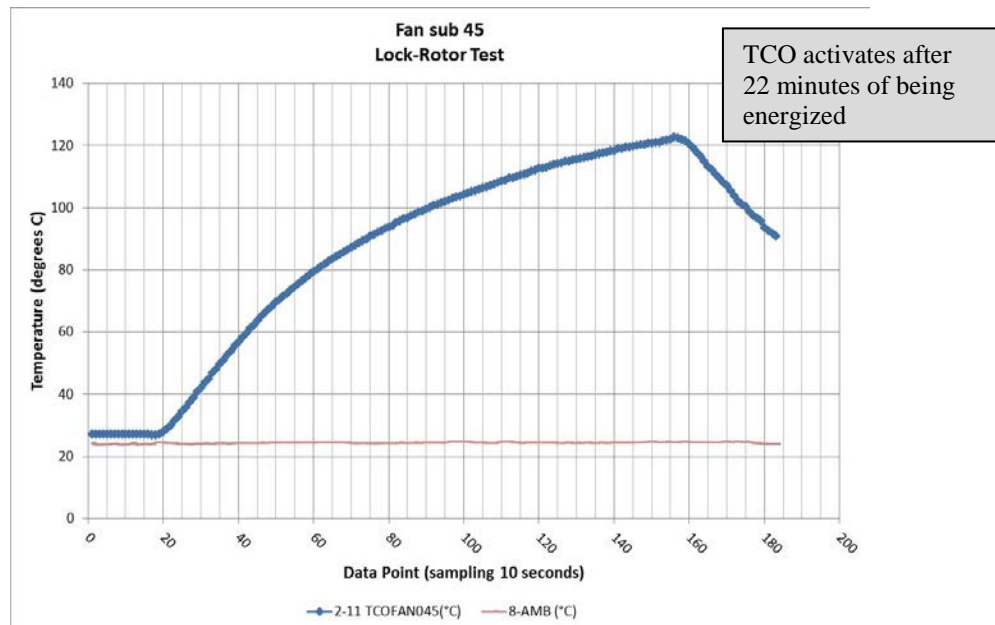
Figure 13. Sub 45 temperature measurement outside the winding

The fan was tested in its as-received condition, *i.e.*, locked-rotor condition. A single thermocouple was placed on the side of the winding, on the outside of the wrap, adjacent to the TCO location. After being energized, the TCO activated after 22 minutes, as shown by the temperature traces in Figure 13. For the location of this thermocouple, the temperature shows a maximum of 120°C, but this location is about 20°C cooler than the actual TCO or at the top of the winding. The actual TCO functioning temperature (T_f) was calculated to be about 140°C (120°C + 20°C), which corresponds closely to the T_f of 136°C. This testing in lock-rotor condition also verified that the side thermocouple measurements on the paper wrap were about 20°C lower than the actual TCO or the top of the windings. Figure 14 shows the radiographs of the TCO’s fusible link after lock-rotor testing, which shows the thermal linkage melted or open.

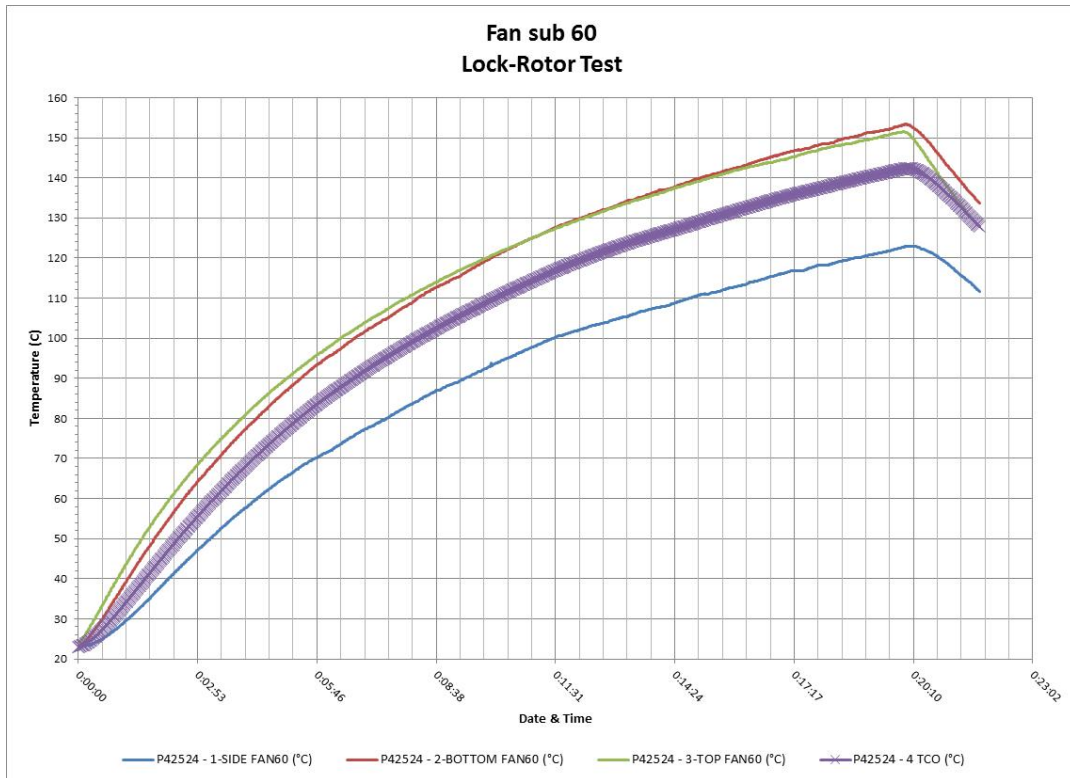
Figure 17. Temperature on the winding and within the TCO during a lock-rotor test

The same fan sub 60 that was instrumented with a thermocouple inside a TCO was used to measure the temperatures during lock-rotor conditions. Similar to the normal operation test, fan sub 60 had the three thermocouples on the paper wrap exterior of the winding and thermocoupled TCO. The lock-rotor condition was operated for 20 minutes to simulate the TCO tripping after 20 minutes in lock-rotor testing, as seen in Sub 45. After 9 minutes 12 seconds, the TCO temperature reached 105°C, as shown in Figure 17. At 15 minutes, the TCO temperatures reached 130°C. Shortly before 20 minutes, the TCO temperature reached 140°C. The TCO temperature measured approximately 142°C at 20 minutes or the manual trip time. The measurements in this test closely correspond to the sub 45 locked-rotor test. As mentioned previously, the TCO in sub 45 tripped at a measured temperature on the side of the winding around 120°C, and the temperature measured on the side of the winding in the test after 20 minutes of operation was about 123°C.

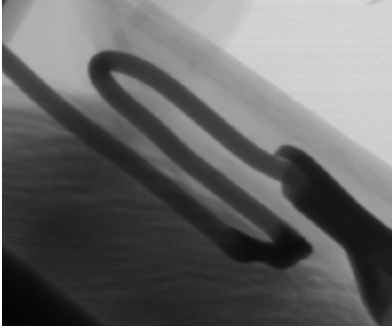
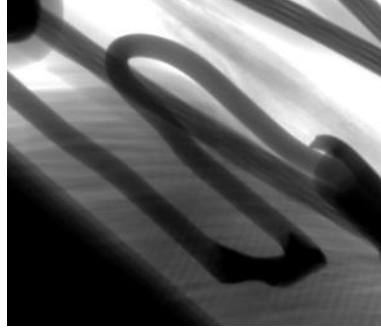
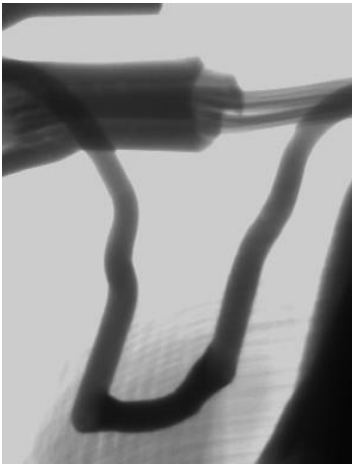
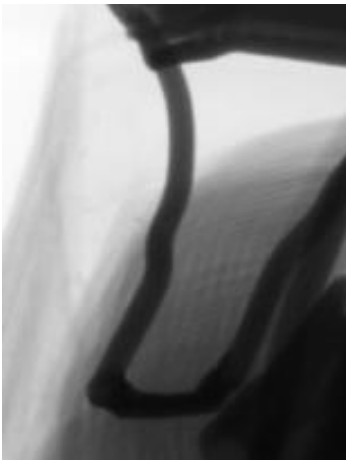
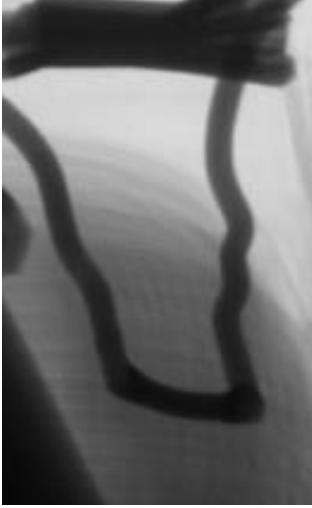
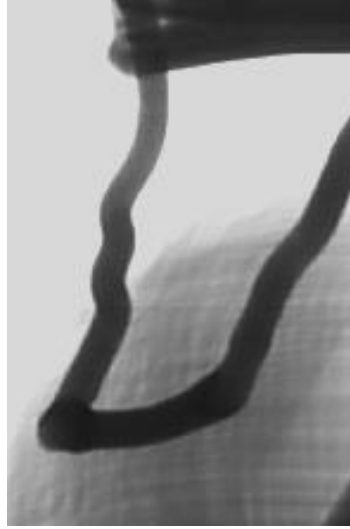
Figure 22 Thermal linkages before and after conditioning

For test group 3, all of the TCOs were x-rayed before and after conditioning. The thermal linkages did not appear visually to have changed after conditioning at 105°C for up to 305 hours. Figure 22 shows radiographs of the thermal linkages before and after conditioning for various lengths of time.

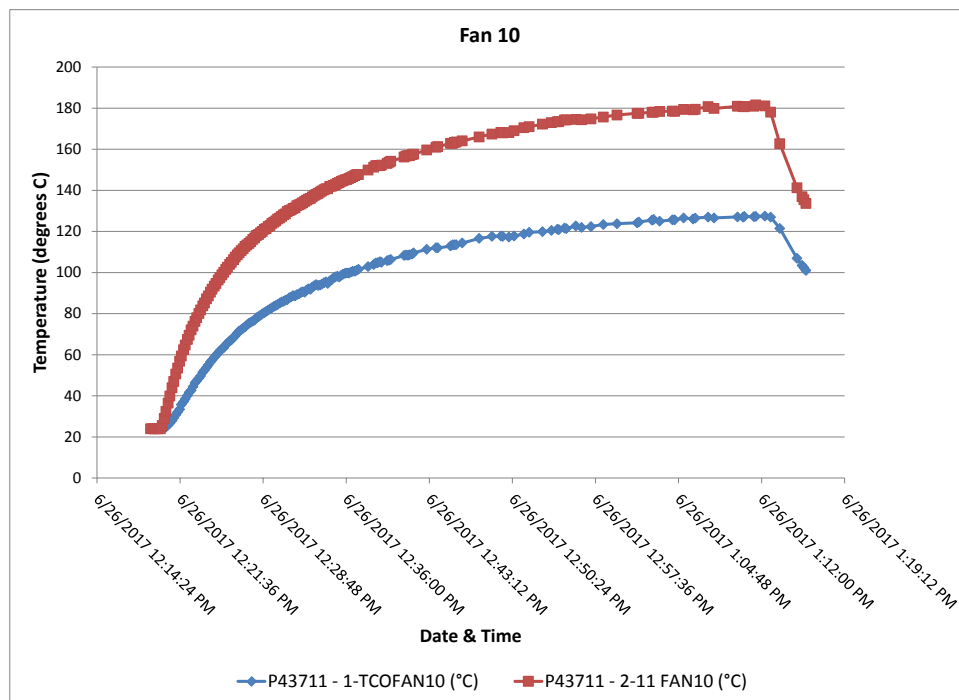
Figure 23. Temperature traces for Sub 10 Test Group 3 - Lock-Rotor Test

Staff conditioned the fan (sub 10) for 64 hours 30 minutes. During the locked-rotor testing, the TCO activated. The TCO activated approximately 52 minutes after the rotor was locked. The activation time was about 30 minutes longer than seen during typical lock-rotor testing, which activated around 20 minutes within the testing. Figure 23 shows the temperature traces for the thermocouples during the lock-rotor test.

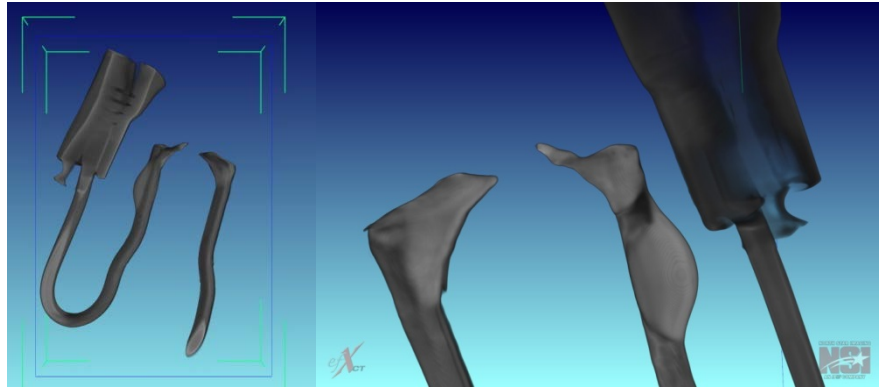
Figure 24. CT scan of the fusible link after lock-rotor testing (sub 10)

Figure 24 shows the CT scan of the fusible link after the lock-rotor test. As seen in prior testing when the trip time is longer than average, the fusible link melts at the center of the link. The figure does show a partial wetting of the electrodes occurred, which allowed the solder link to bead.

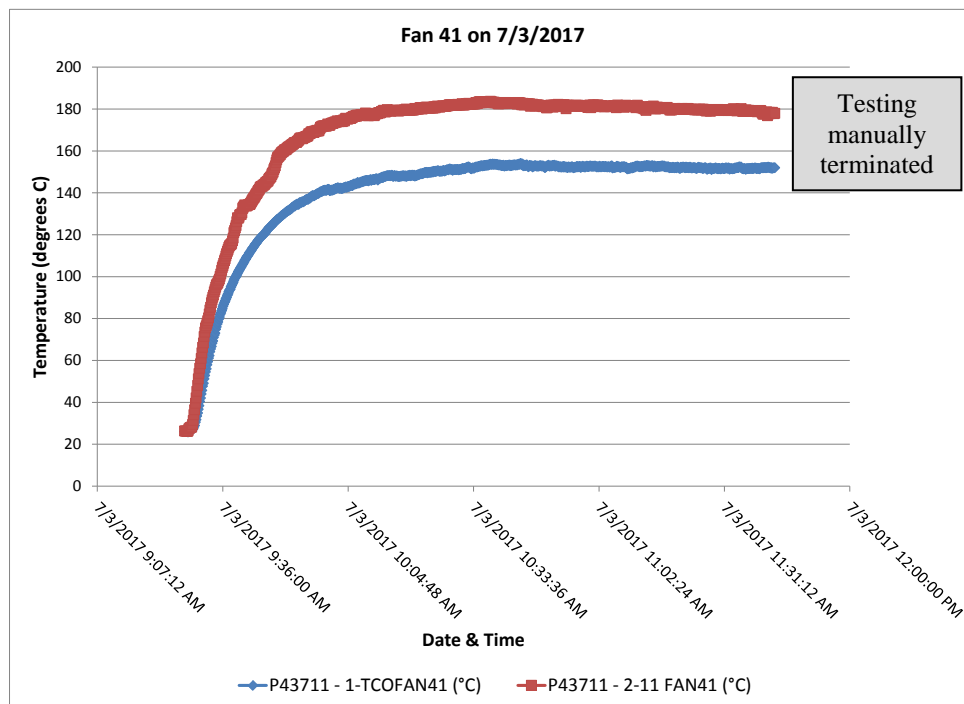
Figure 25. Temperature traces for Sub 41 Test Group 3 - Lock-rotor Test

Staff conditioned the fan (sub 41) for 232 hours 30 minutes. During the lock-rotor testing, the TCO did not activate. After about an hour, the temperature appeared to have leveled to a constant temperature or steady state. Staff terminated the lock-rotor testing after approximately 2 hours 30 minutes. Figure 25 shows the temperature traces for the thermocouples during the lock-rotor test on July 3, 2017.

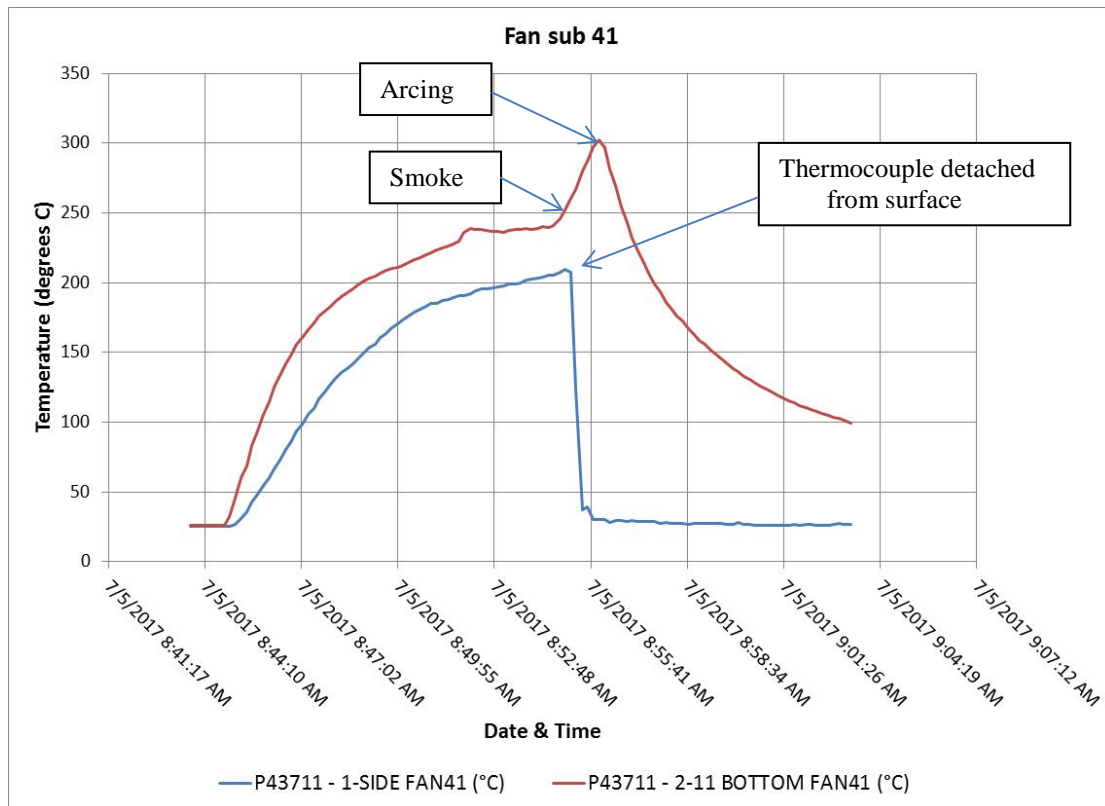
Figure 26. Temperature traces for Sub 41 Test Group 3 - Lock-Rotor Test on July 5, 2017

Staff allowed the fan to cool to room temperature before retesting. During the second lock-rotor test, the temperatures increased rapidly, and the unit began to smoke. The temperature suddenly increased and arcing could be heard. Suddenly the arcing ceased, and the temperature began to decrease. Figure 26 shows the temperature traces for the thermocouples during the lock-rotor test on July 5, 2017. The thermocouple located at the

TCO (blue trace) detached from the surface of the winding when the unit began to smoke, which resulted in a sudden drop in temperature. The elapsed time to maximum temperature was about 9 minutes, 50 seconds.

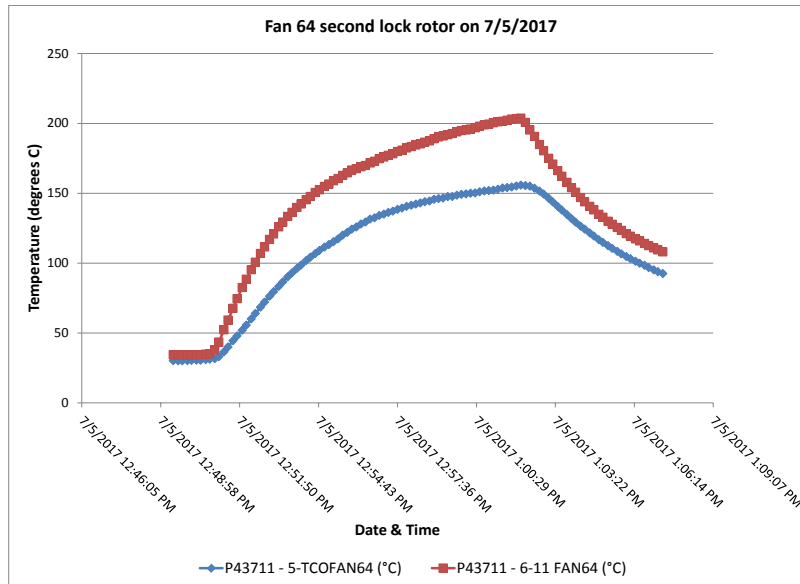
Figure 29. Temperature for Sub 64 Test Group 3 during Second Lock-Rotor Test

Staff allowed the fan to cool for 45 minutes (to approximately room temperature) before retesting. During the second lock-rotor test, the TCO activated. Figure 29 shows the temperature traces for the thermocouples during the second lock-rotor test. The TCO tripped after approximately 11 minutes during the second lock-rotor test.

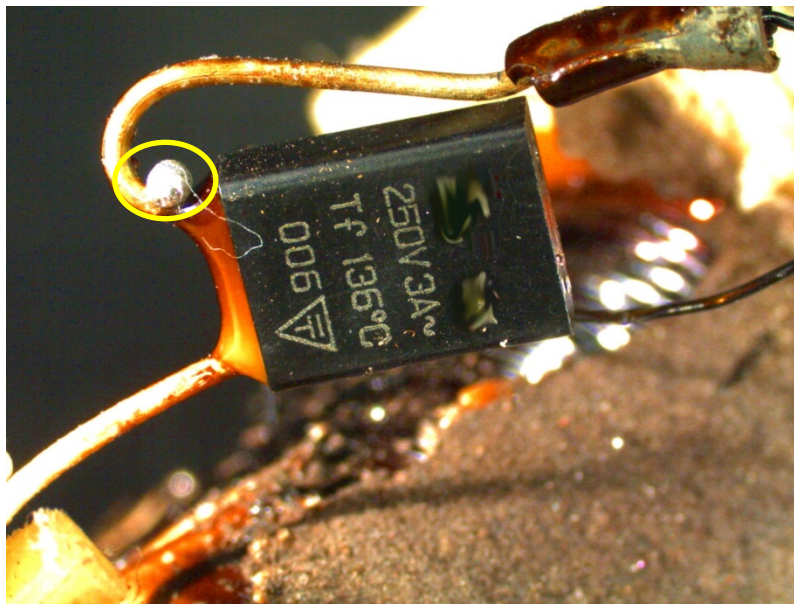
Figure 30. Solder bead on TCO lead from Sub 64 after second Lock-Rotor Test

Post examination revealed a solder bead external to the TCO casing, as highlighted by the yellow circle shown in Figure 30. Microscopic images of the TCO show that the solder bead originated from inside the TCO because solder was located in cracks between the epoxy seal and the lead wire, as shown in Figure 31. Figure 32 shows the CT scans with the partially melted fusible link after the testing, thus, indicating the TCO did activate, but abnormally. Visible in the CT scan is the solder bead, highlighted by the yellow circles.

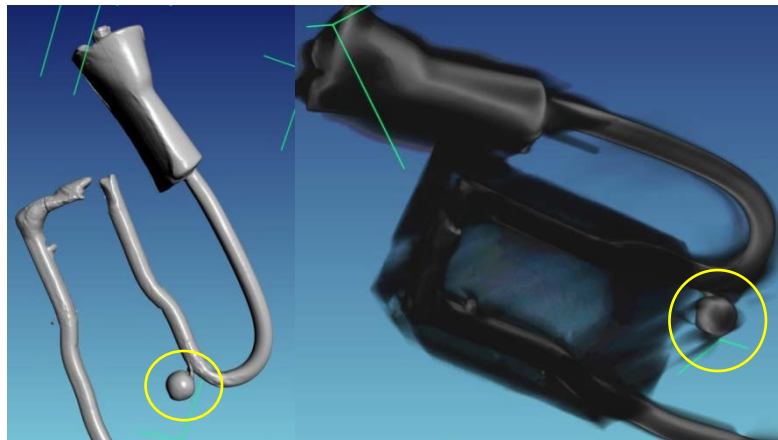
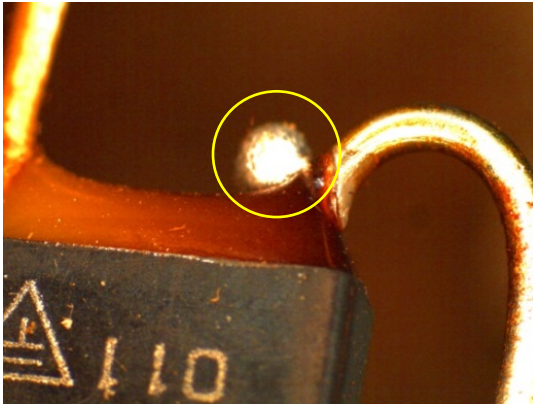
Figure 35. CT scans of the TCO showing the solder bead (Sub 99)

Post examination revealed the TCO had a solder bead external to the TCO casing. Figure 35 shows the CT scans with the partially melted fusible link after the testing, thus, indicating the TCO did activate, but abnormally. Microscopic images show that the solder originated from inside the TCO because of solder located within the cracks between the epoxy seal and the lead wires. Figure 36 shows the microscope images of the solder bead and solder in the cracks.

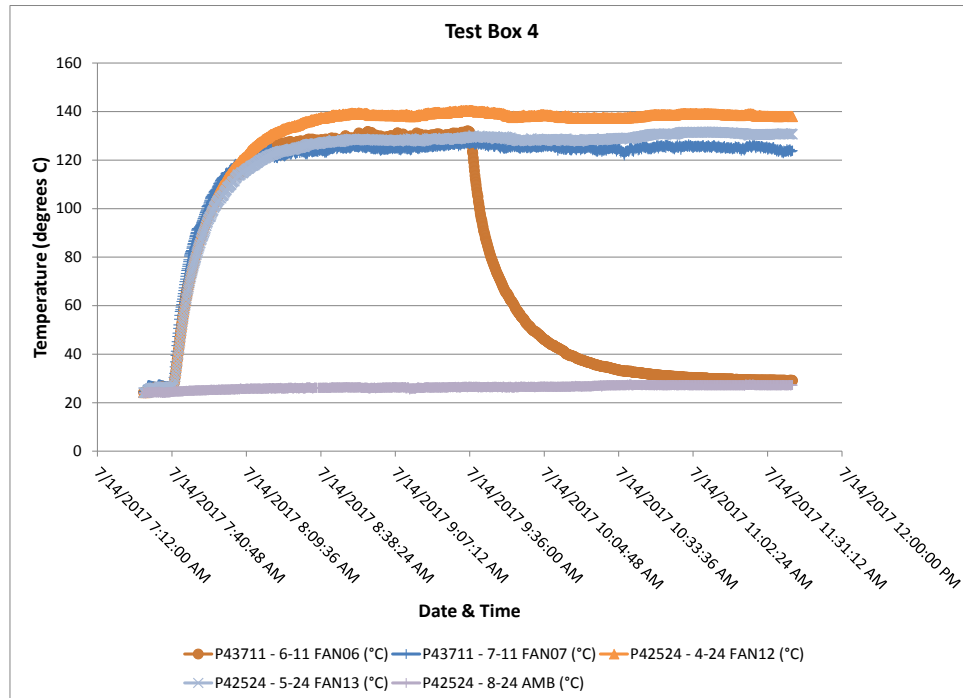
Figure 38. Temperature traces for Subs 6, 7, 12 and 13 (Test Group 4 - Lock-Rotor Test)

Figure 38 shows fan subs 6, 51, 58 and 66 temperature traces for Test Group 4 – Lock-rotor Test. These subs had a TCO that had activation trip times that were long or never tripped. The TCOs were x-rayed and CT scanned.

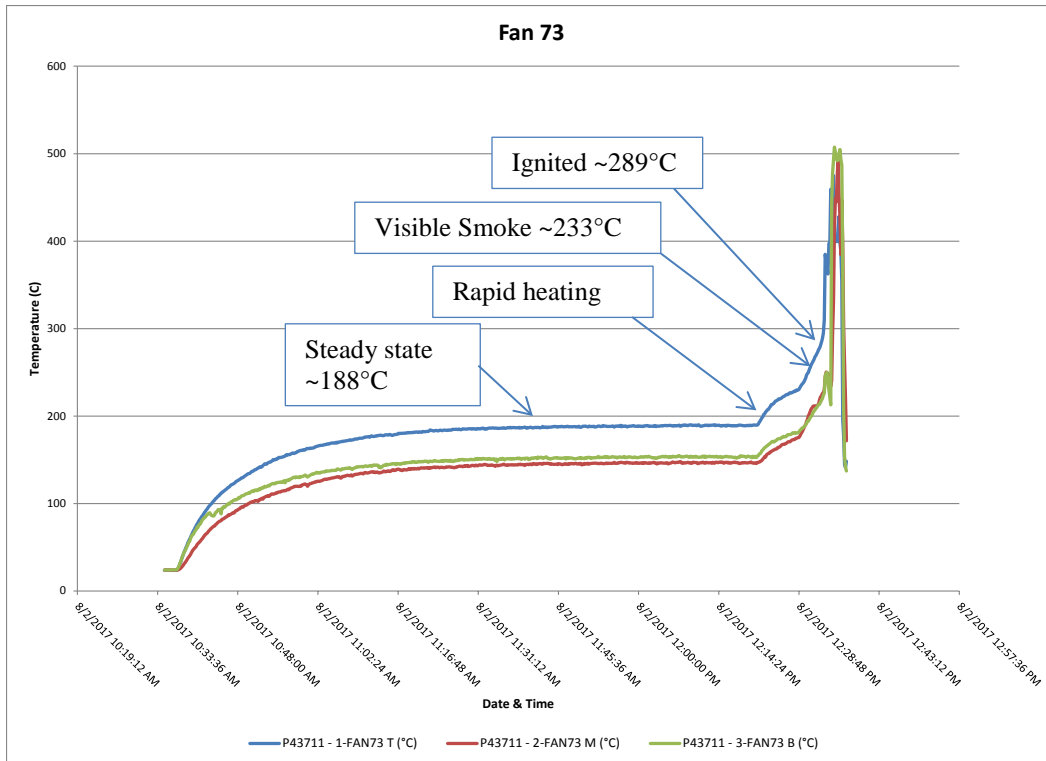
Figure 40. Winding temperatures during lock-rotor test for Fan sub 73

Fan sub 73 was in lock-rotor condition for about 1 hour and 56 minutes before the unit ignited, as shown in Figure 40. The fan's winding temperature was at a steady-state temperature (~188°C) above the TCO function temperature for about 1 hour, until the winding temperature began to increase rapidly. This rapid increase in temperature is an indication of shorting in the winding, which reduces the winding resistance and increases the current. Before ignition, with the winding temperature at about 233°C, the unit was producing visible white smoke. When the unit ignited around 289°C, there was a large flash and flames for a brief moment. It appears that the gaseous vapors driven off the winding coating ignited. The flames subsided slightly until the wrap around the winding and the coating on the windings started to burn, growing in intensity. The flames impinged on and ignited the plastic impeller. The burning impeller and bobbin resulted in dripping flaming plastic. Four layers of cheesecloth were placed under the fan to be used as an ignition indicator to verify that the dripping plastic continued to burn as it landed on the surface below. The dripping flaming plastic caused the cheesecloth to ignite, which indicates that the fan's plastic grill could also ignite in this type of situation. Figure 41 shows a sequence of photographs demonstrating the progression during lock-rotor testing on sub 73.

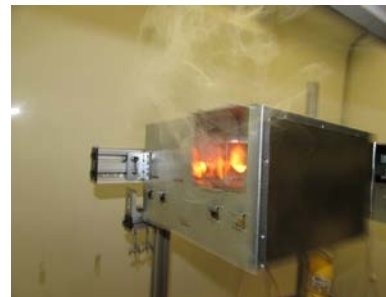
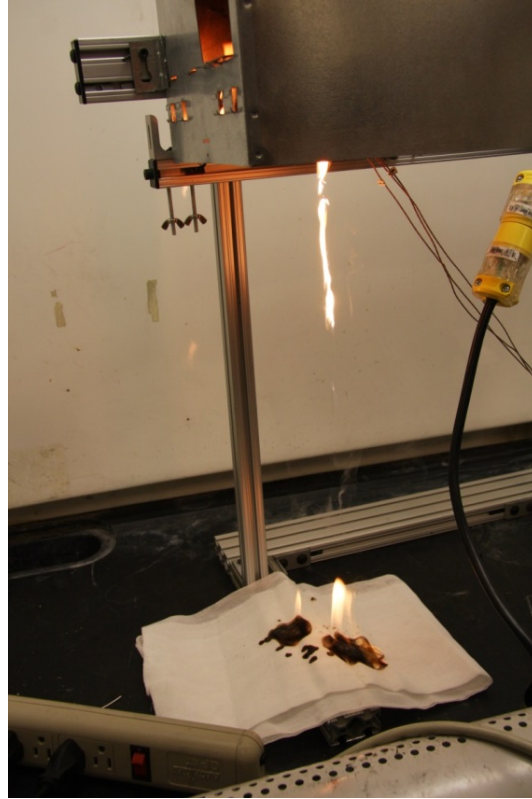
Figure 41. Fan sub 73 during lock-rotor test

At around 233°C, the fan begins producing white smoke

At sufficient temperatures, there appears to be an ignition of gases around the motor around 288°C

Dripping flaming plastic ignites the cheesecloth ignition indicator

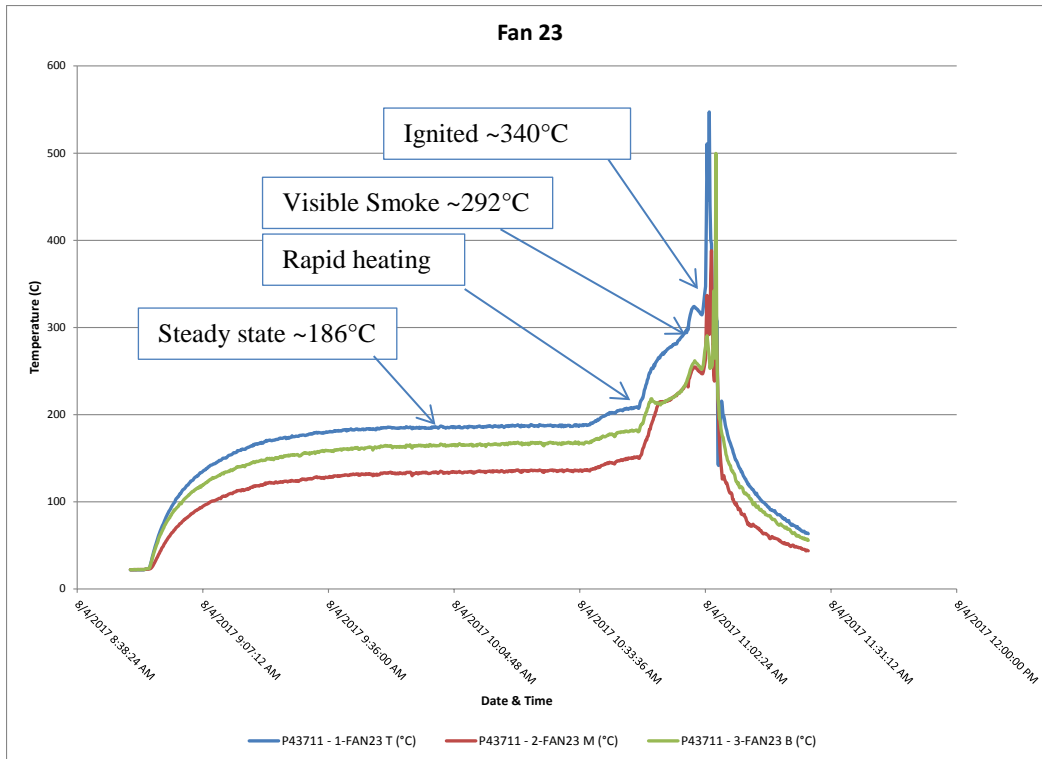
Figure 44. Winding temperatures during lock-rotor test for Fan sub 23

Fan sub 23 was in lock-rotor for about 2 hours and 40 minutes before the unit ignited, as shown in Figure 44. The fan's winding temperature, $\sim 186^{\circ}\text{C}$, was at steady state, above the TCO specified activation temperature, until the winding temperature began to increase rapidly. This rapid increase in temperature indicates shorting in the winding, which reduces the winding resistance. Before ignition, at about $\sim 292^{\circ}\text{C}$, the unit was producing visible white smoke. Similar to Fan sub 73, when the unit ignited at $\sim 340^{\circ}\text{C}$, it produced a large flash and flames for a brief moment. The large flames subsided slightly, until the flames ignited more of the wrap around the winding and/or the coating of the winding. The flames impinged on and ignited the plastic impeller. The burning impeller and bobbin resulted in dripping flaming plastic. Four layers of cheesecloth were placed under the fan to be used as an ignition indicator. The dripping flaming plastic ignited the cheesecloth, which indicates that the fan's plastic grill could also ignite in this type of situation. Figure 45 is a sequence of photographs during lock-rotor testing for sub 23.

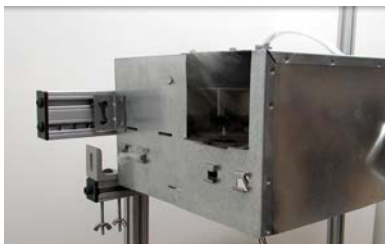
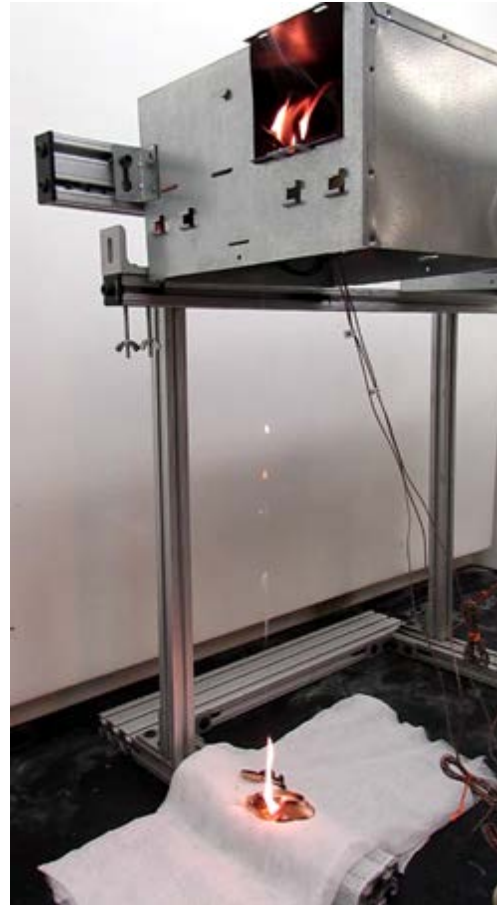
Figure 45. Fan sub 23 during lock-rotor test

At around 292°C, the fan begins producing white smoke

Dripping flaming plastic ignites the cheesecloth ignition indicator

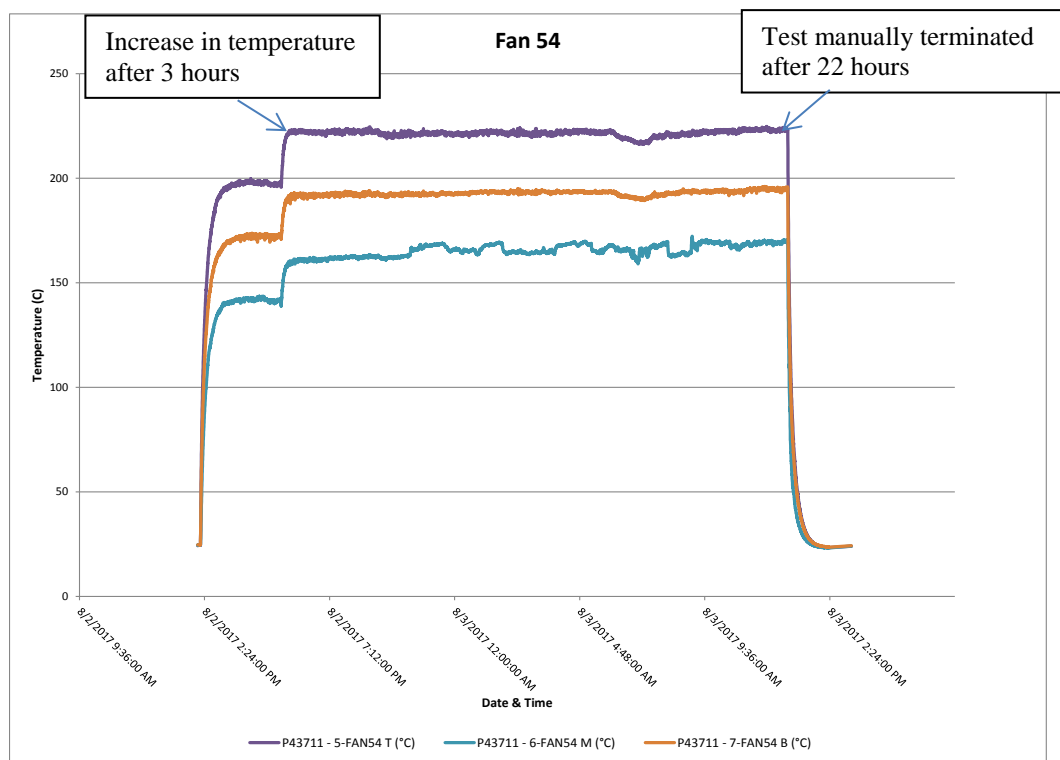
Figure 48. Winding temperatures during lock-rotor test for Fan sub 54

As previously indicated, fan sub 54 was tested in lock-rotor condition for 22 hours. After the initial 3 hours, the temperature increased and then leveled off. The fan maintained a steady temperature that was well above the TCO activation temperature for the majority of the testing, as shown in Figure 48. The TCO did not activate, and staff manually terminated the test after 22 hours. Figure 49 shows radiographs of the TCO after the test. The linkage appears to have thinned out, but is still intact. The figure shows a bead had formed outside the TCO casing.

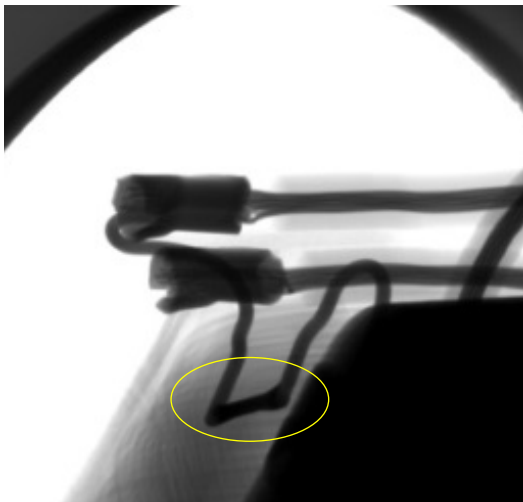
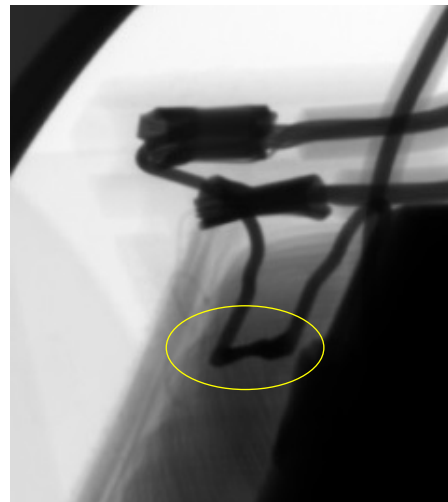
Figure 50. Radiograph of the TCO before and after the test (sub 54)

Figure 50 shows radiographs of the TCO before and after the test. From these angles, the thermal linkage appears not to have changed shape significantly, but depending on the viewing angle, the thermal linkage is thicker or thinner.

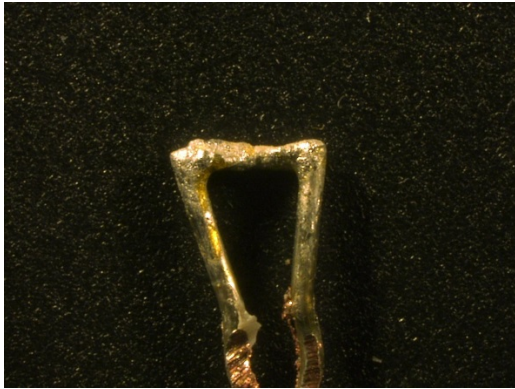
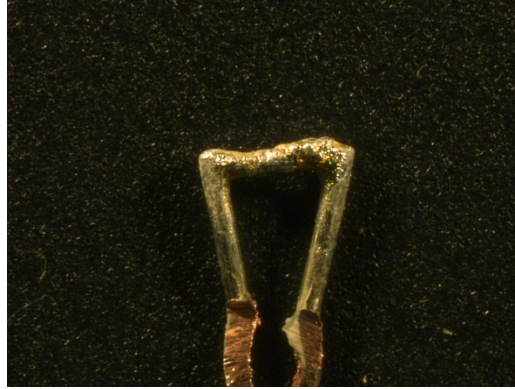
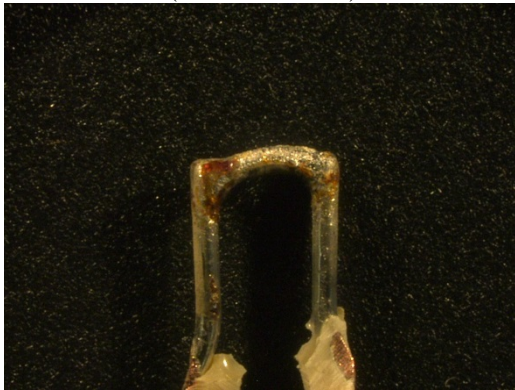
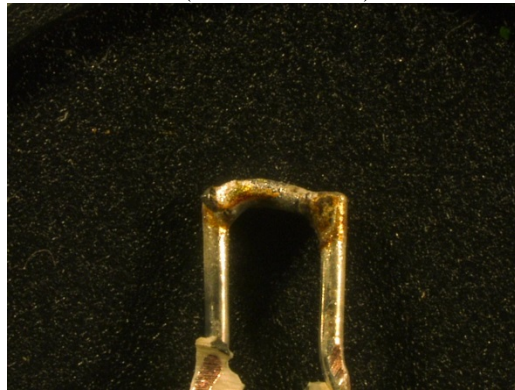
Figure 52. TCO solder link from Fan subs 22 and 59 (conditioned 330 hours @ 105°C)

Subs 22 and 59 (conditioned for 330 hours at 105°C) from Test Group 5 were reserved for analysis of the solder link within the TCO. The TCO casing was opened and the internal components were removed. For comparison, two TCOs, sub 74 and 85 (no conditioning), from Test Group 7 were also reserved for TCO analysis where the TCO casing was opened and the internal components removed. Figure 52 shows the solder links from Fan subs 22 and 59, which have been conditioned 330 hours at 105°C. Figure 53 shows the solder links from Fan subs 74 and 85, which have not been conditioned. Sub 85 shows some deformation in the solder link, where part of the solder link has flattened and formed to the interior of the TCO casing, but this was already present before any conditioning of the TCO. The mechanical structure of the solder linkage appeared unchanged as a result of the conditioning, when the before and after radiographs were compared.

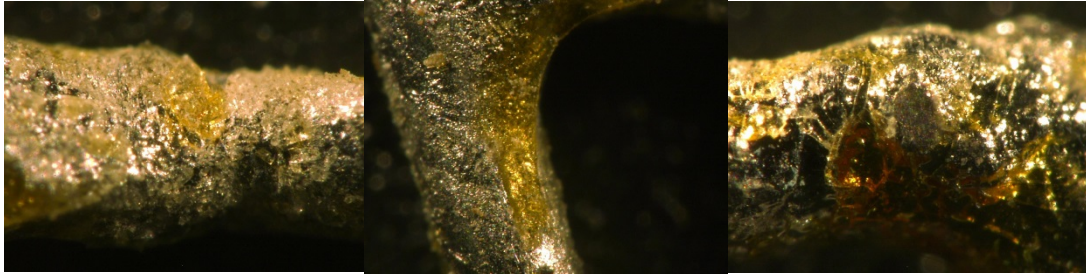
Figure 54. Close-up images of the TCO solder link (conditioned 330 hours @ 105°C)

Staff observed under a microscope that a yellowish substance was on the solder link, as shown in Figures 54 and 55. This was thought to be the special coating or flux material. Staff also observed that the conditioned TCOs appeared to have less of the yellowish substance than the TCOs that were unconditioned, but staff did not measure an actual mass content or volume of the substance for each sample.

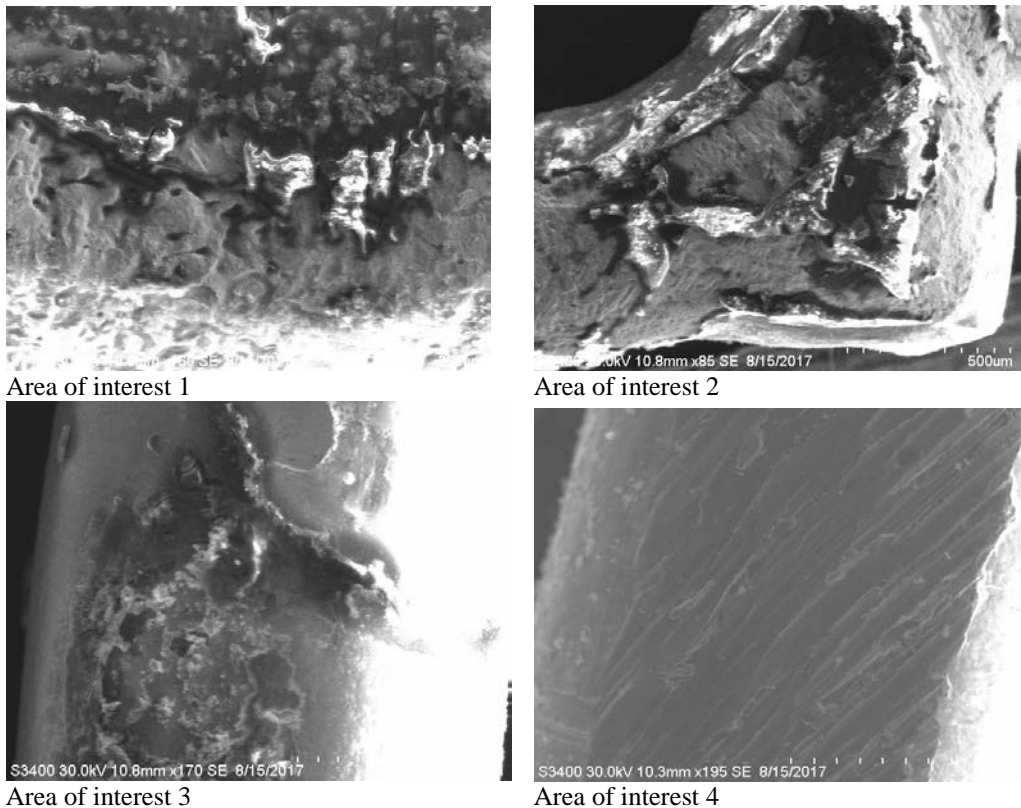
Figure 56. SEM scans for Sub 59

characterization. XRD is used to study nature of phases/microstructure and their crystal structure. Figure 56 shows SEM scans of the solder link and terminals. SEM and XRD analysis for sub 59, which was conditioned at 105°C, show that the wire leads are copper and the thermal linkage is comprised of mainly tin, indium, and lead.

Area of interest 2 is the solder link connection to the copper terminal. This is mainly comprised of C, O, In, Sn and Pb. There is a trace amount of silicon (Si) and copper (Cu). Copper shows up because it is the bulk material of the terminal.

Areas of interest 3 and 4 are the copper terminals. This is mainly comprised of Cu and Sn. There are lower amounts of C and O.

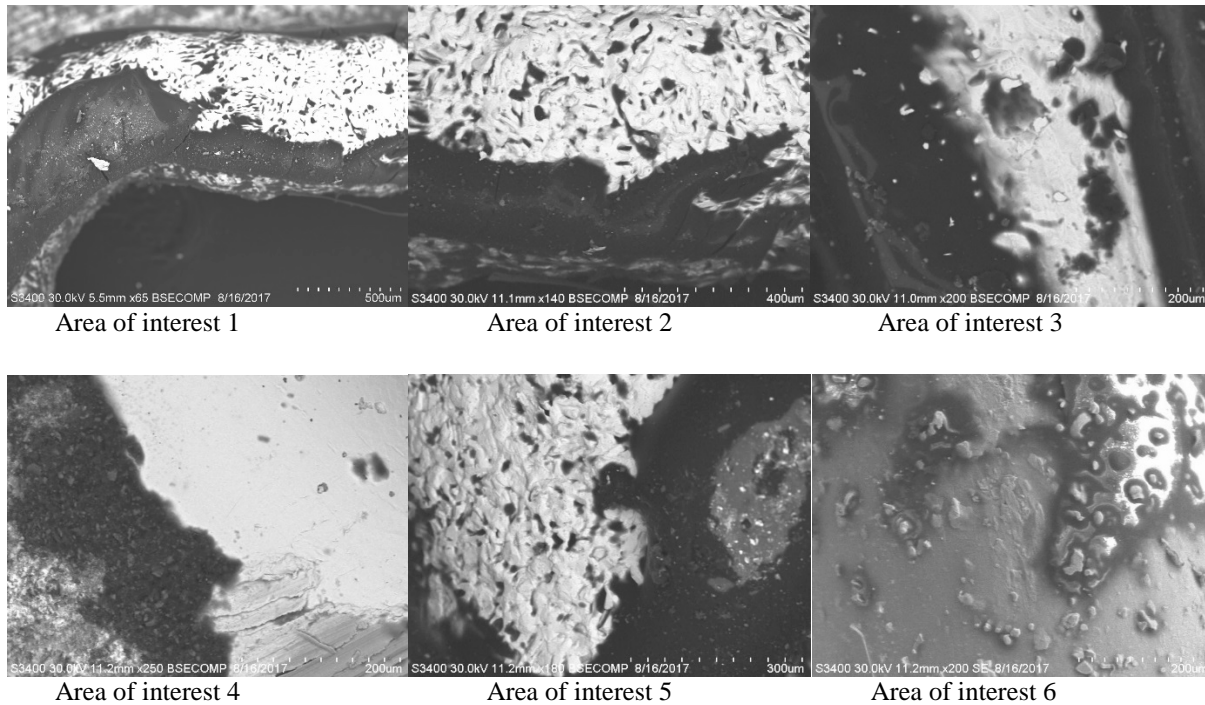
Figure 57. SEM scans for Sub 74

SEM analysis for sub 74, which was not conditioned, is shown in Figure 57. Area of interest 1 is the solder link. This is mainly comprised of C, In, Sn, and Pb. The Indium, Tin, and Lead are most likely the elements that make up the solder linkage. Carbon and Oxygen are most likely the elements that make up the special coating. Area of interest 2 is a close-up of an area from area interest 1. This is mainly comprised of C, O, In, Sn, and Pb. There is a trace amount of Si.

Areas of interest 3, 4, 5, and 6 are areas that had coating on the terminals or solder link.

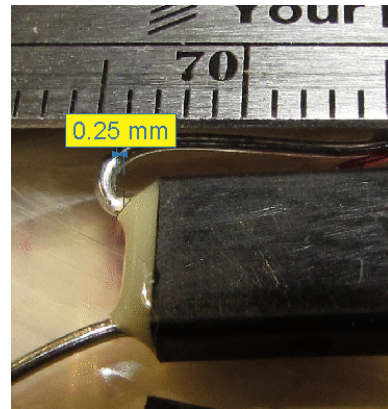
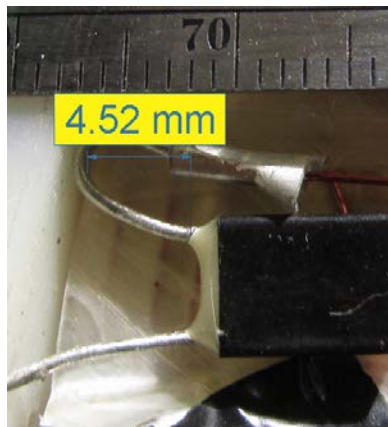
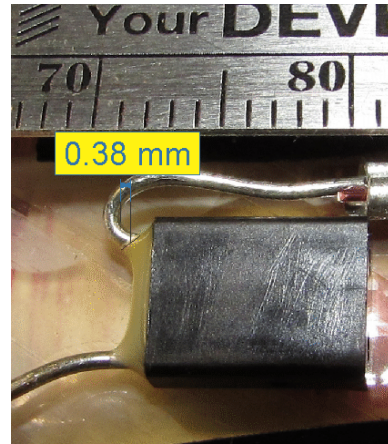
Figure 58. Wire bend lengths vary between TCOs in the Fan samples

Figure 58 shows the TCO wire lead bends can vary between fan motors. Even though sub 27 shows the wire lead bend greater than 3 mm, it appears that the base of the wire lead near the seal was not secured when the wire lead was bent, which is evident by the outward angle of the wire lead.

Wire lead with 0.19 mm length between the seal and bend (Sub 98)

Wire lead with 0.25 mm length between the seal and bend (Sub 26)

Wire lead with 4.52 mm length between the seal and bend (Sub 27)

Wire lead with 0.38 mm length between the seal and bend (Sub 79)

Improper bending of the wire lead may result in cracking of the epoxy seal, thus allowing solder to flow out and oxygen to enter the TCO and alter the functioning temperature of the TCO. Oxygen along with heat and time may also be a combination that could be accelerating the changes in the properties for the thermal linkage and the special compound.

- Lead wires (terminals) are to be bent or cut at least 3mm away from the TCO seals to avoid damaging the TCO (axial/radial type) or body (thin type). The TCO seals (axial/radial type) shall not be grasped with any tools or holders. Terminals of thin type TCO are to be grasped before they are bent. (See Fig. 1) (Reference - XICON PASSIVE COMPONENTS, Thermal Cutoffs (TCO)/Thermal-Links 447-XYP 1BF145-RC).

- When bending the lead wire, to avoid applying excessive pressure to the root of the lead wire, secure the lead wire close to the case, and bend the part beyond the secured section. The lead wire should be bent at a distance of 3 mm or more from the body of the fuse, and should not be twisted. (Reference - NEC/SCHOTT, Thermal Fuse)

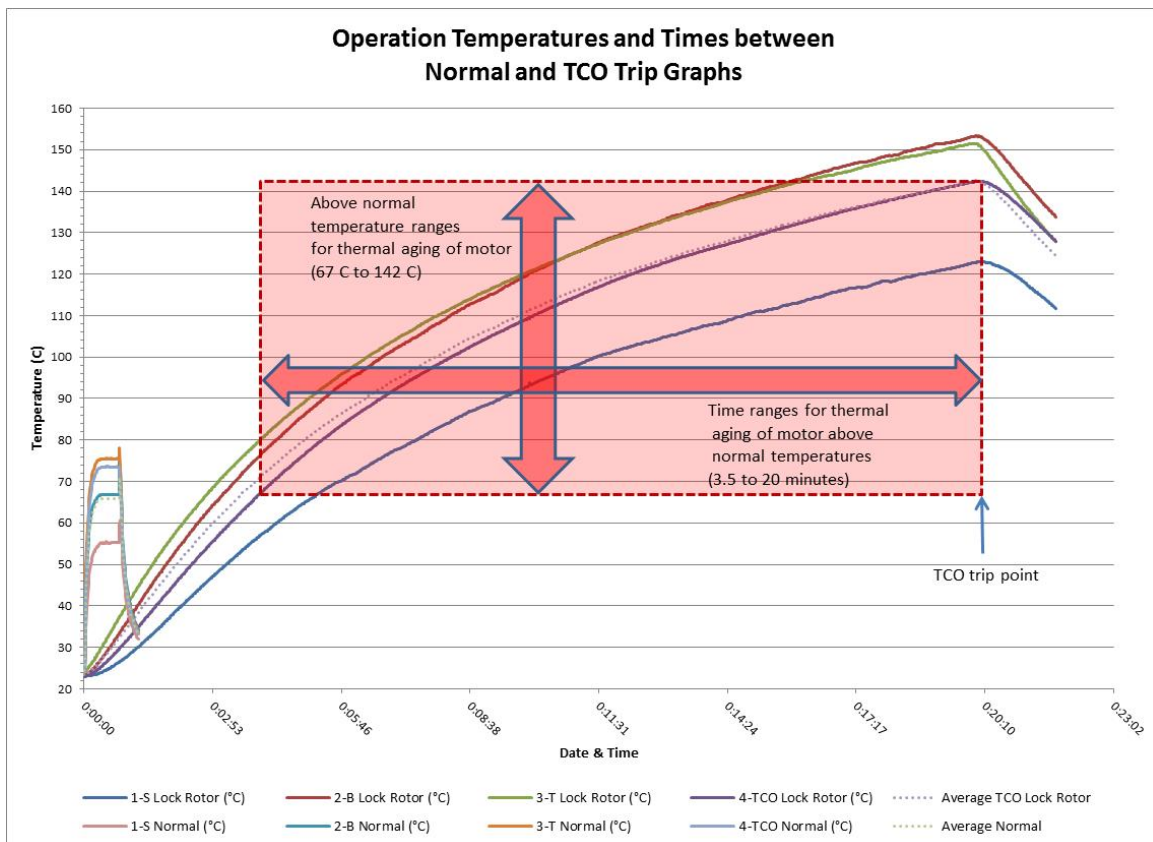
Figure 59. Potential thermal aging of the motor between normal and TCO trip conditions

Figure 59 shows Fan sub 60 temperatures for normal and lock-rotor operation. In normal operations, the TCO temperature stabilizes at around 68°C. For lock-rotor condition, the TCO activates at a TCO temperature around 142°C after 20 minutes. This would suggest that an exhaust fan that is in lock-rotor condition, but is operated for less than 20 minutes, can have the TCO heated to temperatures up to 142°C. If the exhaust fan is operated for more than 3 minutes, the TCO is experiencing temperatures above normal operation.
