U.S. CONSUMER PRODUCT SAFETY COMMISSION  
5 RESEARCH PLACE  
ROCKVILLE, MD 20850

**Re:** Ohio State Fair Fatal Ride Incident

1. Task Number 170727CFE0001		2. Investigator's ID 10837		<b>EPIDEMIOLOGIC INVESTIGATION REPORT</b>
3. Office Code 800	4. Date of Accident YR MO DAY 2017 07 26	5. Date Initiated YR MO DAY 2017 07 27

6. Synopsis of Accident or Complaint UPC The 18 year old victim was riding a high G-force pendulum swing amusement park ride when one of the 4 person gondolas suddenly detached from the main part of the ride, went airborne and finally landed on the ground approximately one foot from the base of the ride. The victim died at the scene and seven other riders were transported to the hospital.

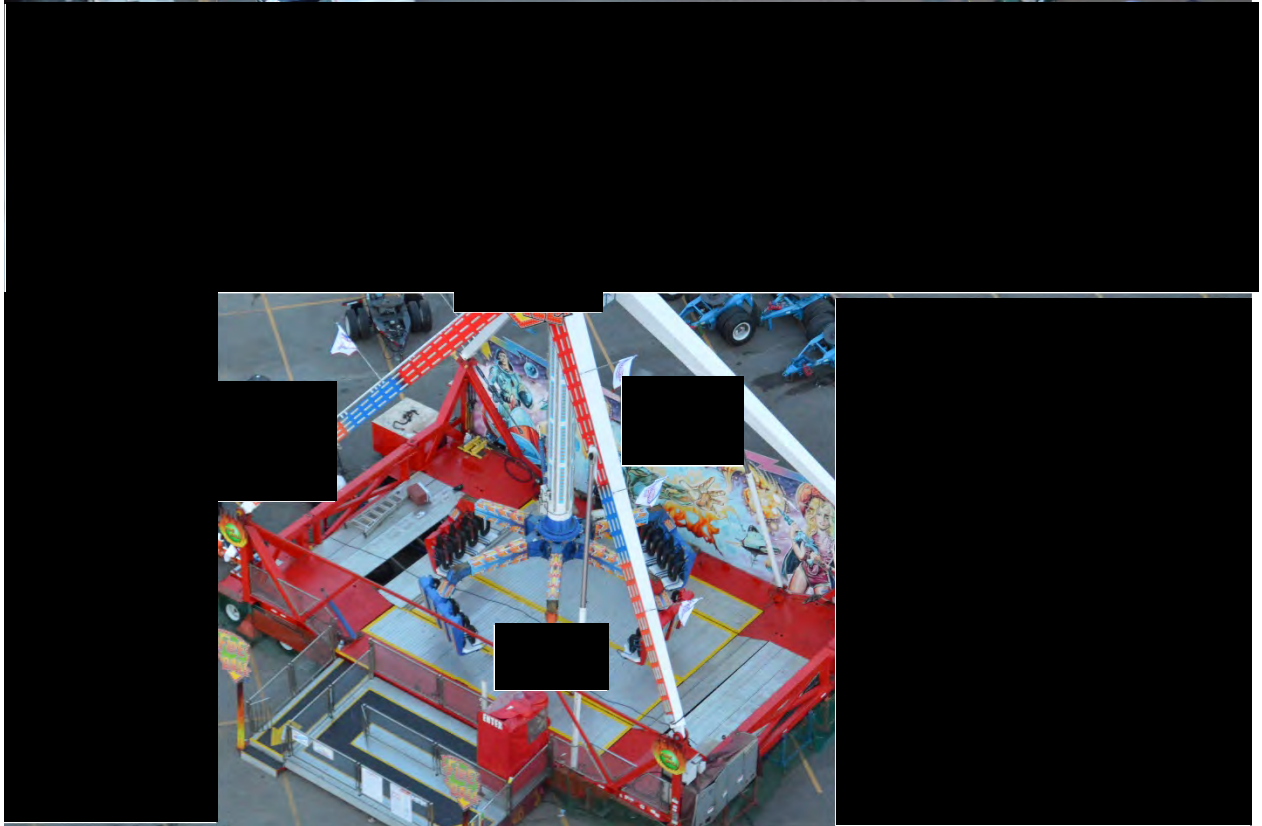
Photo #2 – Additional overall picture of the incident ride and surrounding area. Photograph taken by the [redacted] State Highway Patrol on July 26, 2017 after the incident.

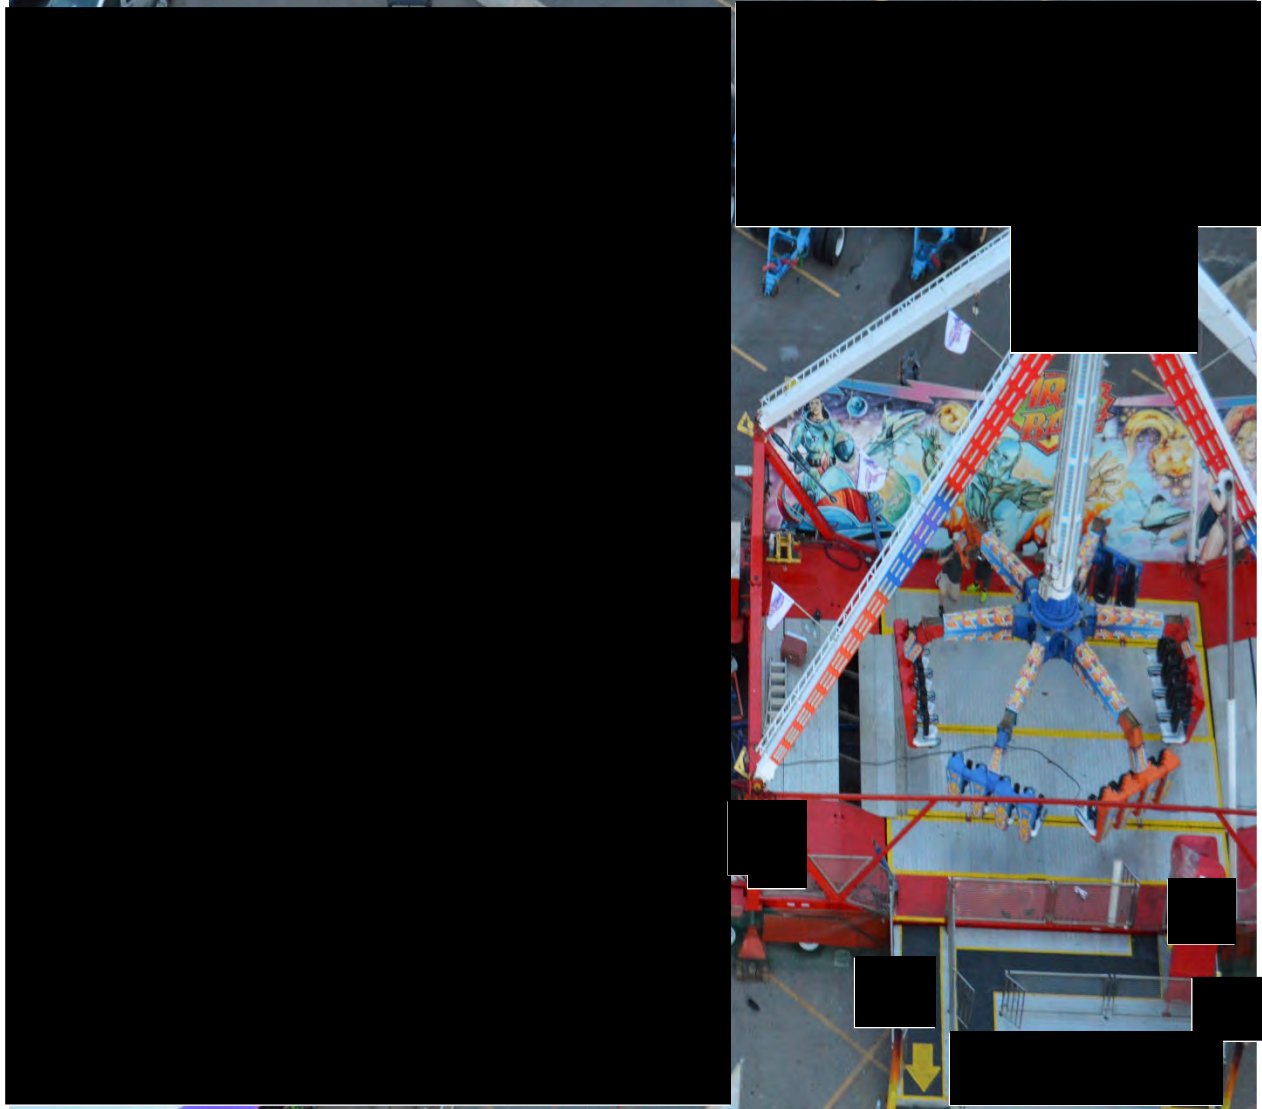
Photo #3 – Additional overall picture of the incident ride and surrounding area. Photo identifies victim location after incident. Photograph taken by the [REDACTED] State Highway Patrol on July 26, 2017 after the incident.

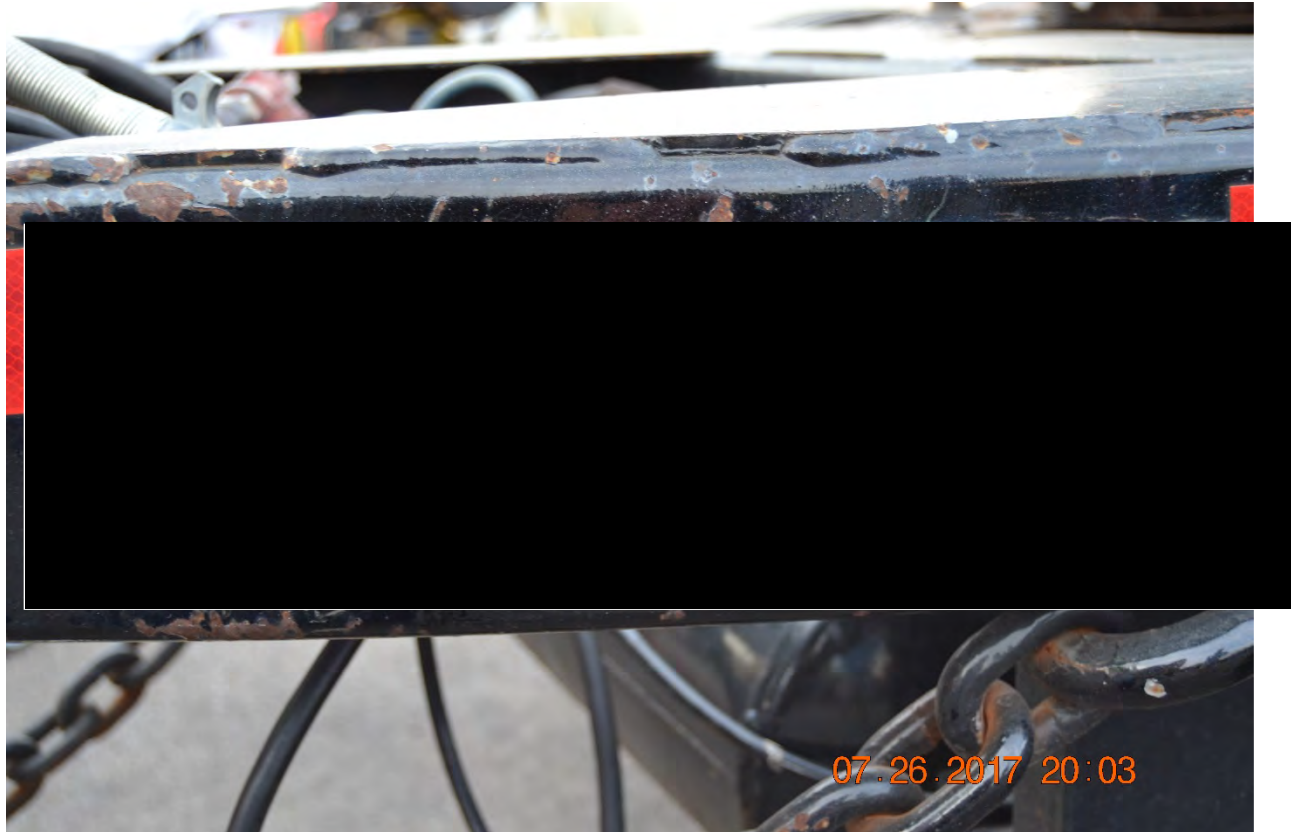
Photo #17 – Additional close up picture of the incident ride. Photo identifies the name plate on the ride trailer. Photograph taken by the [REDACTED] State Highway Patrol on July 26, 2017 after the incident.

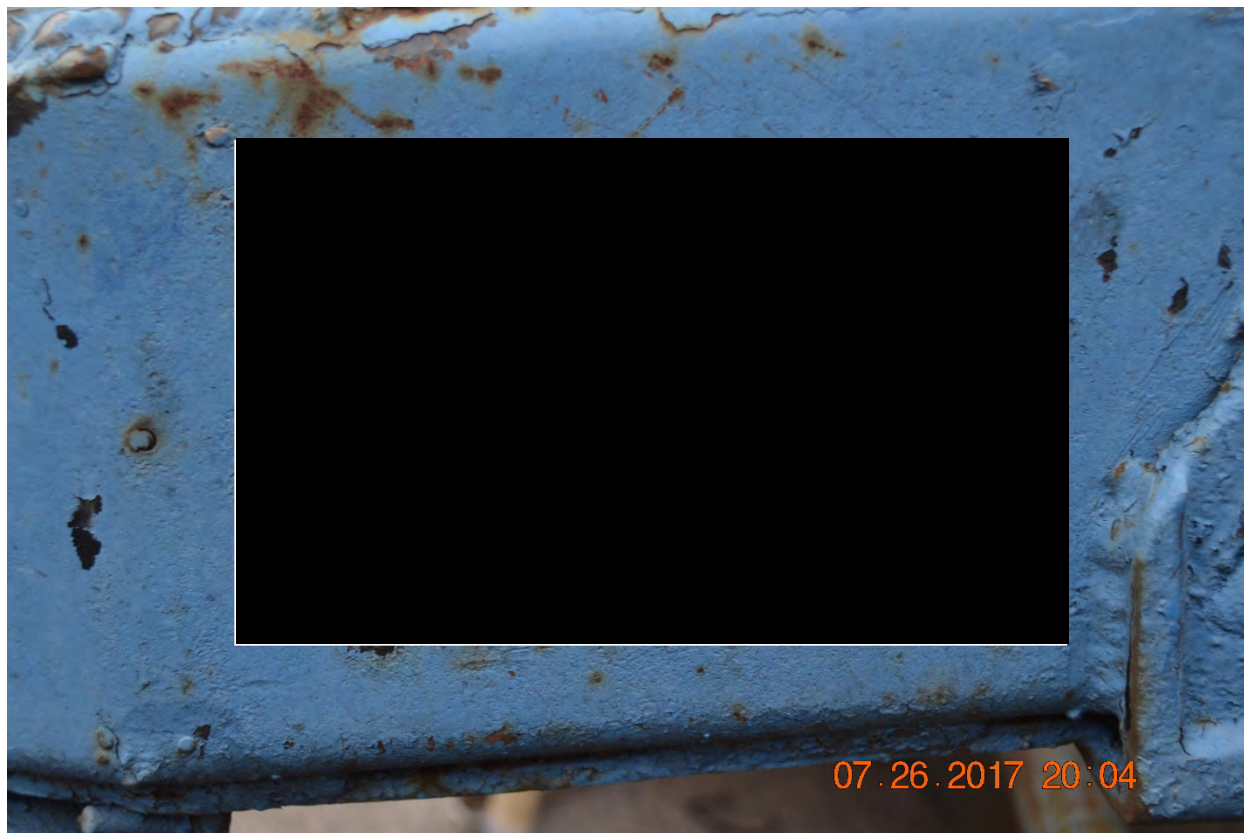
Photo #18 – Additional close up picture of the incident ride. Photo identifies the trailer inspection sticker on the ride trailer. Photograph taken by the [REDACTED] State Highway Patrol on July 26, 2017 after the incident.

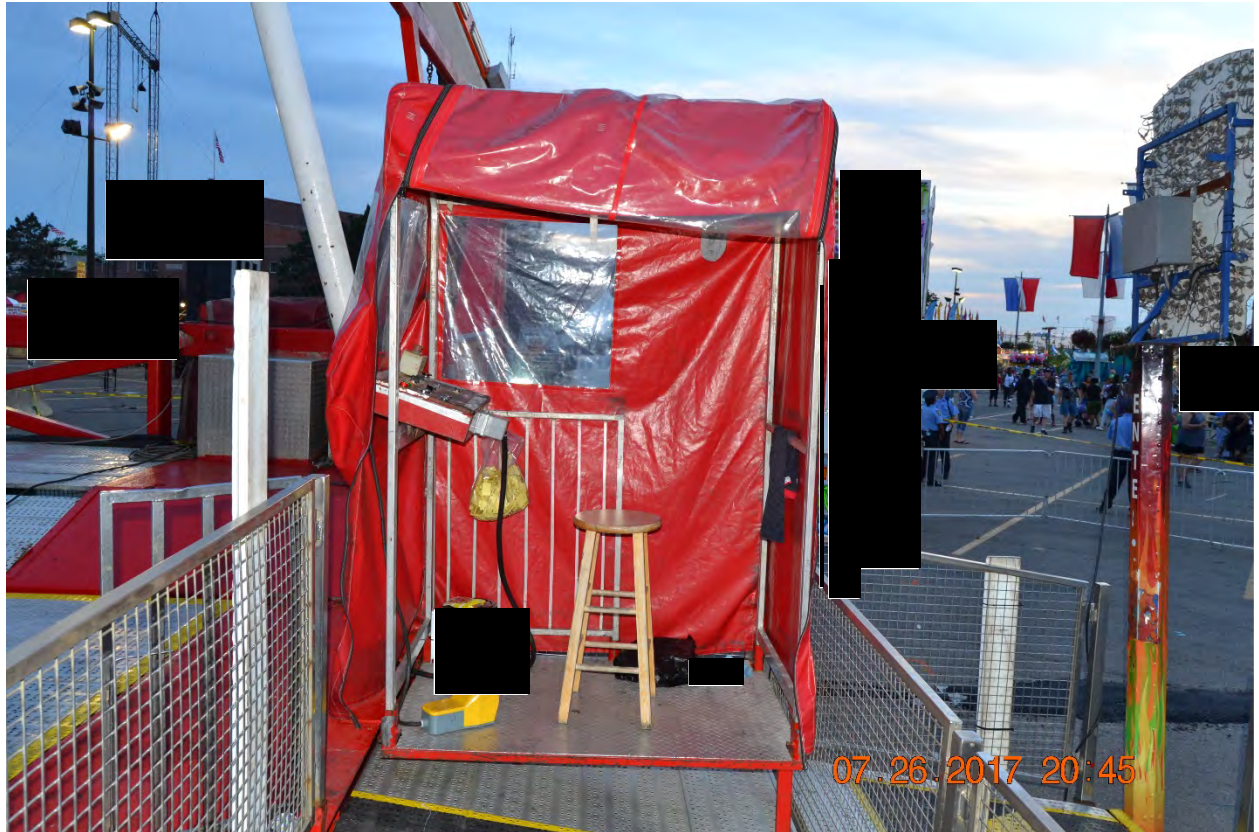
Photo #24 – Additional close up picture of the incident ride. Photo identifies the ride control booth. Photograph taken by the [REDACTED] State Highway Patrol on July 26, 2017 after the incident.

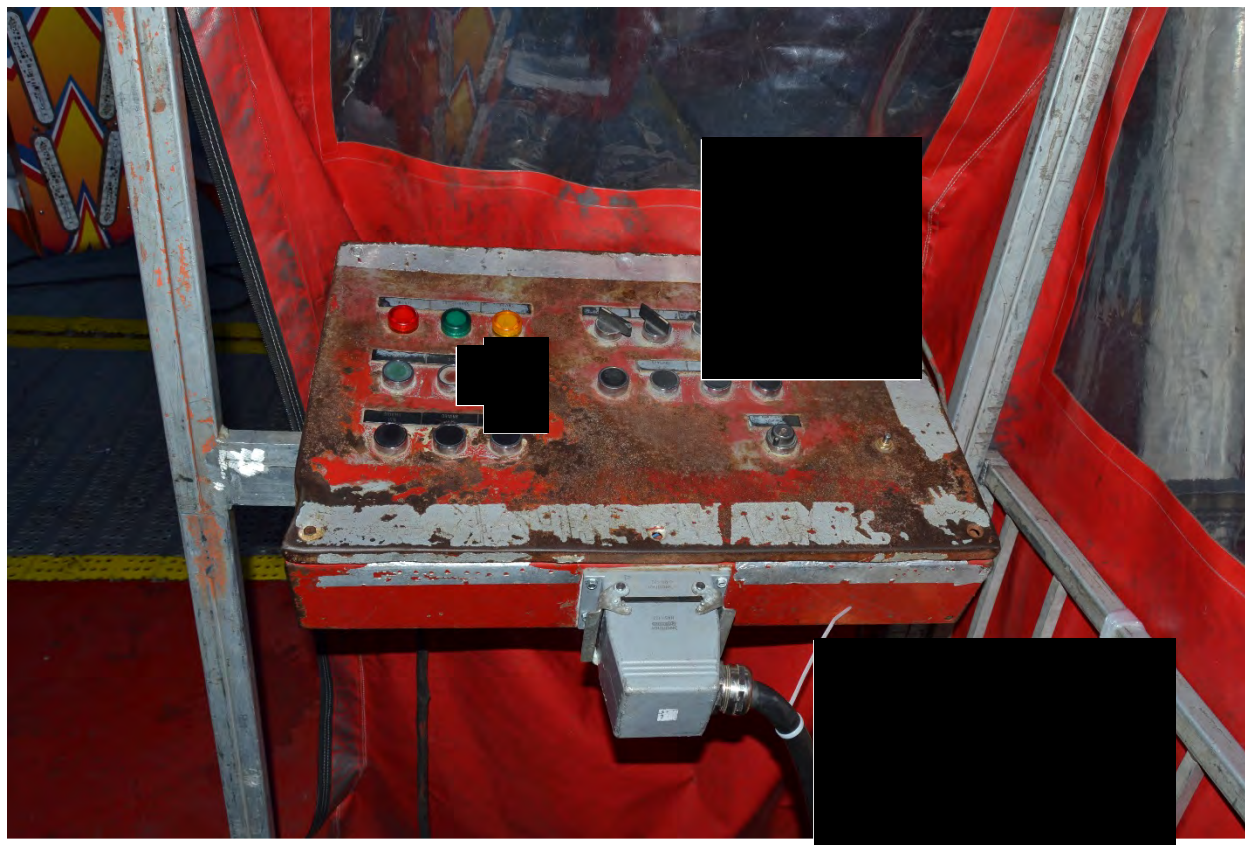
The ride is operated utilizing a Programmable Logic Controller (PLC) system, described as using auto controls to operate the ride. The rider operator cannot manipulate the speed or length of the ride. All controls are set by the manufacturer. The ride also has a safety back up that allows the ride to start only after each shoulder restraint bar has been locked into place and a green indication light is illuminated above the rider's head. When all 24 passenger lights have illuminated, the ride operator may then start the ride by placing his foot on the pedal (Exhibit M, Photo 26) and pressing the button on the control panel (Exhibit M, Photo 25).

Photo #25 – Additional close up picture of the incident ride. Photo identifies the ride control panel located inside the ride control booth. Photograph taken by the [REDACTED] State Highway Patrol on July 26, 2017 after the incident.

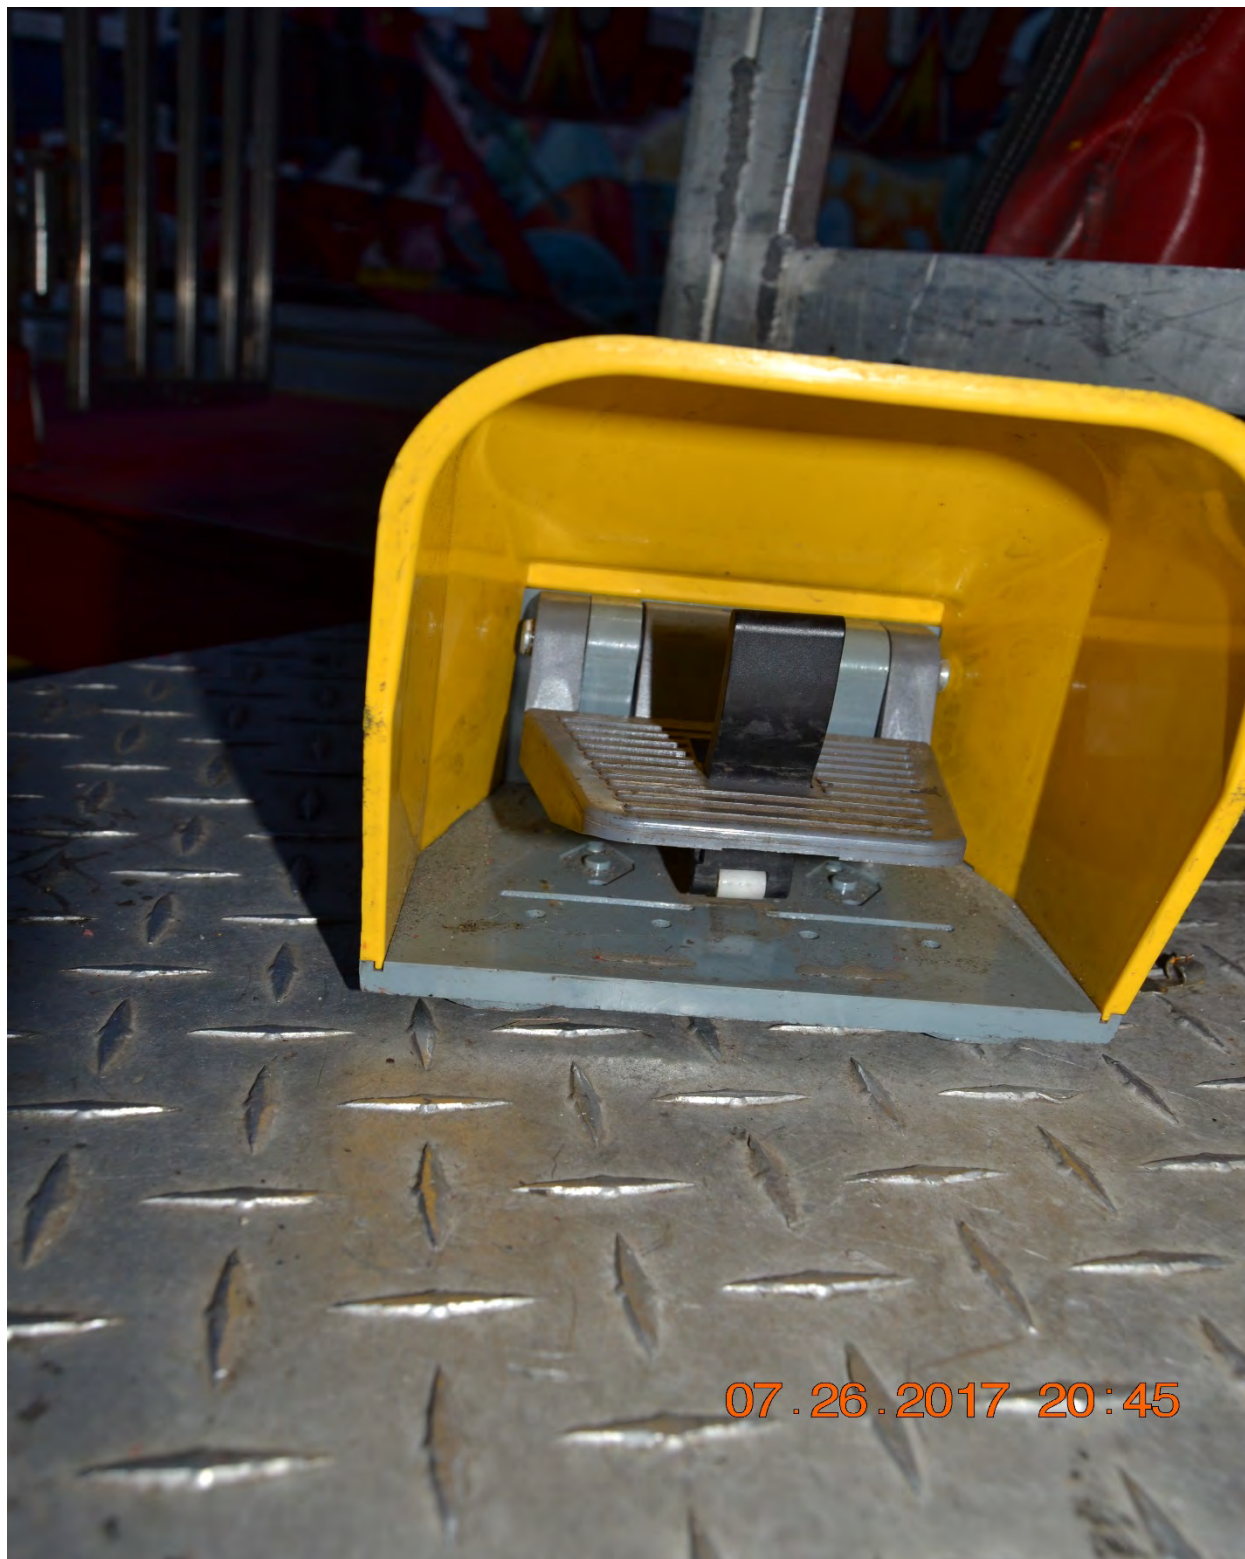
Photo #26 – Additional close up picture of the incident ride. Photo identifies the foot pedal located inside the ride control booth. Photograph taken by the [REDACTED] State Highway Patrol on July 26, 2017 after the incident.

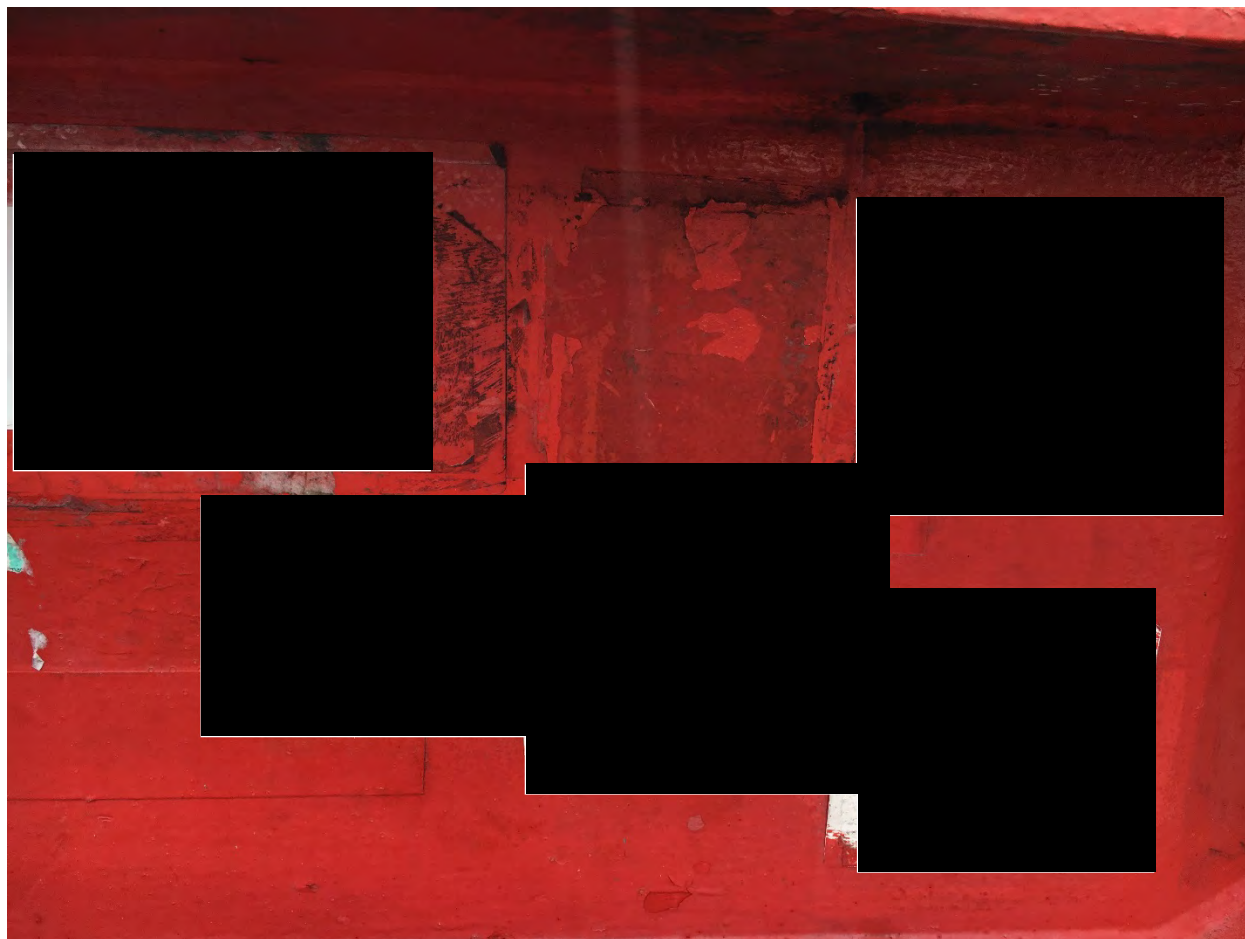
The incident ride had been utilized in [REDACTED] [REDACTED] [REDACTED] [REDACTED] [REDACTED] and [REDACTED] prior to the incident location in [REDACTED] Inspection, Maintenance and Lubrication Reports, Daily Inspection and Maintenance Reports and Certificates for Operator Training for the above referenced locations are attached (Exhibit E). State inspection reports for [REDACTED] [REDACTED] (Exhibit F) and two locations in [REDACTED] (Exhibits G & H) are also attached. Ride owners stated that not all states provide a written report after an inspection is completed; however, an inspection sticker would typically be presented after it passed inspection. Inspection stickers visible on the incident ride include [REDACTED] (Exhibit M, Photos 29 & 30), [REDACTED] (Exhibit M, Photo 28) and [REDACTED] (Exhibit M, Photo 31).

Photo #28 –Photo identifies [REDACTED] permit sticker for 2017. Photograph taken by this investigator on July 27, 2017.

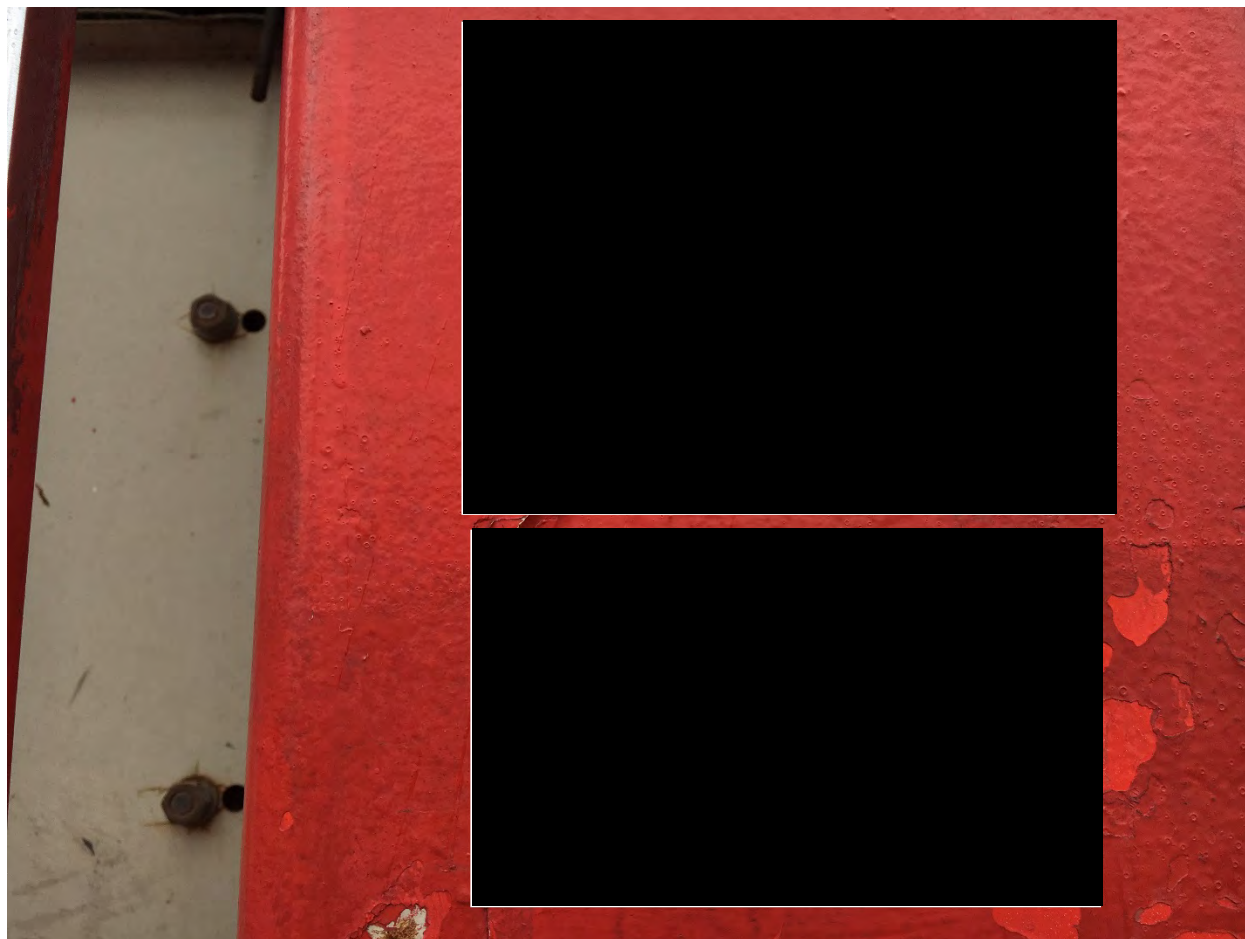
Photo #30 –Photo identifies secondary [REDACTED] permit sticker for 2017. Photograph taken by this investigator on July 27, 2017.

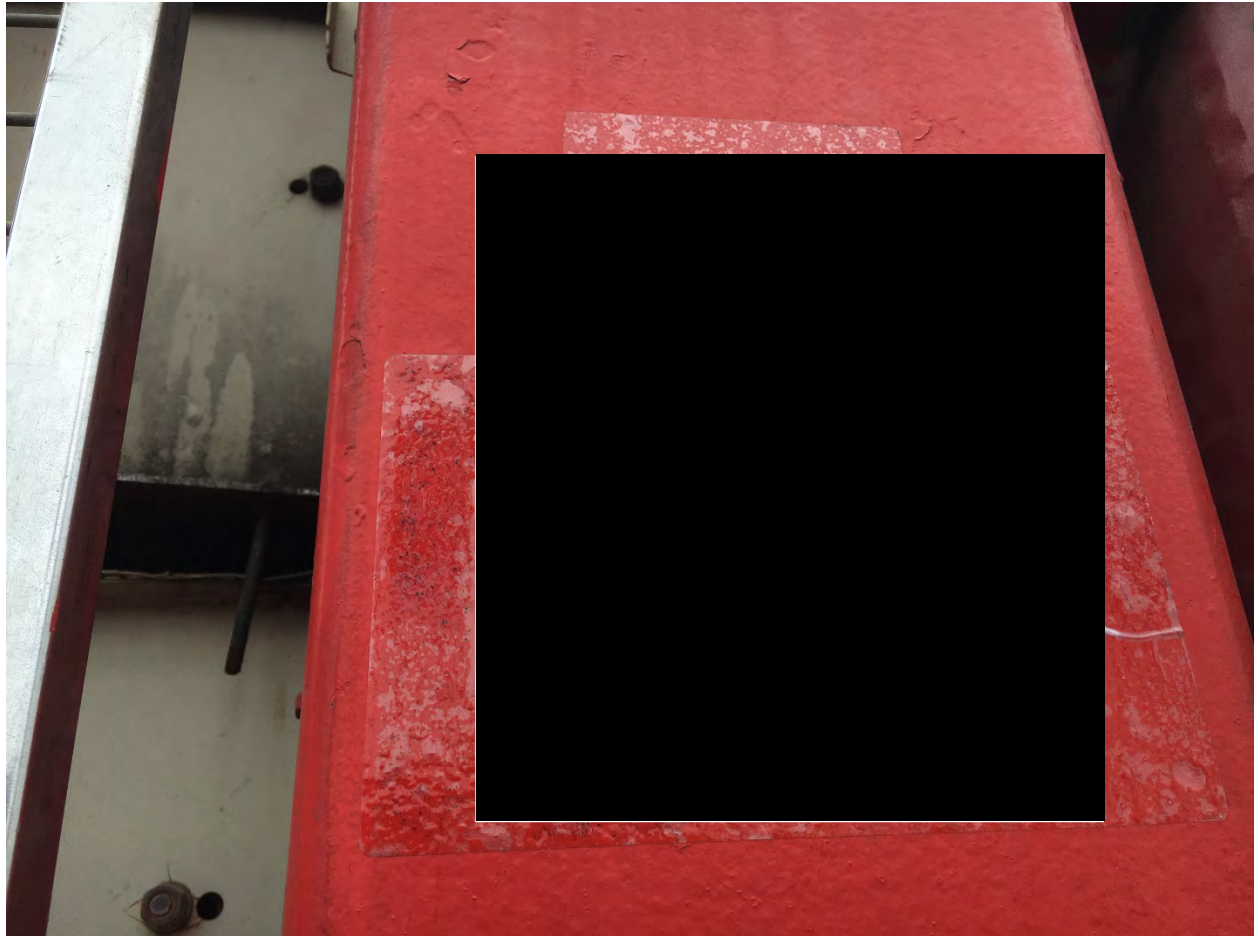
Photo #31 –Photo identifies [REDACTED] permit sticker for 2017. Photograph taken by this investigator on July 27, 2017.
