**Re:** Ohio State Fair Fatal Ride Incident

Attachment – IDI 170727CFE0001

Task Number: 170727CFE0001

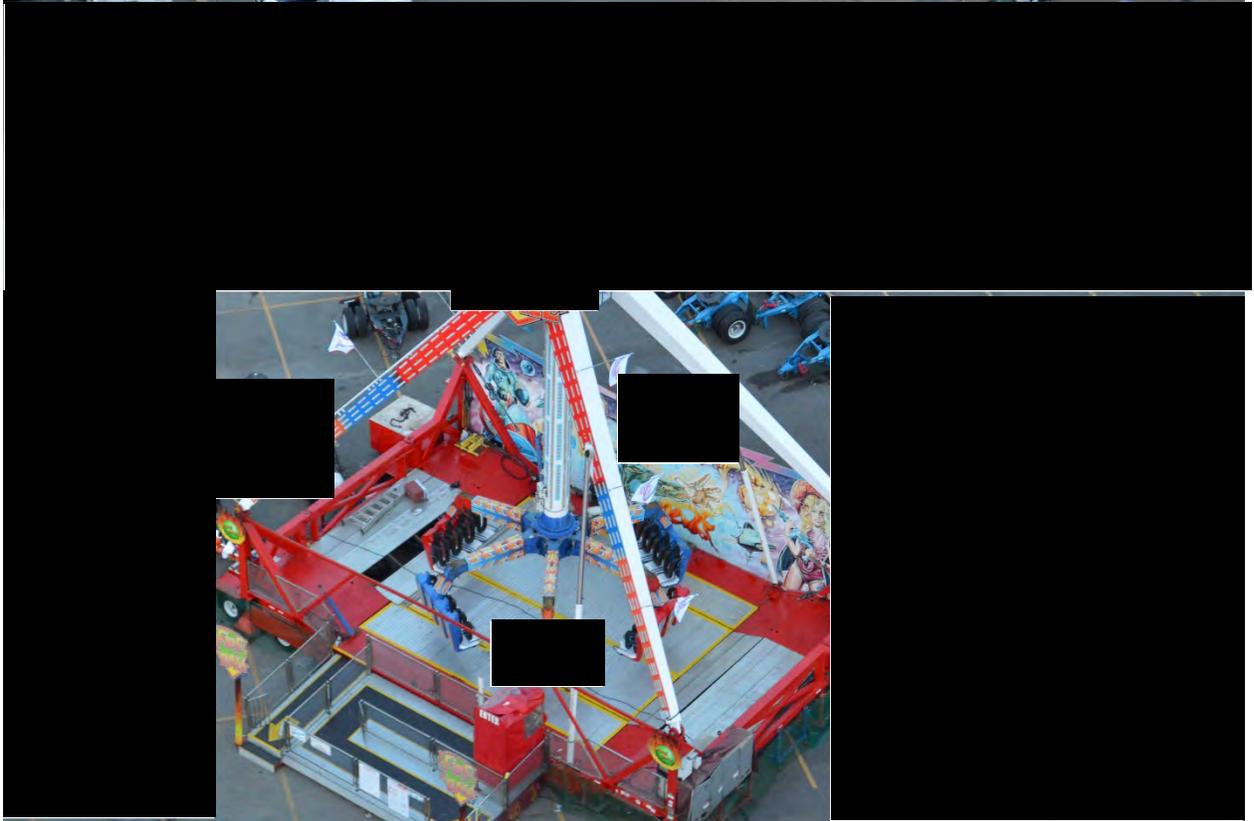
Photo #2 – Additional overall picture of the incident ride and surrounding area. Photograph taken by the [redacted] State Highway Patrol on July 26, 2017 after the incident.

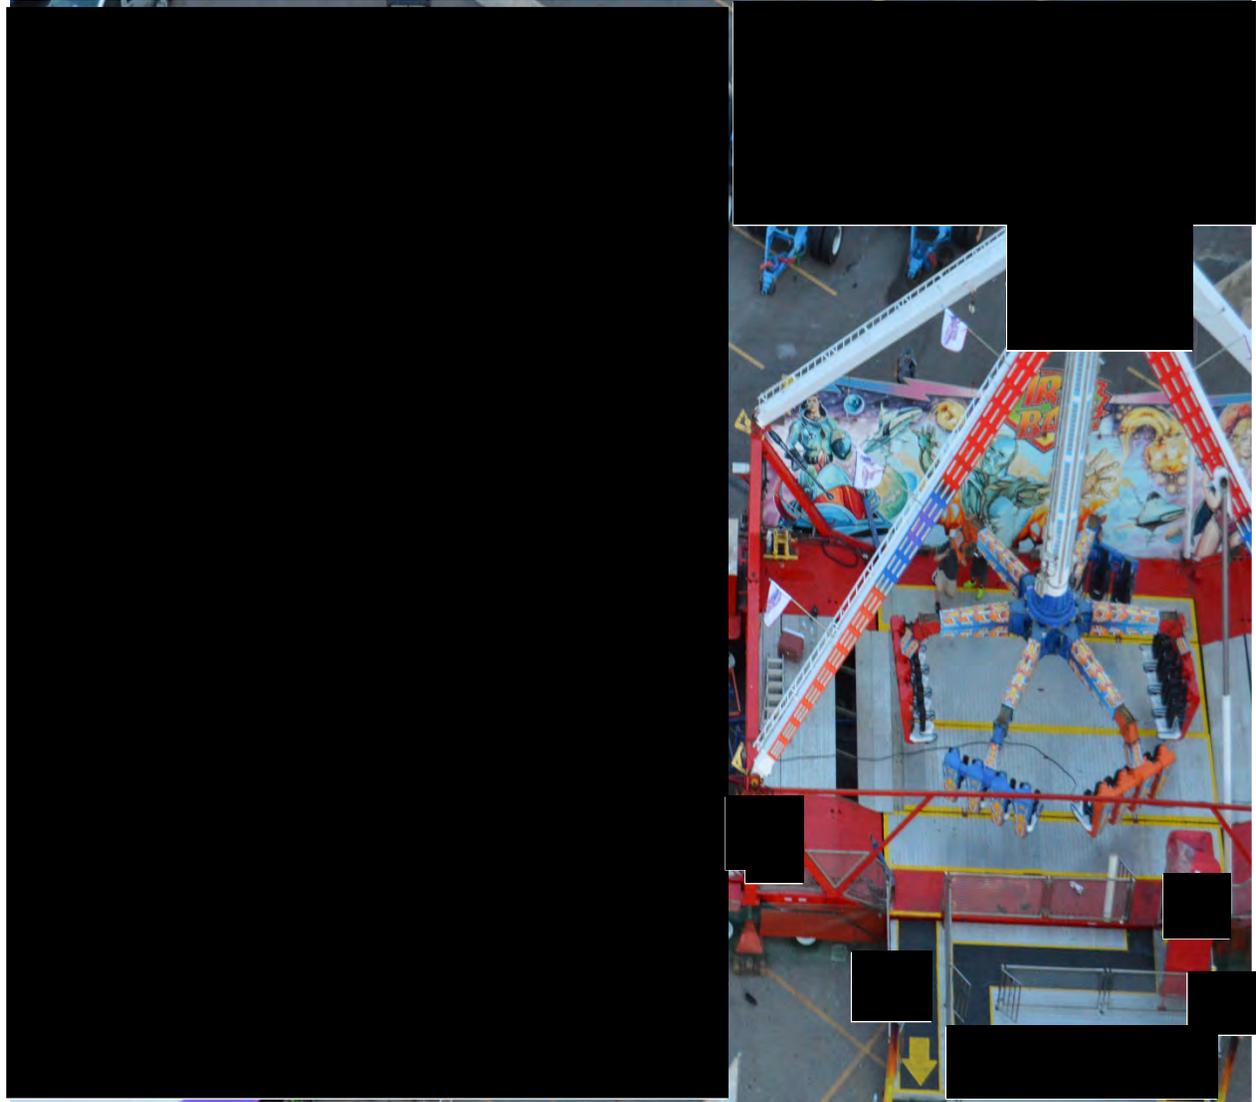
Photo #3 – Additional overall picture of the incident ride and surrounding area. Photo identifies victim location after incident. Photograph taken by the [REDACTED] State Highway Patrol on July 26, 2017 after the incident.

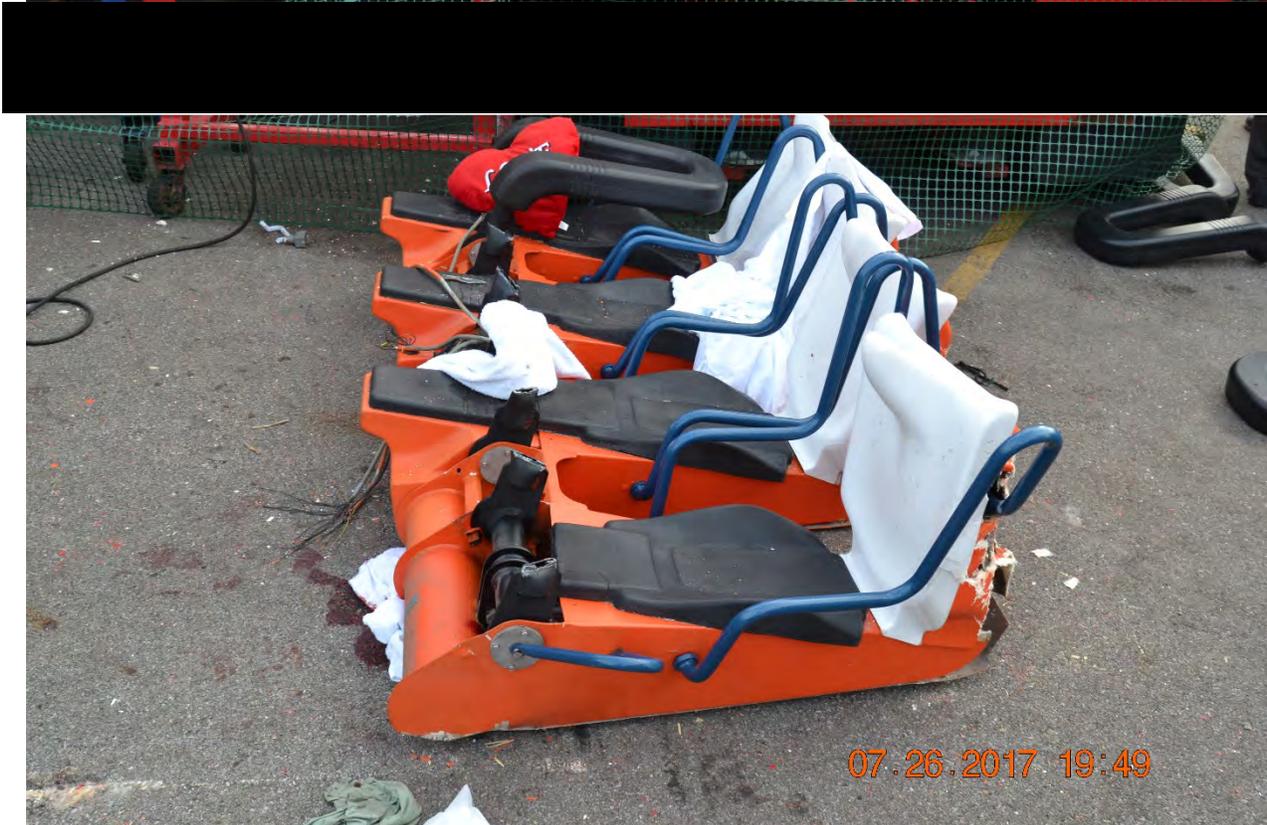
Photo #11 – Additional close up picture of the incident ride. Photo identifies the gondola that separated from the ride. Photograph taken by the [REDACTED] State Highway Patrol on July 26, 2017 after the incident.

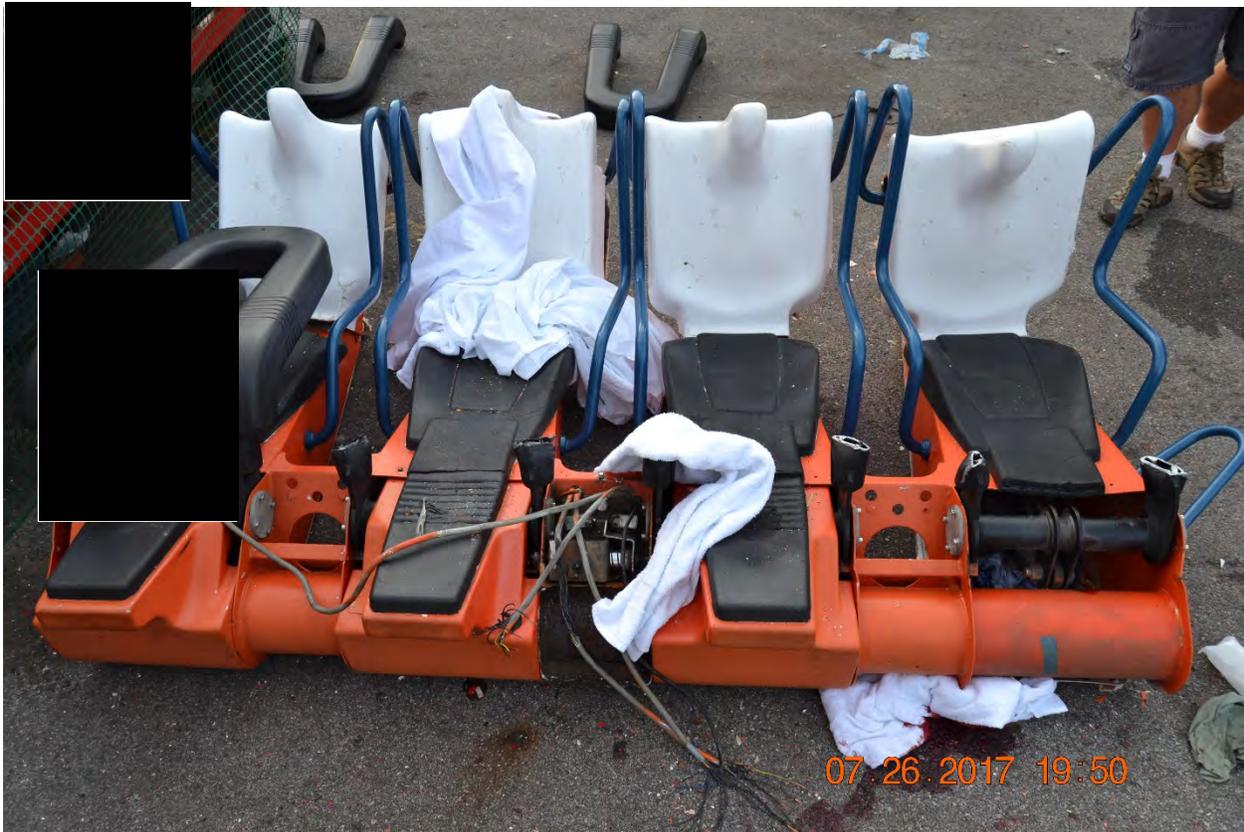
Photo #12 – Additional close up picture of the incident ride. Photo identifies the gondola that separated from the ride. Photograph taken by the [REDACTED] State Highway Patrol on July 26, 2017 after the incident.

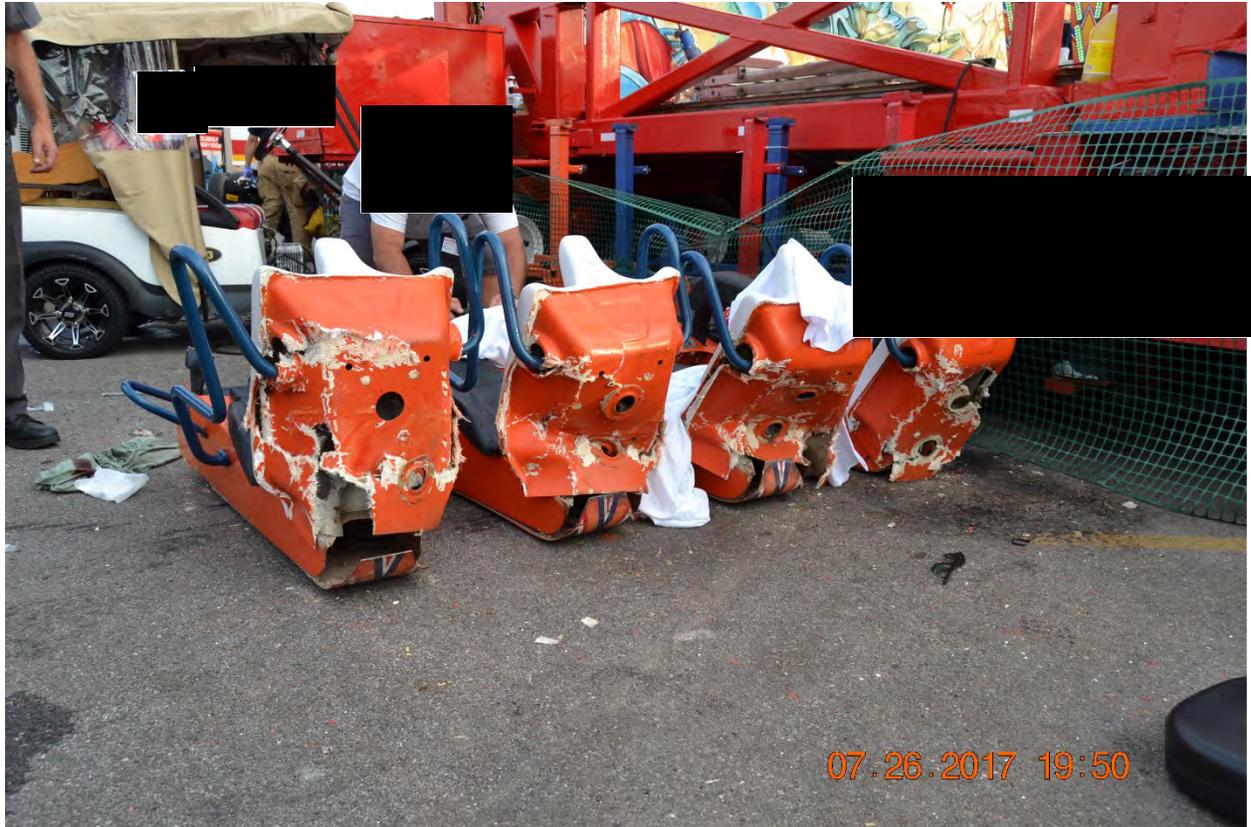
Photo #13 – Additional close up picture of the incident ride. Photo identifies the gondola that separated from the ride. Photograph taken by the [REDACTED] State Highway Patrol on July 26, 2017 after the incident.

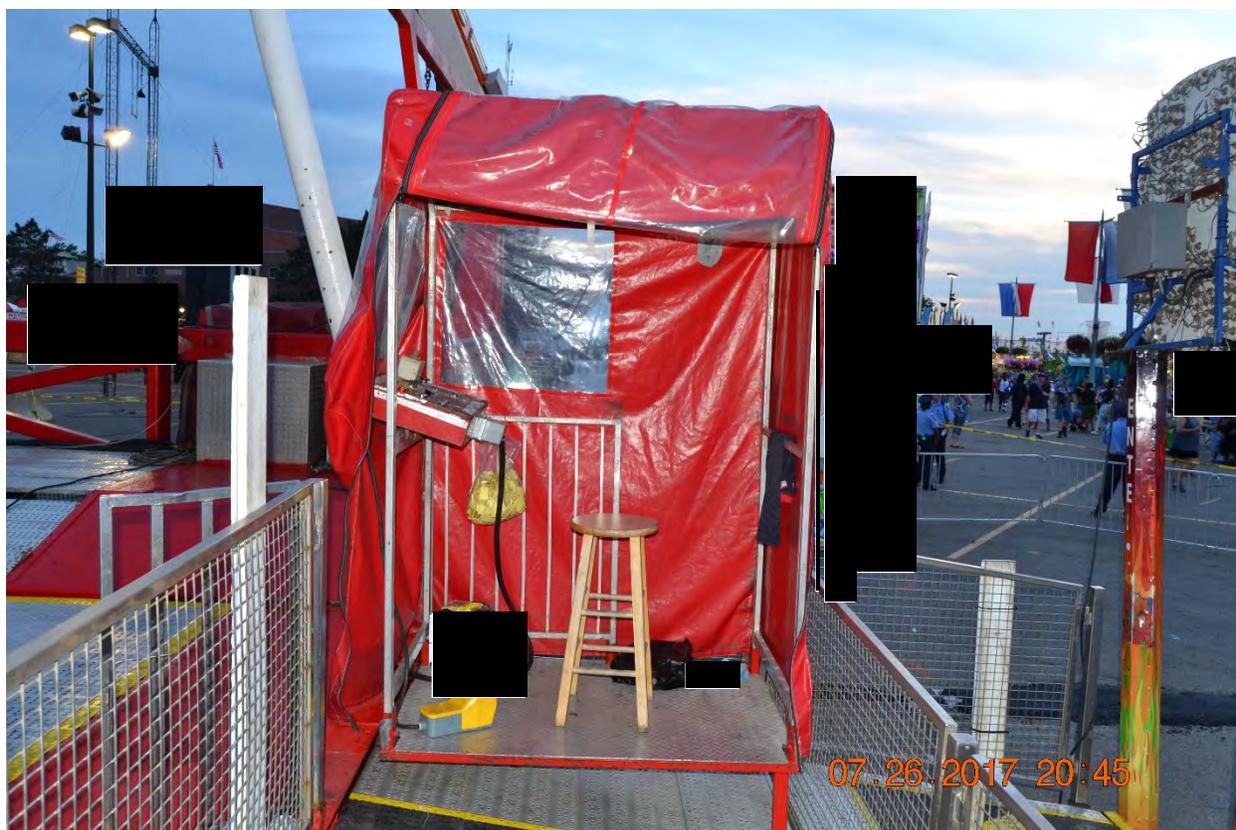
Photo #24 – Additional close up picture of the incident ride. Photo identifies the ride control booth. Photograph taken by the [REDACTED] State Highway Patrol on July 26, 2017 after the incident.

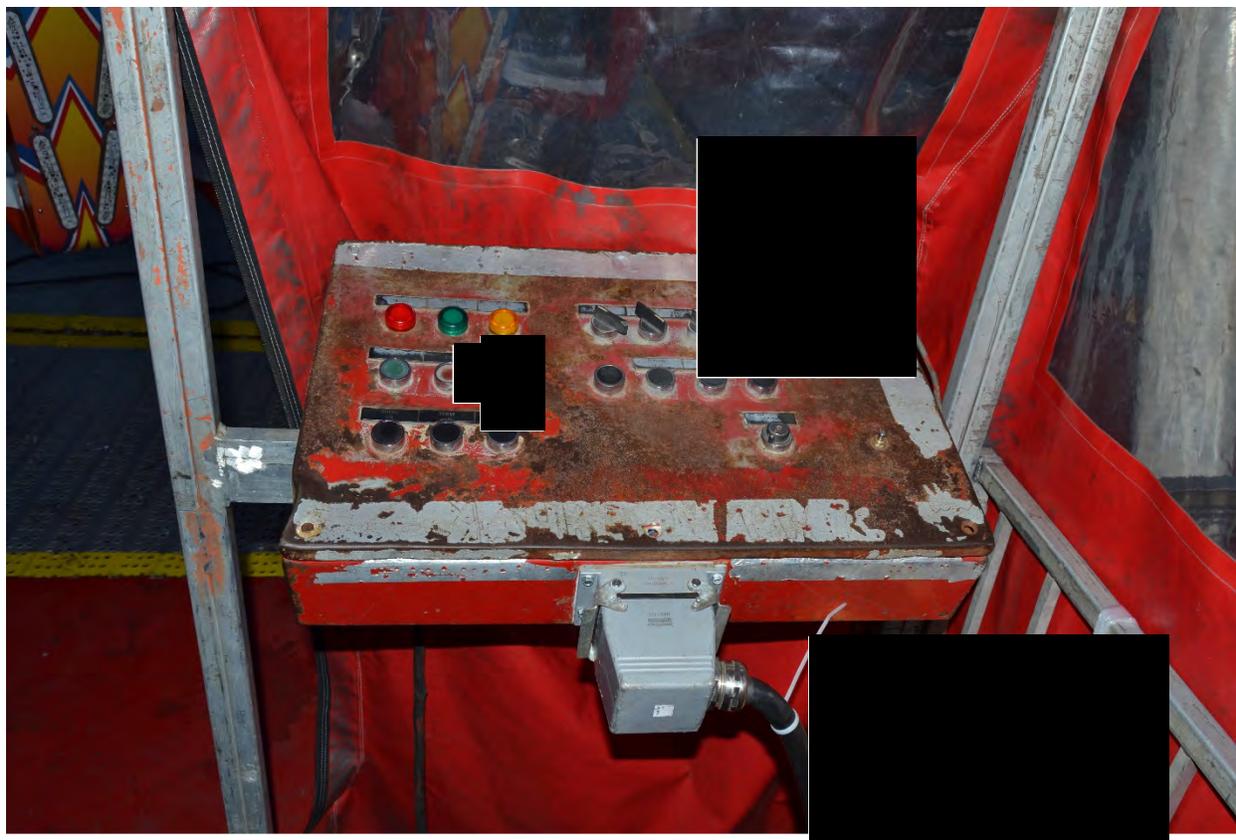
The ride is operated utilizing a Programmable Logic Controller (PLC) system, described as using auto controls to operate the ride. The rider operator cannot manipulate the speed or length of the ride. All controls are set by the manufacturer. The ride also has a safety back up that allows the ride to start only after each shoulder restraint bar has been locked into place and a green indication light is illuminated above the rider's head. When all 24 passenger lights have illuminated, the ride operator may then start the ride by placing his foot on the pedal (Exhibit M, Photo 26) and pressing the button on the control panel (Exhibit M, Photo 25).

Photo #25 – Additional close up picture of the incident ride. Photo identifies the ride control panel located inside the ride control booth. Photograph taken by the [REDACTED] State Highway Patrol on July 26, 2017 after the incident.

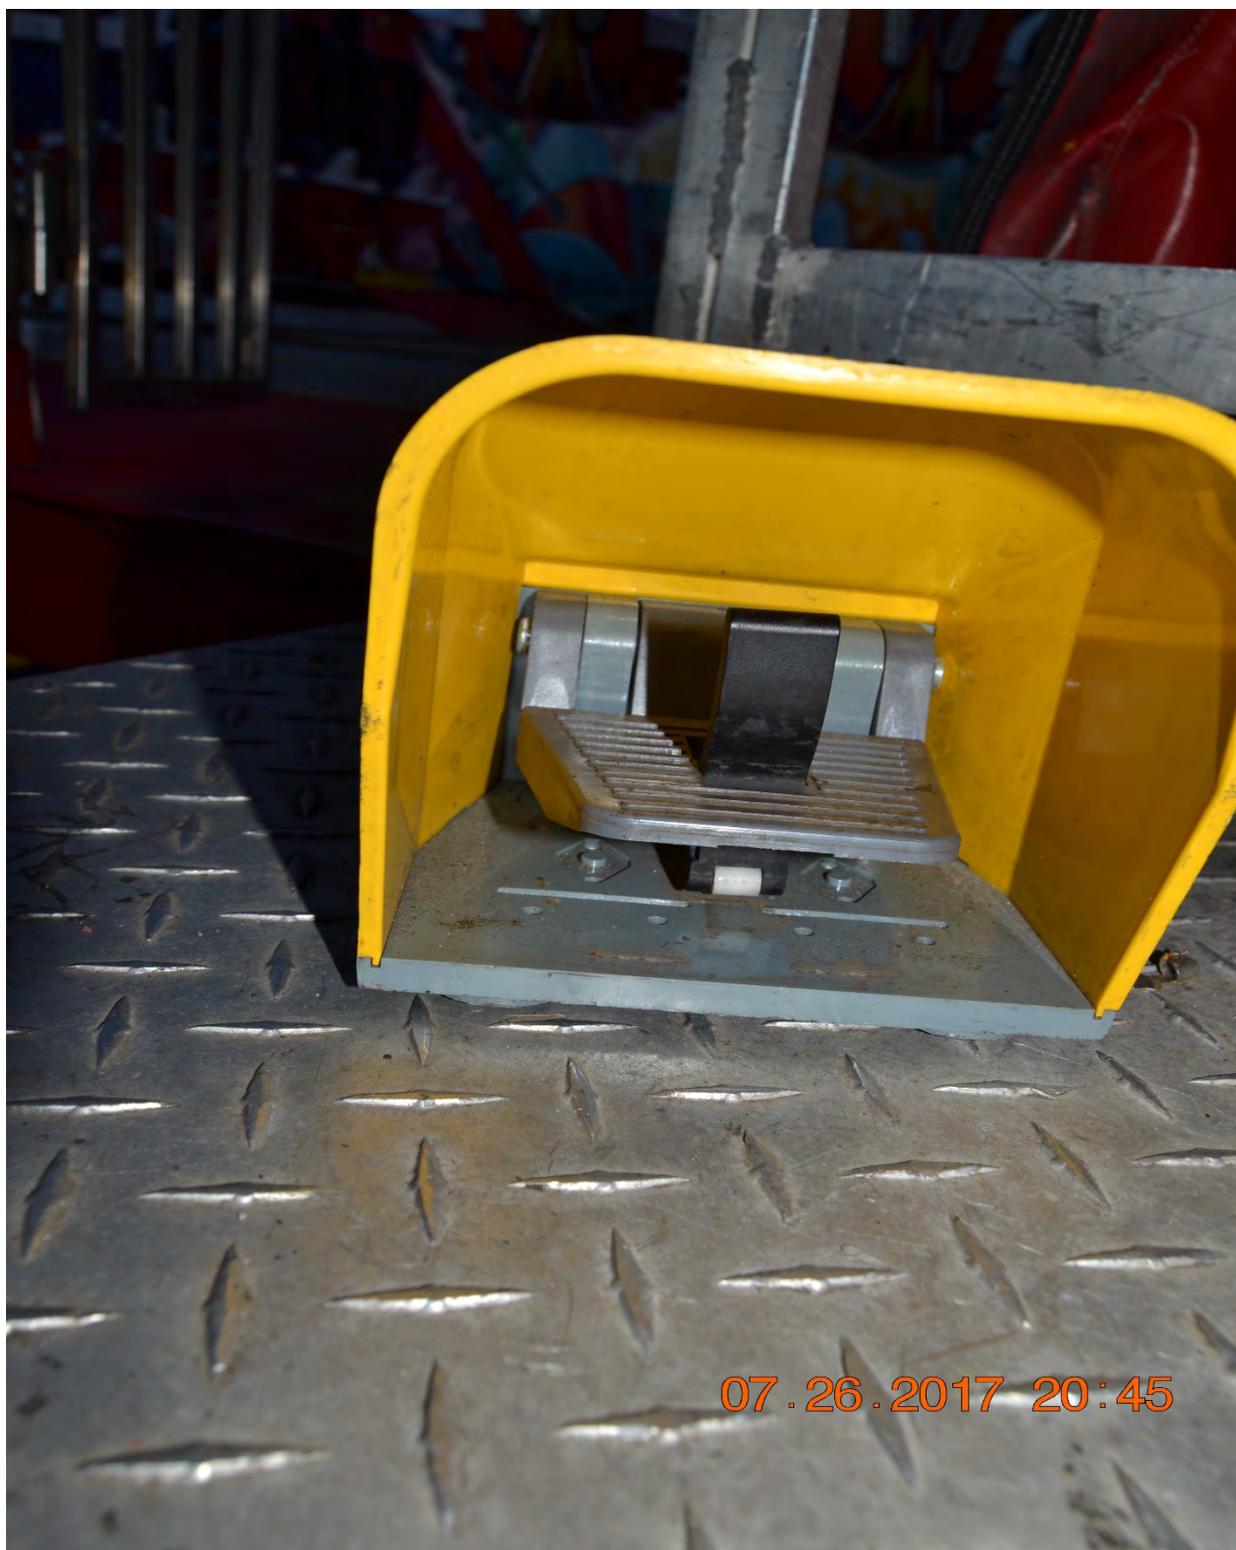
Photo #26 – Additional close up picture of the incident ride. Photo identifies the foot pedal located inside the ride control booth. Photograph taken by the [REDACTED] State Highway Patrol on July 26, 2017 after the incident.

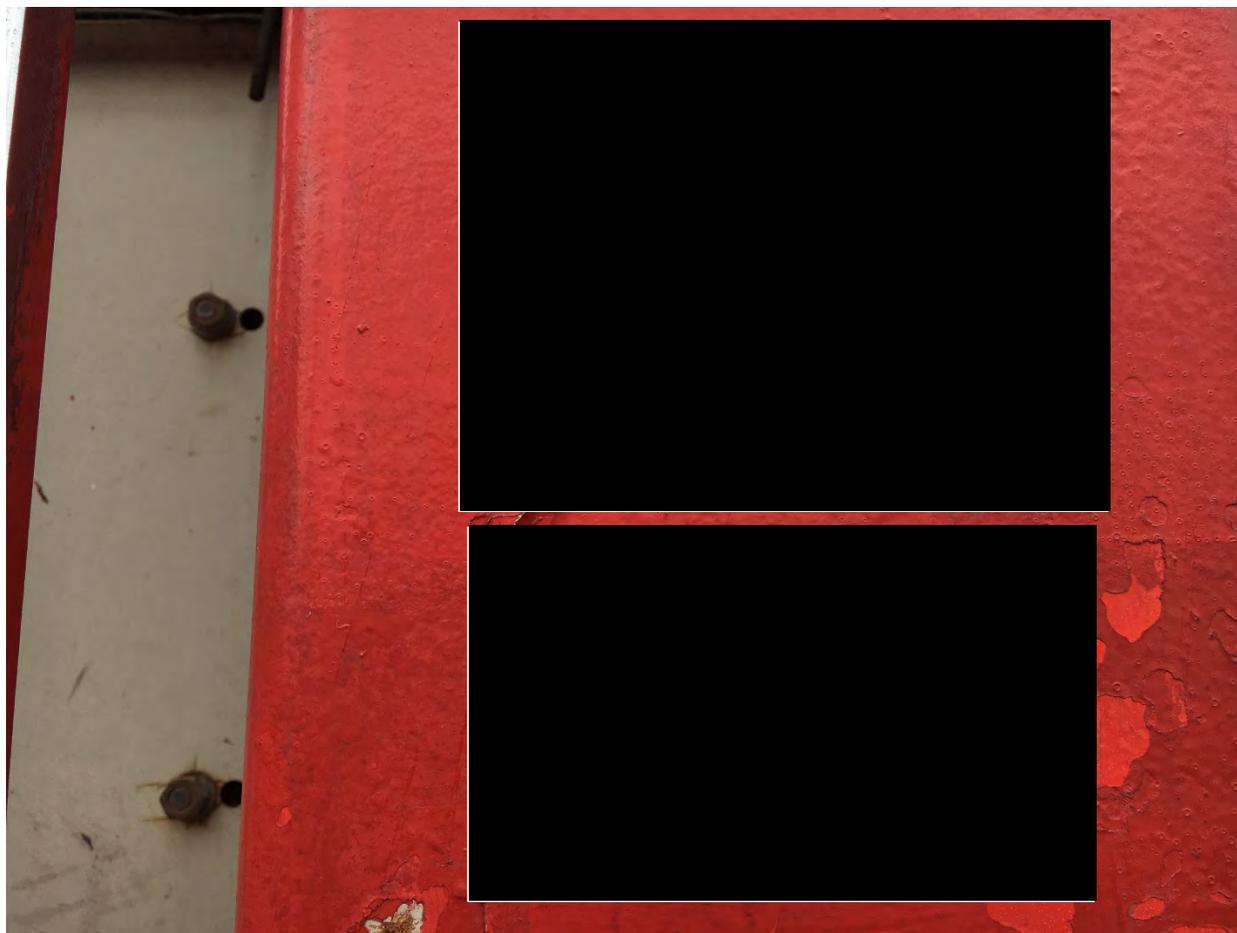
The incident ride had been utilized in [REDACTED] [REDACTED] [REDACTED] [REDACTED] [REDACTED] and [REDACTED] prior to the incident location in [REDACTED] Inspection, Maintenance and Lubrication Reports, Daily Inspection and Maintenance Reports and Certificates for Operator Training for the above referenced locations are attached (Exhibit E). State inspection reports for [REDACTED] [REDACTED] (Exhibit F) and two locations in [REDACTED] (Exhibits G & H) are also attached. Ride owners stated that not all states provide a written report after an inspection is completed; however, an inspection sticker would typically be presented after it passed inspection. Inspection stickers visible on the incident ride include [REDACTED] (Exhibit M, Photos 29 & 30), [REDACTED] (Exhibit M, Photo 28) and [REDACTED] (Exhibit M, Photo 31).

Photo #30 –Photo identifies secondary [REDACTED] permit sticker for 2017. Photograph taken by this investigator on July 27, 2017.

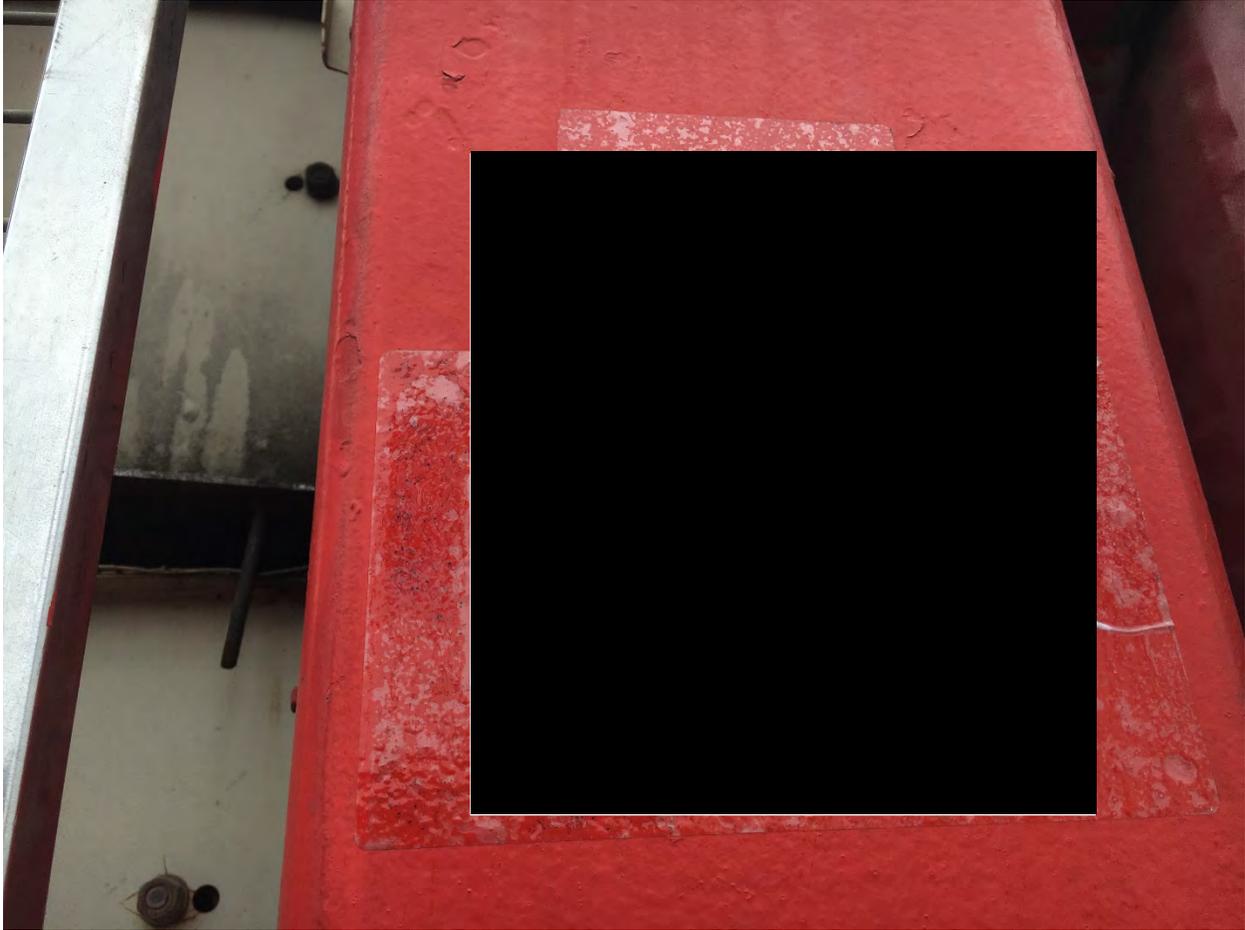
Photo #31 –Photo identifies [REDACTED] permit sticker for 2017. Photograph taken by this investigator on July 27, 2017.
