**CPSC Staff's Statement on SEA Ltd.'s (SEA's) Report, "Study of Debris Penetration
of Recreational Off-Highway Vehicle (ROV) Floorboards"
December 2021**

Study of Debris Penetration of Recreational Off-highway Vehicle (ROV) Floorboards

for:
Consumer Product Safety Commission

December 2021

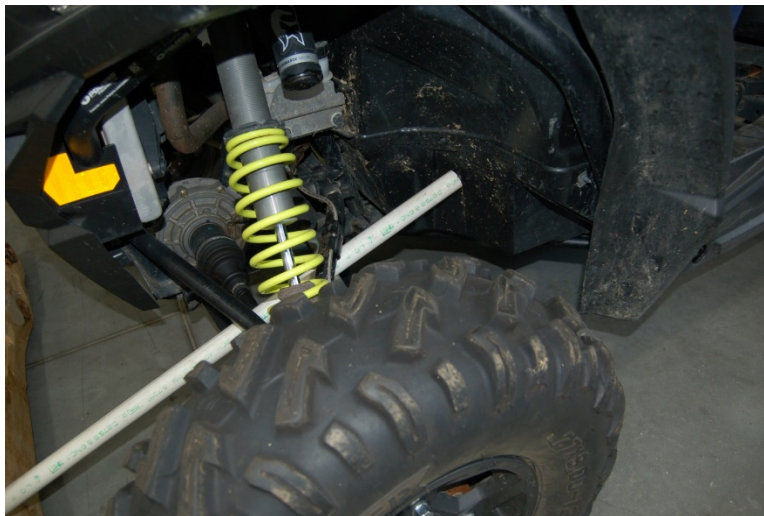
Figure 1: Simulated Stick at an Angle Where it Could Get Caught up in Suspension of Vehicle A.

The outdoor tests were designed to simulate the more serious accidents. A popular type of vehicle, which is called Vehicle A in the sled test sequence, was examined for the possibility of this type of accident, as seen in the photos of Figure 1. The middle photo of Figure 1 shows that with the end of the stick positioned where it is, if the vehicle were moving forward, the stick would pass between or above the suspension components. The angle of the simulated stick and the height of the tip of the stick in the middle photo were measured. These two factors together set the preliminary length and angle of the above-ground portion of the stick in the outdoor testing. The final angles for the sticks in the outdoor testing were adjusted somewhat from these initial values, as will be described later.

The bottom photo of Figure 1 shows the same stick with the vehicle moved forward, showing that a straight stick can find its way between the suspension components and strike the floorboard or firewall, similar to how sticks struck vehicles in the severe accidents. The angle of the stick may potentially change as the vehicle moves; however, it was determined that a straight stick could pass through the suspension components. During the final set up of the outdoor test, it was decided to use two stick penetration zones, one between the lower and upper suspension A-arms like Figure 1, as indicated by the rectangle in Figure 2. The other penetration zone was with a higher impact point above the suspension upper A-arm and below the spring/shock strut as indicated by the triangle in Figure 2. The test using the triangular impact zone is referred to as Run 1 and the test using the rectangular impact zone is Run 2.

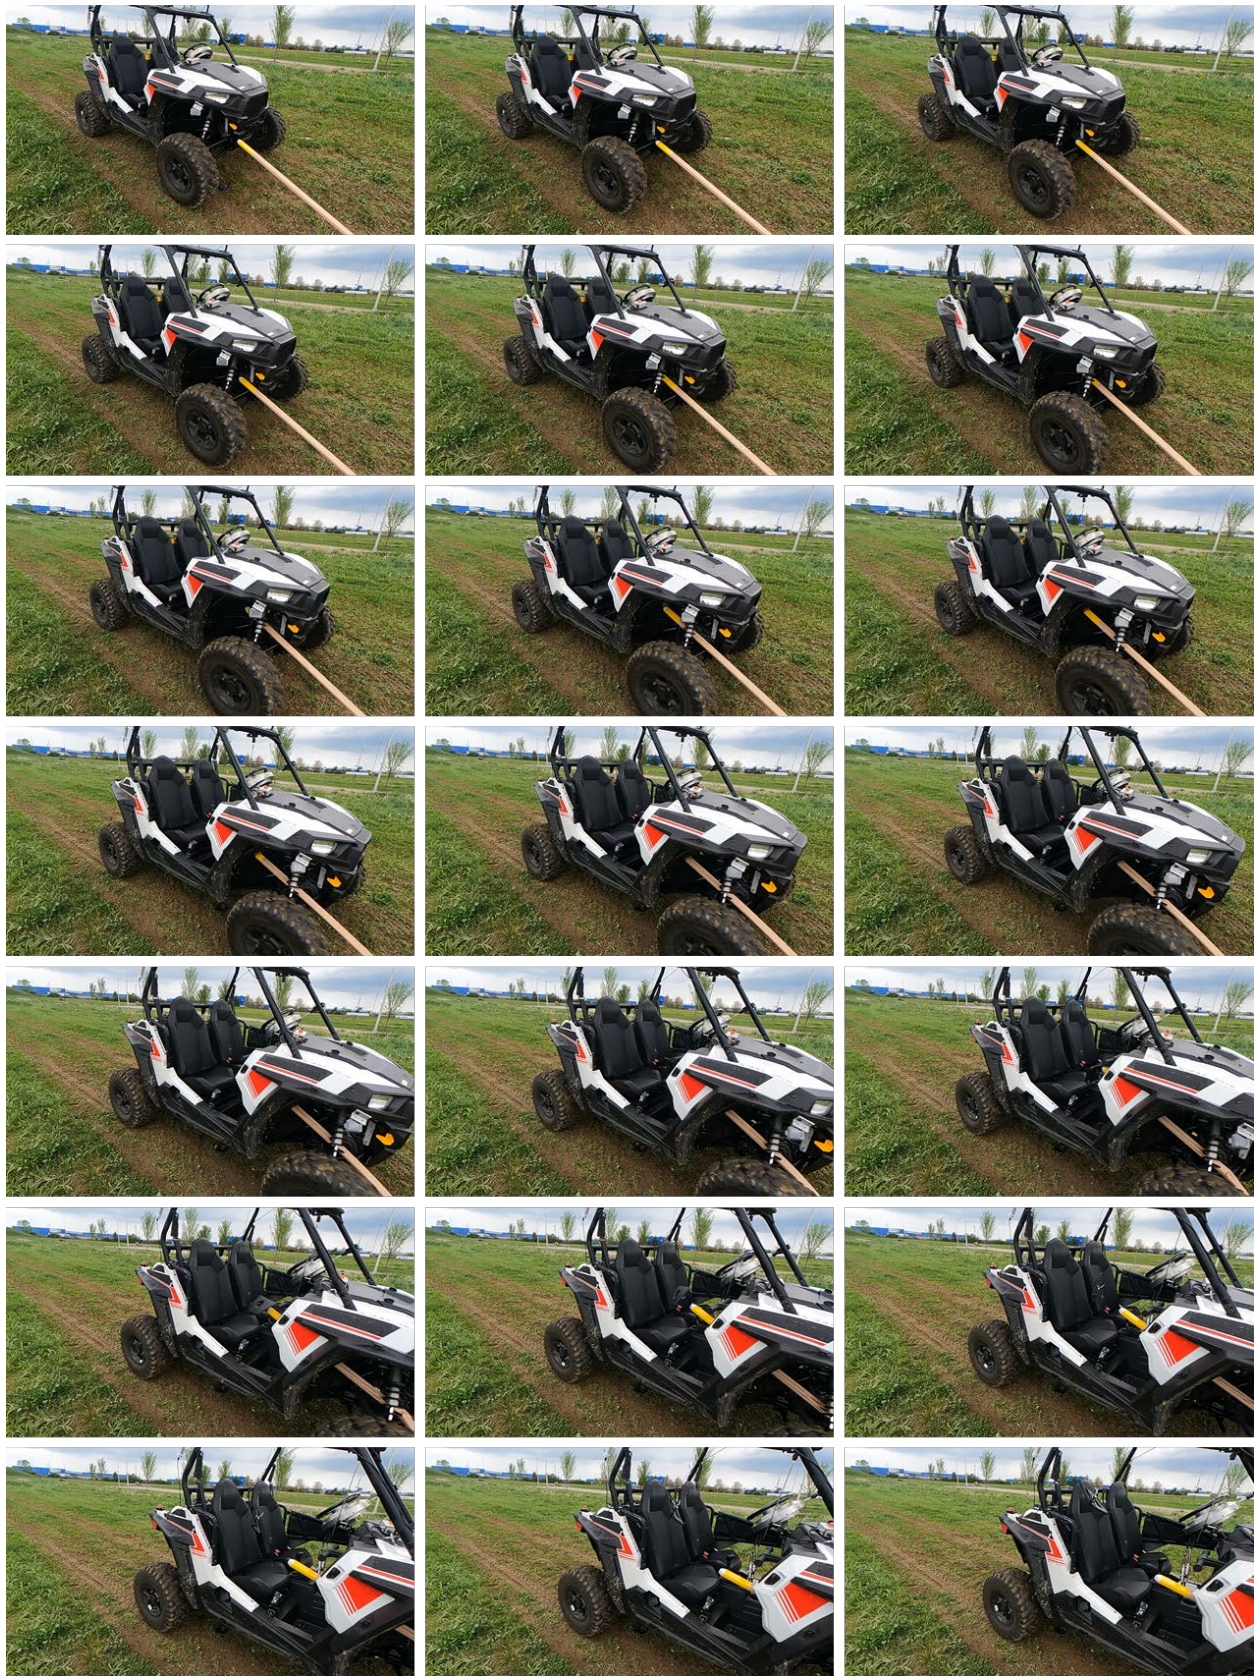
Figure 14: Time Lapse Images of Run 1

Figure 14 is a collection of images from the off-board video camera, arranged to provide a time-lapse portrait of the penetration during Run 1. The video was taken at 240 frames per sec and the sequential images shown are five frames apart. With the vehicle traveling 10 mph, the vehicle travels about 3.67 inches between the sequential images shown. The total distance traveled between the first image and last image shown is about 72 inches.

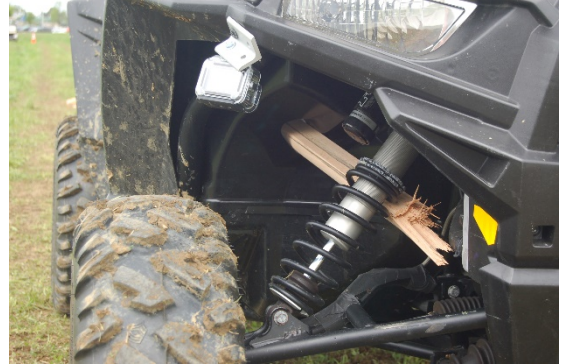
Table 1: Full Scale, Autonomously Driven ROV (Vehicle A) Impact Run #1

Complete stick penetration through firewall section.

After penetrating the firewall and becoming engaged with suspension components, the stick broke as the vehicle moved past the fixture holding the base of the stick.

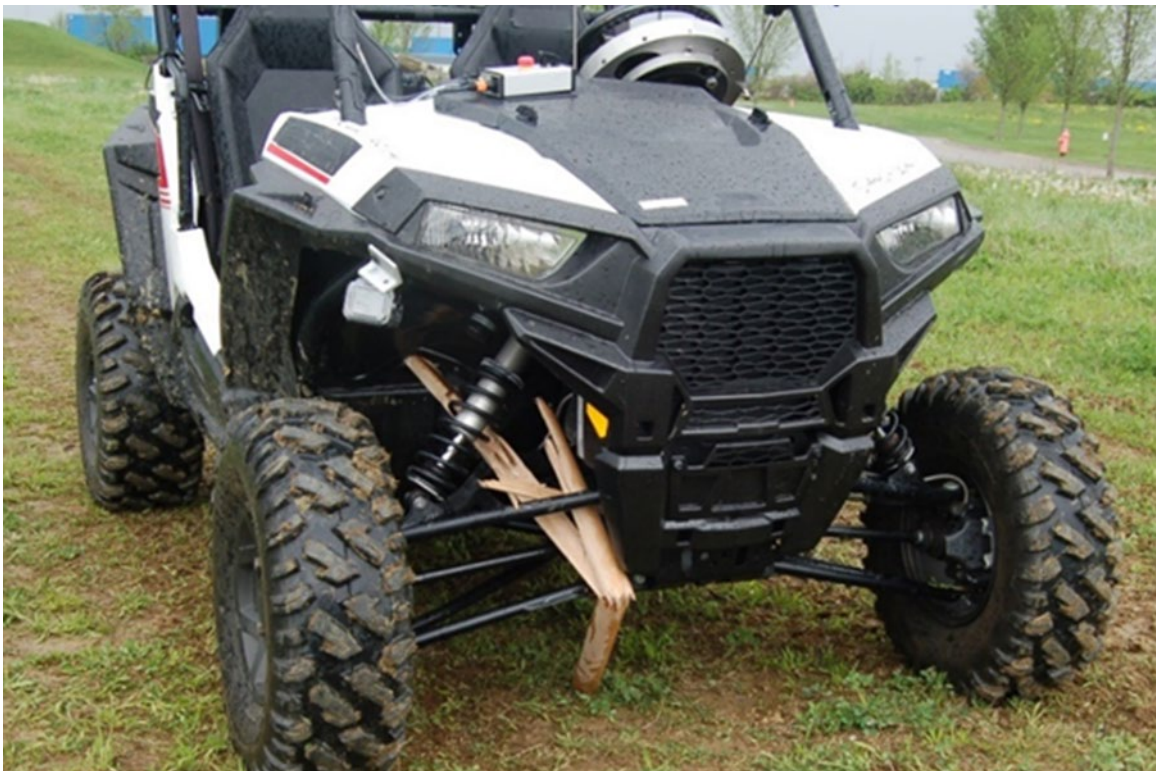
Figure 16: Run 2 Post-Impact Front View

The pre-impact stick alignment for Run 2 is shown on Figure 15, with the end of the stick positioned to go between the upper and lower control arms. Figure 16 shows a post-impact front view of the vehicle. The stick was guided between the control arms and into the upper floorboard / lower firewall area. The stick penetrated the floorboard/firewall seam, became intertwined in the suspension components, and broke off as the vehicle passed over the wooden box holding the far end of the stick.

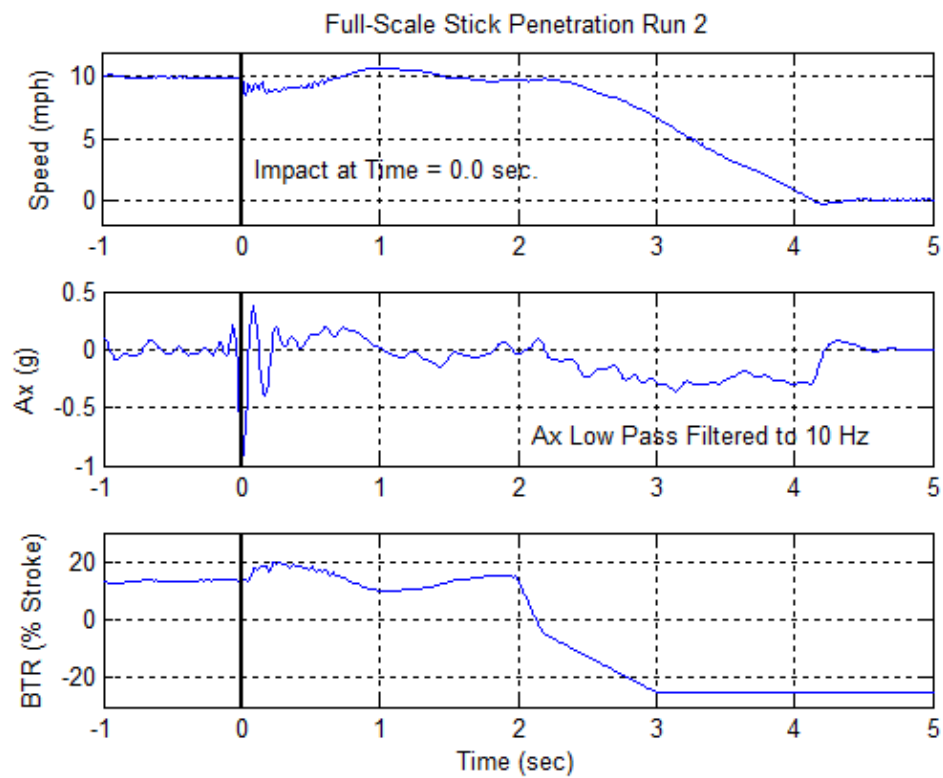
Figure 20: Results from Full-Scale Stick Penetration Run 2

Figure 20 contains graphical results for Run 2 and Figure 21 contains the time lapse images for Run 2. For this run, the impact speed was 9.96 mph, and the vehicle slowed down more than it did during the Run 1 impact. The peak deceleration of about 0.90 g resulted from the tip of the stick directly impacting one of the suspension control arms. The second image on Figure 21 shows that the stick is bending under the force of this impact. After this impact, the stick continues to travel between the control arms, and a less severe impact occurs when the tip of the stick impacts and penetrates the floorboard/firewall seam. The BTR stroke increased immediately after the impact to compensate for the speed reduction caused by the impact. The throttle dropped and the brake applied starting at about 2.0 sec, the time when the vehicle traveled the brake trigger distance. The vehicle came to rest about 4.2 sec after the impact.

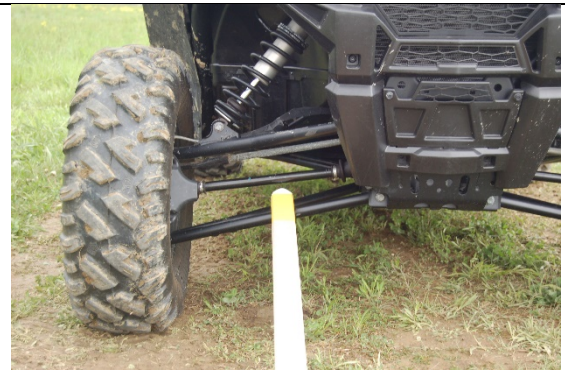
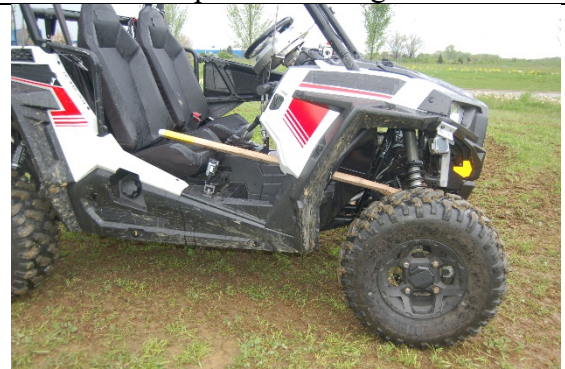
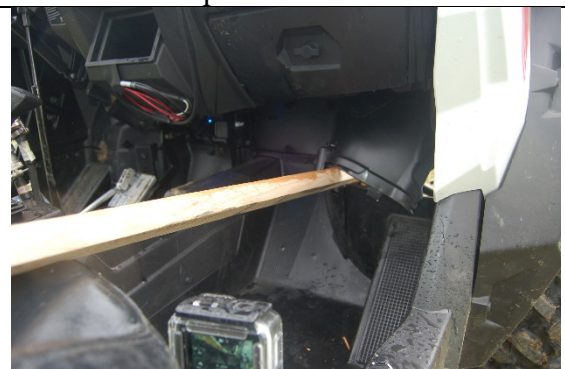
Table 2: Full Scale, Autonomously Driven ROV (Vehicle A) Impact Run #2

Complete stick penetration through seam area between floorboard and firewall sections.

After penetrating the floorboard/firewall and becoming engaged with suspension components, the stick broke as the vehicle moved past the fixture holding the base of the stick.

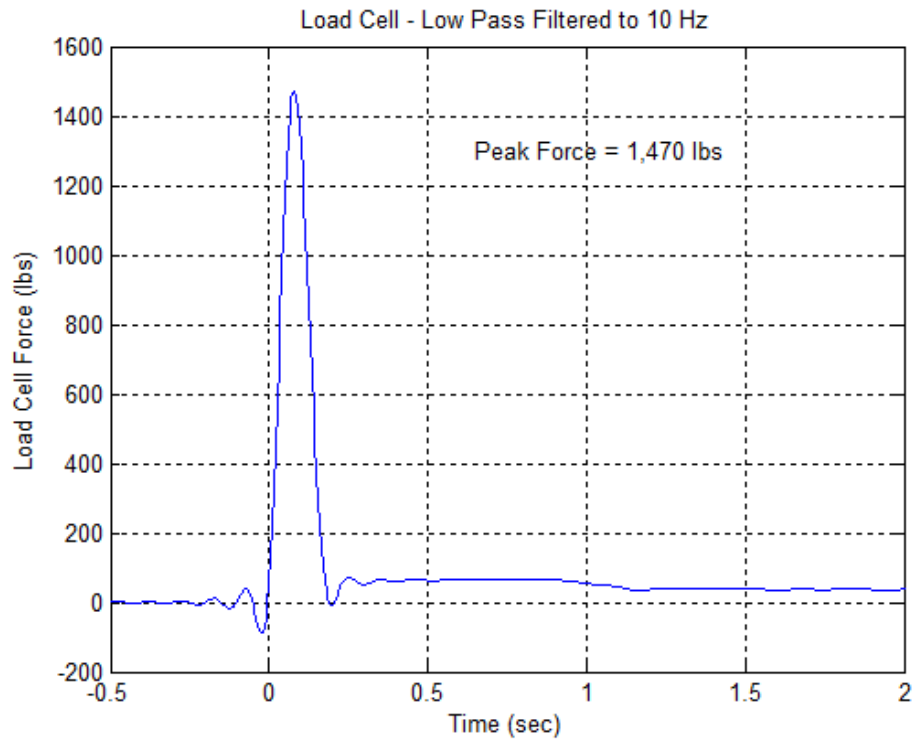
Figure 28: Measured Load Cell Force – Vehicle A – Run 1

The load cell arrangement used provides for measurement of force in-line with the stick. Long pieces of wood can be very strong in compression but not strong in bending. Therefore, the stick can never see significant loads except parallel to its long axis. Figure 28 shows the measured force during the first test (Run 1) done on Vehicle A, the test using only the OEM floorboard and firewall sections. This force trace is like the traces from all the sled tests, with the force very high for fractions of a second after the initial impact (at time equal to zero seconds), and then quickly dropping back to a low force level.

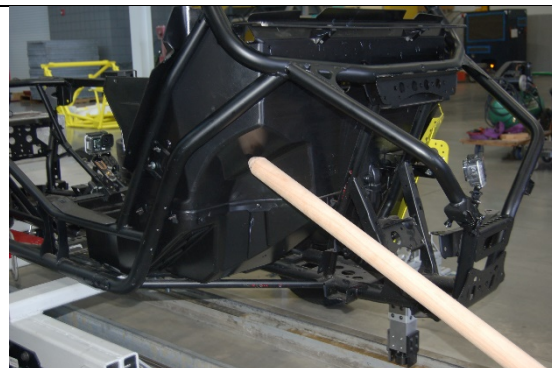
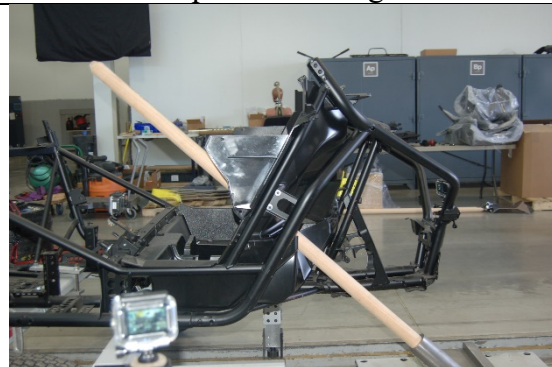
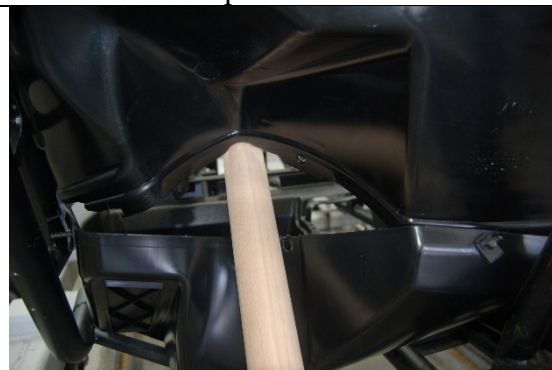
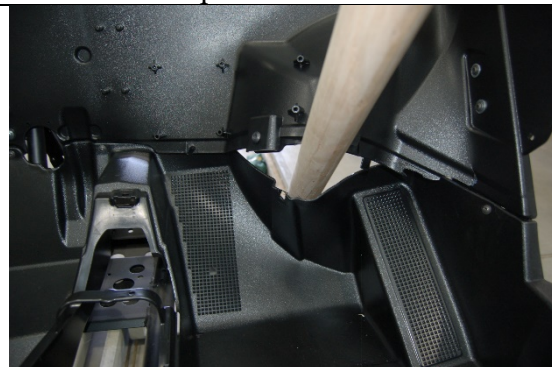
Complete stick penetration through seam area
between floorboard and firewall sections.

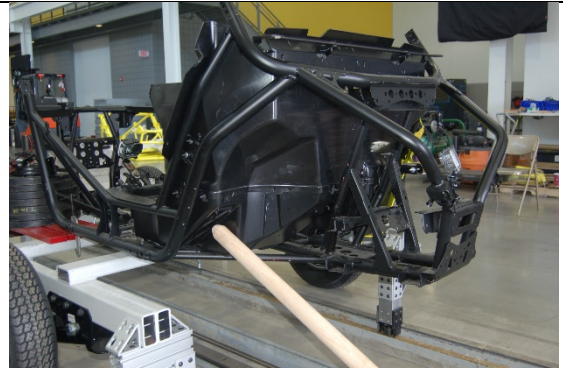
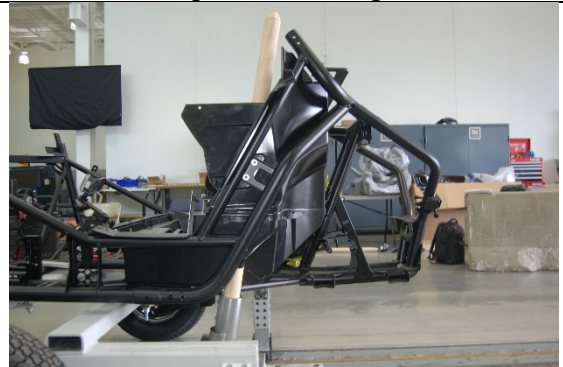
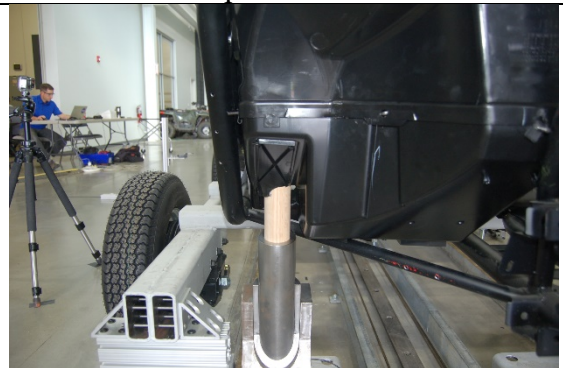
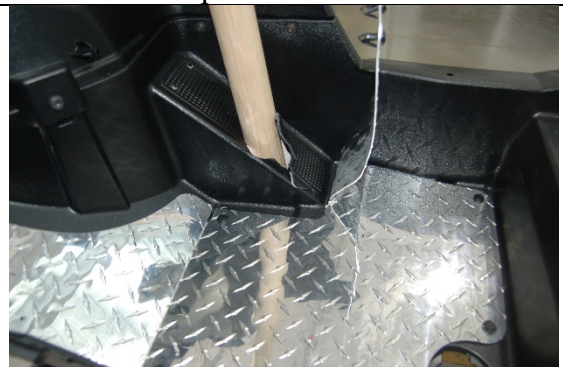
Complete stick penetration through floorboard section and past Aftermarket Guard A1.

Fasteners securing top portion of guard on to footrest failed.

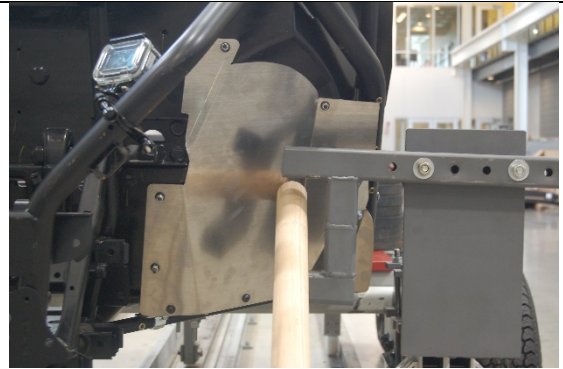
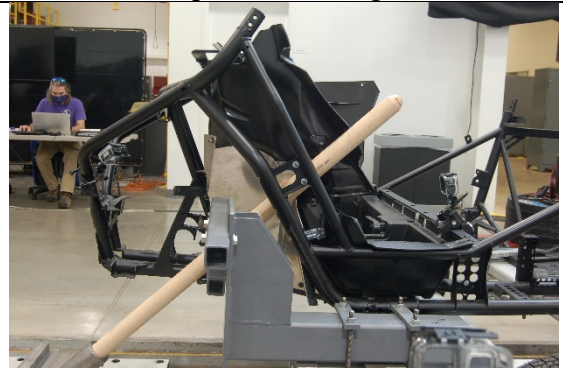
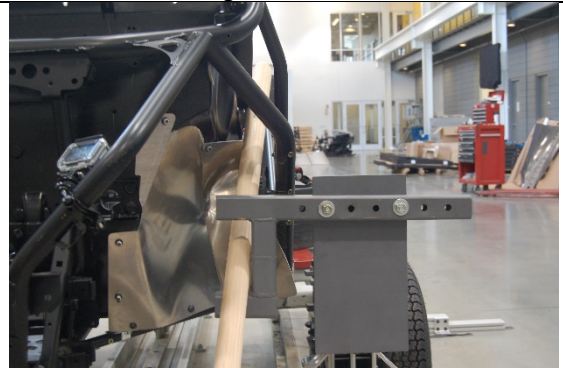
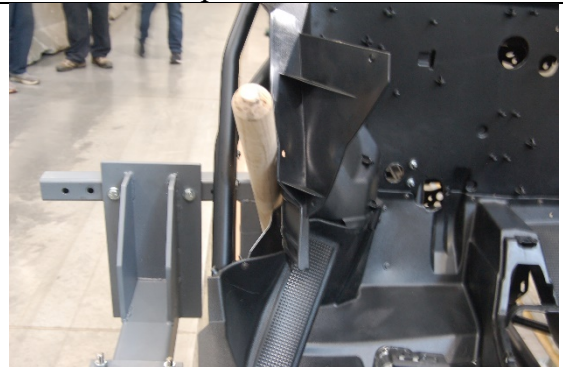
Table 7 (Continued): Vehicle A – Sled Impact Run #3 – Aftermarket Guard A2

The guard deformed and the C-hook securing the outside edge of the guard became disconnected from the frame of the vehicle. The stick moved up and outward, past the outside of the deformed guard, then penetrated between the vehicle frame and floorboard/firewall sections.

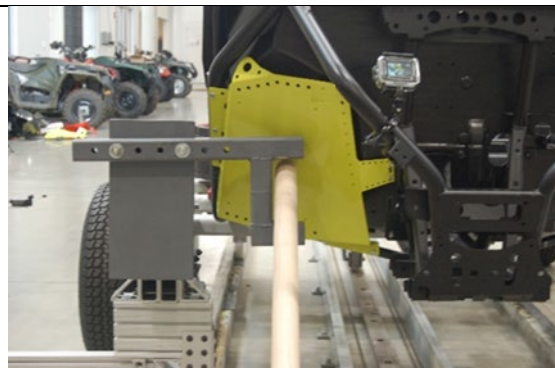
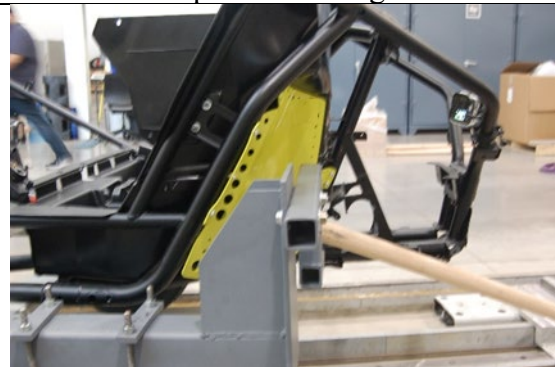
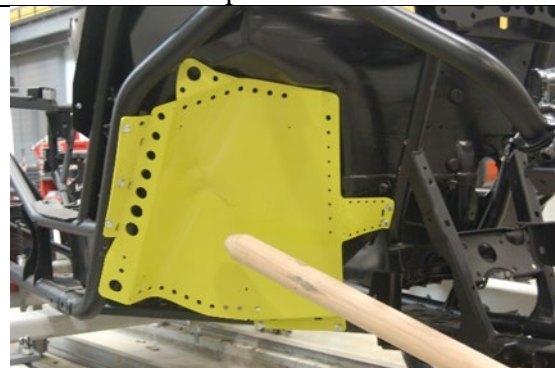
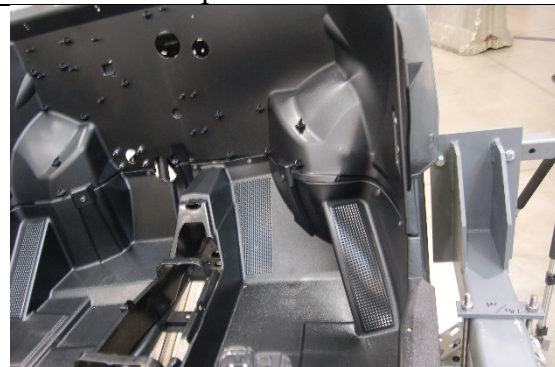
Table 8 (Continued): Vehicle A – Sled Impact Run #4 – Aftermarket Guard A3

The guard deformed and pushed into the area of the seam between the floorboard and firewall. The post-impact maximum deflection of the floorboard/firewall was 2 ¼".

During the impact, the sled cart with vehicle chassis lifted over 10" and yawed clockwise about 10 degrees.

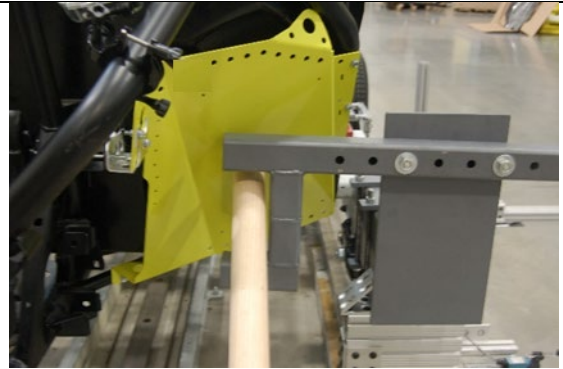
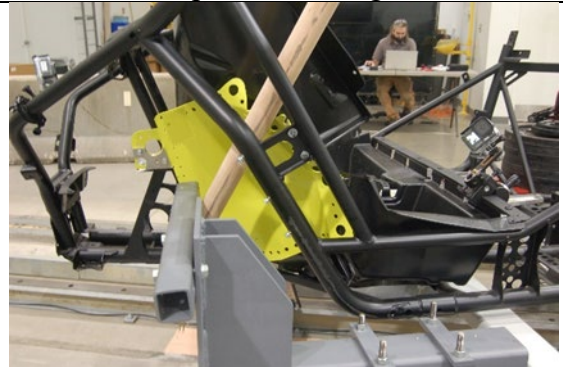
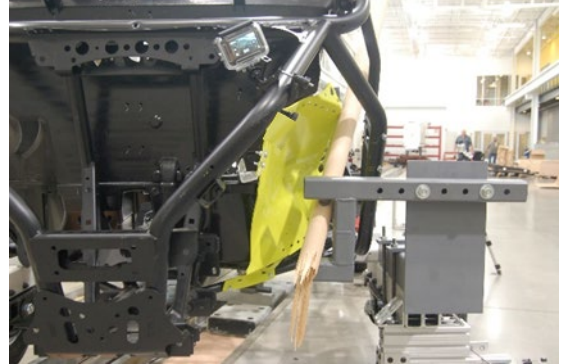
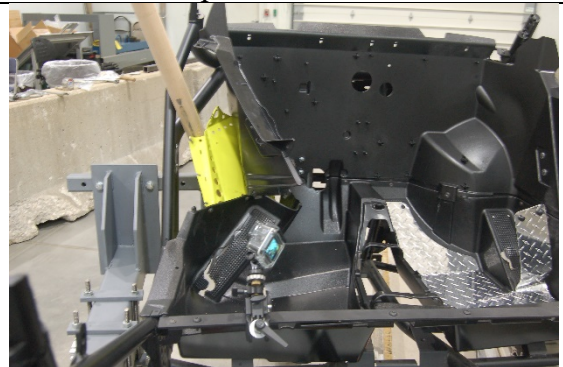
Table 9 (Continued): Vehicle A – Sled Impact Run #5 – Aftermarket Guard A3

The guard deformed and the guard material around the holes for the three outside guard fasteners failed, allowing the guard to release from the outside fasteners. The fasteners themselves did not fail.

The stick moved outward and up, past the outside of the deformed guard, then the stick and guard penetrated between the vehicle frame and floorboard/firewall sections.

After penetrating the occupant compartment and becoming engaged with the C-Brace, the stick broke as the vehicle chassis moved past the fixture holding the base of the stick.

The bottom left photo shows the failed guard material around the holes for the three outside guard fasteners. The bottom right photo shows the maximum deflection in the middle of the part, about 3 3/8 inches.

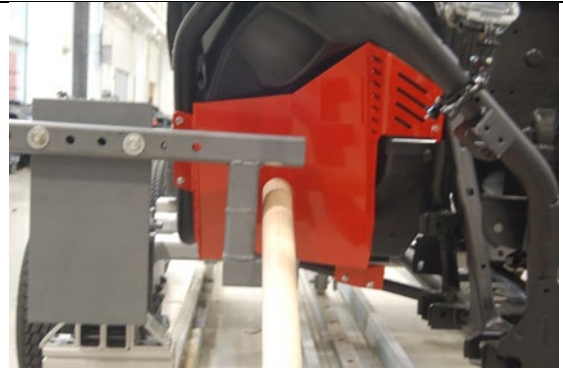
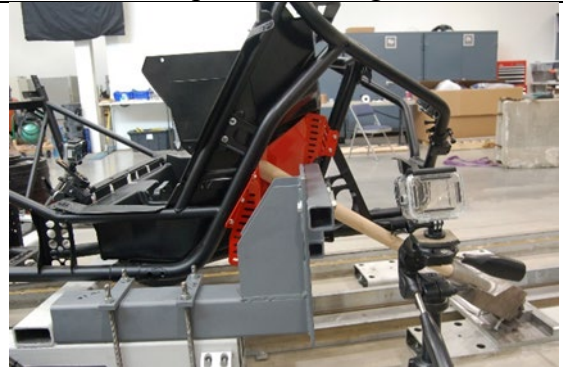
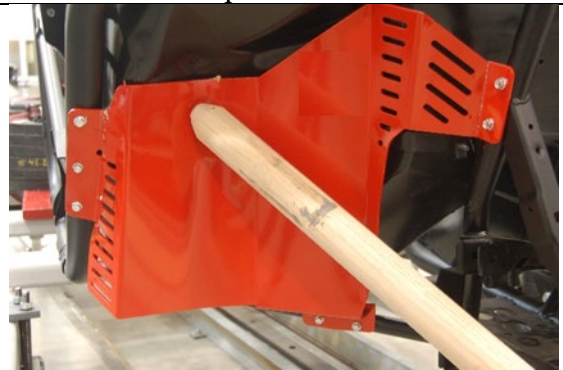
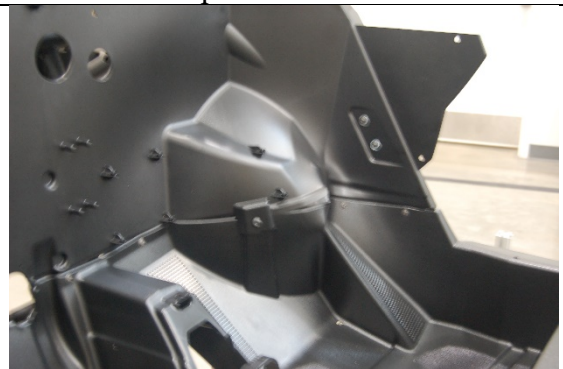
Table 10: (Continued) Vehicle A – Sled Impact Run #6 – Aftermarket Guard A4

The guard deformed and pushed into the area of the seam between the floorboard and firewall. The post-impact maximum deflection of the floorboard/firewall was 2 ¾".

During the impact, the sled cart with vehicle chassis lifted over 8" and yawed clockwise about 11 degrees.

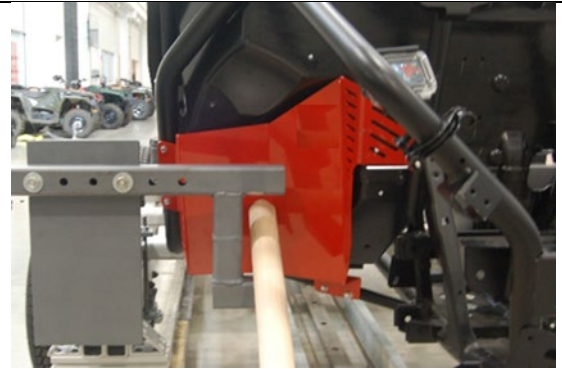
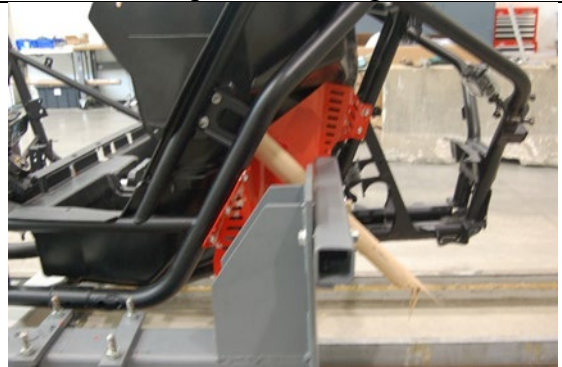
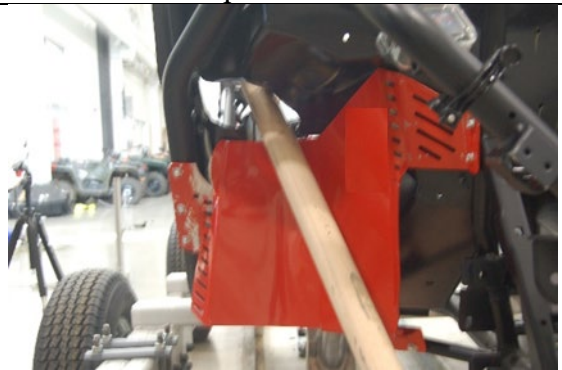
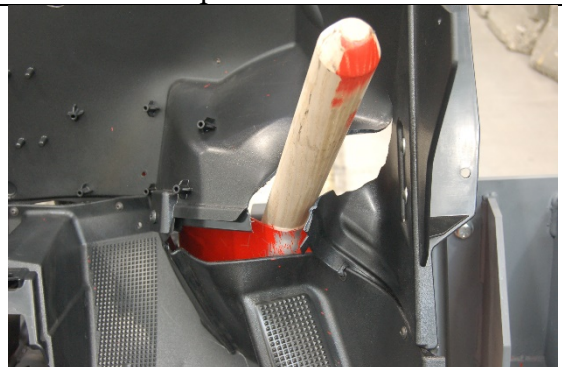
Table 11 (Continued): Vehicle A – Sled Impact Run #7 – Aftermarket Guard A4

The guard deformed and the guard material ripped near the top outer edge of the guard. None of the guard fasteners failed.

The stick rode up the guard, after significant guard deformation, and penetrated the firewall above the floorboard/firewall seam.

After penetrating the floorboard/firewall and becoming engaged with the C-Brace, the stick broke as the vehicle chassis moved past the fixture holding the base of the stick.

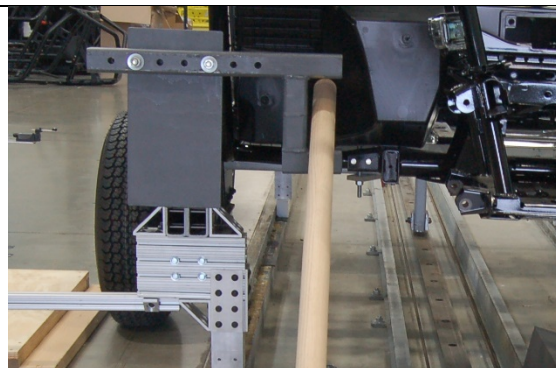
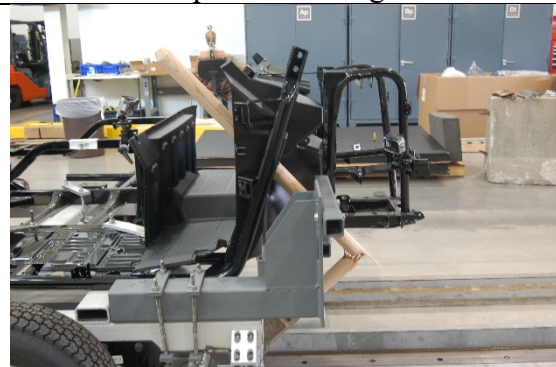
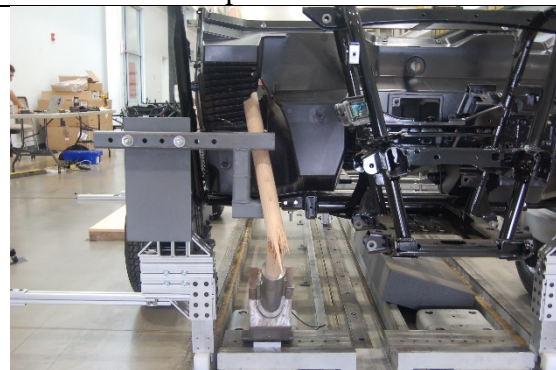
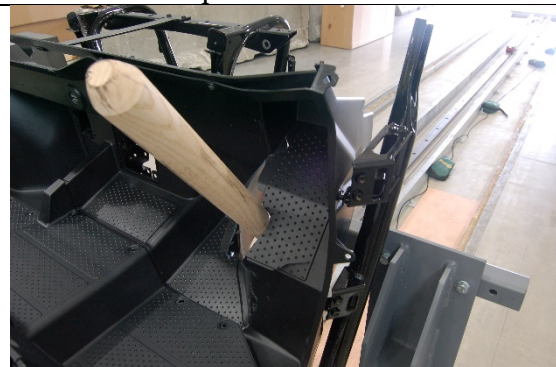
Complete stick penetration through floorboard/firewall.

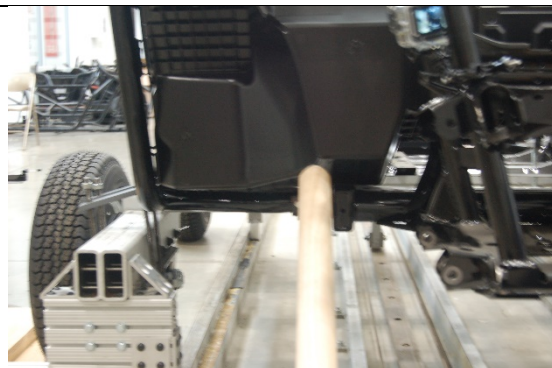
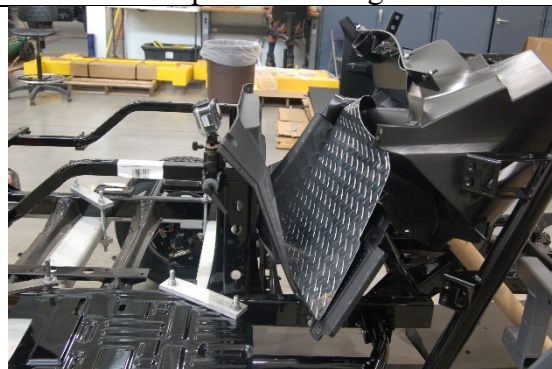
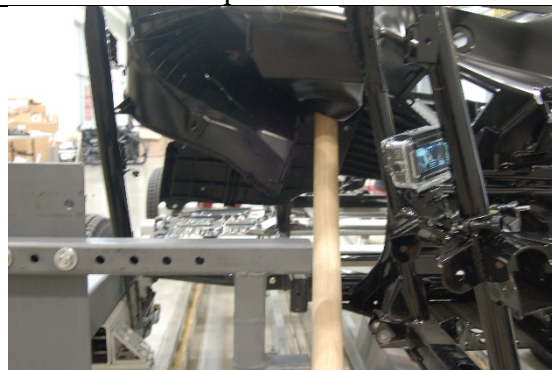
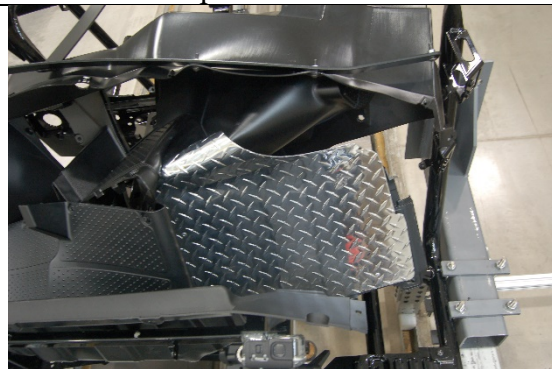
Table 13 (Continued): Vehicle B – Sled Impact Run #2 – Aftermarket Guard B1

One rivet connection of the guard failed, but

the two rivets nearest the impact did not fail.

The guard deflected about one inch more than floorboard.

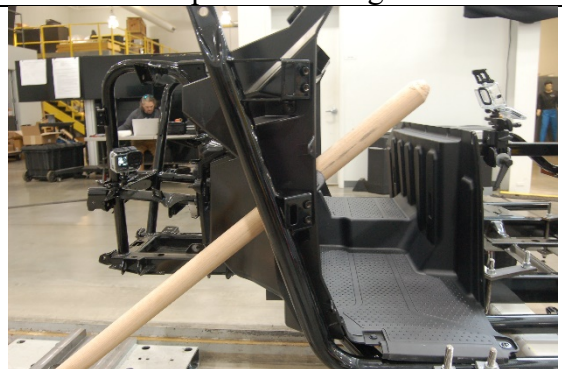
Table 15: Vehicle C – Sled Impact Run #1

Complete stick penetration through floorboard/firewall.

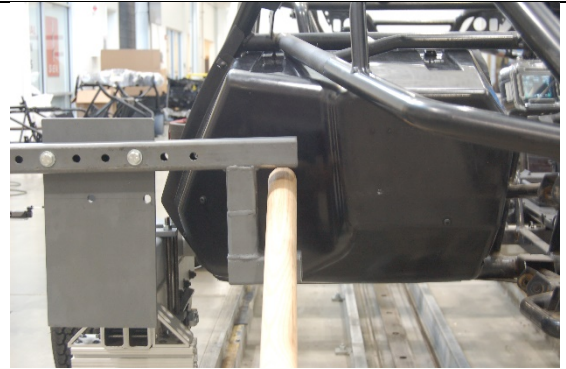
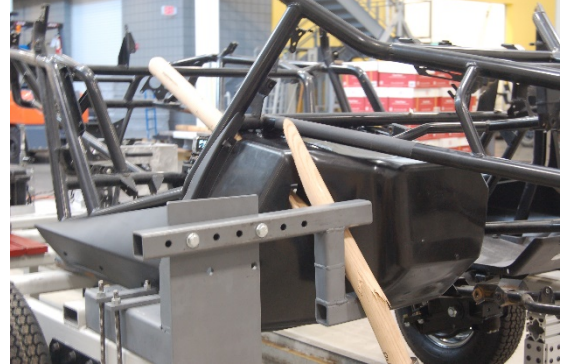
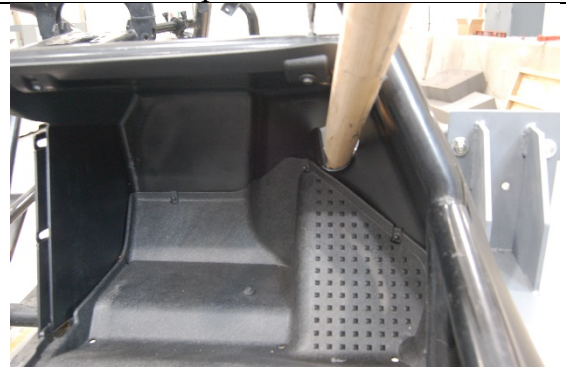
Table 16: Vehicle C – Sled Impact Run #2

A repeat run at 5 mph in the OEM condition was conducted on Vehicle C, and both runs resulted in full penetration through the OEM floor. The measured stick force was greater in Run 2 (Table 16) because the tip of the stick had greater engagement/impact with the upper frame member than it did in Run 1 (Table 15). This greater impact force also slowed the cart enough to prevent the stick from breaking during Run 2.

Complete stick penetration through firewall, above footwell section. Tip of stick contacted and went below upper frame member.

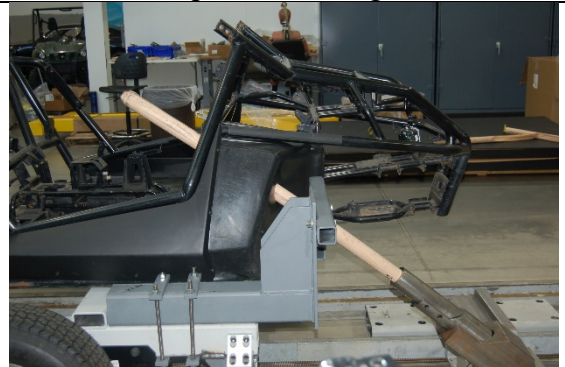
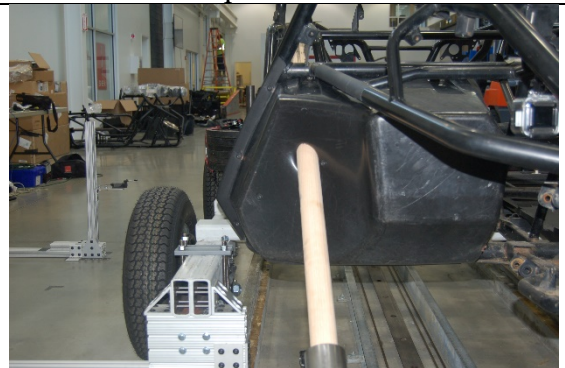
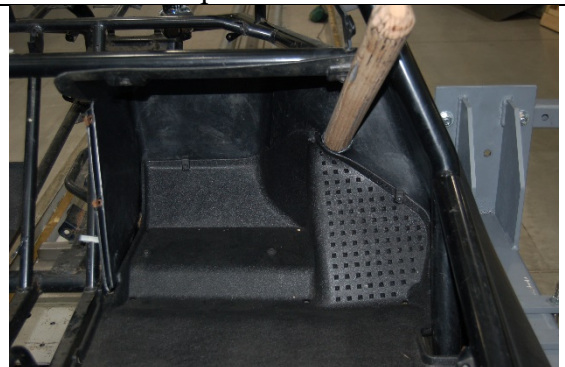
Complete stick penetration through firewall, above footwell section. Tip of stick contacted and went below upper frame member.

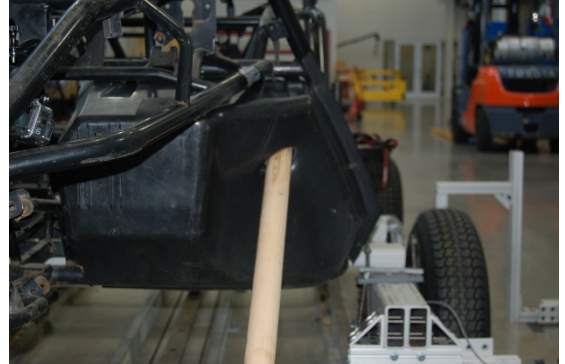
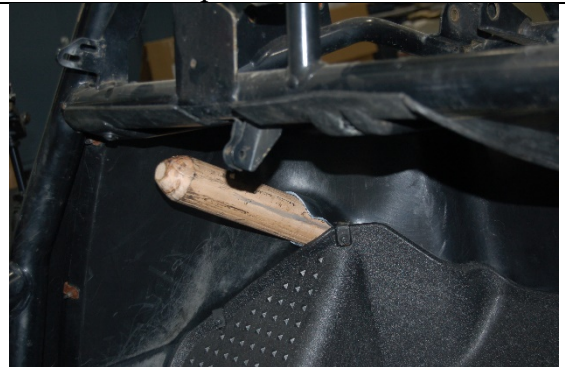
Complete stick penetration through firewall, above footwell section. Penetration not far enough for tip of stick to contact upper frame member.

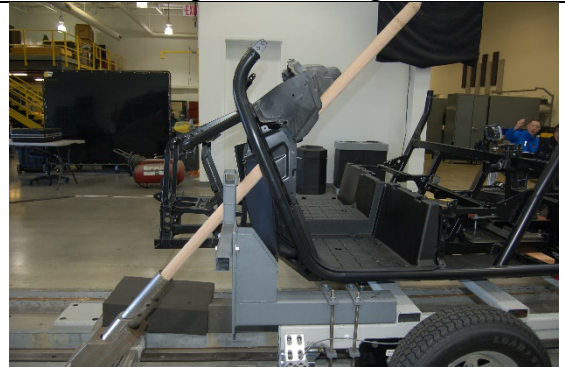
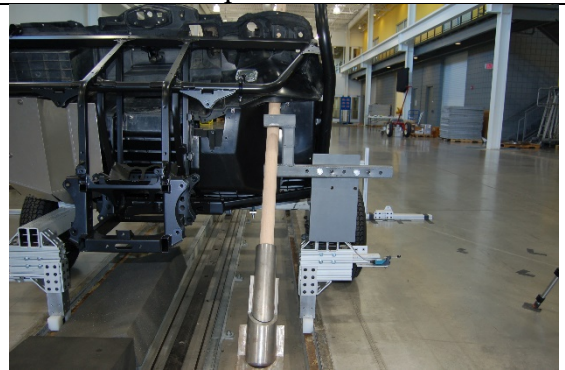
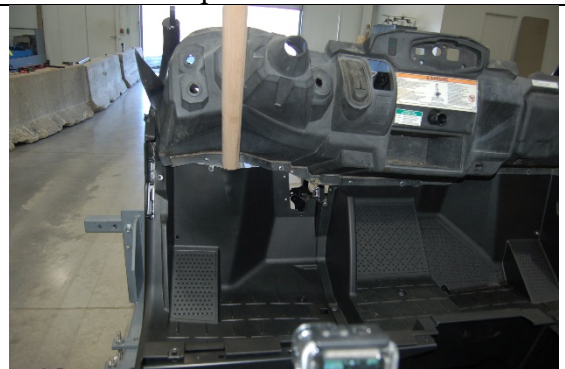
Complete stick penetration in seam where
firewall section meets dash section.

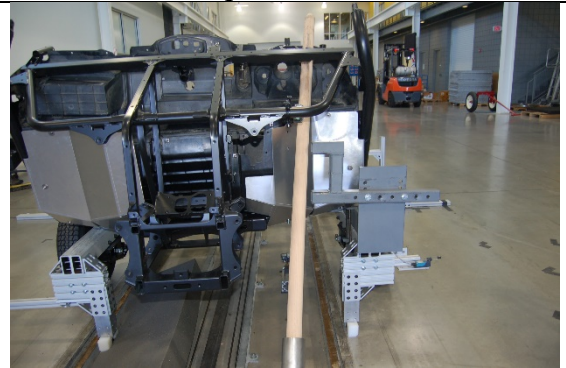
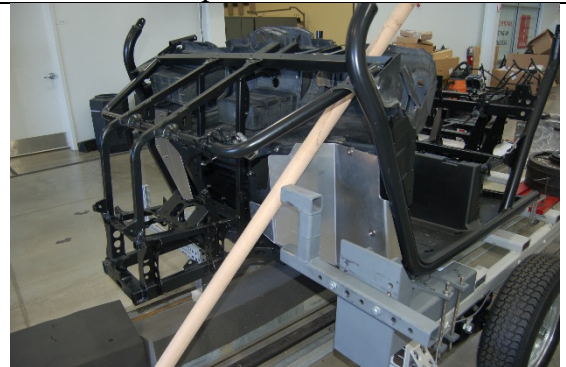
Complete stick penetration in the dashboard section, above firewall. The guard deflected about 5/8". The stick moved outside of the C-Brace and upward above guard and into the dashboard.

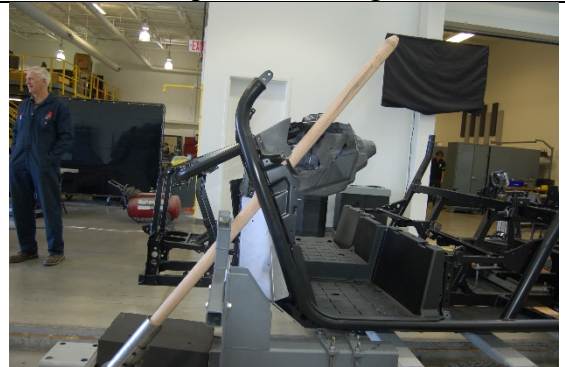
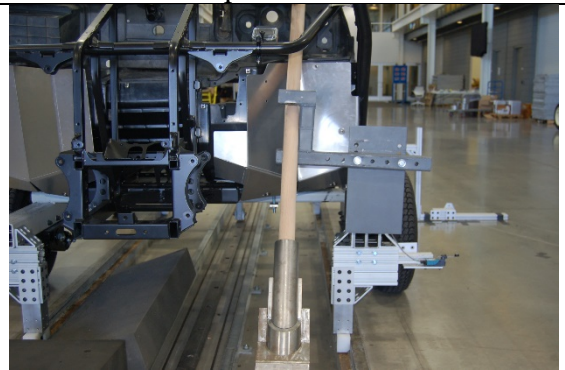
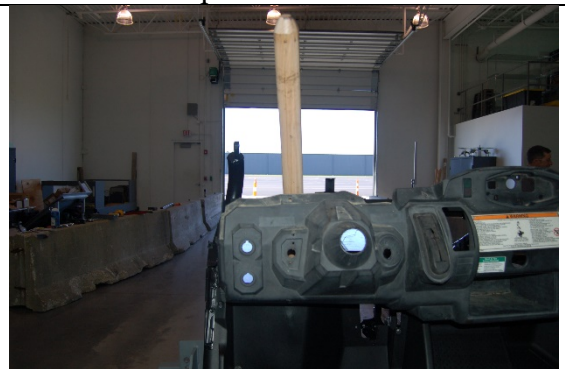
Complete stick penetration in the dashboard section, above firewall. The guard deflection was about 5/8". The stick remained in the C-Brace, and again moved upward above guard and into the dashboard.

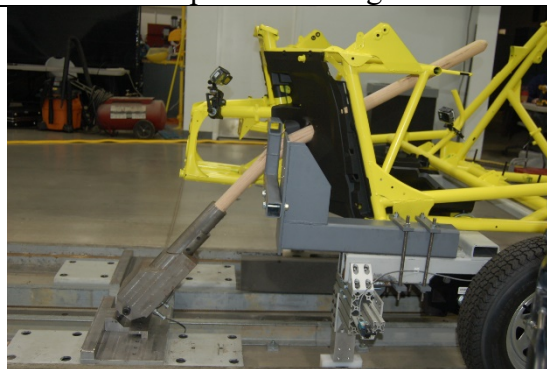
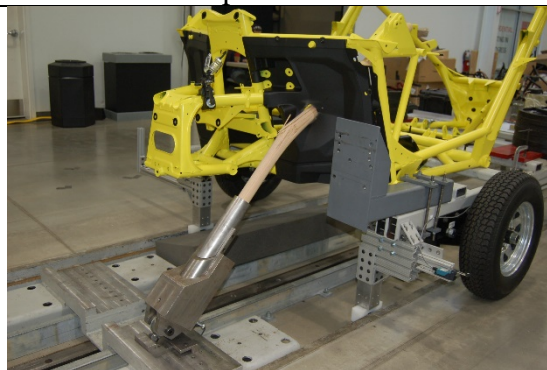
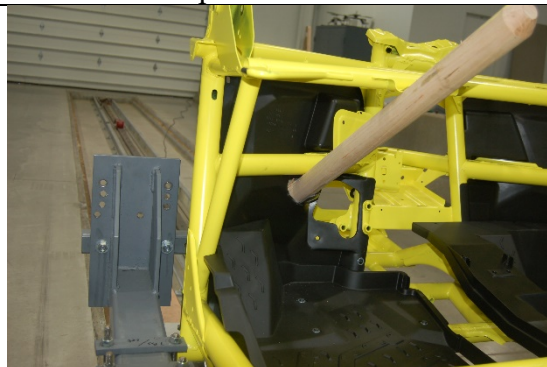
Complete stick penetration into firewall section.

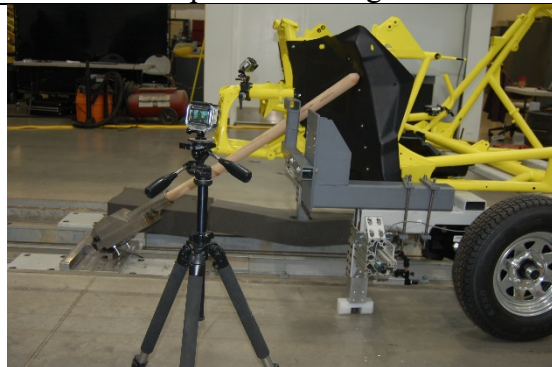
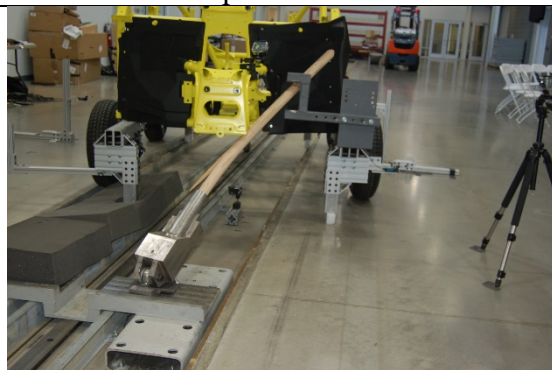
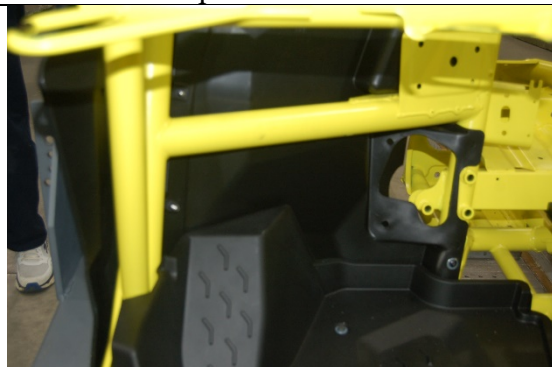
Small dent, about ½", in plastic guard. No damage to OEM firewall or fasteners.

During the impact, the sled cart with vehicle chassis lifted over 8" and yawed counterclockwise about 8 degrees.

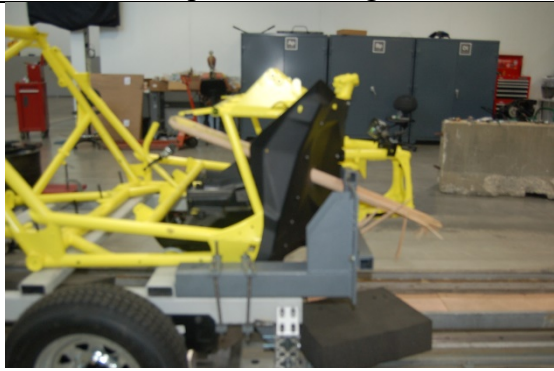
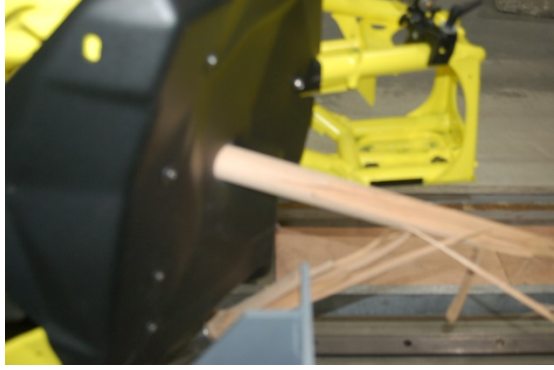
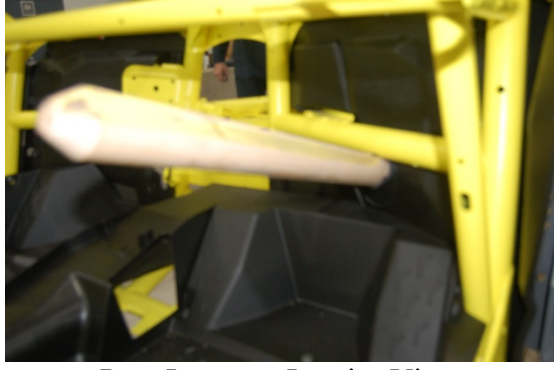
<p>Configuration: Aftermarket Guard E1</p> <p>Nominal Impact Speed: 10 mph</p> <p>Actual Impact Speed: ~10 mph (No Speed Data)</p> <p>Primary Impact Location: Stick aligned to impact center of the guard</p> <p>9" Above Bottom of Floorboard 13 ¾" Right of Vehicle Centerline</p> <p>Stick Length: 53"</p> <p>Stick Penetration: Yes</p> <p>Peak Force at Base of Stick: 9,392 lbs</p> <p>Run Outcome Narrative: Complete stick penetration through guard and OEM firewall section.</p>

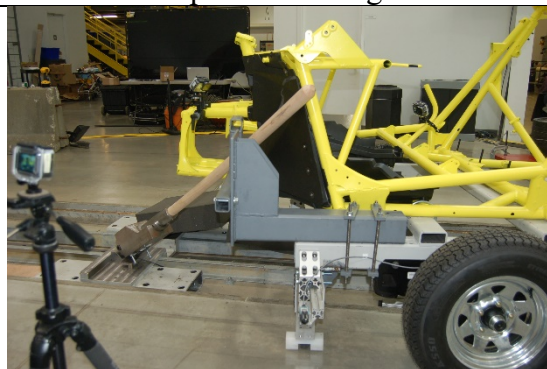
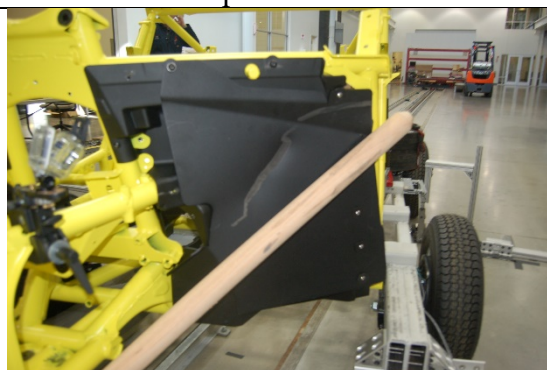
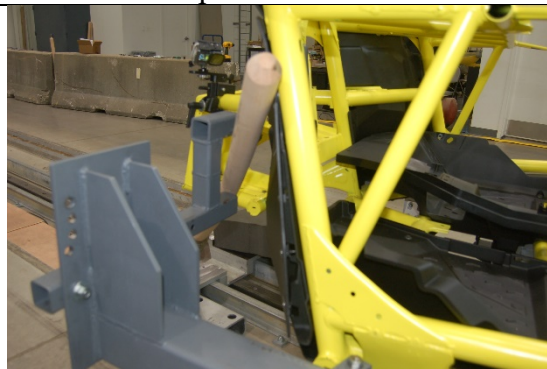
Indentation in guard of about one inch. No damage to OEM firewall or fasteners.

During the impact, the sled cart with vehicle chassis lifted over 8" and yawed counterclockwise about 9 degrees.

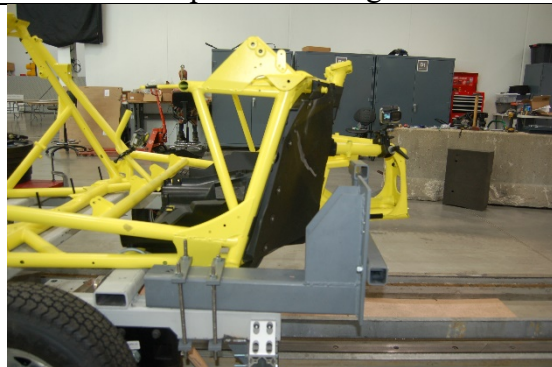
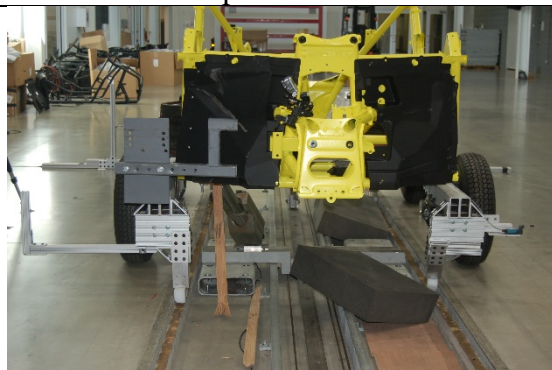
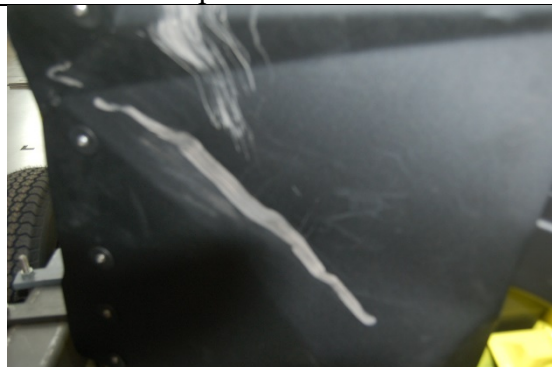
Stick shattered. Indentation in guard of about 1 3/16". The guard covered an area extending beyond the outside frame of the vehicle, and there was no failure of the guard material or guard fasteners. No damage to OEM firewall or fasteners.
