CPSC Staff Statement on the University of Northern Iowa (UNI)'s "Report for National Study of Public Playground Equipment and Surfacing"¹
October 2019

Final Report for CPSC on the National Study of Public Playground Equipment and Surfacing

February 2018

Heather Olsen, Ed.D., & Eric Kennedy, Ph.D.²³⁴
The National Program for Playground Safety
University of Northern Iowa

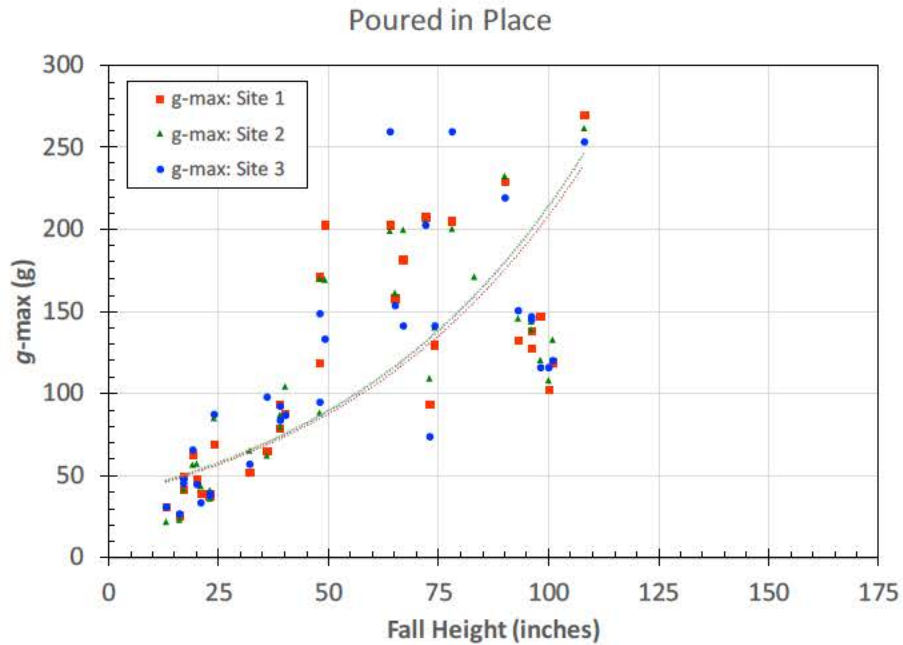
Figure 12: G-max vs. fall height for all test sites, at all test structures evaluated with a surface material indicated as poured-in-place unitary surfacing. Two outliers not depicted on Y-axis at 83 inches, 372 g and 429.5 g.

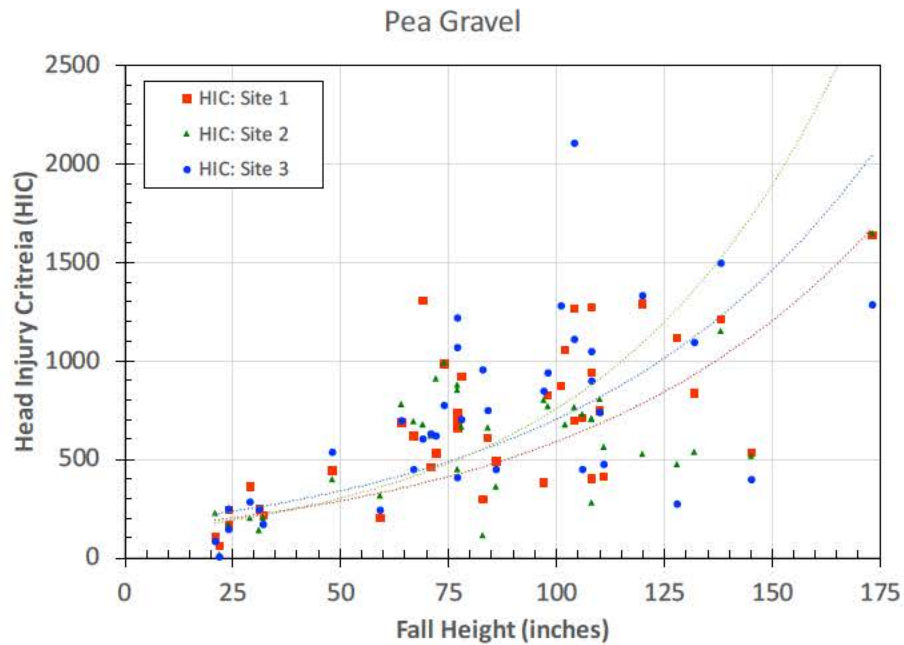
Figure 15. Head injury criteria (HIC) vs. fall height for all test sites, at all test structures evaluated with a surface material indicated as pea gravel. Single outlier not depicted on Y-axis at 108 inches, 6012.5 HIC. This may explain differing trend-lines.

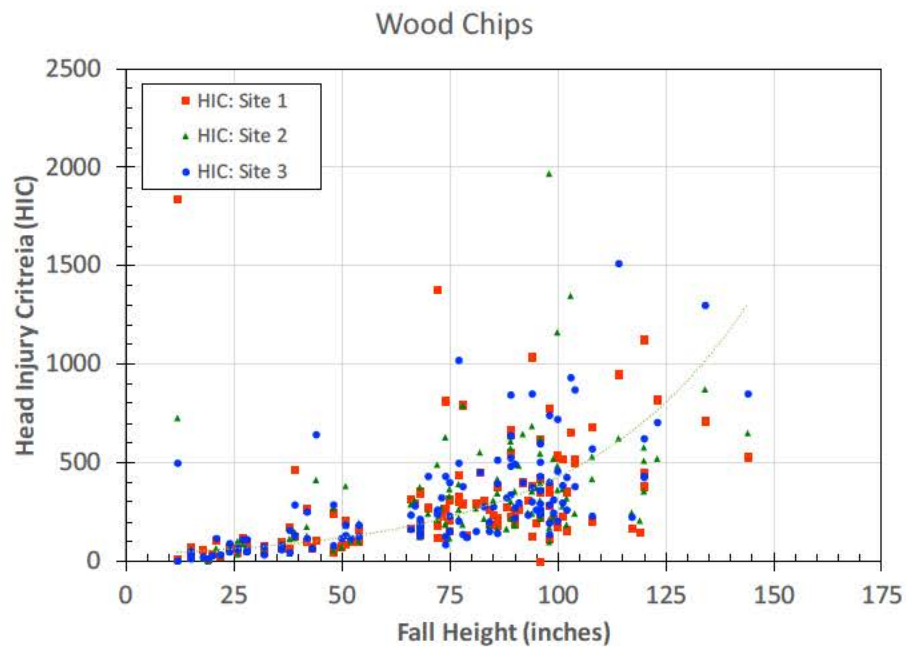
Figure 17. Head injury criteria (HIC) vs. fall height for all test sites, at all test structures evaluated with a surface material indicated as wood chips. Single outlier not depicted on Y-axis at 119 inches, 2519.5 HIC.

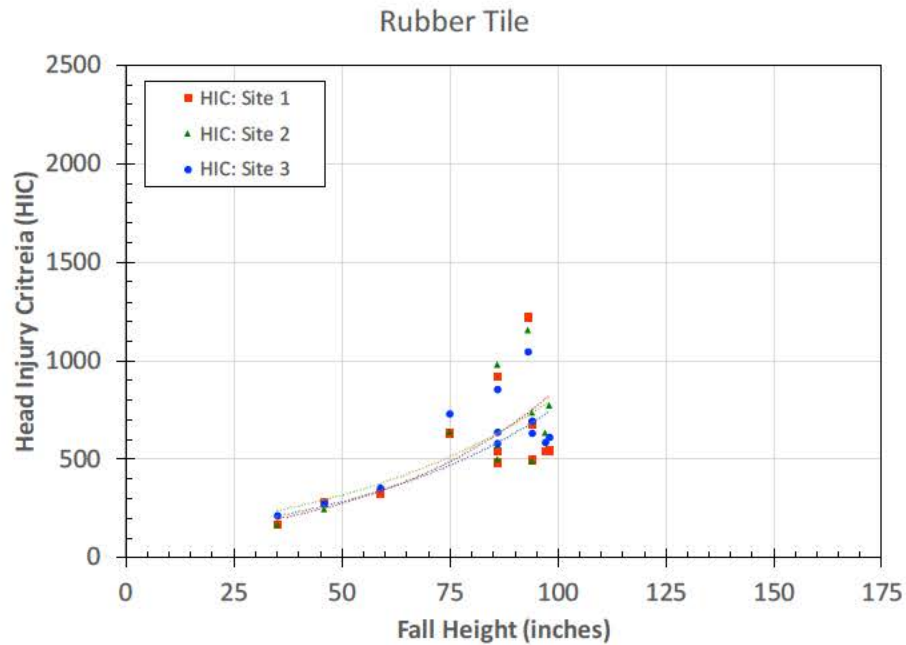
Figure 20. Head injury criteria (HIC) vs. fall height for all test sites, at all test structures evaluated with a surface material indicated as rubber tile. Notice the 9 data points above the trend lines. Playground 5 structures 2 and 3 compromise six of those data points (Fall Heights 86 and 93) while structure 1 includes the other two (Fall Height 75)

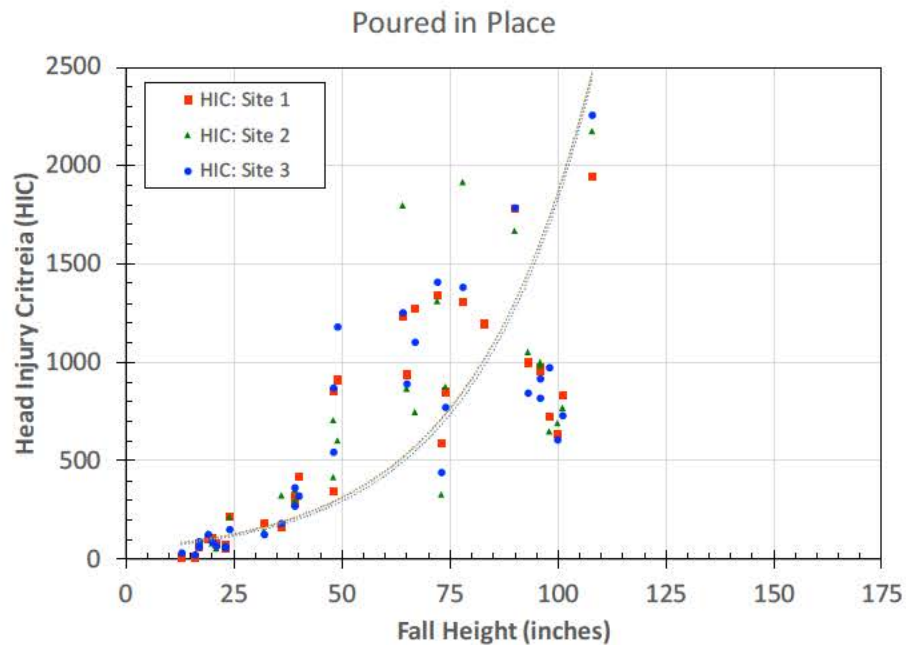
Figure 21. Head injury criteria (HIC) vs. fall height for all test sites, at all test structures evaluated with a surface material indicated as poured-in-place unitary surfacing. Two outliers not depicted on Y-axis at 83 inches, 3445.5 HIC and 4252.5 HIC.
