CPSC Staff Statement on the University of Northern Iowa (UNI)'s "Report for National Study of Public Playground Equipment and Surfacing"¹
October 2019

Final Report for CPSC on the National Study of Public Playground Equipment and Surfacing

February 2018

Heather Olsen, Ed.D., & Eric Kennedy, Ph.D.²³⁴
The National Program for Playground Safety
University of Northern Iowa

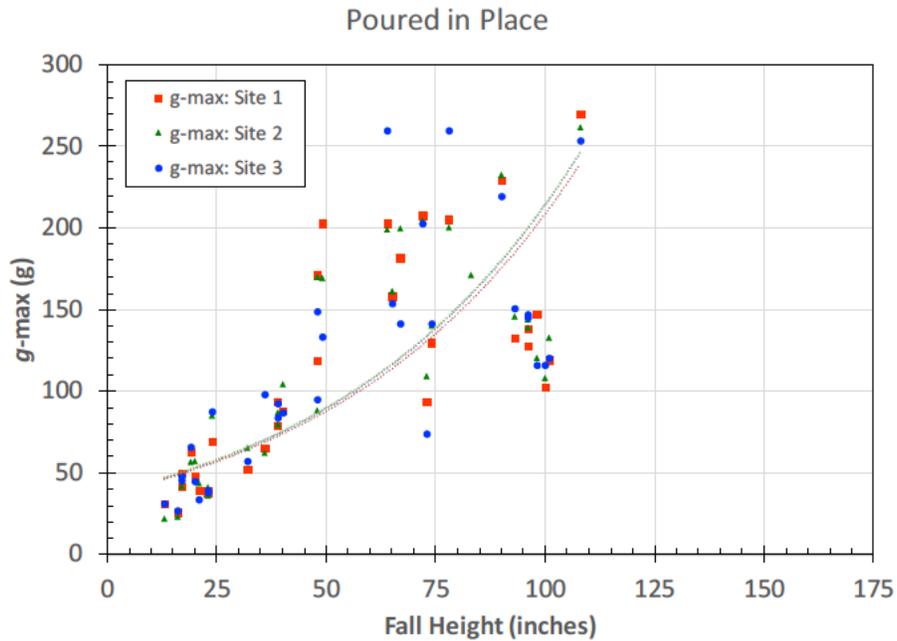
Figure 12: G-max vs. fall height for all test sites, at all test structures evaluated with a surface material indicated as poured-in-place unitary surfacing. Two outliers not depicted on Y-axis at 83 inches, 372 g and 429.5 g.

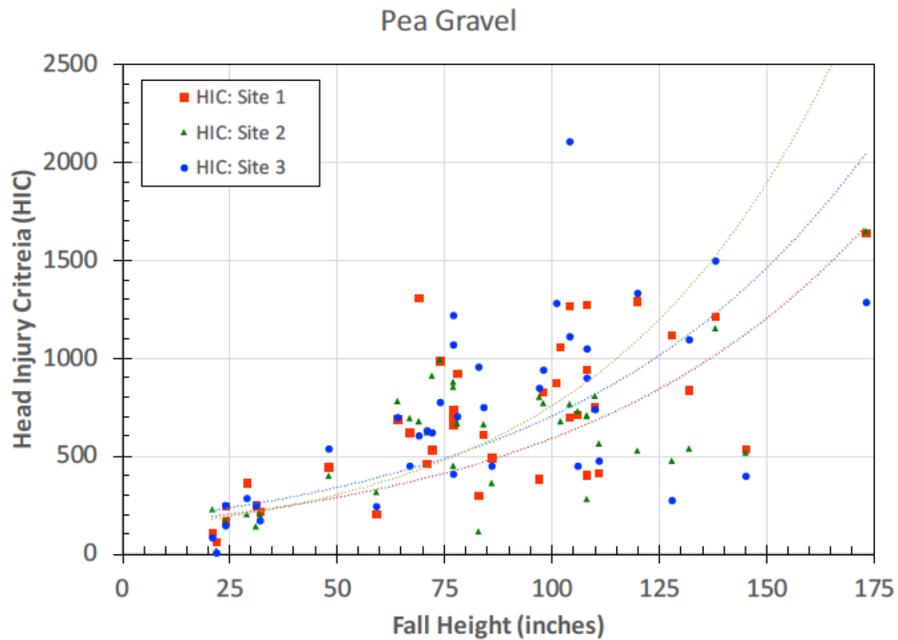
Figure 15. Head injury criteria (HIC) vs. fall height for all test sites, at all test structures evaluated with a surface material indicated as pea gravel. Single outlier not depicted on Y-axis at 108 inches, 6012.5 HIC. This may explain differing trend-lines.

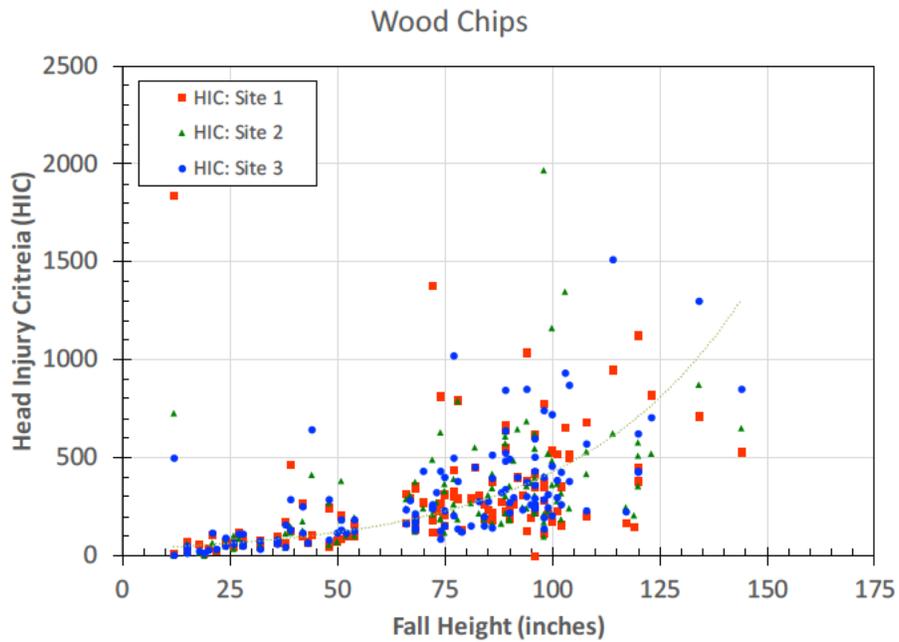
Figure 17. Head injury criteria (HIC) vs. fall height for all test sites, at all test structures evaluated with a surface material indicated as wood chips. Single outlier not depicted on Y-axis at 119 inches, 2519.5 HIC.

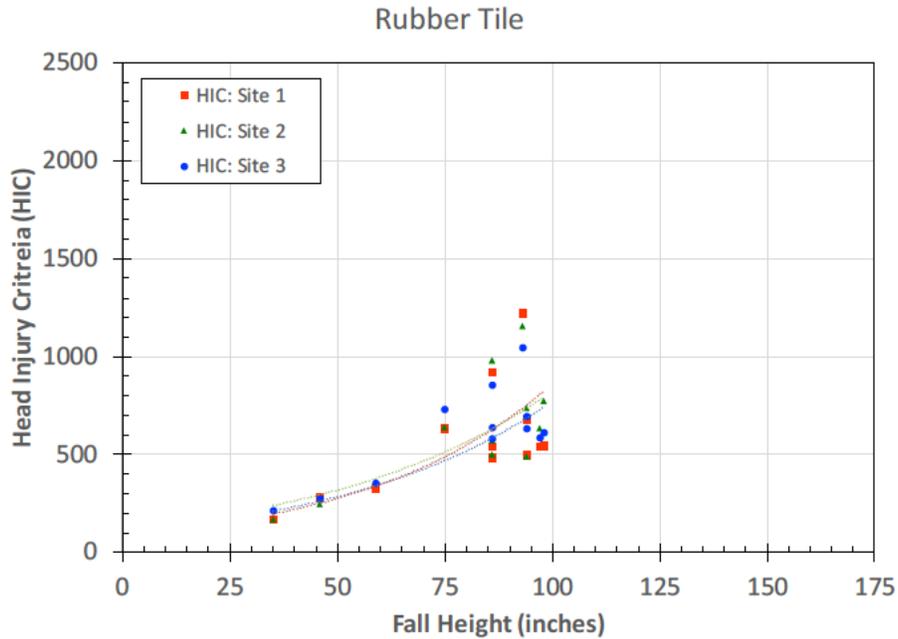
Figure 20. Head injury criteria (HIC) vs. fall height for all test sites, at all test structures evaluated with a surface material indicated as rubber tile. Notice the 9 data points above the trend lines. Playground 5 structures 2 and 3 comprise six of those data points (Fall Heights 86 and 93) while structure 1 includes the other two (Fall Height 75)

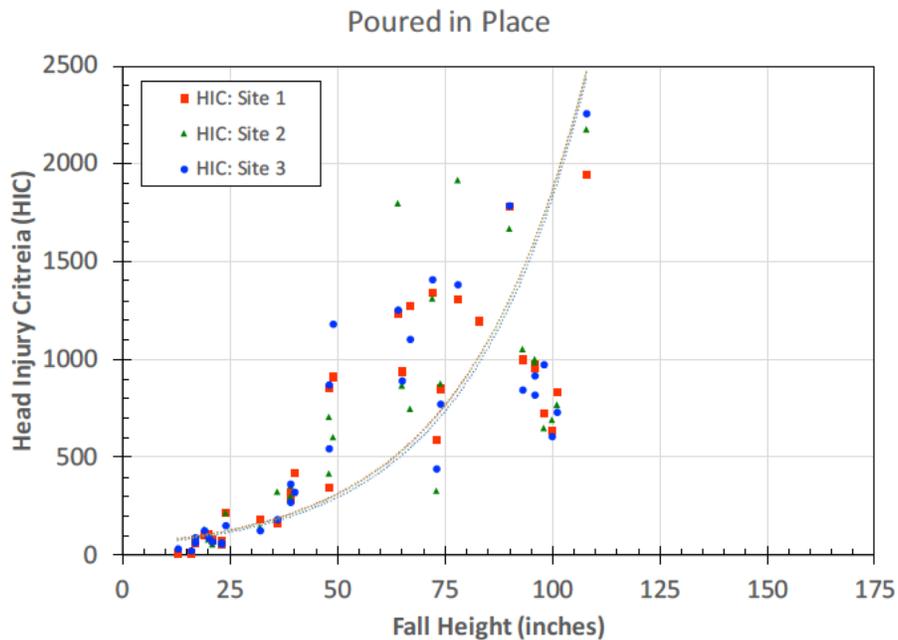
Figure 21. Head injury criteria (HIC) vs. fall height for all test sites, at all test structures evaluated with a surface material indicated as poured-in-place unitary surfacing. Two outliers not depicted on Y-axis at 83 inches, 3445.5 HIC and 4252.5 HIC.
