**U.S. CONSUMER PRODUCT SAFETY COMMISSION
DIRECTORATE FOR ENGINEERING SCIENCES**

**EVALUATION OF
ELECTRIC LIGHTING PRODUCTS**

December 2007

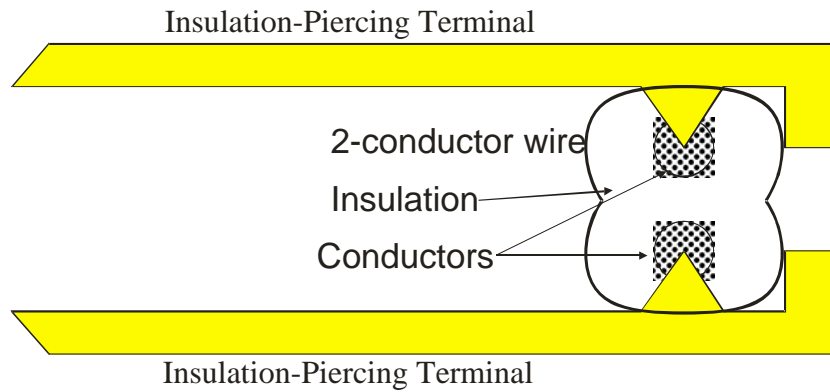
Figure 3. Insulation-Piercing Terminals for Lampholders

A ceiling-surface-mounted fixture typically consists of a metal housing/plate with three or four lampholders (candelabra-base or Edison-base) attached to it. The lampholders are connected to the input power via wiring, which ultimately is connected directly to the home's branch circuit wiring. In the samples examined by CPSC engineering staff, the lampholders were connected to the input power by sandwiching the wiring between two socket halves that included insulation-piercing electrical terminals directly onto the cord, as illustrated in Figure 3; the socket halves were then riveted together to mechanically hold the connection.

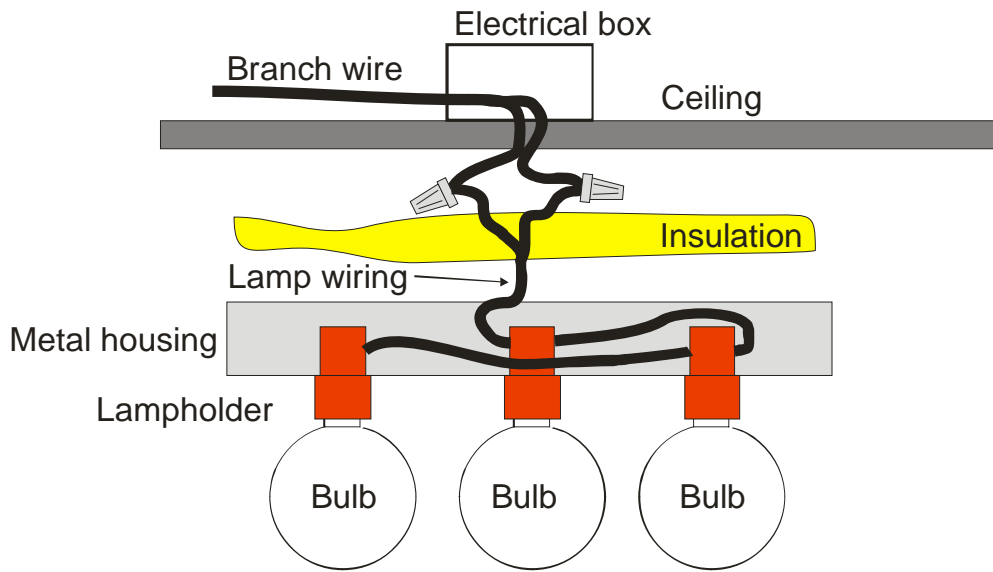
Figure 4. Typical Configuration for Ceiling-Surface-Mounted Lighting fixture

Depending on the depth of the housing (proximity of the bulbs to the ceiling), the fixture may include thermal insulation over the lampholders, which would help protect the ceiling from damage due to bulb heat, as illustrated in Figure 4.
