**Status Report on the Preliminary Analysis of HVAC, Gas
Distribution, and Fire Safety Equipment Installed in Homes with
Chinese Drywall**

U.S. Consumer Product Safety Commission

November 2009

**Interim Report on the Examination of Corrosion Damage in
Homes Constructed with Imported Wallboard
I. Examination of Samples Received September 28, 2009**

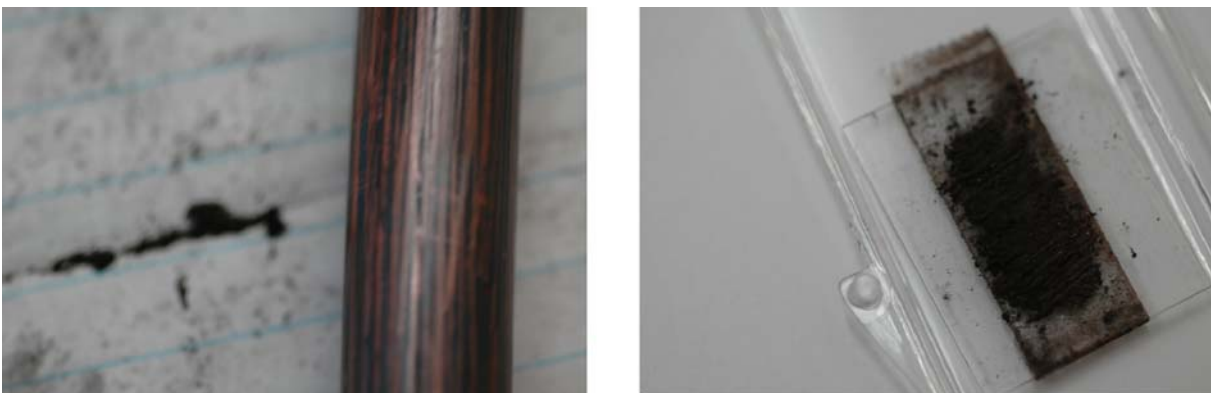
Figure 5 – Photographs of the scraped copper natural gas supply line and the slide holding the sample for X-ray diffraction.

The black substance observed on the surfaces of the copper components was identified by X-ray diffraction. This was accomplished by scraping the black substance from the surface of one of the sample of copper natural gas line tubing using a razor blade. The powder removed in this manner was accumulated on double stick tape and attached to a glass slide as shown in Figure 5. A powder diffraction pattern was then obtained from this sample of scrapings using Siemens D500 X-ray diffractometer with a $\text{Cu K}\alpha$ radiation source operated at 40 kV and 30 mA using a step size of 0.03 degrees, and a dwell time of 5 s.*
