# **Report on Study of Electrical Component Corrosion Related to Problem Drywall**

Division of Electrical Engineering  
Directorate for Engineering Sciences  
U.S. Consumer Product Safety Commission

March 2011

## **Report on Accelerated Corrosion Studies of Electrical Components**

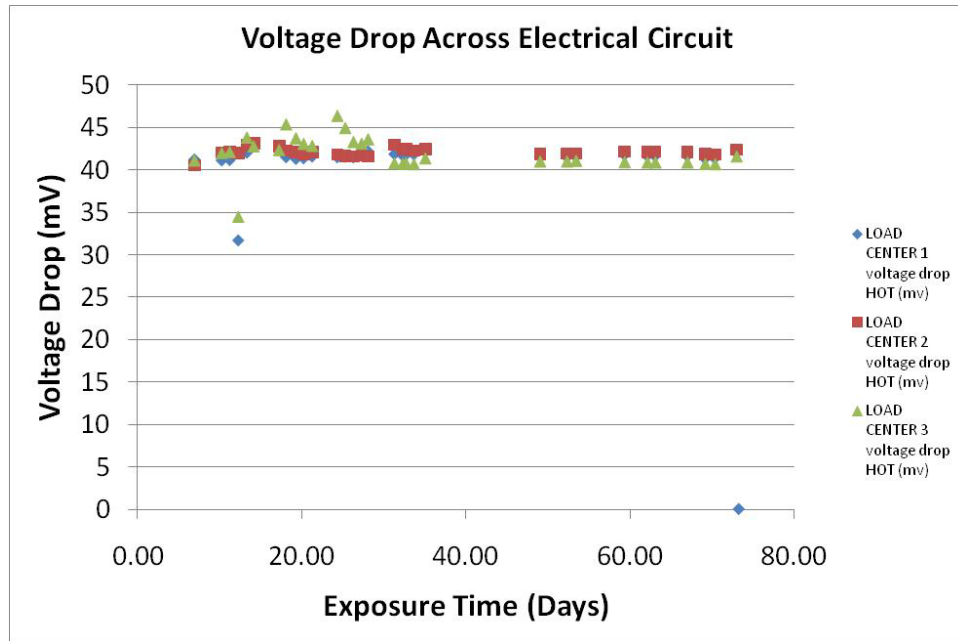
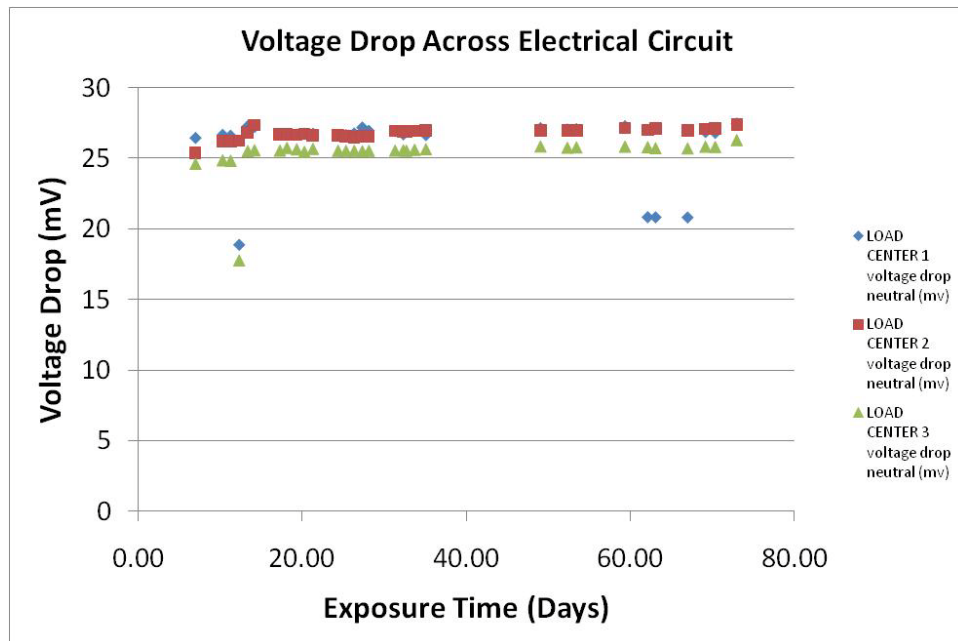
To determine if corrosion products on contacts could lead to resistive heating, measurement points were established to allow the voltage drop across the entire electrical circuit to be measured. Measurements were made several times a week and were taken while the circuit was activated under a 12 A load. Measurements were made with a Keithley 2000 multimeter. Dedicated test points were wired into the circuit (external to the exposure chamber) to allow measurement on a regular basis. Voltage drop data are shown in Figure 8 (hot leg) and Figure 9 (neutral leg). All three of the circuits exhibited essentially identical behavior. The hot leg of the circuit registered about 40 milli-volts and remained constant throughout the test. The neutral leg of the circuit registered about 25 milli-volts and remained constant. The difference is due likely to the smaller number of components with neutral wire connections (both switches and the standard circuit breaker used only hot wire connections). The small magnitude of the voltage drop suggests that resistive heating—due to the presence of corrosion products—should not be a concern.

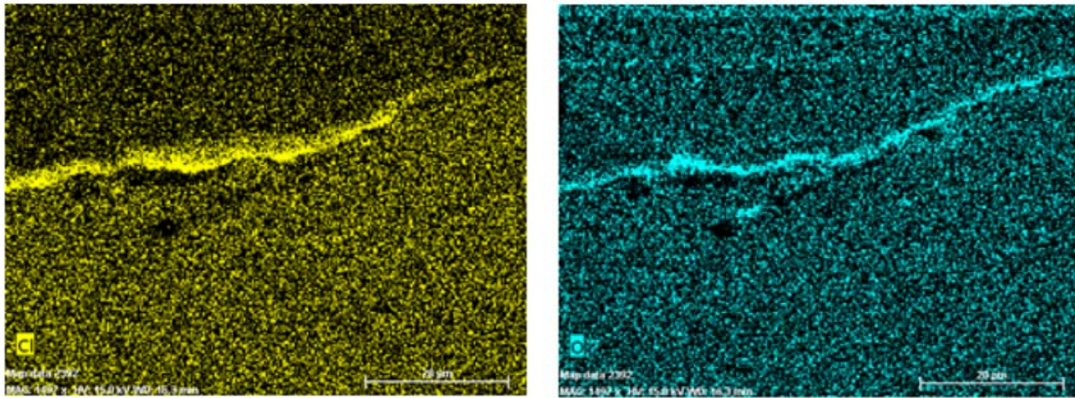
Figure 14. Elemental maps using EDS of HSP2, showing chloride (yellow), and oxygen (blue).

Figure 12 shows SEM images of a cross section of the hot screw plate from the rocker switch. Figure 13 and 14 present the elemental data obtained from EDS analysis of the cross section shown in Figure 12. In Figure 13A, a thin layer of corrosion product is visible on the surface of the contact plate. There is evidence of voids below the corrosion product layer, consistent with the sulfidation process. The elemental maps also show Cu and Zn (Figure 13C-D), elemental constituents of the substrate (brass). The sulfide layer is clearly visible on the surface. As seen in Figure 14, the corrosion product layer also contains chlorine and oxygen.

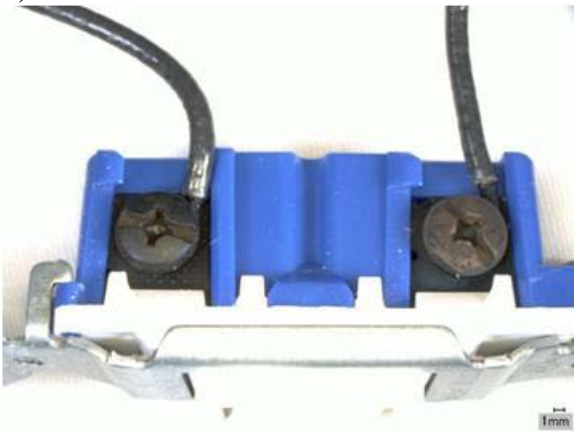
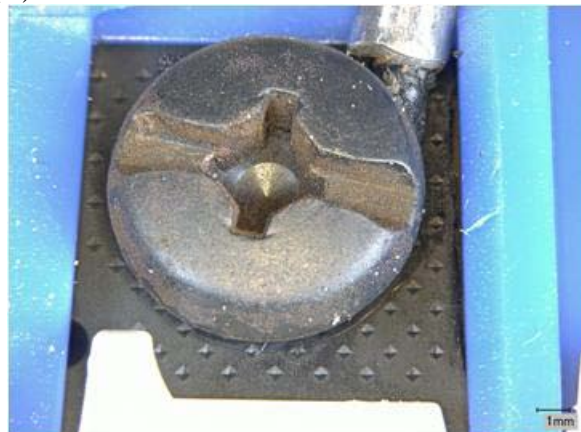
Figure 15. Photographs of toggle switch from Circuit 1.

Figure 15 shows optical images of the toggle switch from Circuit 1. The metal contact surfaces exhibit sulfidation. Tarnishing of the wires, contact plates, and screws was observed.

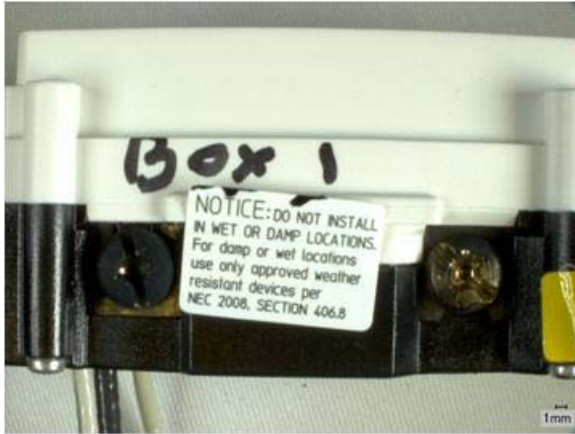
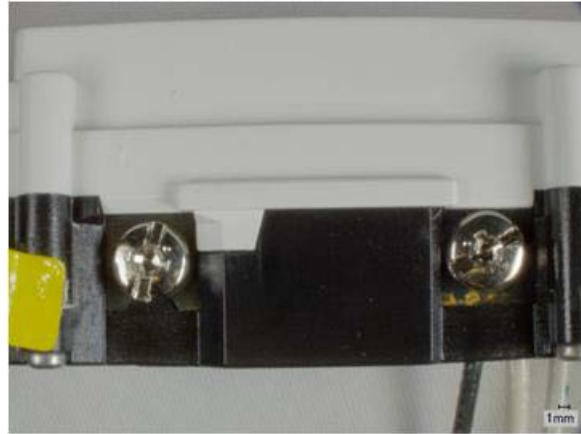
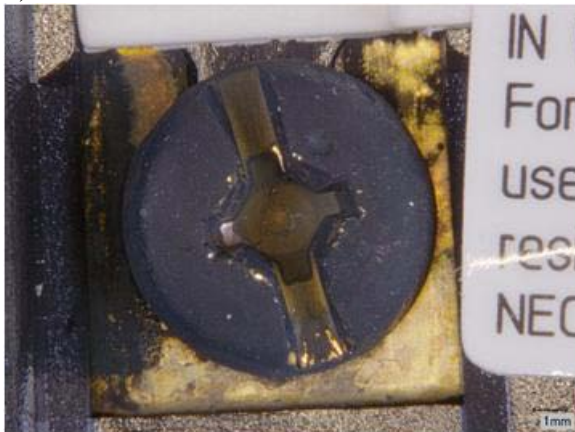
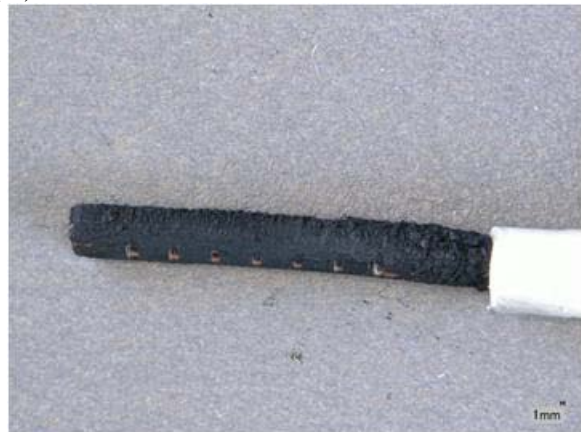
Figure 16. Photos of outside of GFCI receptacle from Circuit 1.

Optical images of the GFCI receptacle from Circuit 1 are given in Figure 16 and Figure 17. Corrosion of the contact surfaces was observed. The screws presented in (B) do not exhibit significant attack. Their color indicates that they are not brass screws, so they are considerably more resistant to sulfidation. Interestingly, the push-in wire (D) exhibits the presence of an extensive layer of corrosion product. This indicates that the gas permeated the receptacle itself. This is supported by the images in Figure 17, which show the insides of the GFCI. Clearly, the receptacle case presents little or no impediment to the corrosion gas. It is interesting to note that many of the internal components were corroded during this test (Figure 17D). Note that the majority of the contact is tarnished, with the real contact area (the spot near the center) exhibiting considerably less corrosion. During the test, one of the load lamps arced, resulting in tripping of

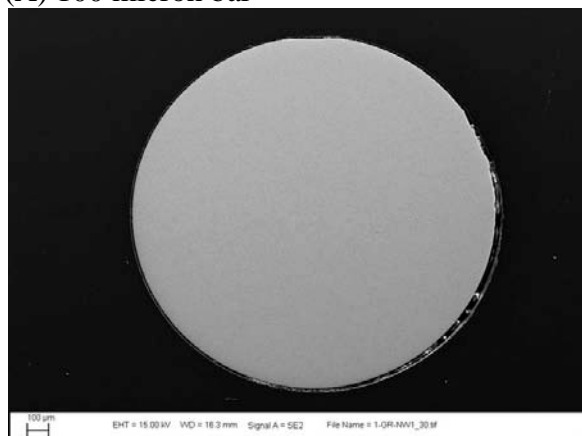
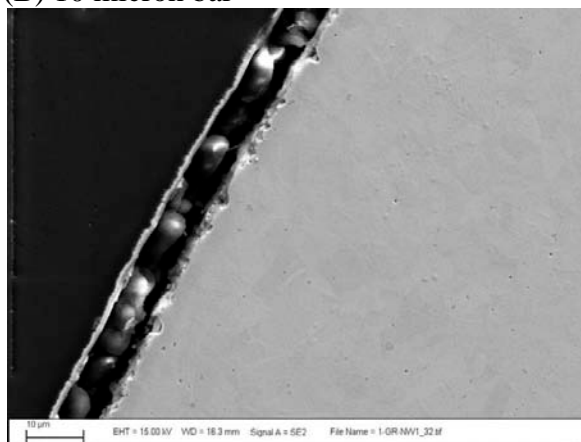
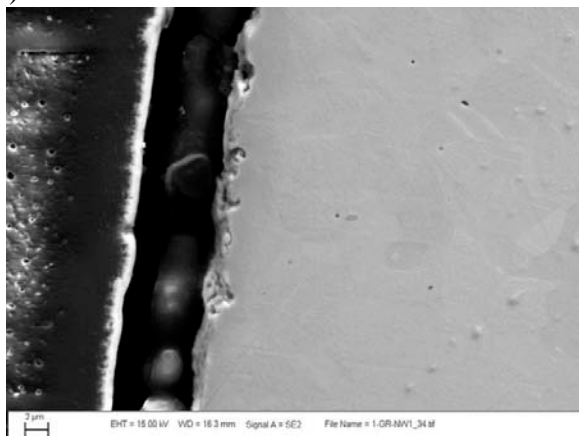
Figure 18. SEM images of cross section of neutral wire 1-GR-NW1.

The neutral wire from the GFCI receptacle was cross sectioned for analysis. The SEM images are shown in Figure 18. A thin corrosion product layer can be seen covering the wire surface. A very conservative estimate of the decrease in cross section of the wire can be calculated based on the SEM images. As given in Table 2, the corrosion product thickness was 11 microns. If we assume that the thickness is uniform, and that the corrosion product thickness equals the loss of metal, the cross sectional area of the wire at the conclusion of the test is 98% of the original cross section. In reality, the area decrease is considerably less (the corrosion product thickness is less than the thickness of lost). Thus, attack of the wire did not result in a significant decrease in cross sectional area and does not affect the current carrying capabilities of the wire.

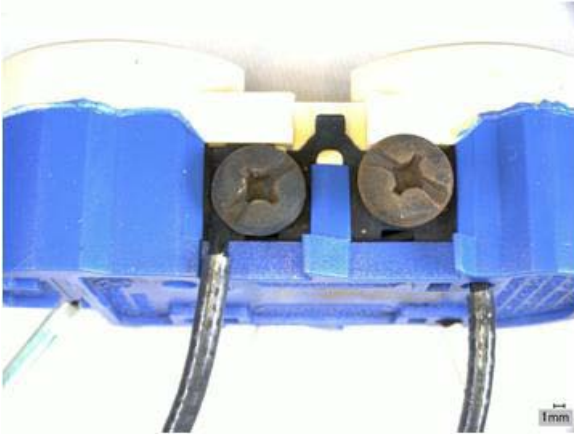
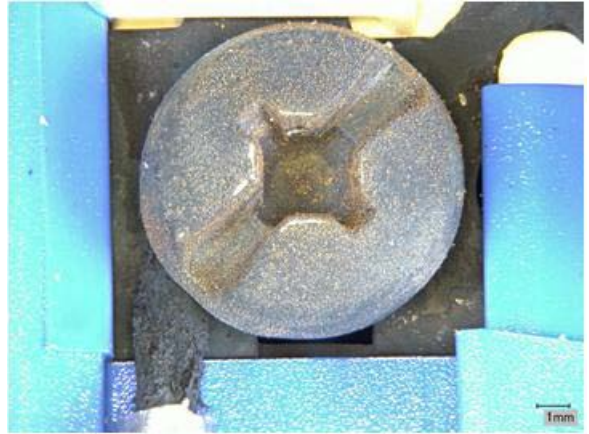
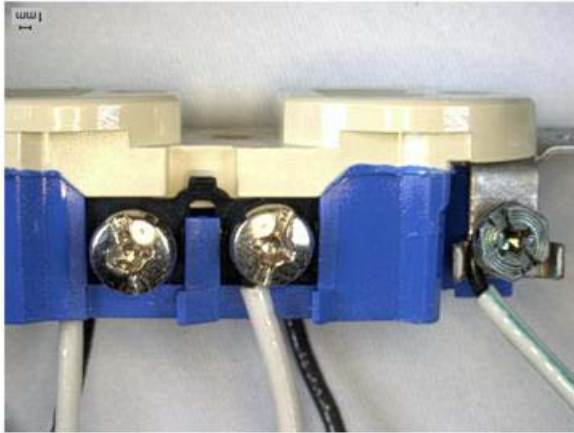
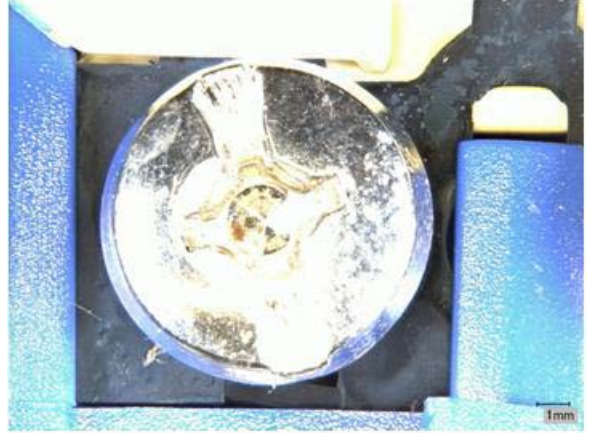
Figure 19. Optical photographs of receptacle from Circuit 1. The image in (A) shows the side view of hot wires; (B) hot screw and contact plate; (C) side view of neutral wires; and (D) neutral screw and contact plate.

Analysis of the receptacle from Circuit 1 included optical images and SEM analysis of the hot wire. Optical images are presented in Figure 19 and Figure 20. They show corrosion of the Cu base materials. Very little attack of the neutral screws or the ground screw was observed. The wires exhibited significant attack, but were essentially untouched in two locations: where the wire was in intimate contact with screws, and where the wire contacted the pressure plate.

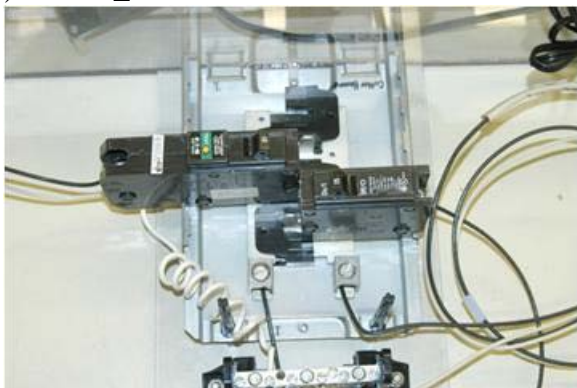
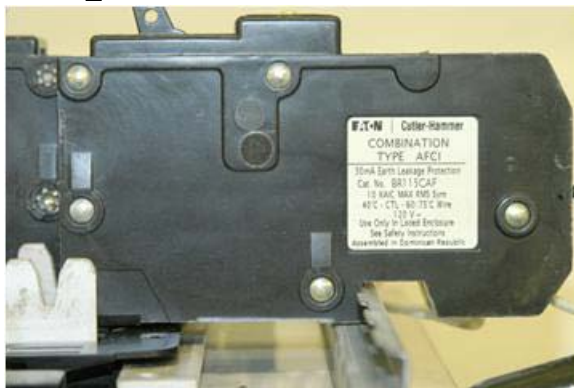
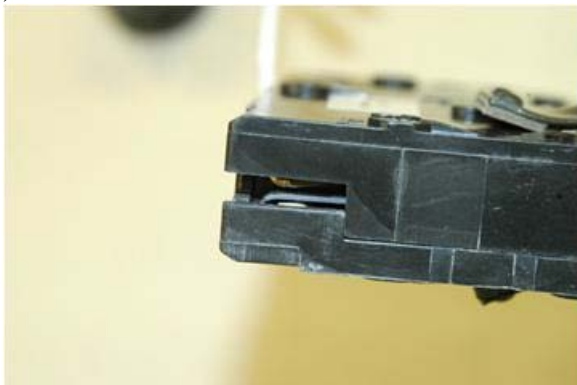
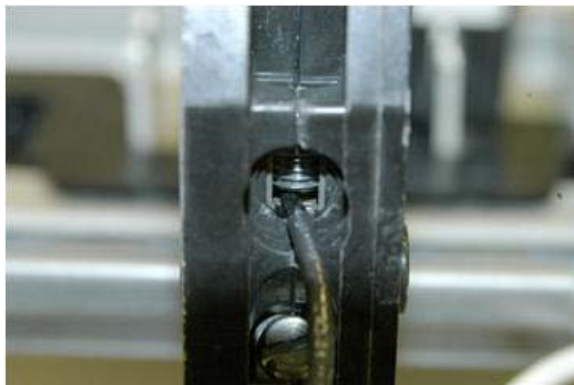
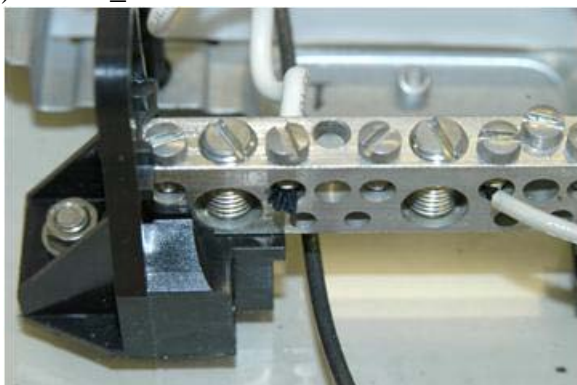
Figure 24. Optical images of the load center and AFCI for Circuit 1.

Figure 24 shows optical images of the AFCI from Circuit 1. The output from the standard circuit breaker provides the input to the AFCI. In addition, the neutral feed is connected to the neutral input, and the neutral sense wire is connected to the load center bus. Sulfidation of the contact surfaces can be seen. Both the neutral and hot wires exhibit corrosion, as well as the stranded neutral sense wire (where it is connected to the load center bus—lower left image).

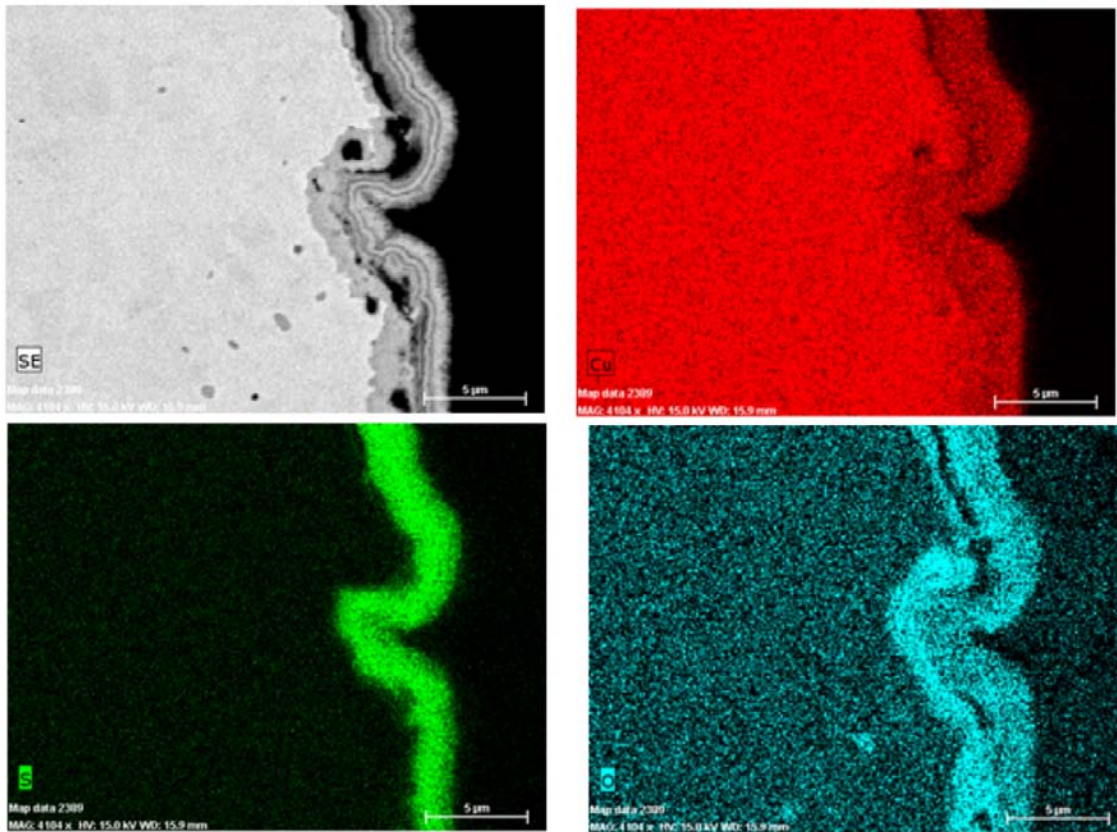
Figure 27. Elemental maps taken on cross section of the neutral wire from the arc-fault circuit breaker from Circuit 1. The image at the top left is an SEM image of the area being analyzed. The elemental maps for Cu (red), S (green), and oxygen (blue) are shown.

Elemental maps for the neutral wire are shown in Figure 26 and Figure 27. A continuous sulfide film can be seen, with subsurface attack of the base metal which is typical of copper sulfidation reactions. In the void formed in the base metal, oxidation has occurred, filling the cavity with copper oxide and/or copper sulfate.

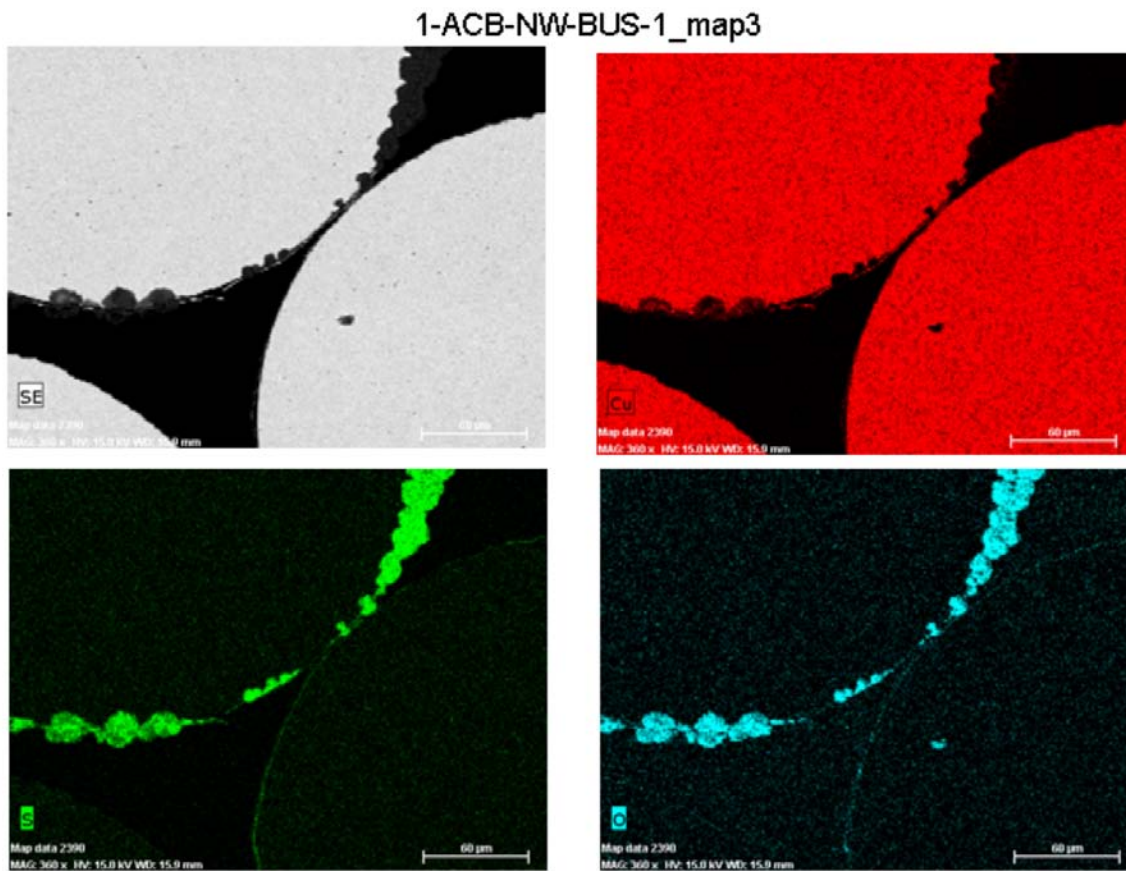
Figure 28. Elemental maps taken on cross section of the neutral wire from the arc-fault circuit breaker from Circuit 1. The image on the left is an SEM image of the area being analyzed. The elemental maps for Cu (red), S (green), and oxygen (blue) are shown.

Figure 28 shows elemental maps taken on the stranded wire from the AFCI that was attached to the load center bus. All of the strands of wire are covered with a sulfide layer.

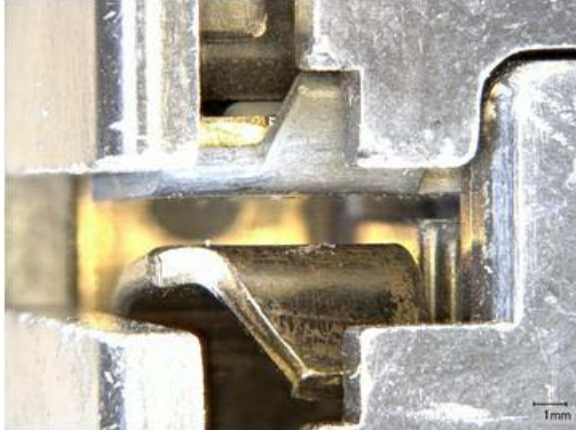
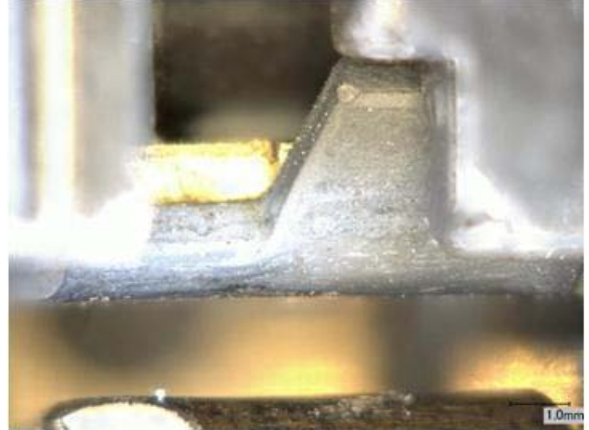
Figure 29. Optical images of the contacts in the standard circuit breaker in Circuit 1.

Figure 29 shows optical images of the contact surfaces of the standard circuit breaker from Circuit 1. Corrosion of the upper contact is visible. The lower contact appears to be plated, or constructed of a different material. It did not exhibit extensive corrosion.

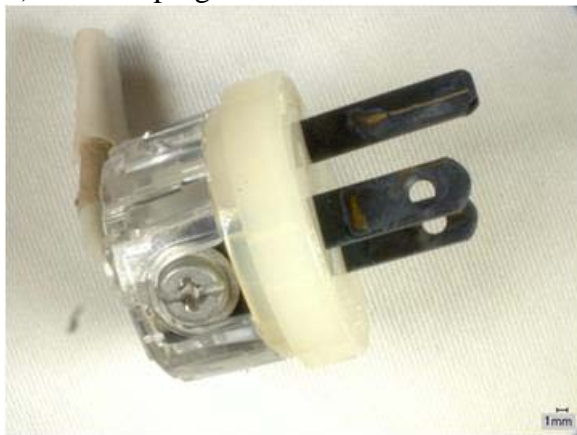
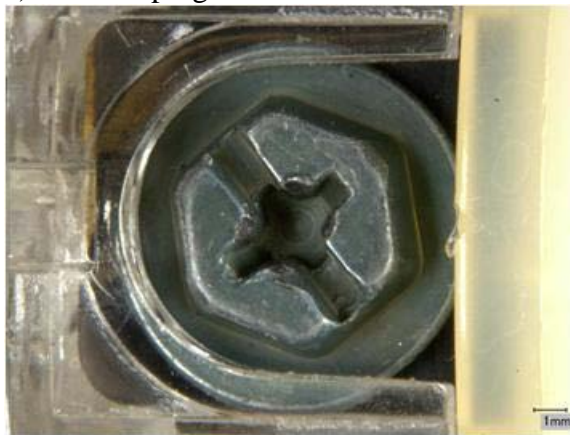
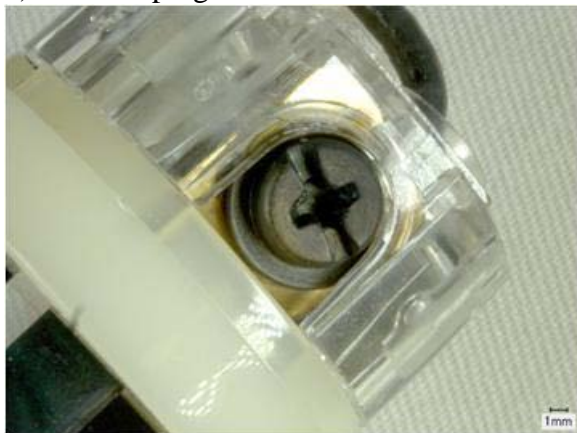
Figure 30 shows images of the plug used to connect the standard receptacle to the GFCI receptacle in Circuit 1. Note that the contact surfaces exhibit corrosion, even when inserted into the socket. Also, note that there are areas of contact that prevented or reduced the attack of the base metal.

Figure 30. Optical images of the plug used to connect the standard receptacle to the GFCI receptacle in Circuit 1. The prongs and screws are blackened relative to those on a new, as-received, unexposed plug.

Corrosion product was scraped from the “hot” prong of the plug and analyzed by XRD, and an *in situ* spot was analyzed by  $\mu$ XRD. These tests detected that the base metal is a copper-zinc alloy and revealed the presence of a covellite ( $\text{CuS}$ ) copper sulfide phase. Additional phases detected only by XRD include: copper sulfate hydroxide hydrate and copper zinc sulfate hydroxide hydrate (Ktenasite), whereas, only cuprite  $\text{Cu}_2\text{O}$  was detected by  $\mu$ XRD. Lack of full cross-validation of XRD and  $\mu$ XRD is expected due to the differences in counting statistics and sampling area. The  $\mu$ XRD spectrum is shown in Figure 31 and illustrates the peaks attributable to the covellite, cuprite, and copper-zinc alloy. The figure is also labeled with the approximate locations where a digenite copper sulfide phase would be detected.

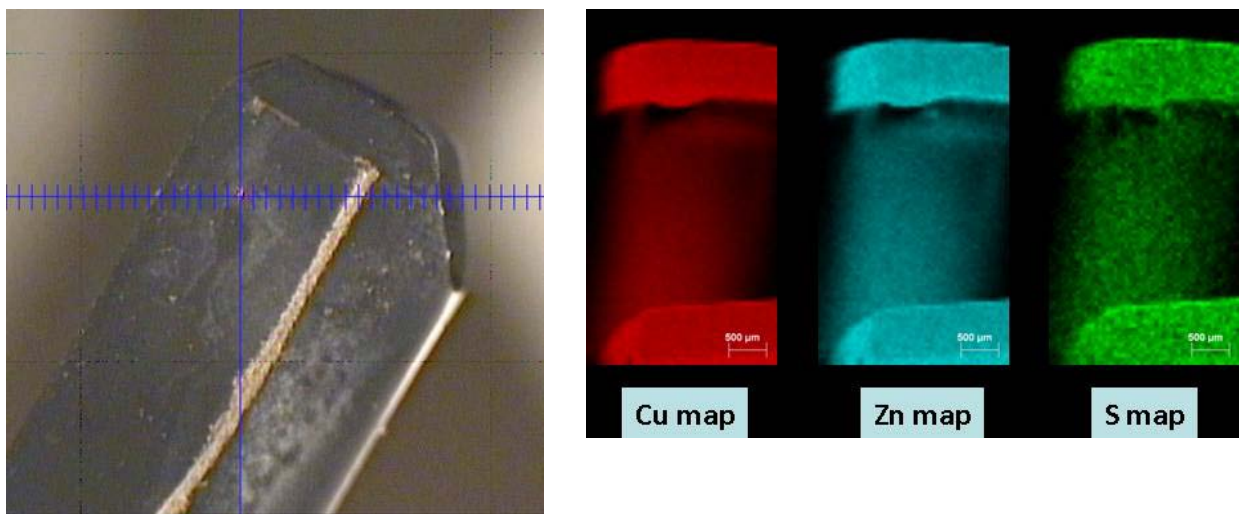
A copper-zinc alloy was detected for the ground prong of the plug by XRF analysis, and the elemental map, Figure 32, shows that the sulfur coverage is uniform within the tested length (approximately 2.5 mm) near the prong end.

Figure 32. Photo of one side of ground prong and XRF element maps of ground prong of grounded plug. XRF images taken “end-on” of full prong.

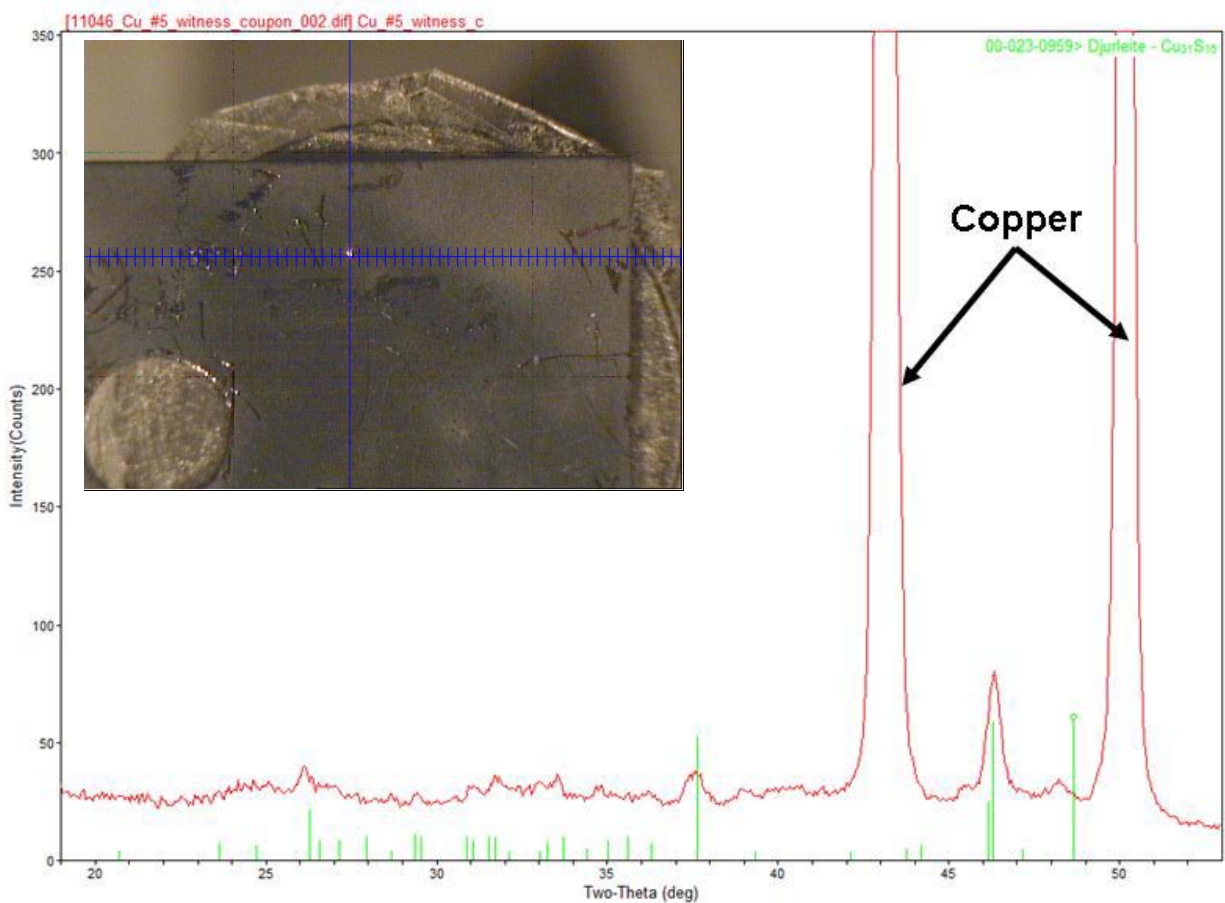
XRD of scraped powder and *in situ*  $\mu$ XRD both detected the copper sulfide phase known as “djurleite” ( $\text{Cu}_{31}\text{S}_{16}$ ) as the predominant corrosion product observed on copper witness coupon No. 5. Data for the  $\mu$ XRD, along with the image indicating the location of the analysis, are shown in Figure 33. The image shows the copper witness coupon (which has a small hole for mounting, which was not used in these tests) on top of the metal instrument sample holder. The grey to bluish-black appearance of the sample is consistent with the appearance of djurleite. Both XRD and  $\mu$ XRD techniques verify also that the witness coupon is pure copper.

Figure 33. Video image (inset) showing location of  $\mu$ XRD analysis and  $\mu$ XRD data for witness coupon No. 5, showing labeled copper and djurleite peaks (green).

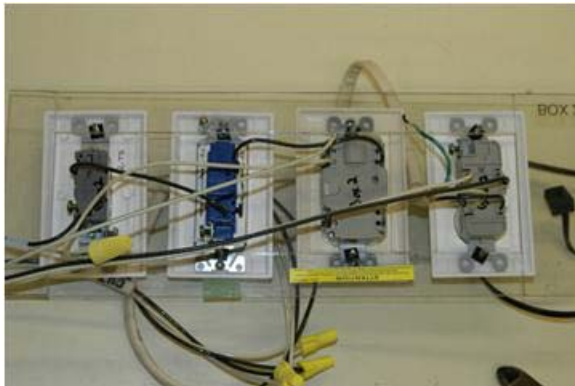
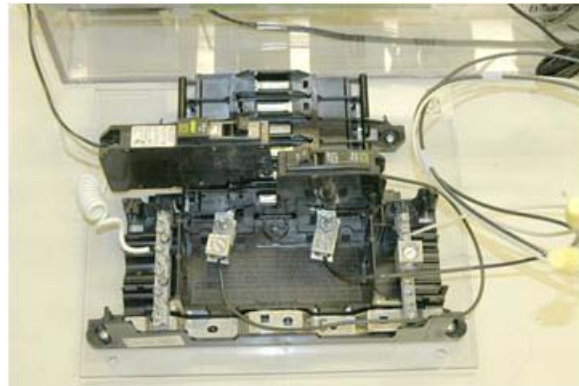
Figure 34 shows optical images of the load center and the back side of the components for Circuit 2. Parts from the rocker switch and the GFCI receptacle were selected for cross section SEM and X-Ray analysis (see Table 5).

Figure 34. Photographs of the electrical components tested in Circuit 2. The view from the bottom (left image) shows how the system was wired electrically. The image on the right shows the load center.

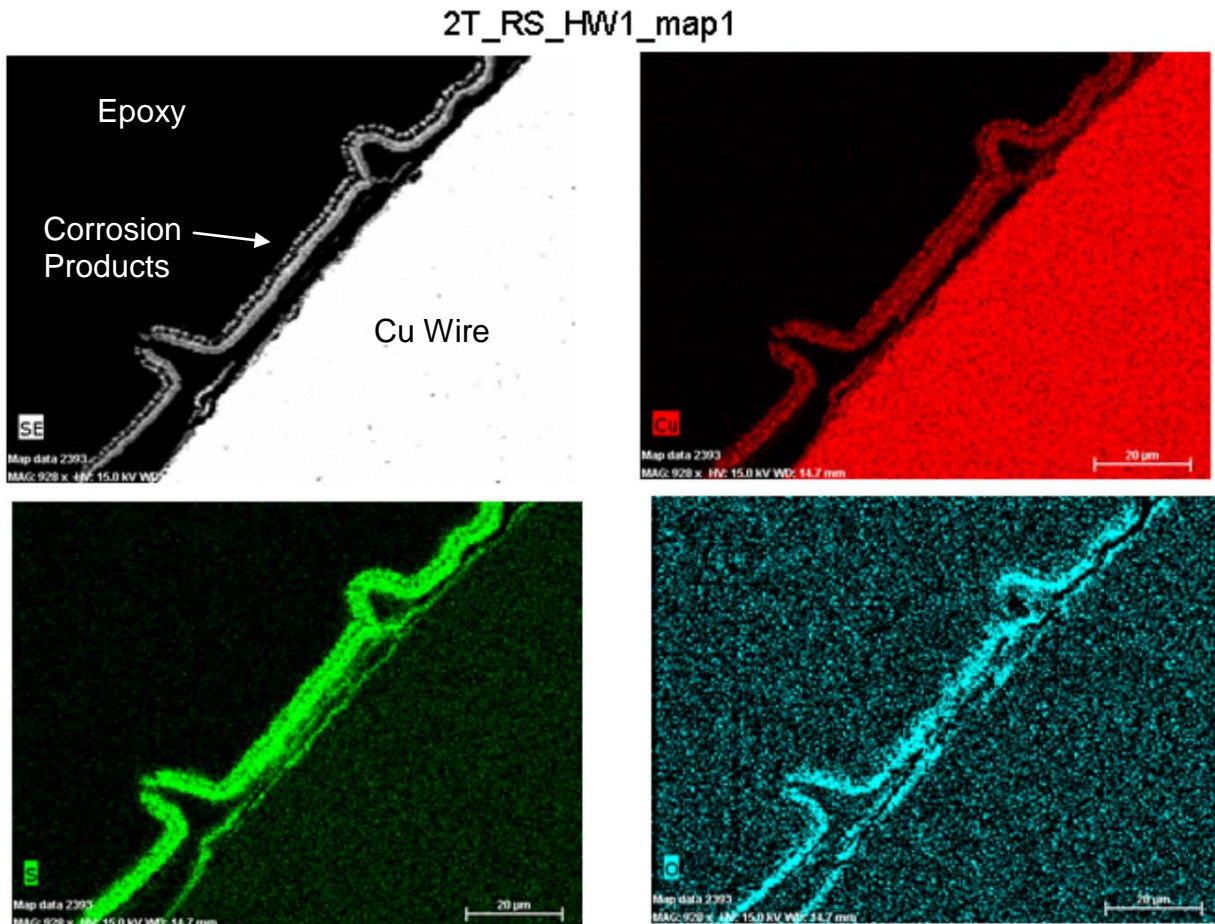
Figure 37 shows the elemental maps of the wire shown in Figure 36. The corrosion product consists of a layer of copper sulfide, with a thinner layer of either copper oxide or possibly copper sulfate.

Figure 37. Elemental maps from the rocker switch hot wire (cross sections) in Circuit 2. The upper left image is an SEM image identifying the area being analyzed. Three maps are shown for Cu (red), S (green), and oxygen (blue).

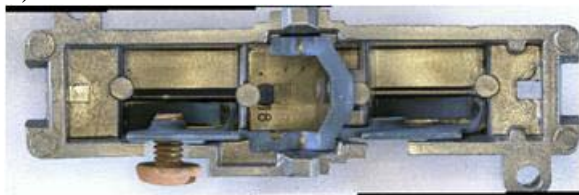
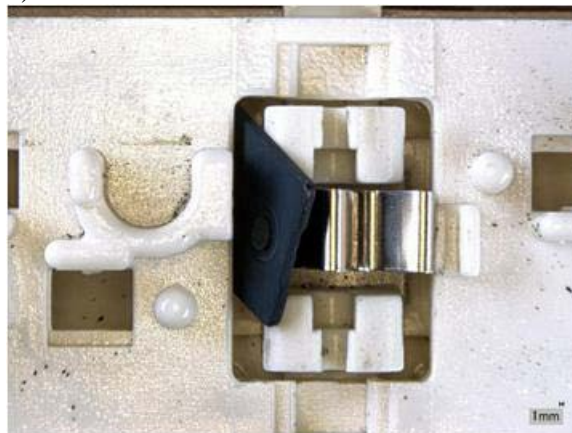
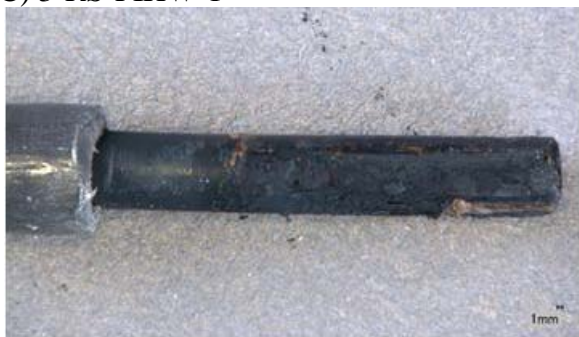
Figure 40 shows optical images for the rocker switch from Circuit 3. The case was removed to reveal the interior components. As with other components, it appears that the case provides little or no protection against the corrosive gasses. Both interior and exterior components exhibit corrosion. The bottom two images show both sides of the hot wire. In this case, the wire was connected to the push-in contact. Corrosion of the wire surface was less nonuniform, but it essentially covered the entire surface other than the contact point.

Figure 40. Optical images of the rocker switch and hot wires from Circuit 3.

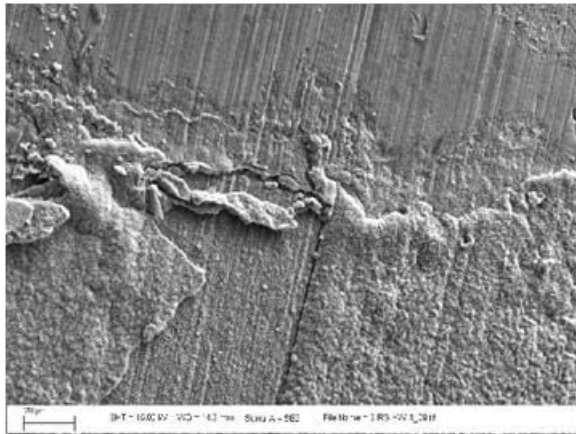
(C) 3-RS-HW-1\_093

Figure 41 shows SEM images of the hot wire from the rocker switch. The figures on the left are secondary electron images that show topography. In this case, the insulation was removed next to the corroded area. The images on the right are back-scattered electron images. In these images, brightness is a function of the atomic number of the element on the surface. The bright area in the top of the image represents bare copper exposed by the removal of the insulation; the lower portion of the picture is darker and represents the sulfide layer (*i.e., copper has a higher/larger atomic number than sulfur*). These images show that sulfidation of the copper stops where the insulation protects the underlying copper. Figure 42 shows the elemental maps associated with this location. Clearly, the insulation protected the underlying copper from sulfidation because the top of the elemental maps showing the region of the wire that was covered with insulation shows no sulfur.

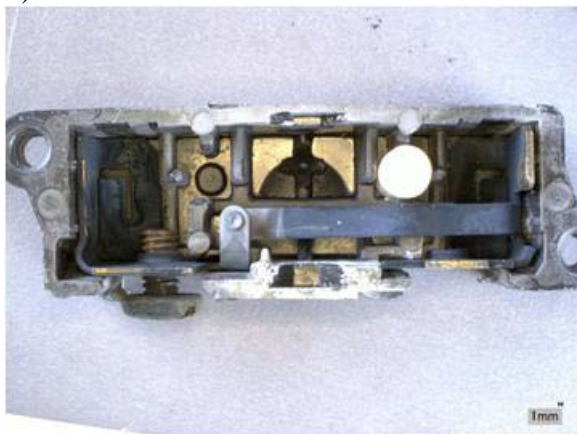
(A) 3-TS-insides-1

Figure 43. Optical images of the toggle switch in Circuit 3. The figure on the left shows the inside of the switch. Note the extensive corrosion product on some of the components. The image on the right is of the hot wire connected to the toggle switch (screw side).

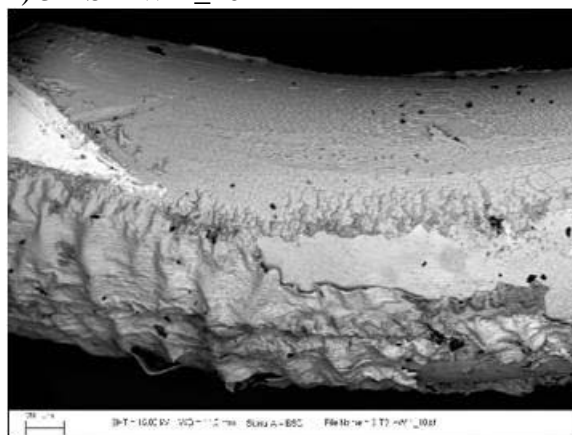
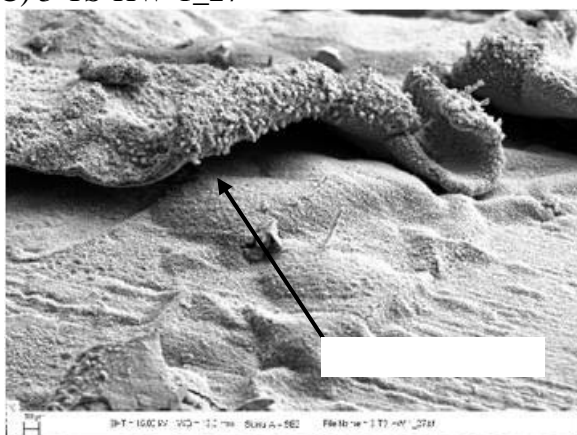
Figure 44 shows SEM images of the hot wire from this component. The top two images are back-scattered electron images and show the presence of bare Cu at a contact point (light region). The corrosion product film structure/morphology is similar to that found on other components, exhibiting layering, buckling, and spalling.

Figure 44. SEM images of the hot wire from the toggle switch in Circuit 3. Note the spalling of the corrosion product film. The contact areas can be seen in the upper two images (bright areas) where the contact shielded the surface from the corrosive gasses.

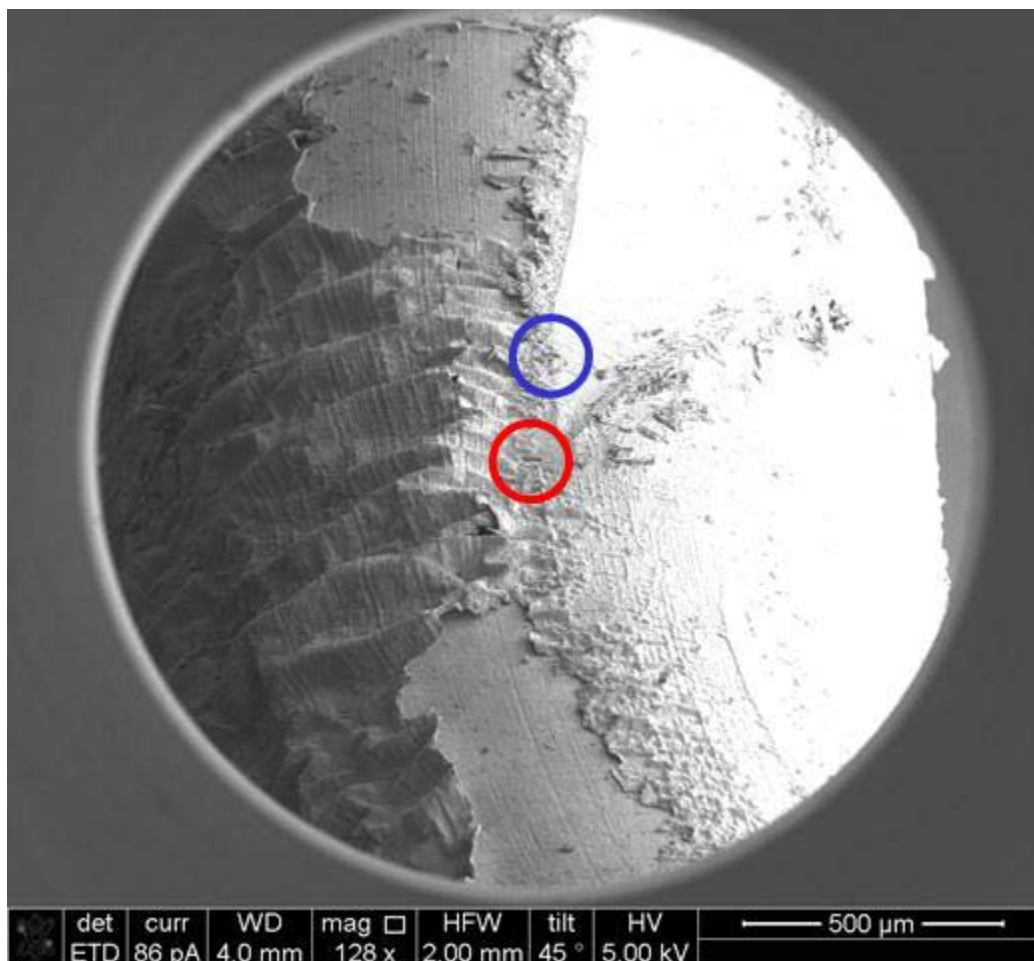
potentially less damaging to the surface layers; however, it is time consuming; therefore, only limited FIB analyses were performed. Figure 46 shows a low magnification view with circles indicating locations of two FIB cuts. Since this is a very low magnification, the instrument aperture is observed as the wider circle. The bright area in the upper right, is the area where the screw made contact with the wire and appears to be free of corrosion product.

Figure 46. Low magnification FIB image of hot wire from toggle switch (3TS-HW-1), showing location of FIB cuts (red designated as “Section 1” and blue designated as “Section 2”) into corrosion product film.

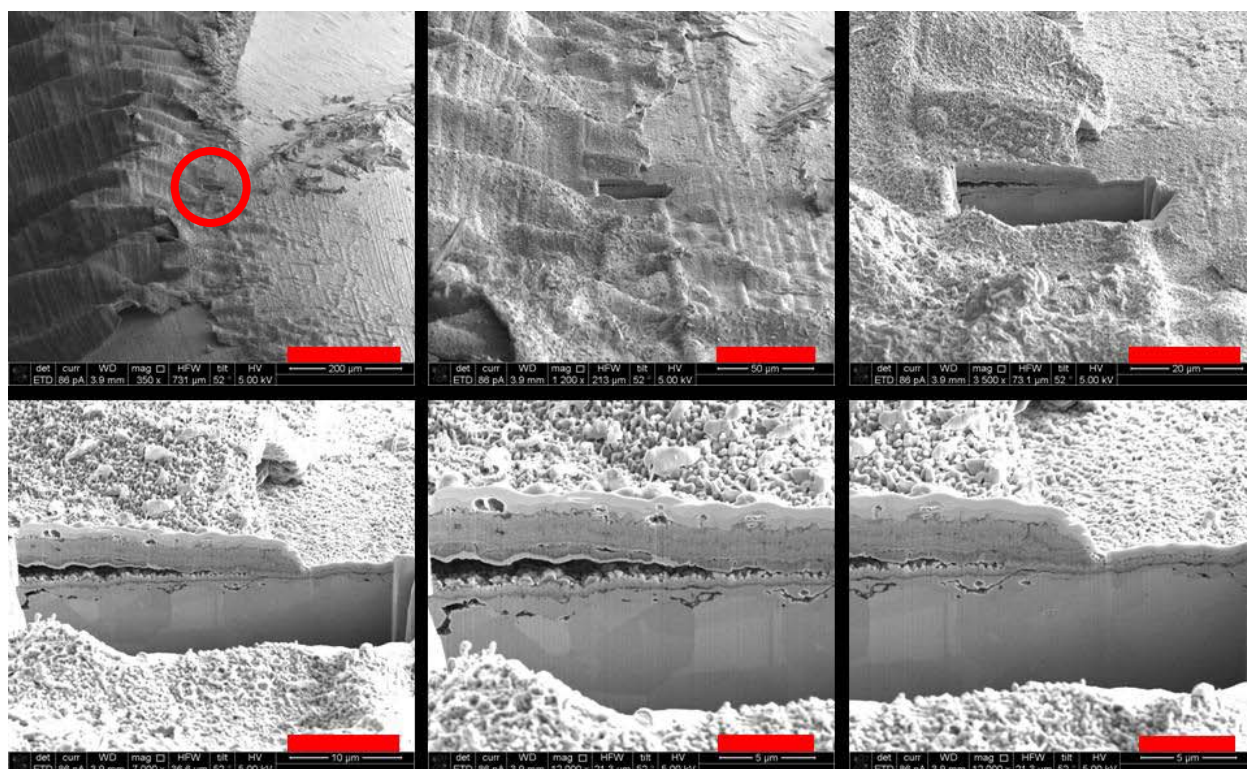
Figure 47 shows SEM images of the FIB cut designated as “Section 1,” indicated by the red circle in the previous figure, at increasing magnifications (350 to 12,000X magnification). This FIB cut is approximately 50 microns from the nearest portion of the wire contacted by the screw. The middle top image illustrates wavy features of the corrosion product observed in SEM cross sections of other samples. The right top and lower left images illustrate an abrupt edge of the wavy growth that appears to have smaller features, suggesting flaking and regrowth of the corrosion product. The middle lower and right lower images show closer views of the corrosion layer and the varying gap between the wire and corrosion product. This is consistent with crosssection observations of other wires.

Figure 47. FIB cuts into 3-TS-HW-1 “Section 1” (see Figure 46) with scale bars at 200 (350X), 50, 20, 5, and 5 (12,000X) microns, respectively.

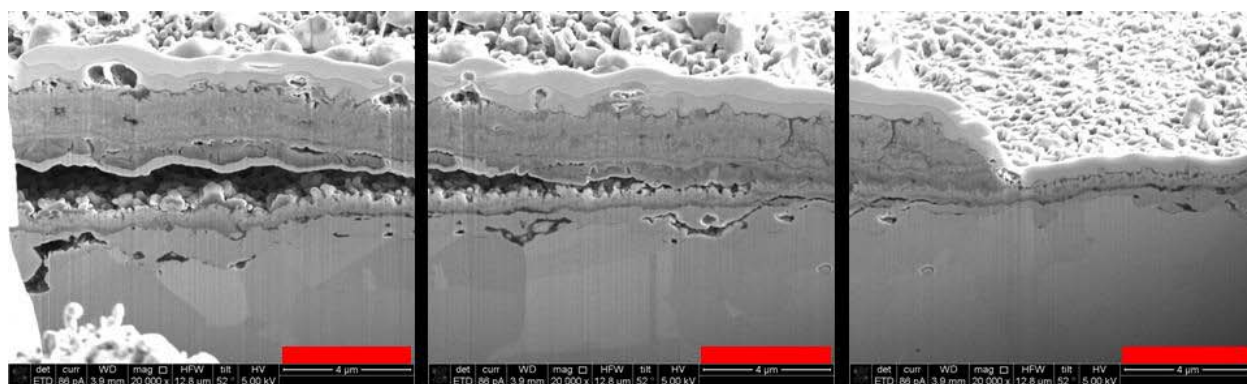
Figure 48 shows three images at the same magnification (20,000X) of the edge of the FIB cut. The copper wire is at the bottom, the varying contrast areas are consistent with solid copper. Some pitted areas are observed along with roughened product growth underneath the upper layer of corrosion. The bright white top layer is the platinum layer deposited on the sample to preserve features.

Figure 48. FIB cuts into 3-TS-HW-1 “Section 1” (see Figure 46) with scale bars at 4 microns each.

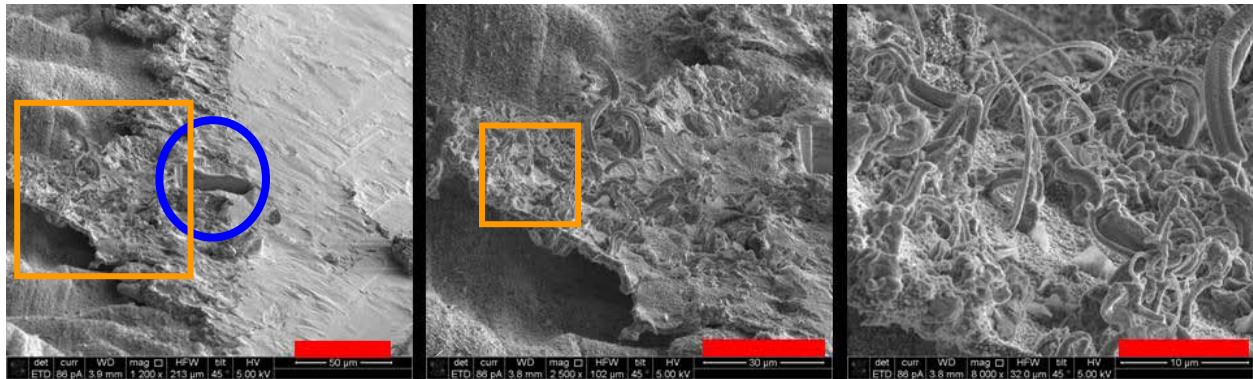
in Figure 49 at various magnifications. On the left is a wider view of “Section 2,” indicated with the blue circle. The orange box indicates the approximate area of the middle image, while the orange box in the middle image indicates the approximate area of the image on the right.

Figure 49. FIB cuts into 3-TS-HW-1 “Section 2” (see Figure 46) with scale bars at 50, 30, and 10 microns, respectively.

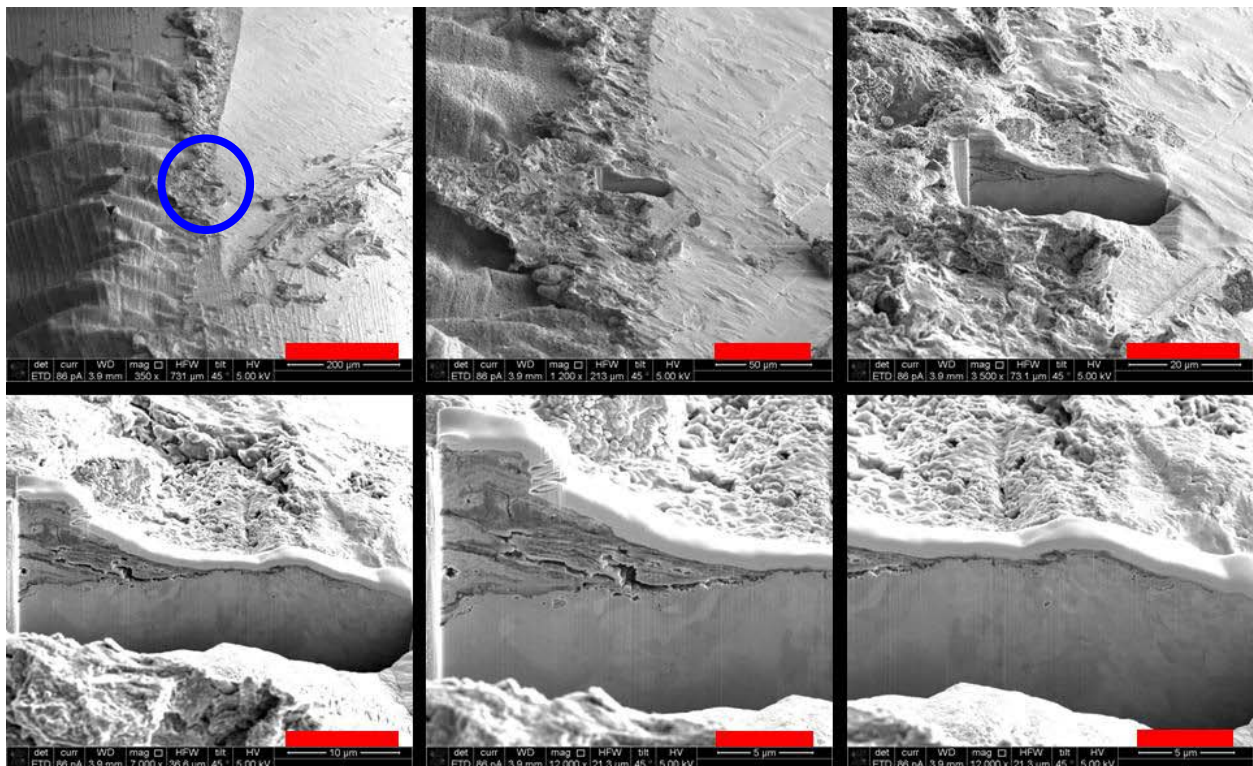
A closer look at the cross section of corrosion growth revealed by the FIB cut designated as “Section 2” is shown in Figure 50. In the top row, a bare copper area is observed to the upper right of the images, the area underneath the screw. The lower row shows higher magnification views of the change in the corrosion growth thickness from left to right.

Figure 50. FIB cuts into hot wire from Circuit 3 toggle switch (3-TS-HW-1) “Section 2” (see Figure 46) with scale bars at 200, 50, 20, 10, 5, and 5 microns, respectively.
