# **Report on Study of Electrical Component Corrosion Related to Problem Drywall**

Division of Electrical Engineering  
Directorate for Engineering Sciences  
U.S. Consumer Product Safety Commission

March 2011

## **Report on Accelerated Corrosion Studies of Electrical Components**

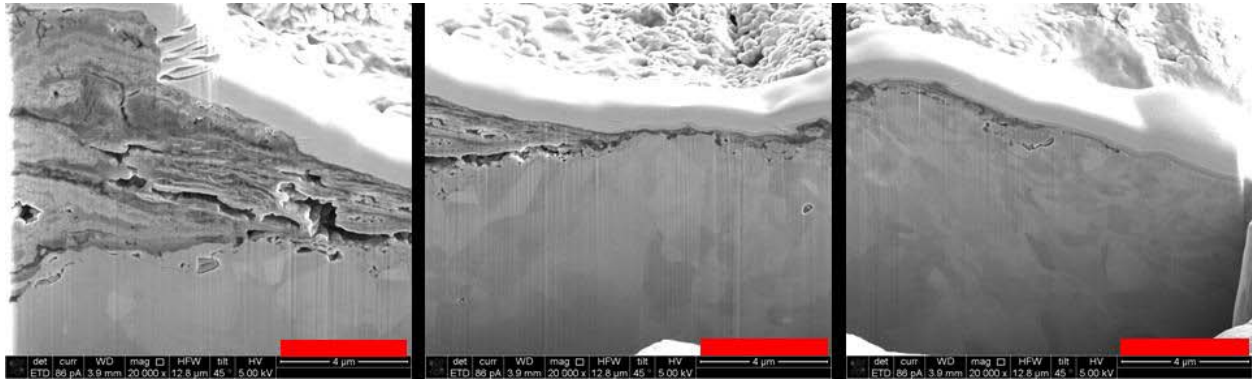
Figure 51 contains a series of SEM images across the FIB cut at 20,000X magnification. Layering and pitting is observed; moving from left to right and closer to the contact point of the screw, the overall corrosion thickness transitions from approximately nine microns to significantly less than one.

Figure 51. FIB cuts into 3-TS-HW-1 “Section 2” (see Figure 46) with scale bars at 4 microns each (20,000X).

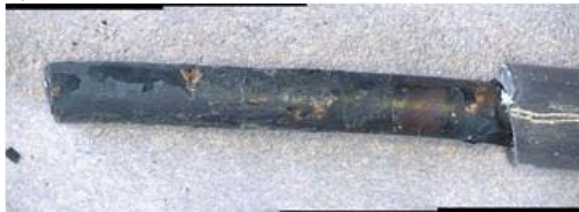
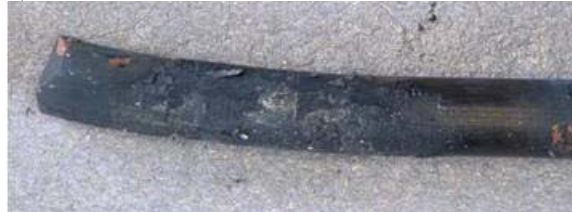
Figure 53 shows optical images of the hot wires (push-in contacts) from the standard receptacle from Circuit 3. These results are consistent with previous samples, showing corrosion product across the surface except where the contact was made.

Figure 53. Optical images of wires from the standard receptacle from Circuit 3. Both the (A) hot and (B) neutral wire are shown. Both are “push-in” type contacts.

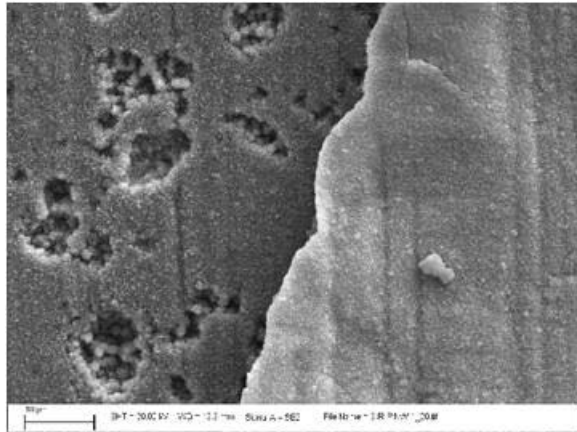
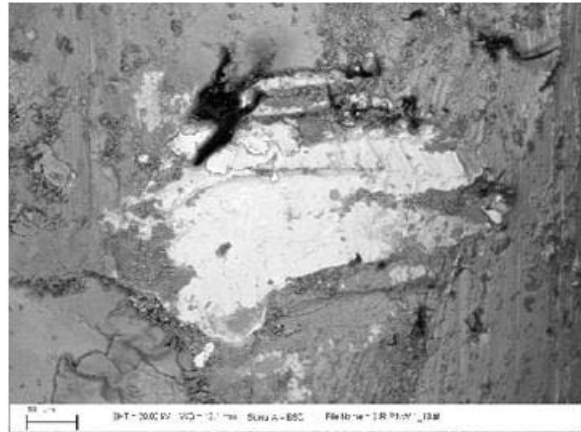
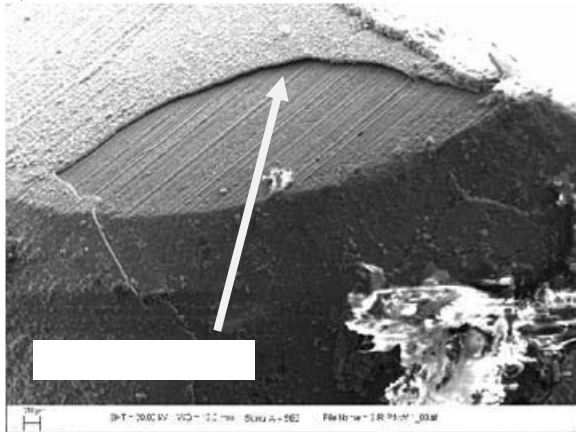
The SEM images shown in Figure 54 show similar features to other samples: multiple layers of the film, spalling, voiding of the metal, and bare metal at the contact point.

Figure 54. SEM images of the surface of the neutral wire from the receptacle in Circuit 3. The connection was a push-in connection. (B) shows the contact point, which is brighter due to the presence of Cu without S. The end of the wire is shown in the lower images at two magnifications. Note the spalling of the corrosion product film. It is believed that the spalling occurred during the test, but is it possible that it occurred after exposure and prior to analysis.

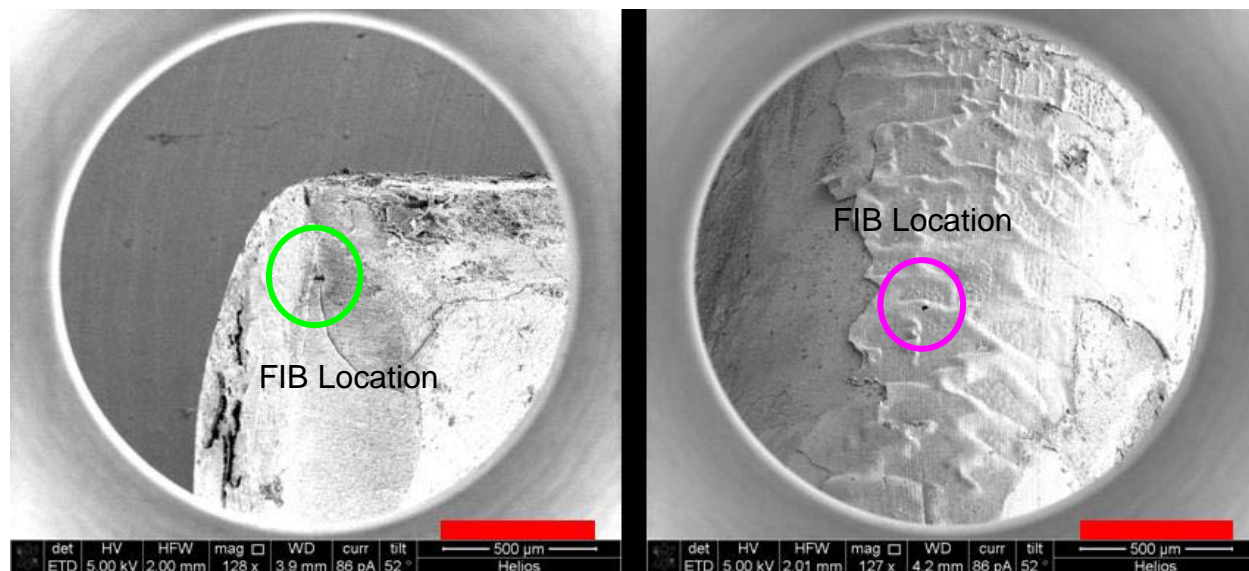
SEM images of two FIB cuts (designated as “Section 3” and “Section 4”) on the neutral wire from the push-in connector of the receptacle are shown below at magnifications of 128x and 127x. The aperture of the instrument is observed as the outer view circle due to wide view and low magnification. “Section 3” (left) was cut at the edge of the corrosion product film. Section 4 (right) was cut into an area surrounded by “wavy” corrosion growth.

Figure 55. FIB cuts into corrosion product on surface of neutral wire 3-R-PINW-1 with “Section 3” (left) and “Section 4” (right) with scale bar of 500 micron.

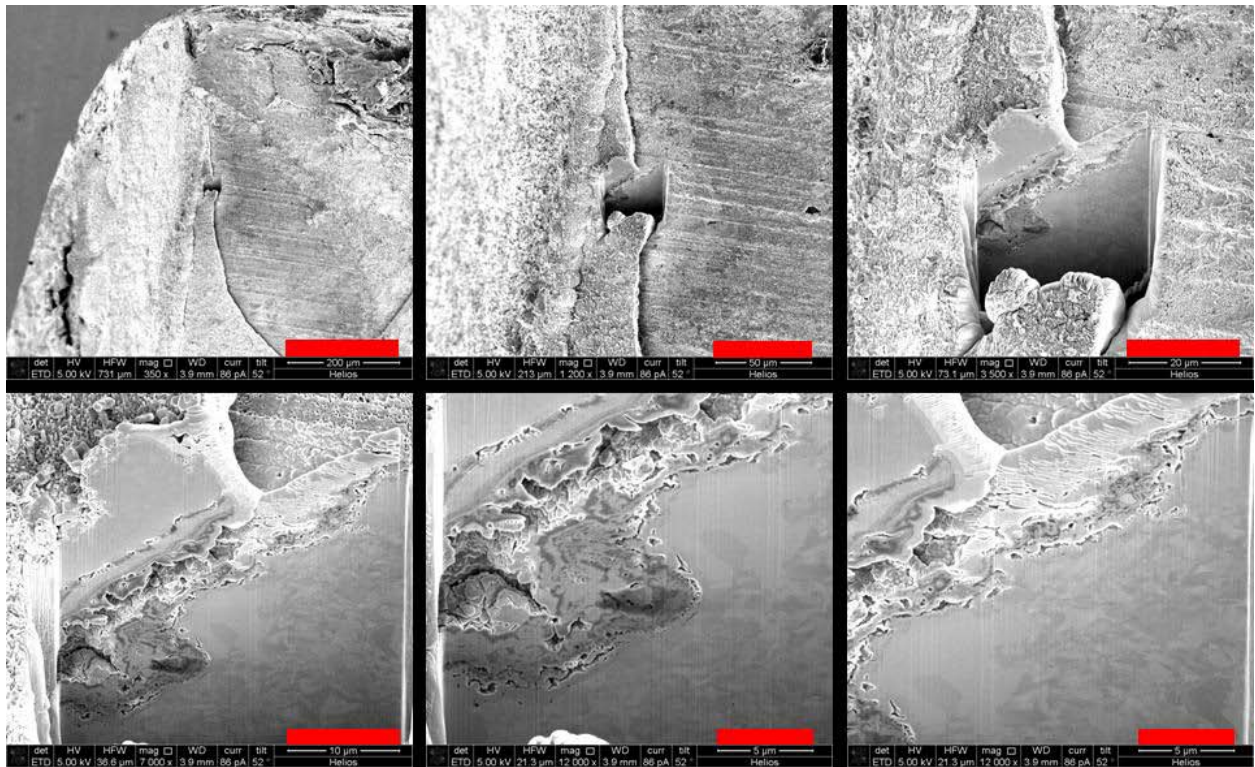
Higher magnification images of “Section 3”, ranging from 350X to 12,000X are presented next (Figure 56) and display varying thickness as well as voiding of the copper below the corrosion product film. The fracture line down the center of the images in the top row shows an area of corrosion product that flaked off.

Figure 56. FIB cuts into neutral wire 3-R-PINW-1 “Section 3” (see Figure 55) with scale bars of 200, 50, 20, 10, 5, and 5 microns.

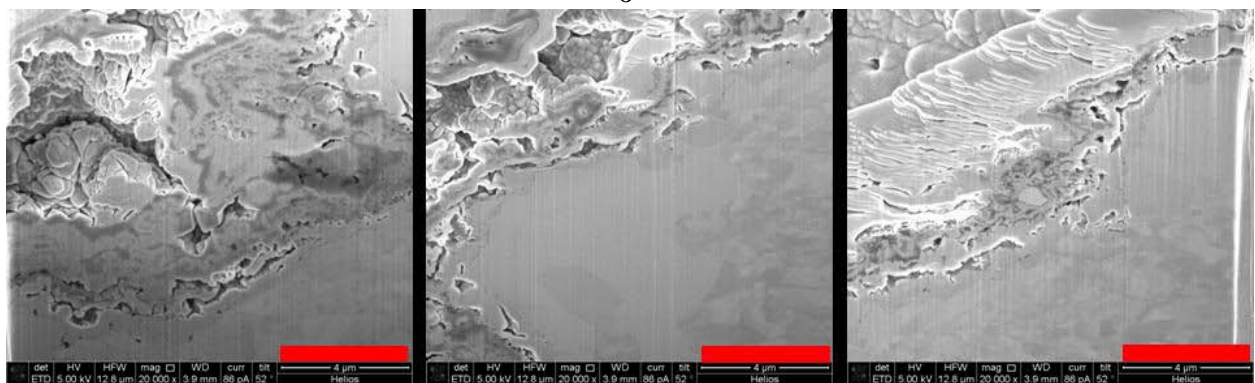
Higher magnification images of the pitting observed in “Section 3” are below (Figure 57); with the thinnest corrosion growth, the platinum FIB coating, and pure copper grains prevalent in the image on the right.

Figure 57. FIB cuts into neutral wire 3-R-PINW-1 “Section 3” (see Figure 55) with scale bars of 4 micron each.

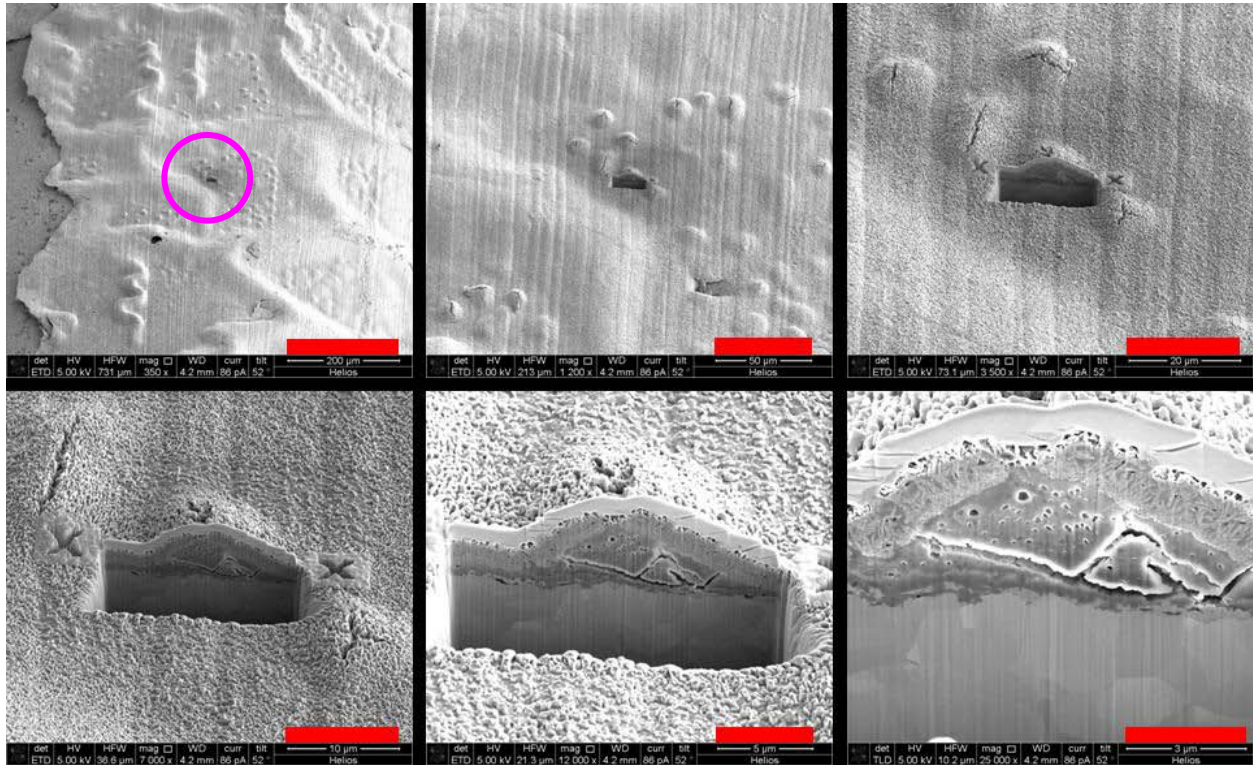
Higher magnification views of “Section 4” are shown in Figure 58 and illustrate an additional morphology seen in some samples—that of a “bubbling” or blistering of the corrosion product layer. The magnification ranges from 350X to 25,000X. In the lower right image, three different kinds of growth layer are observed—a layer with few voids, a middle layer with multiple voids,

and a third solid layer with what appears to be striated growth. The top-most white layer in the image is the platinum FIB overcoat.

Figure 58. FIB cuts into neutral wire 3-R-PINW-1 “Section 4” (see Figure 55) with scale bars of 200, 50, 20, 10, 5, and 3 microns, respectively.

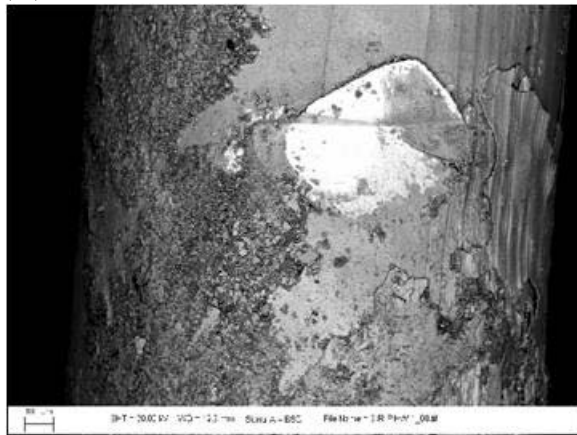
(A) 3-R-PIHW-1\_08

Figure 59 shows SEM images of the push-in hot wire from the receptacle in Circuit 3. The image on the left shows the contact point. It is clear that the intimate contact between the wire and the receptacle contact prevented sulfidation from occurring in the contact area. The image on the right shows the wire at the interface with the insulation. In this case, the insulation was removed to reveal the wire surface directly beneath the insulation. The fact that bare copper is visible in the region shielded by the insulation suggests that the insulation prevents the pollutant gas from contacting the copper wire.

Figure 59. SEM images of the hot wire from the receptacle in Circuit 3. The connection was a push-in connection. The contact point is shown in the image on the left. The image on the right shows a region of a hot wire that was covered by insulation on the bottom.

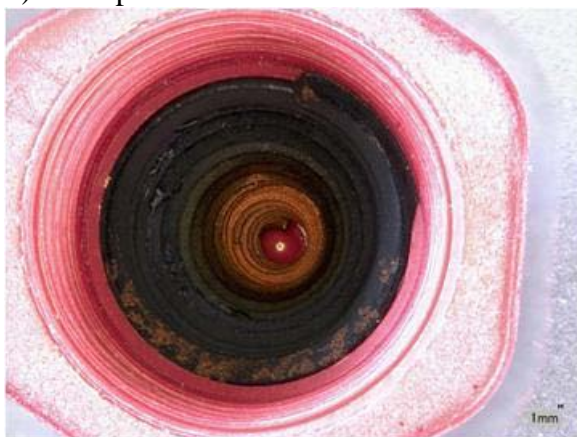
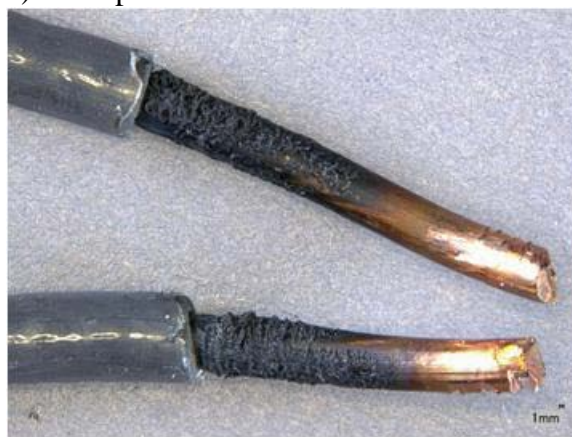
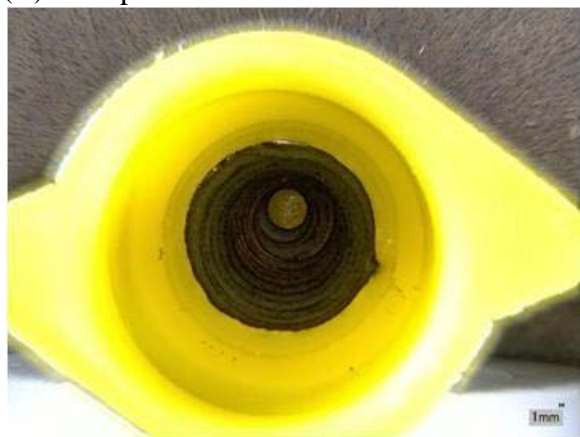
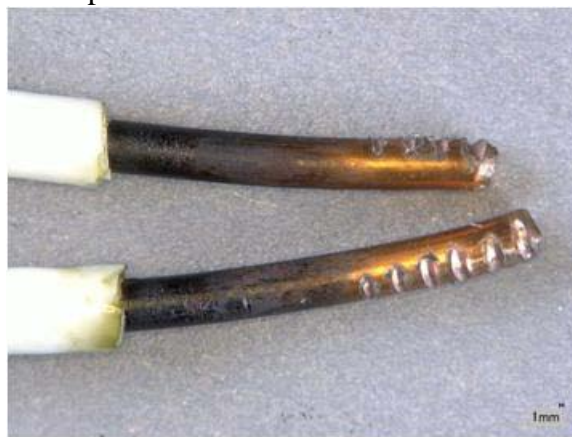
Figure 61 shows optical images of twist-on connectors and the associated wires used to connect component assemblies inside the chamber. Corrosion of both the wires and the twist-on connectors was observed. The extent of corrosion decreased with depth into the twist on connector. A thick corrosion product layer was found next to the insulation. The ends of the wires, where protected by the twist-on connector, exhibit bare copper.

Figure 61. Optical images of twist-on connectors with hot and neutral wires used on the output section of Circuit 2.
