## **Interim Report on the Status of the Analysis of Electrical Components Installed in Homes with Chinese Drywall\***

Division of Electrical Engineering

U.S. Consumer Product Safety Commission

November 23, 2009

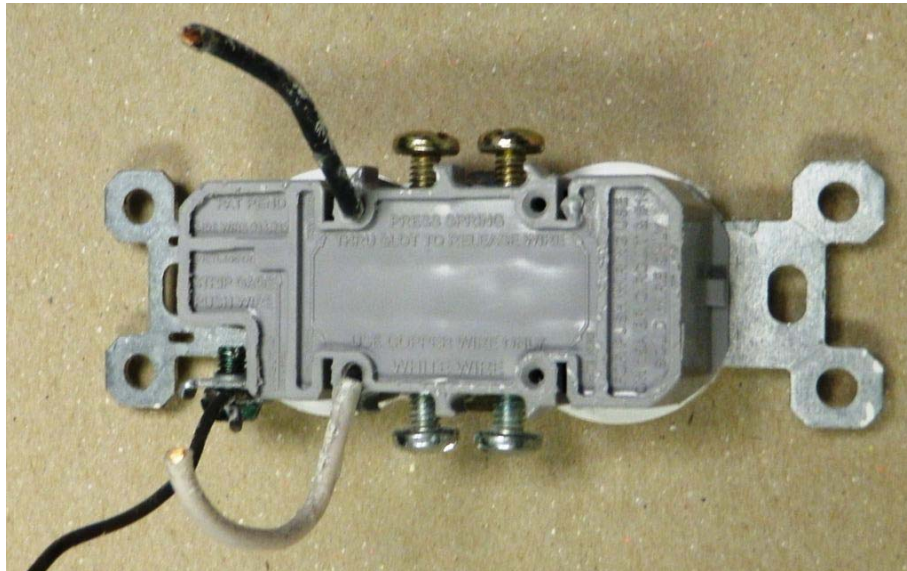
created by a preset force and exerted primarily at the contact point on the spring clip. Therefore, areas of concern for corrosion of a BWPI connection are from the wire to the spring clip and along the surface of the wire between the wire and the side of the terminal in contact with the wire.

Figure A2. The back of a standard receptacle with wires connected via BWPI terminals.

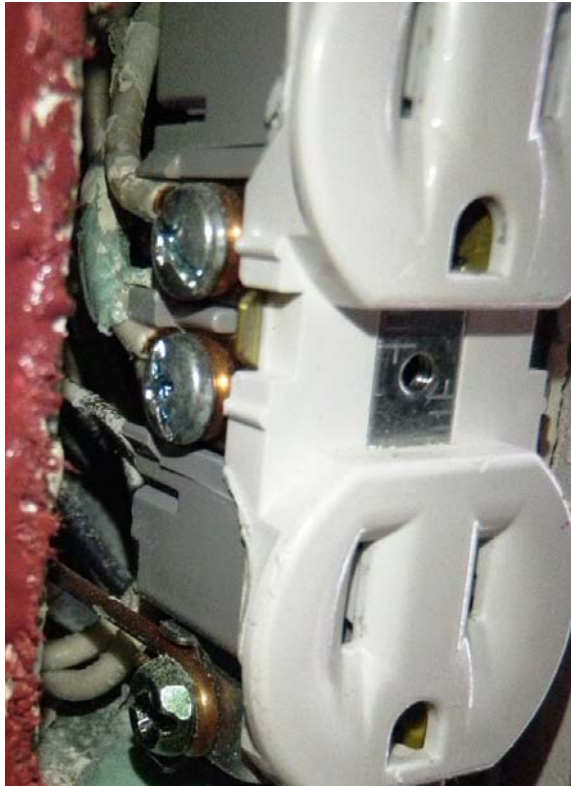
Figure A4. Receptacle wired via WBS terminals.

The tightness of the connection is dictated by the installer. Workmanship plays a large role in the tightness of the connection and how well the loop is captured under the head of the screw. Areas of concern for corrosion of a WBS connection are from the wire to the contact plate and exposed surfaces of the stripped-back wire lead. A connection in which the wire is tightly looped around the screw, has been tightened with the proper torque and has an optimal amount of insulation stripped back will have less surface area exposed to the air than in a BWPI connection. However, one of the objectives of the detailed metallurgical analysis is to study the wire/contact plate interface to see if corrosion intrusion is present.

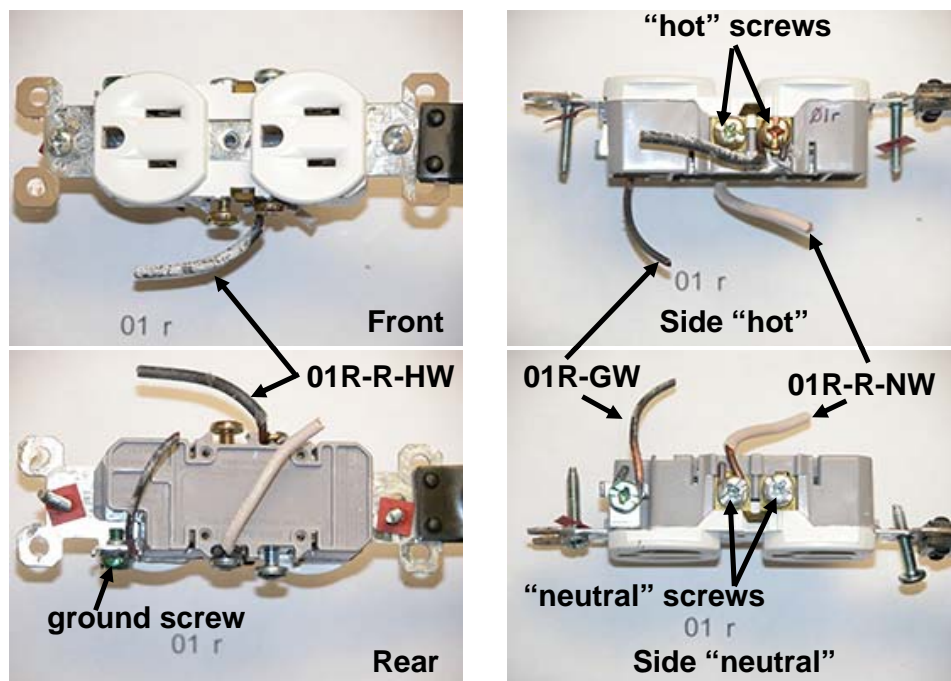
Figure 4: Example optical photographs showing four views of a duplex receptacle. The neutral and hot wires have electrical insulation on the part of the wire away from the attachment screws. The ground wire has no electrical insulation, but could appear to due to it being blackened over much of its area.

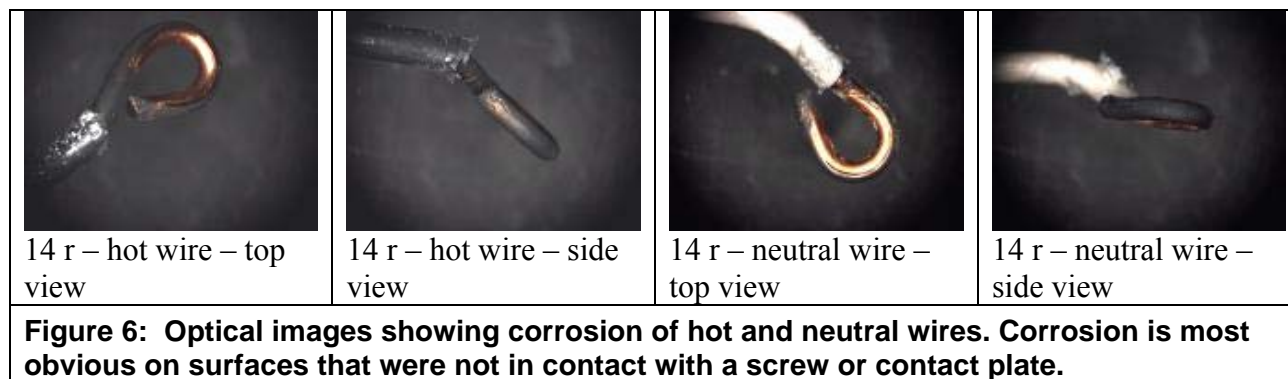
Each of the six 110V rated, screw-type connection receptacles (5 duplex, 1 single pole) had paint or plaster splatter on various surfaces including the wires. There was visible corrosion on the ground, neutral, and hot wire surfaces as well as on the contact plate surfaces for the neutral and hot wire connections. Figure 5 shows the corrosion (blackened regions) that is observed on both sides of ground wires from the six receptacles examined to date. Each of these wires was originally fastened to the receptacle with a screw at the curved section of the wire. The areas where the wire made contact with its screw or contact plate show less blackening or no blackening compared to other regions of the wire where it was not in contact with another material. The lack of corrosion in these areas is likely due to this region being somewhat shielded from any corrosive gasses that are present. Some of the wires also show a white material (likely paint, texturing material, or drywall debris). Some of this appears to have been introduced prior to it being fastened to the receptacle as it is located in a region that was under the screw when it was fastened to the receptacle. Blackening was observed on neutral and hot wires as shown in the examples in Figure 6.
