# PURAFIL ENVIRONMENTAL CORROSION REPORT

21-Oct-2010

CCC Panel #: P68025

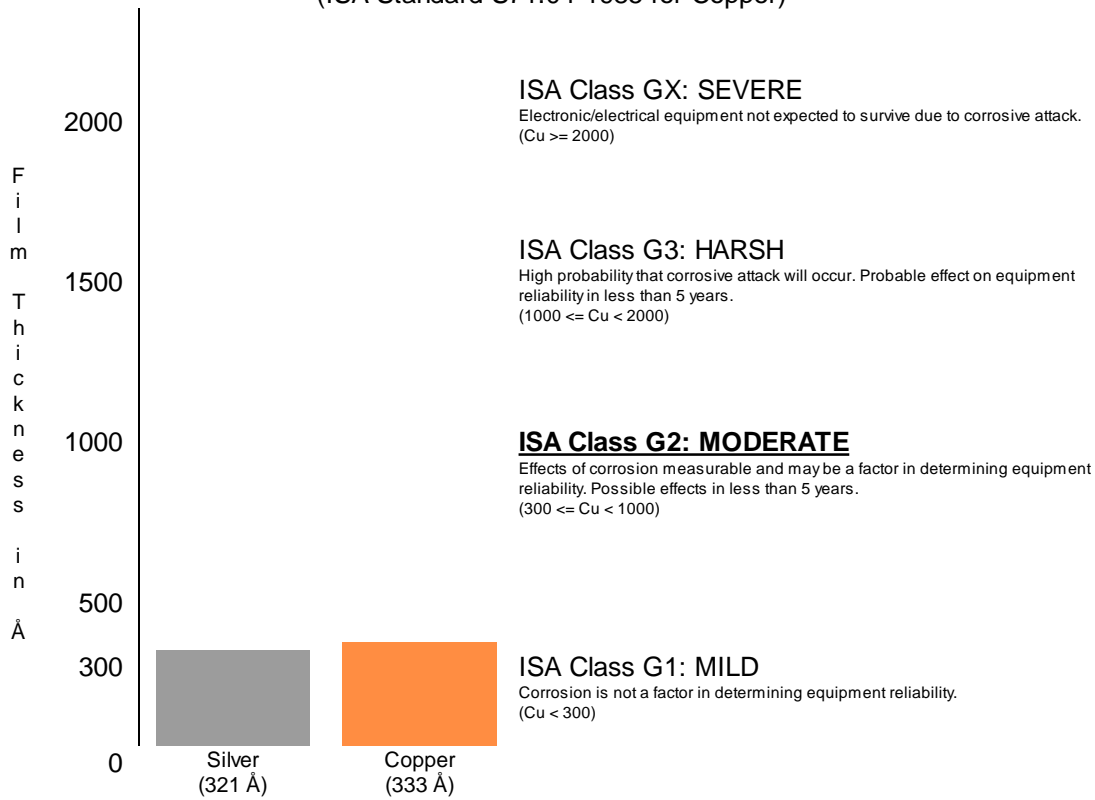
<b>CCC Panel # P68025</b>
<b>ISA Class G2</b>
Moderate

<b>Copper Corrosion</b>
333 Å/30 Days
<b>Silver Corrosion</b>
321 Å/30 Days

**Equipment Reliability Correlation**  
 (ISA Standard S71.04-1985 for Copper)
