SUBJECT : Electric and Gas Clothes Dryers – Staff Evaluation and Contractor Report

FINAL REPORT ON ELECTRIC AND GAS CLOTHES DRYERS
February 2000

ENGINEERING ANALYSIS OF GAS AND ELECTRIC CLOTHES DRYER FIRES FINAL REPORT

Prepared for:
The U.S. Consumer Product
Safety Commission
Directorate for Engineering Sciences
Project Order No. CPSC-S-99-5130

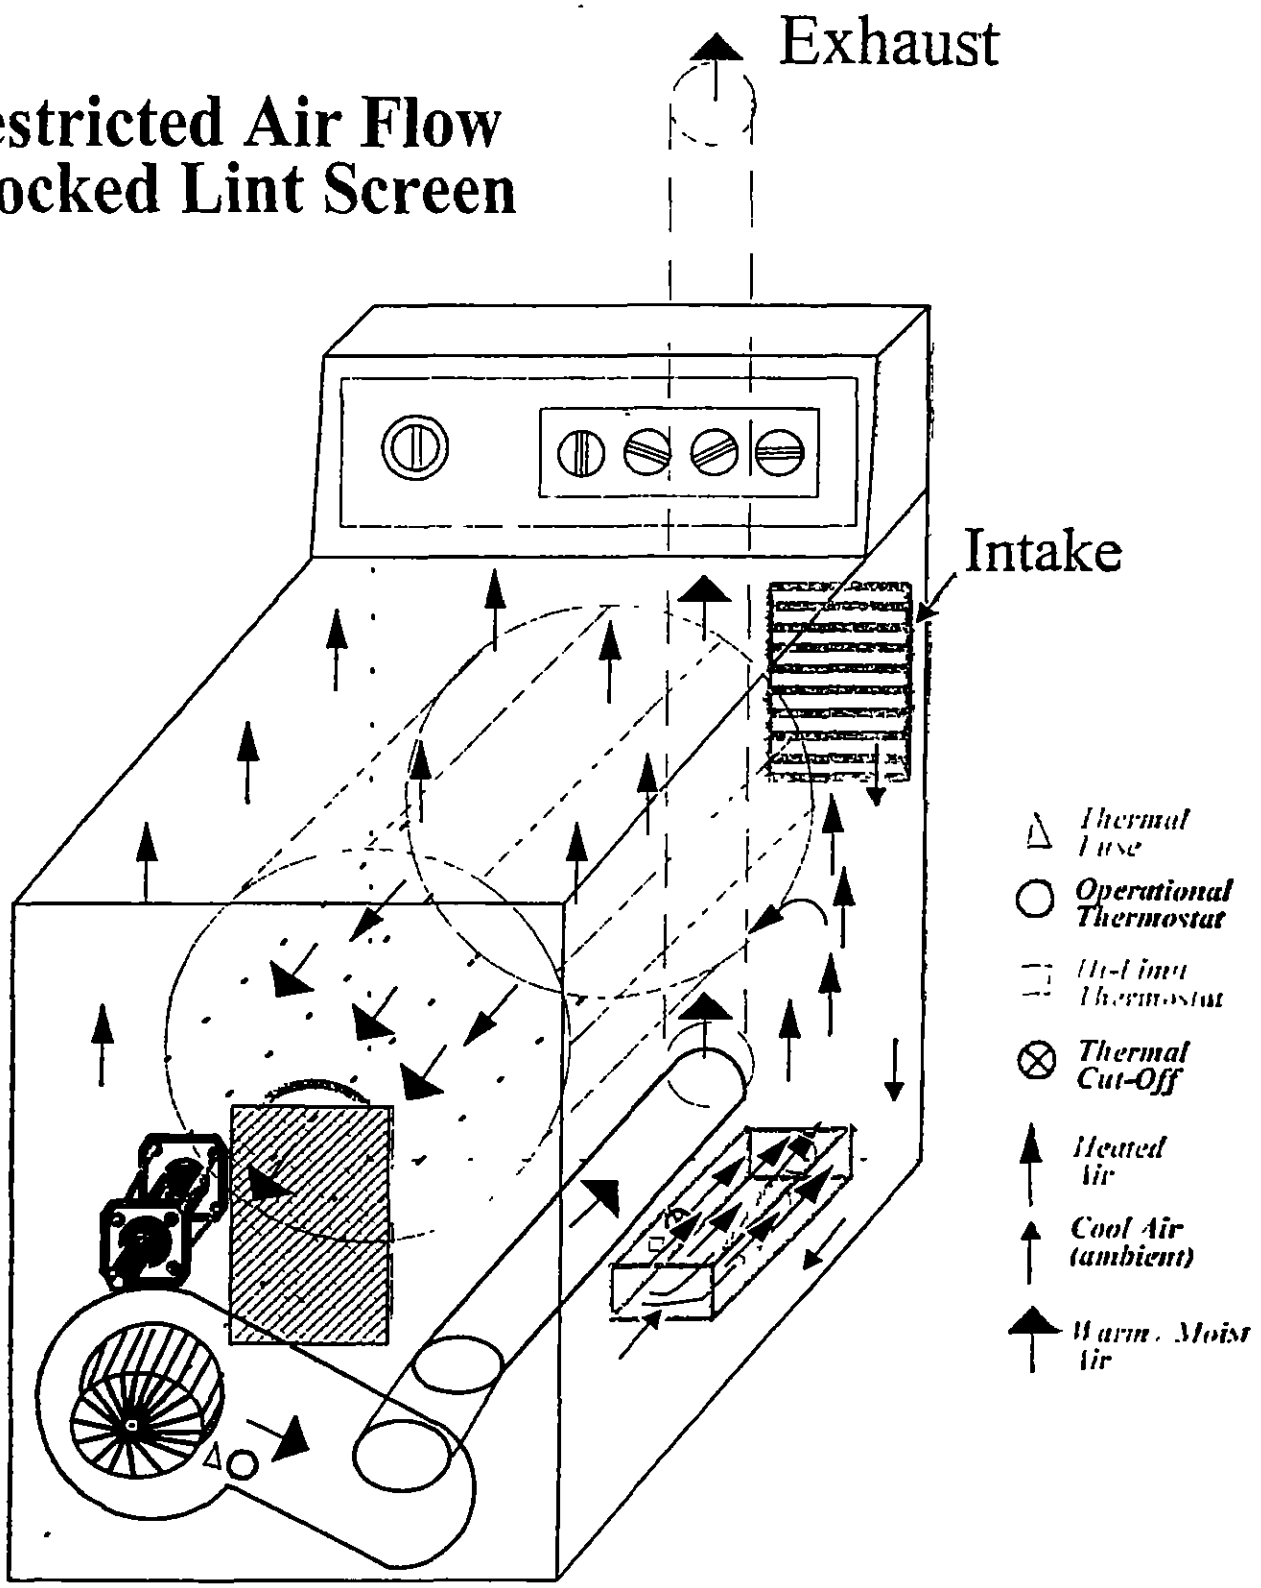
gure Number. 6 *Drawn by: N.M.* *Date: 11/16/99* *File Number. 9903.0002*

The improper installation of the owner-furnished ventilation system and/or the accumulation of lint can result in obstructions in the dryer exhaust and vent airflow system. These obstructions cause the dryer's airflow to be restricted. This restricted airflow causes rapid cycling of the dryer's energy (heat) source by activation of the heat-source high-limit thermostat device(s), and is not detected by either the regulation thermostats or the thermal fuse limit device(s) as the drum temperature actually decreases during this operating mode. A subsequent failure of the high-limit thermostat can result in the ignition of either the accumulated lint in the airflow system or in the lint screen. The test results indicate that unconditioned lint will auto-ignite at approximately 500 degrees F. The operation of an audible device to detect a clogged lint screen may go undetected by a hearing-impaired user, and in that case will do little to minimize a potential fire hazard of a clogged screen. The installation of either a positive airflow or pressure differential device should be considered by the dryer manufacturers. This device would disable (turn off) the heat sources and warn the operator of a restricted airflow condition. Such devices have been installed in gas dryers, as required by the ANSI standard, to avoid improper

Restricted Air Flow
Blocked Lint Screen

le Name. Analysis of Clothes Dryer Fires
awing Title: 1998 Typical Clothes Dryer - Restricted Air Flow Pattern

1. The installation of a device(s) to detect restricted airflow through the dryer. The detection device could be either a positive airflow switch or a set of differential pressure detectors at the inlet and discharge of the blower. The detection of a restricted airflow condition should disable (turn off) the heat source, stop the drum-drive motor, and warn the operator.

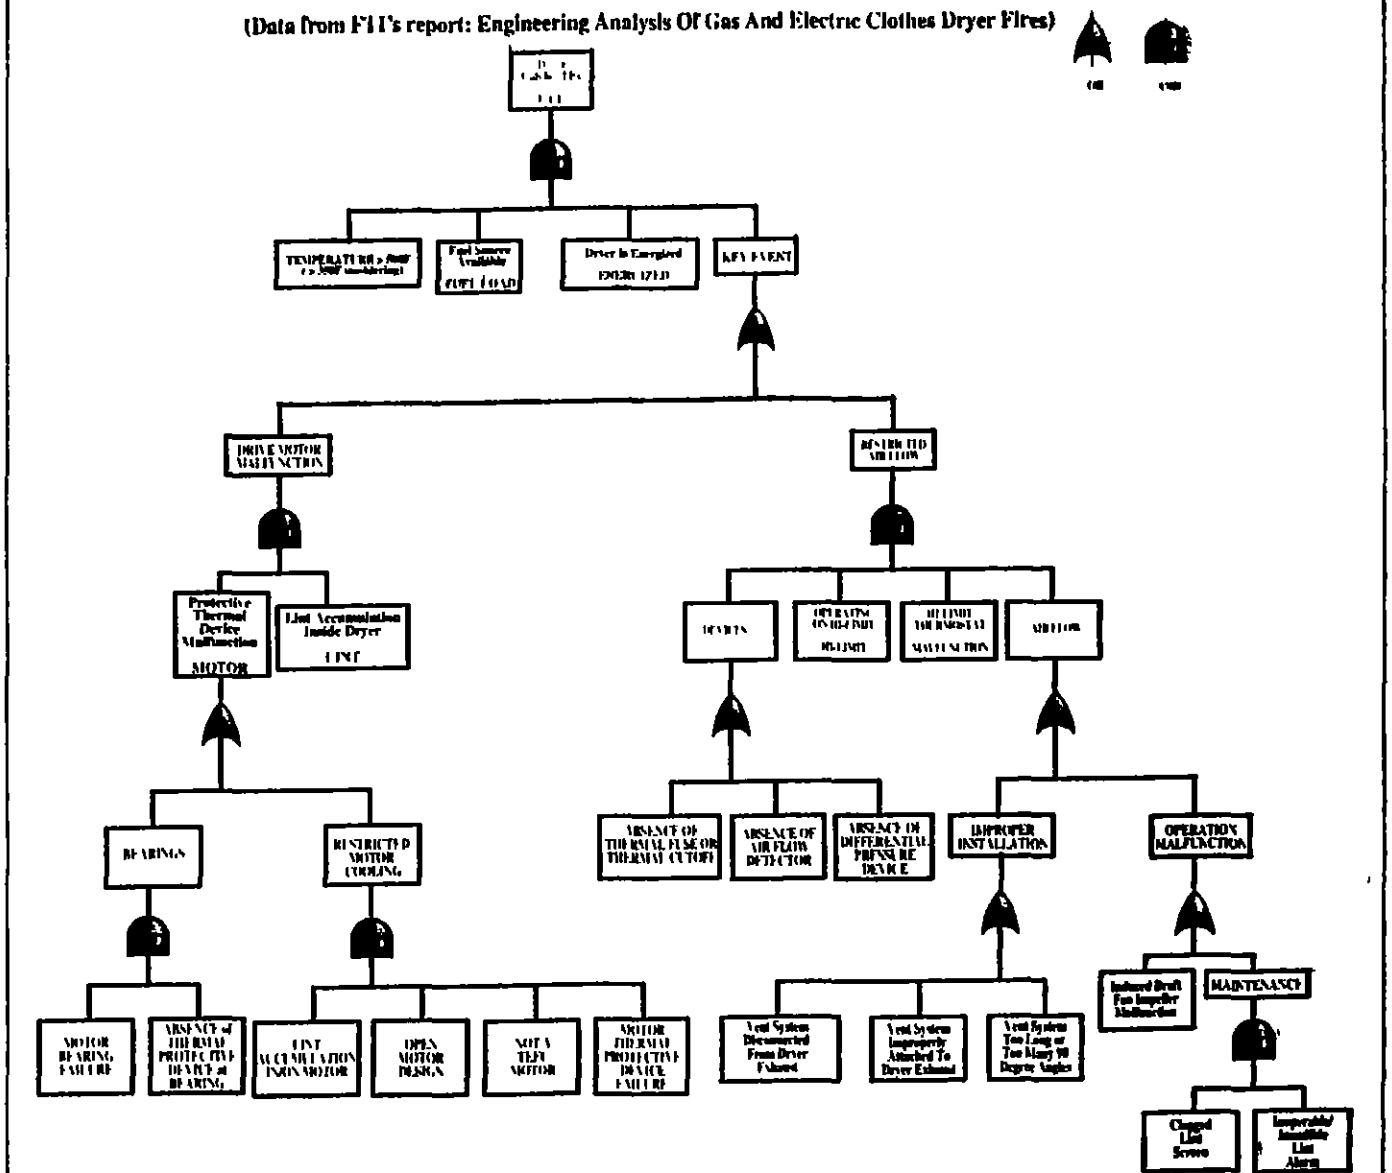
Figure Number 8 *Drawn by N M Date 11/16/99* *File Number 9903 0002*

Two fault trees were constructed, one utilizing the general failure mode data summarized from the 79 CPSC Epidemiologic Investigation Reports, Figure No. 7, and the other for the drum-drive motor and restricted airflow failure modes analysis conducted by FTI, Figure No. 8 (see *Appendix E*). The overall predictability of the fault tree analysis was hindered by the limited detail in the causation analysis and lack of empirical data.

FTI CLOTHES DRYER FAULT TREE ANALYSIS

(Data from FTI's report: Engineering Analysis Of Gas And Electric Clothes Dryer Fires)
