Detection of Abnormal Operating Conditions in Electric Clothes Dryers

April, 2004

**Directorate for Engineering Sciences
Randy Butturini
Arthur Lee**

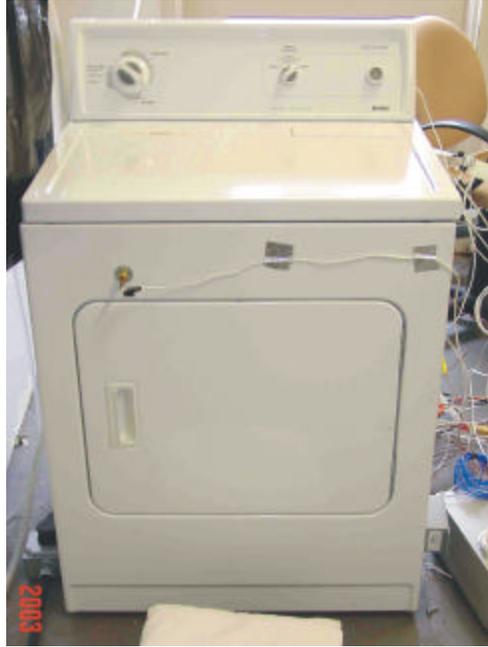
Figure 1. Sample Clothes Dryer Used for Testing

The sample clothes dryer used in these experiments is a mid-range model, with a retail cost of about \$350. The major components of the appliance consist of a rotating tumbler (or drum), a removable lint screen, an electric heating element, and a blower that creates a slight negative pressure in the drum as it exhausts the heated and moistened air out the exhaust ducting. Figure 1 shows a photograph of this product.

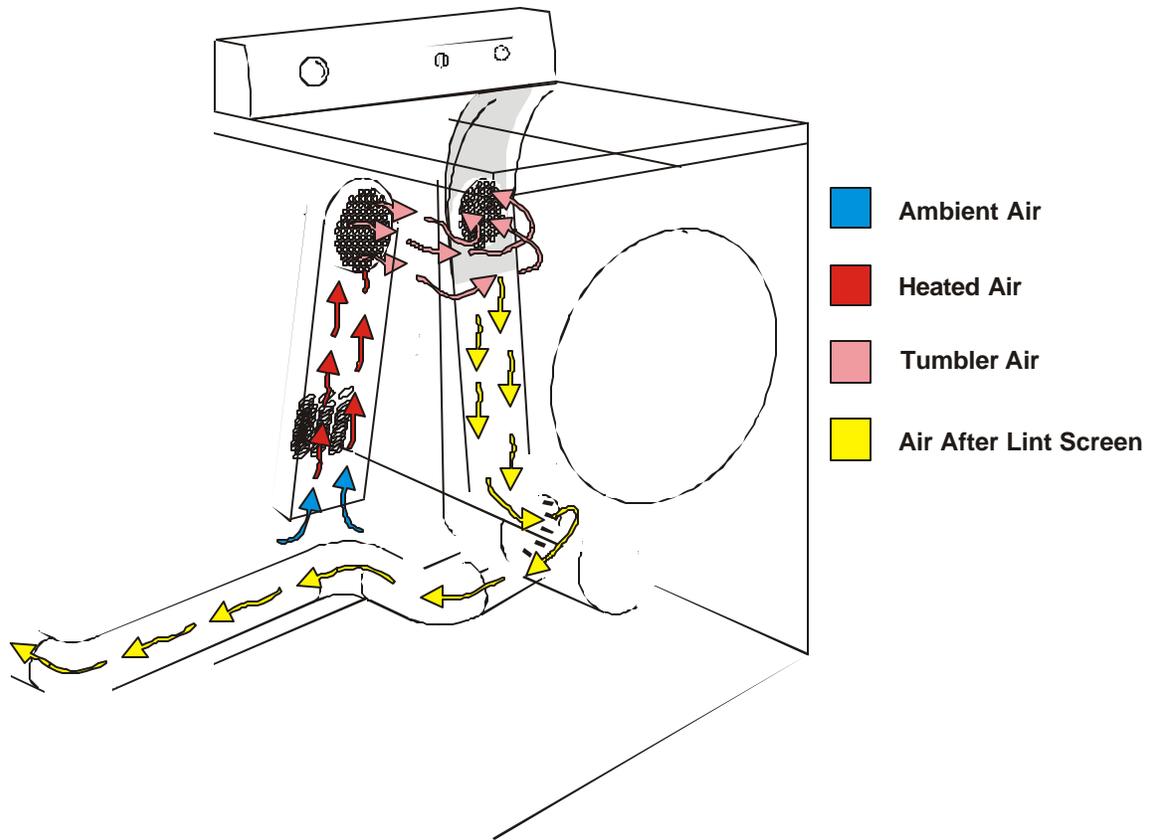
Figure 2. Airflow Pattern in Test Clothes Dryer

Room air is brought into the clothes dryer and exhausted in the sequence shown in Figure 2. Room air is drawn into the appliance through louvered slots in the back panel. The air enters the heater housing opening and flows across the heating element, which is mounted vertically on the back of the dryer chassis. The heated air enters the rear of the drum interior through a screen on the top left side (as viewed from the front). The air mixes with the tumbling clothes load and exits the drum on the top right side. The (now) moist air passes downward through a chute and across the lint screen, against which most of the suspended lint particles are trapped. The air then enters the clothes dryer blower located at the bottom of the dryer and is pressurized as it passes through the impeller. The exhaust ductwork provides a path for the air to exit the clothes dryer to the outdoors.

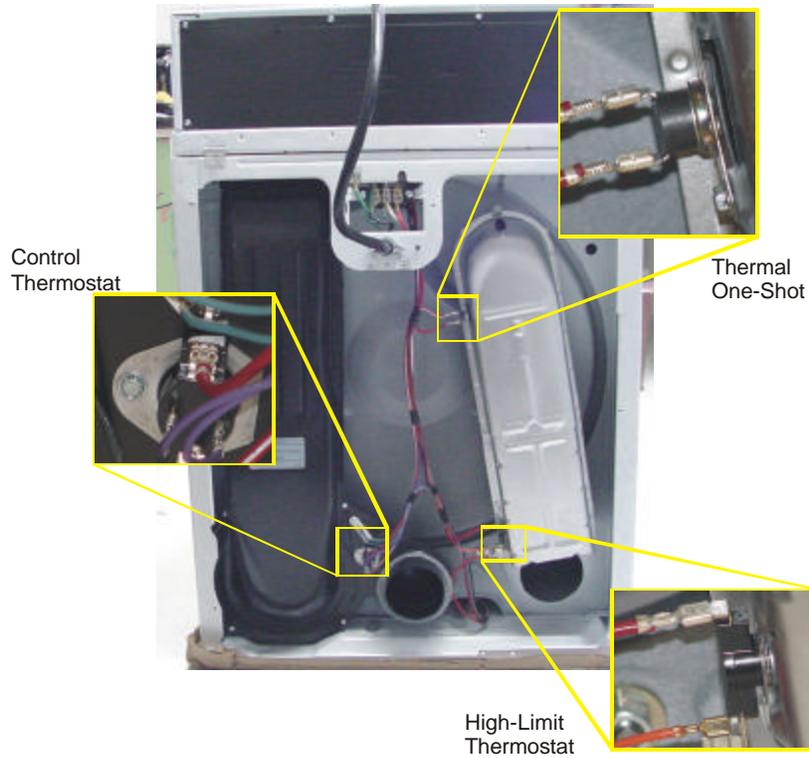
Figure 3. Locations of Temperature Devices

The clothes dryer is equipped with two temperature-limiting controls and a temperature-limiting device as shown in Figure 3. The first control is the control thermostat, located just after the blower exhaust. During normal operation, the control thermostat disconnects electric power to the heating element once the air temperature of the blower exhaust reaches a pre-set level. When the air has cooled down, the thermostat resets and the heating element is again energized. The second temperature-limiting control is a high-limit thermostat, positioned at the air intake of the heating element. If the air temperature at the heating element intake is above a pre-set threshold, the high-limit thermostat will activate and de-energize the element. After the high-limit thermostat has cooled down, the thermostat resets and energizes the heating element. The temperature-limiting device is a thermal one-shot, located near the tumbler air intake. The thermal one-shot is designed to activate at temperatures above the set points of the high-limit and control thermostats. When the thermal one-shot activates, the heating element is permanently disconnected from electric power.

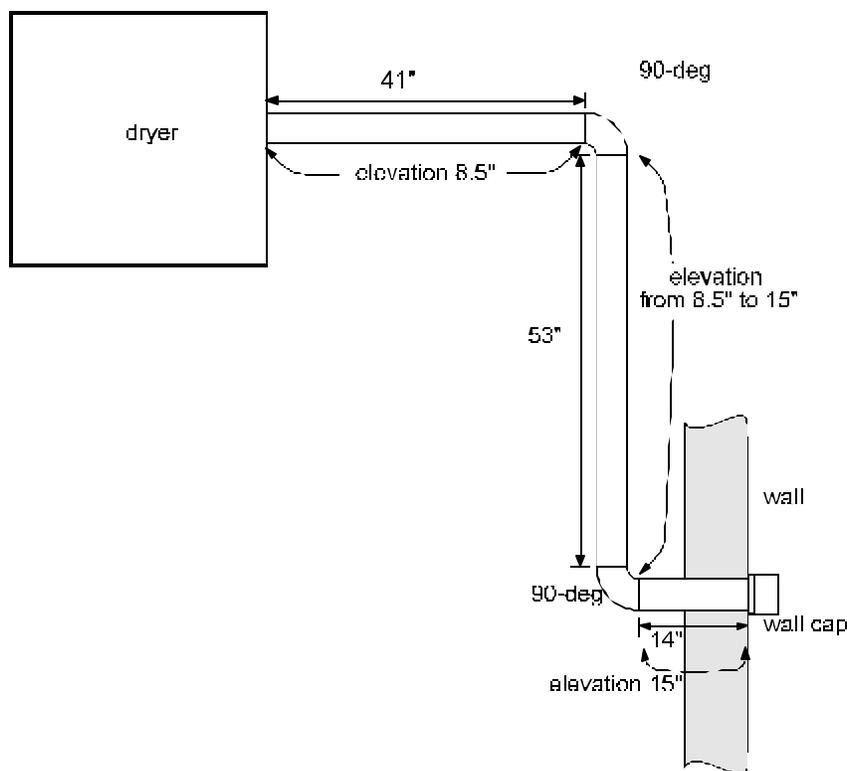
Figure 4. Exhaust Duct Setup Top View

For the tests, exhaust ducting was installed per the clothes dryer manufacturer's instructions. Rigid metal exhaust ducting consisting of about 9 feet of standard 4-inch diameter ductwork with two 90 degree bends was positioned horizontally from the clothes dryer exhaust to the outdoors and was terminated with a 4" cap, as shown in Figure 4.

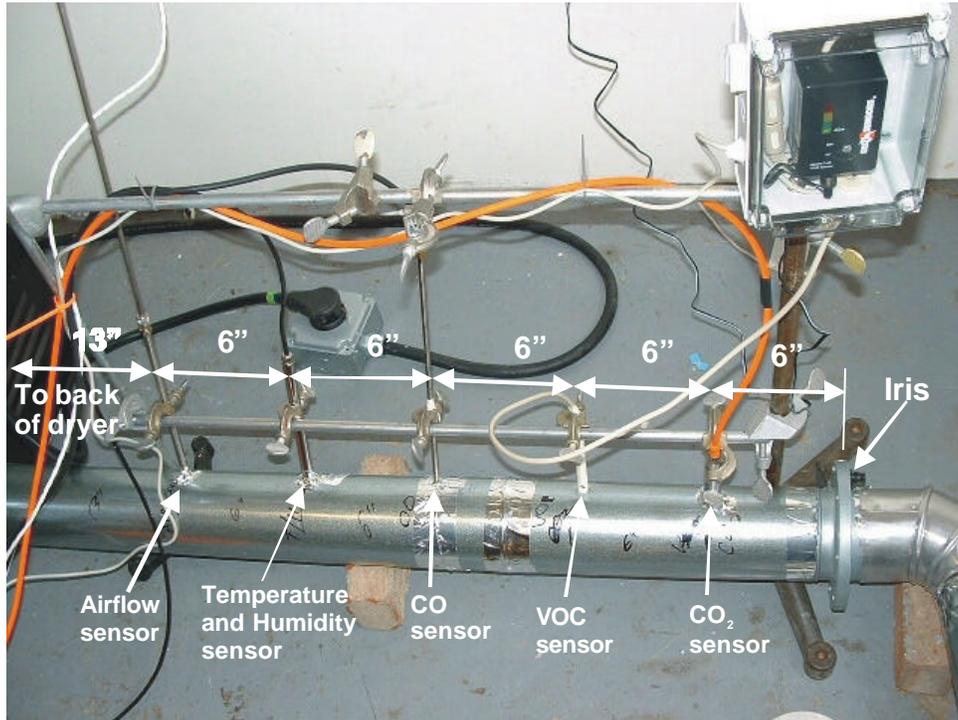
Figure 5. Sensors in the Exhaust

Six sensors were placed in the clothes dryer exhaust duct, as shown in Figure 5.

- Carbon monoxide. A sensor system with a 0 to 2000 parts per million (ppm) sampling range was used.
- Carbon dioxide. The sensor system used has a 0 to 5000 ppm sampling range.
- Volatile organic compounds (VOC). A broad-spectrum sensor, sensitive to many organic complexes, alcohols, and chlorinated compounds was used. The sensor's dynamic range varies depending on the chemical sensed but is generally in the few hundred-ppm range.
- Airflow was measured using a hot-wire anemometer. The output of the anemometer was scaled to standard feet per minute. That is, the output airflow value represents the same mass transfer of air standardized to 25-degrees Celsius and 1 atmosphere.

- Relative humidity. The sensor was capable of measuring from 0% to 100% relative humidity.
- Air Temperature. The relative humidity sensor was also capable of measuring the exhaust air temperature.

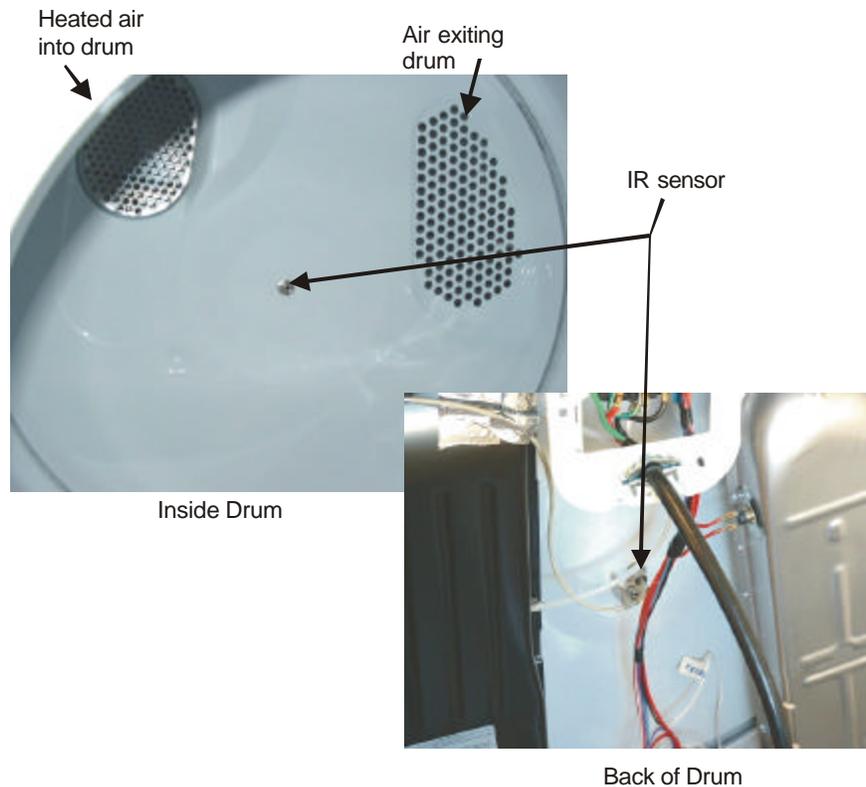
Figure 6. Infrared (IR) Sensor

In addition to the thermocouples, an infrared (IR) detecting sensor was installed to sense the temperature of the clothing load in the drum, as shown in Figure 6. This sensor was installed in the stationary rear wall of the drum and “looked” into the drum during operation.

In Figure 9, the infrared (IR) sensor temperature profile is not as smooth as the thermocouple temperatures, as expected. The IR sensor's viewing angle has a 2:1 ratio of distance to diameter and detects warm objects in a cone extending from the sensor front. As shown in the setup, Section 2.2.3, the IR sensor was installed at the rear of the drum to observe the load temperature. The tumbling load caused the IR temperature profile to be more erratic. Also seen in Figure 9, the IR profile became more erratic as the load became drier and tumbled more.

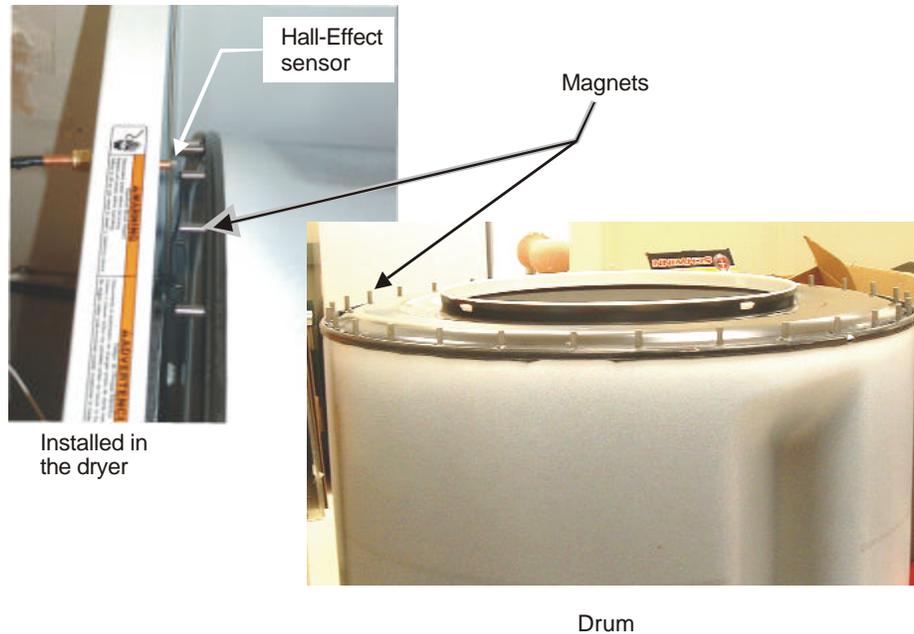
Figure 7. Hall Effect Sensor and Magnets

The rotation of the drum was detected through the use of magnets and a Hall Effect sensor. Thirty-two magnets were glued to the clothes dryer drum as shown in Figure 7. The sensor was positioned such that rotation of the drum caused an output pulse to occur whenever a magnet passed in front of the sensor. Hall

Effect sensors are insensitive to dust, temperature and vibration, all normal characteristics of electric clothes dryer operation. The number of magnets passing in front of the sensor for each 2-second sampling period was converted into revolutions per minute of the drum.

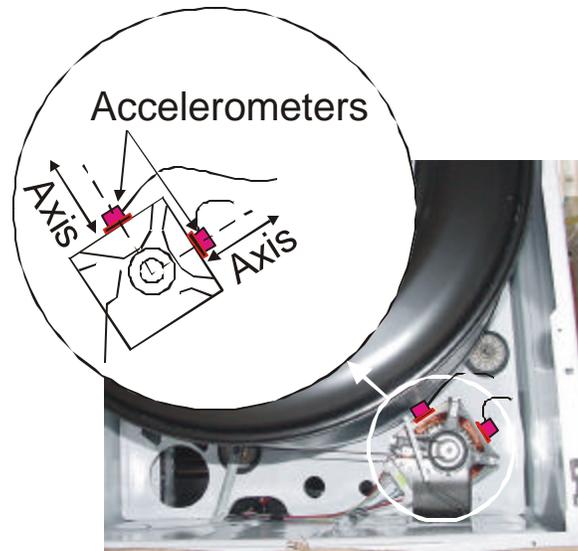
Figure 8. Accelerometers on the Motor Mount

Motor vibration was sensed with two single-axis accelerometers, attached perpendicularly to the motor mount, as shown in Figure 8. The accelerometers had a dynamic range of 0 to 20 g of acceleration. Eight seconds of data at a 128 Hz sampling rate were collected once each minute. A fast-Fourier transform (FFT) was performed on each data set, resulting in 0.125 Hz resolution over a dynamic range of 0 to 64 Hz.

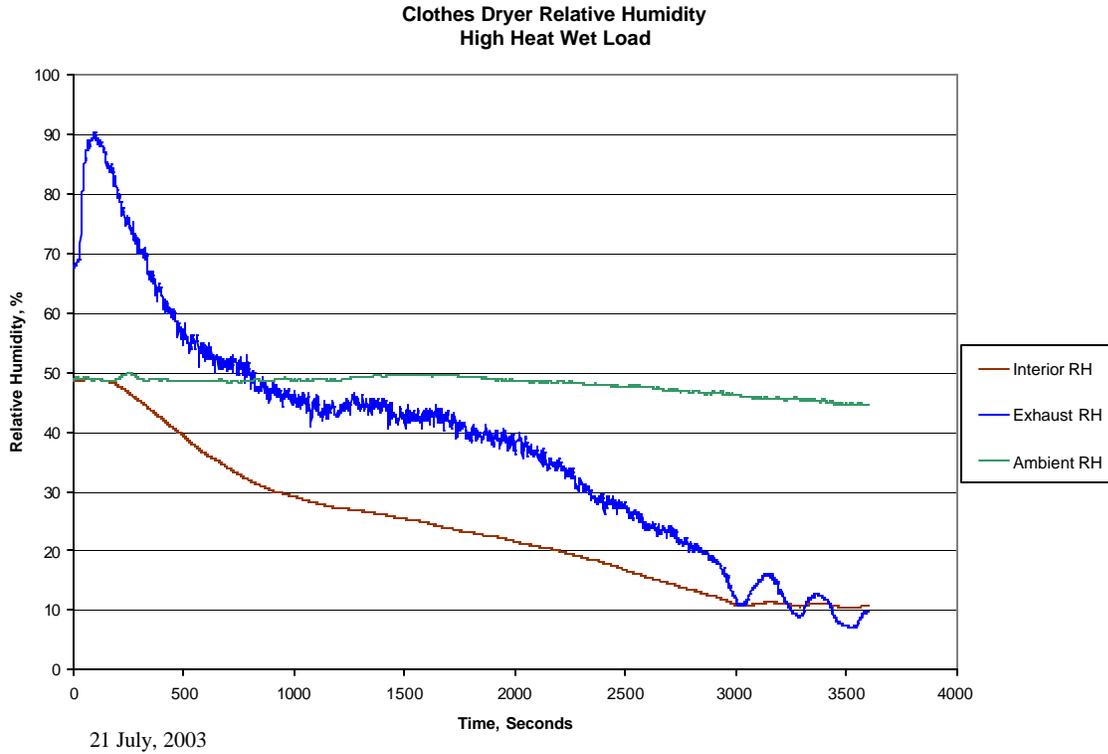
Figure 10. Relative Humidity

Figure 10 shows the response of the relative humidity sensors during a drying cycle. The control thermostat cycled three times during the test.

The ambient humidity also began to decrease slightly about halfway through the drying cycle. This was mainly caused by the increase in ambient room temperature from heat dissipated by the dryer and the exhaust duct. The test room's dimensions were approximately 15 feet long by 10 feet wide by 10 feet high.

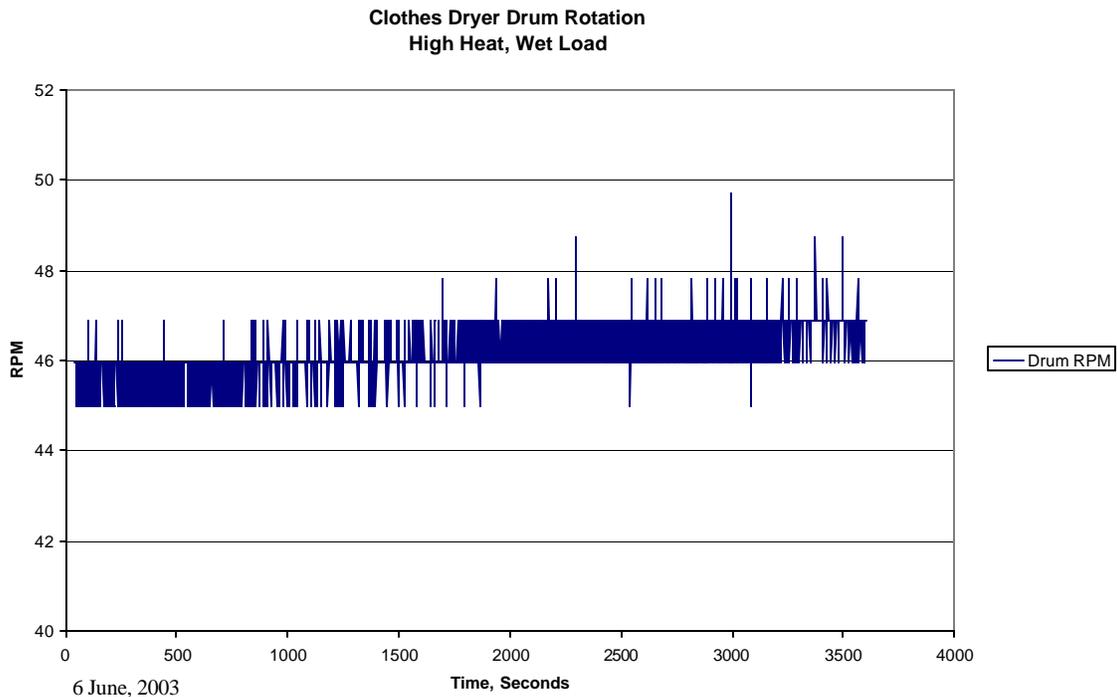
Figure 11. Drum Rotation During Drying

A load of wet towels weighed about 22.2 pounds (10.1 kg) from which about 10 pounds (4.5 kg) of water were removed during the drying cycle. This represents a decrease of 45% of the load's weight. This weight change was only weakly reflected in the rotation rate of the drum. For the model clothes dryer tested, the average drum rotation rate was 46.3 revolutions per minute (RPM). Despite the large decrease in the weight, the drum rotation speed increased by about 1 RPM, or 2%, during the drying cycle. With no load in the drum, the average rotation rate was measured at 47.6 RPM. Figure 11 shows a plot of the calculated rotation rate versus time for a drying cycle with a wet towel load.

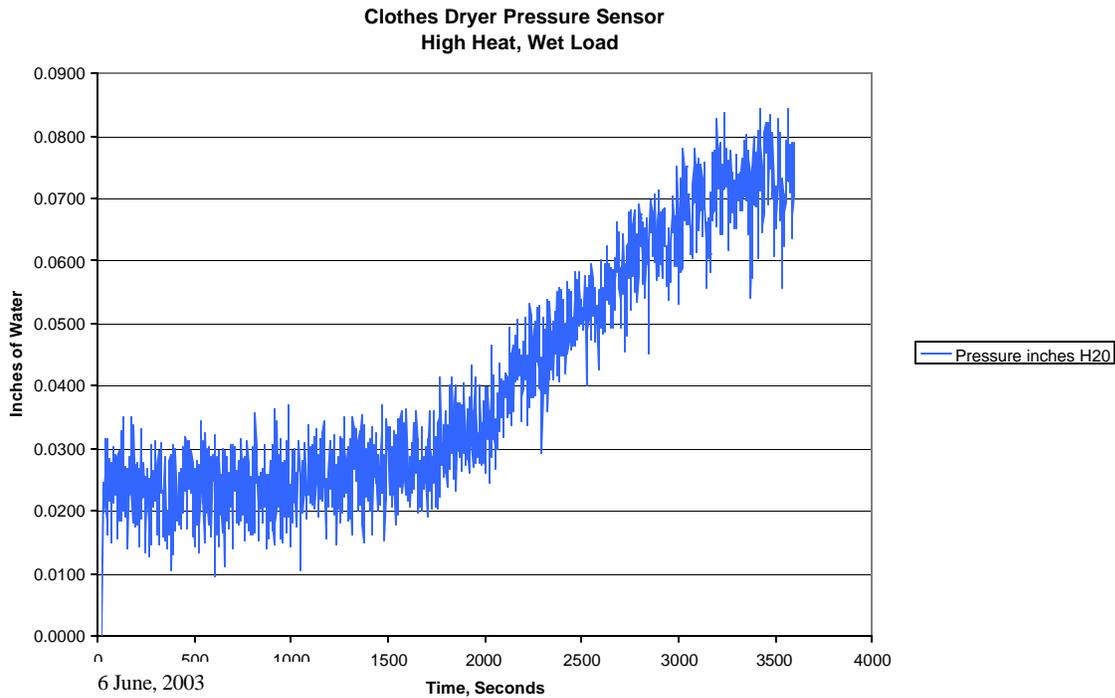
Figure 12. Pressure Drop Across the Lint Screen

When the clothes dryer was started, there was an immediate increase in the pressure drop sensed across the lint screen. The pressure difference from the front to the rear of the lint screen increased by about 0.025 inches of water (6.2 Pascals, Pa or N/m²). As the load dried, the pressure typically increased by another 0.043 inches of water (10.6 Pa). Interestingly, the pressure change was not linear. Rather, the pressure difference increased very slowly for about the first 30 minutes then rose more rapidly for the last half of the drying cycle. About one-fifth to one-third of the total pressure change occurred in the first half of the drying cycle, with the remainder accumulating in the latter half. Figure 12 shows a typical pressure profile of a wet towel load during drying.

The location of the lint screen is also a place with a great deal of air turbulence, shown as reading-to-reading variations that are a significant fraction of the average values.

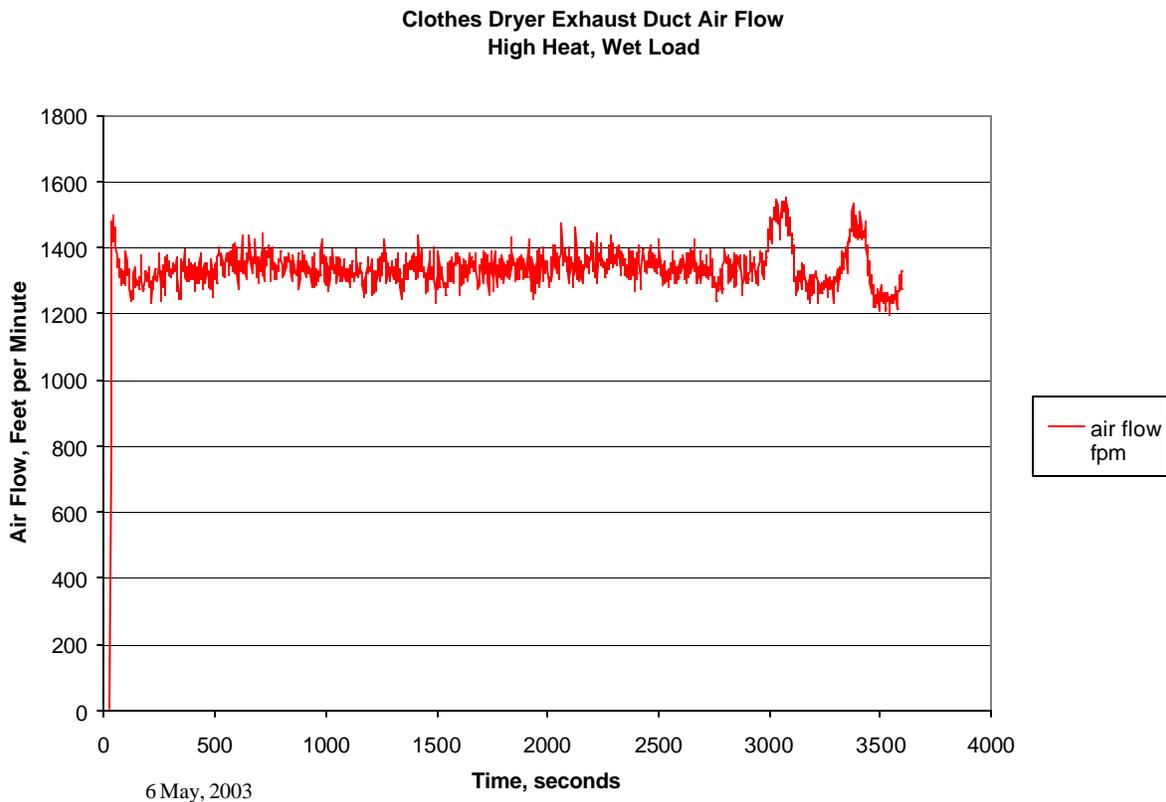
Figure 13. Typical Exhaust Duct Airflow

Airflow through the exhaust duct was characterized by a constant flow, unaffected by the accumulation of small amounts of lint in the lint screen. The average exhaust velocity was about 1337 feet per minute (fpm). Figure 13 illustrates a typical flow profile during the drying cycle. The “bumps” at the end of the cycle are due to rapid air temperature changes when the control thermostat cycled the heating element. The anemometer used two resistance temperature detector (RTD) sensors, one heated from 50 to 100 °C above the airflow’s ambient temperature. The other RTD monitored the airflow temperature. The amount of electrical power needed to maintain this temperature difference was the measured output variable. As the airflow temperature changed, the control circuit maintained a constant “over-heat” temperature difference between the heated sensor and the ambient airflow temperature. Since the anemometer is a device that uses heat transfer to determine airflow, rapid temperature changes created temporary artifacts in the calculated flow values. In this sequence, the control thermostat cycled twice.

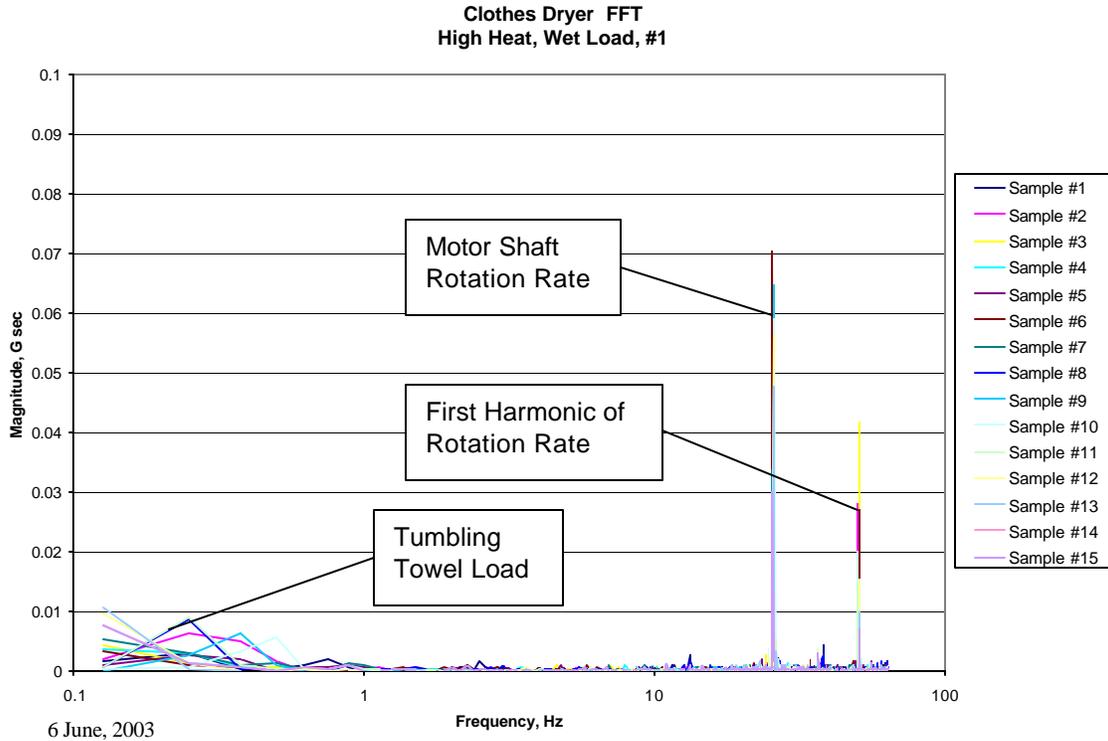
Figure 14. Fast Fourier Transforms of Accelerometer Data

Figure 14 shows an example of the FFT of a wet load at the beginning of the drying sample. An eight-second data set was taken each minute for fifteen minutes. The FFT of each data set was computed and plotted.

The third feature associated with the FFT was related to the tumbling of the towel load in the tumbler. Vibrations were detected at frequencies below 1 Hz as the drum baffles lifted the load, and the load then fell onto the drum bottom. Due to the erratic nature of tumbling, the peak magnitudes occurred at various frequencies below 1 Hz. Generally, as the towel load dried, there was a tendency to see lower amplitudes and very slightly higher frequencies. This may be due to the relative lightness of the mostly-dry load compared to startup conditions. At the end of a drying cycle, the towels tumbled more uniformly and easily; and they landed on the drum more softly than did wet towels.

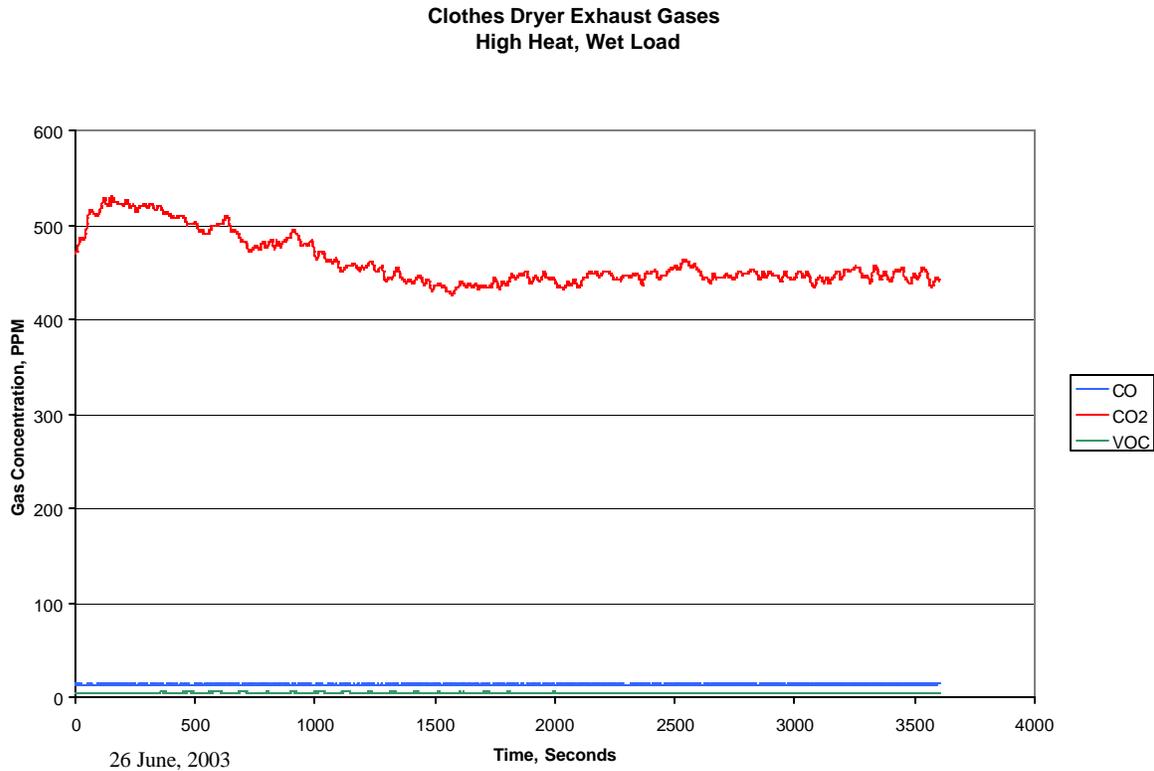
Figure 15. Exhaust Gases During Drying

The sensors utilized to monitor the exhaust air from the clothes dryer during testing were: carbon monoxide (CO), carbon dioxide (CO₂), and a broad range of volatile organic compounds (VOC). For the CO and VOC sensors, regular towel loads (with or without use of a detergent during the wash cycle) generated predictably low signals. For CO₂, the ambient background levels were detected. These values varied from around 330 ppm up to 800 ppm. A number of tests showed a higher CO₂ level at the beginning of the drying

cycle, then a decrease as the towel load dried. As seen in Figure 15, the CO₂ level rose to around 575 ppm, then decreased to about 420 by the end of the test.

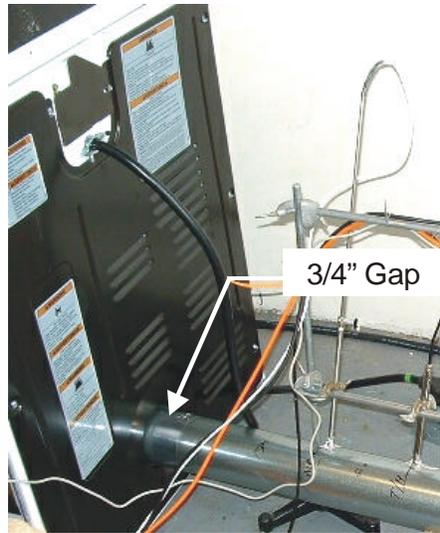
Figure 16. Exhaust Air Leak Location

For this test scenario, the exhaust duct was separated from the dryer by a gap of about $\frac{3}{4}$ inches. Figure 16 illustrates the test condition.

Shown without gap

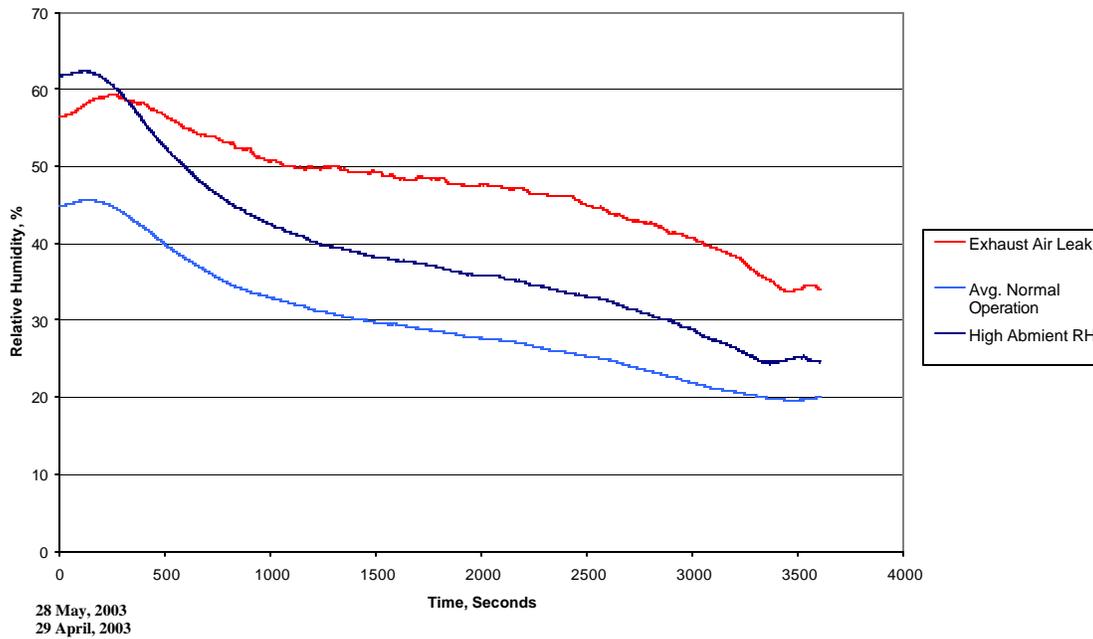
Figure 17. Relative Humidity

The only observed effect of this type of abnormal operation inside the clothes dryer was that of the relative humidity inside the chassis but outside of the drum. The interior relative humidity at the end of the drying cycle was 34%. Normal operation results in an interior relative humidity of about 20%, even for high humidity ambient conditions. In this circumstance, humid exhaust air was leaking into the dryer interior from the blower output. Figure 17 shows the relative humidity of the exhaust air leak test, the relative humidity of an average of normal operations, and the relative humidity of a normal test with high ambient humidity.

**Clothes Dryer Relative Humidity
High Heat, Wet Load
Normal Operation and Exhaust Air Leak**

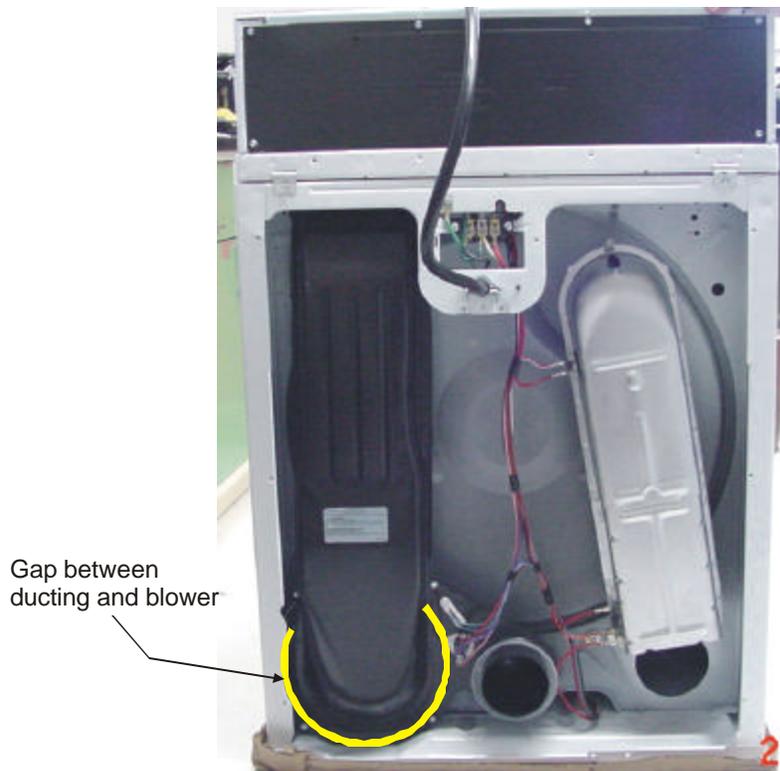
Figure 18. Blower Air Leak Location

A ¼ inch gap was created at the bottom of the ducting that directs air from the tumbler to the blower. Figure 18 shows a picture of the leakage path.

Shown without back cover for clarity
Yellow highlight represents location of air leakage

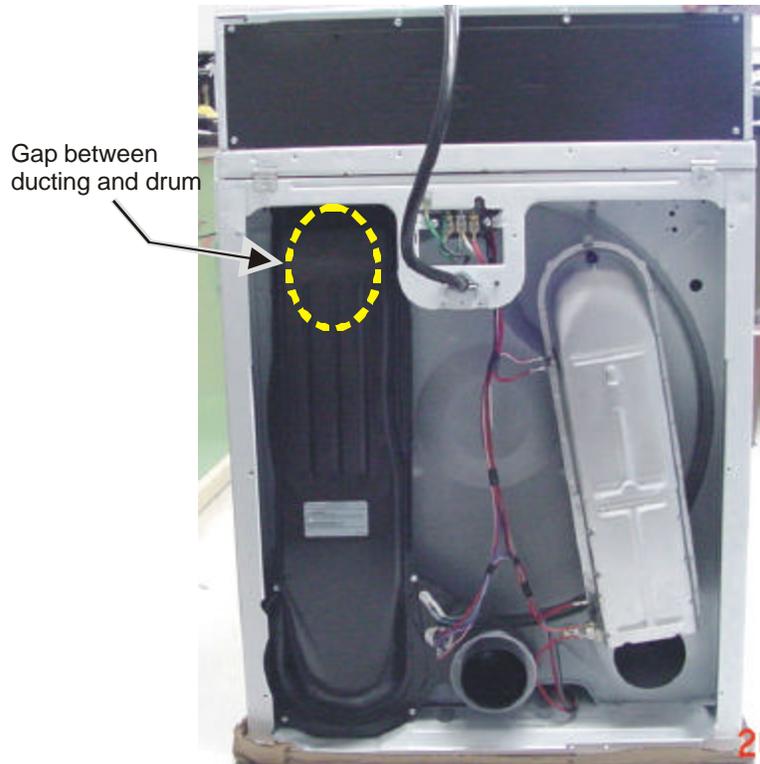
Figure 19. Air Gap Behind Drum

Similar to the air leak created at the blower intake, a gap was created between the stationary tumbler rear wall and the ducting to the blower. The gap was $\frac{3}{4}$ inches wide on the right side (as seen from the rear) and $\frac{1}{2}$ inches wide on the left side. Figure 19 shows the testing set-up.

Shown without back cover for clarity
Yellow highlight represents location of air leakage

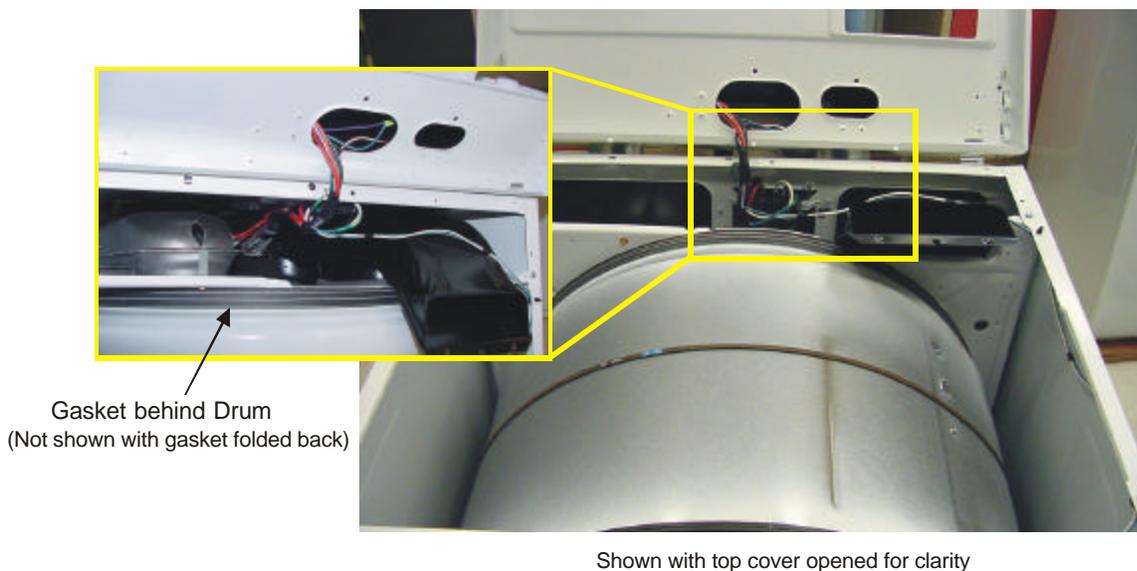
Figure 20. Drum Gasket Air Leak Location

The felt gasket located between the rotating drum and the stationary rear wall was folded back to create an air leak between the two components. This created an approximately ½ inch gap. Figure 20 illustrates this arrangement.

The change in airflow for this abnormal condition resulted in very high temperatures measured at the tumbler intake and relatively low temperatures measured “downstream” from the tumbler. The temperature around the heating element was hot enough to cause the high limit thermostat to cycle. The tumbler intake air temperature reached as high as 240 °C, or 50% above the normal temperature for this area. Elsewhere in the clothes dryer, temperatures of about 70 °C were observed – 10 °C less than their usual values. In a manner similar to other air leakage conditions, the reduced airflow across the heating element, combined with a constant power output, combined to overheat the air around the heating element.

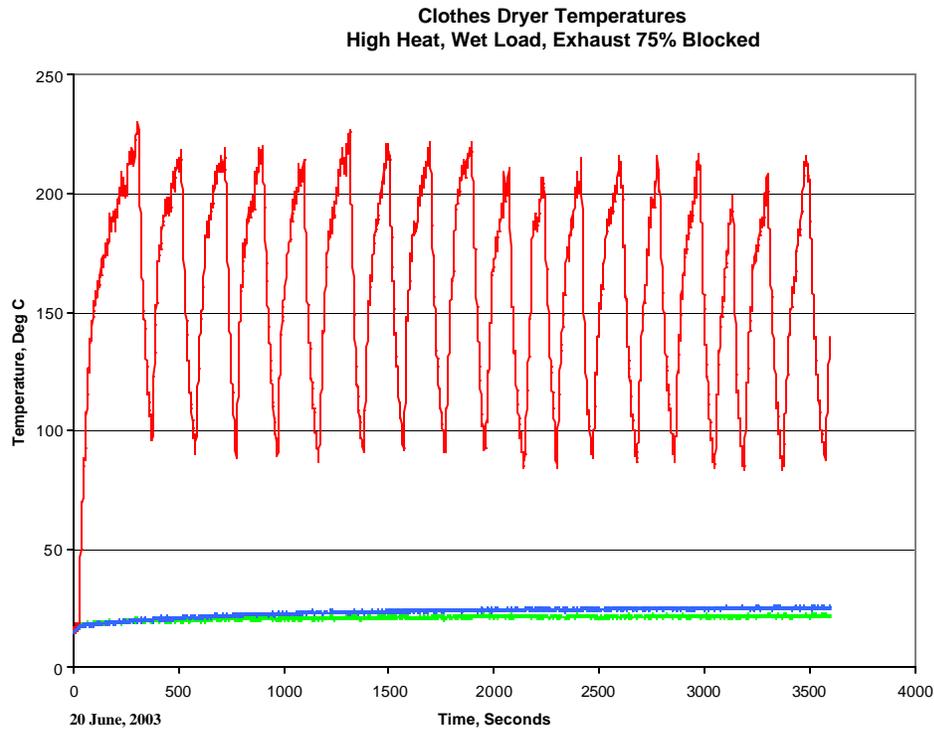
Figure 21. Thermostat Temperatures at 75% Blockage of the Exhaust Duct

At 50% blockage, the high limit thermostat was at an elevated temperature but not high enough to activate. The peak temperature of the high limit thermostat was recorded at 185 °C, or 6% above average. The control thermostat temperature increased by only 3 °C. When the blockage was increased to 75%, the system quickly started cycling on the high limit thermostat instead of the control thermostat. The cycling was rapid enough to keep the air in the area of the control thermostat cooler than normal. The control thermostat air temperatures were only slightly above ambient values. Figure 21 shows the high limit and control thermostat temperatures during a test with the exhaust duct blocked 75%. This graph is characteristic of a system cycling on the high limit thermostat. Under these conditions, the tumbler intake air temperature is higher than normal and there are many cycles in a short period. An exhaust duct blockage of 100% generated similar results.

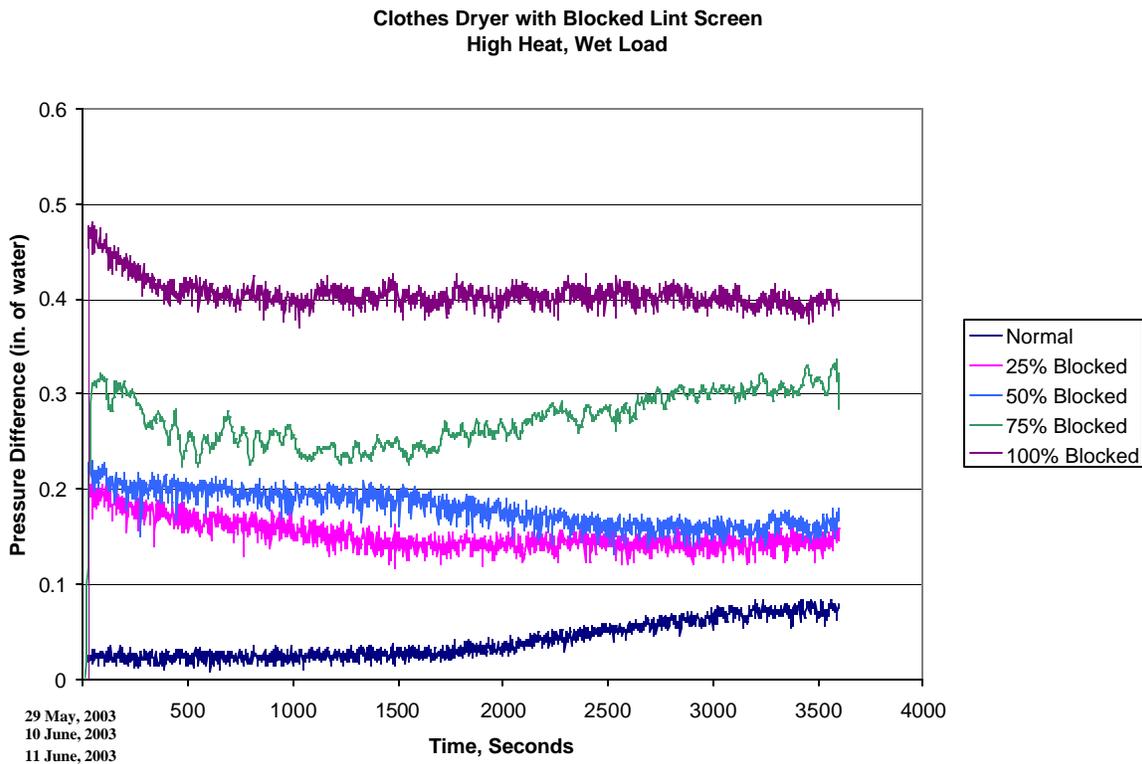
Figure 22. Differential Pressure across the Lint Screen with Successive Blockages

At higher blockages, the static pressure change also increased. With a 50% blockage, the static pressure change at dryer turn-on was 0.21 inches of water (52.5 Pa). A blockage of 75% generated a static change of 0.31 inches of water (77.5 Pa), and a fully blocked lint screen created a pressure difference of 0.46 inches of water (115 Pa). In each case of lint screen blockage, the static change persisted throughout the drying cycle. Figure 22 shows the pressure changes with successive lint screen blockages.

The effects of lint screen blockage on exhaust airflow were more modest. At 25% blockage, the exhaust airflow was only slightly less than expected values. With a lint screen blockage of 50%, the airflow decreased to about 1200 fpm, or 89% of the regular flow. At a blockage of 75%, the exhaust duct airflow had decreased to around 1000 fpm, or 75% of the normal airflow. Even at 100% blockage, a 950 fpm airflow (71% of the normal airflow) was detected in the exhaust duct. This last value may represent the ability of air to leak around the lint screen.

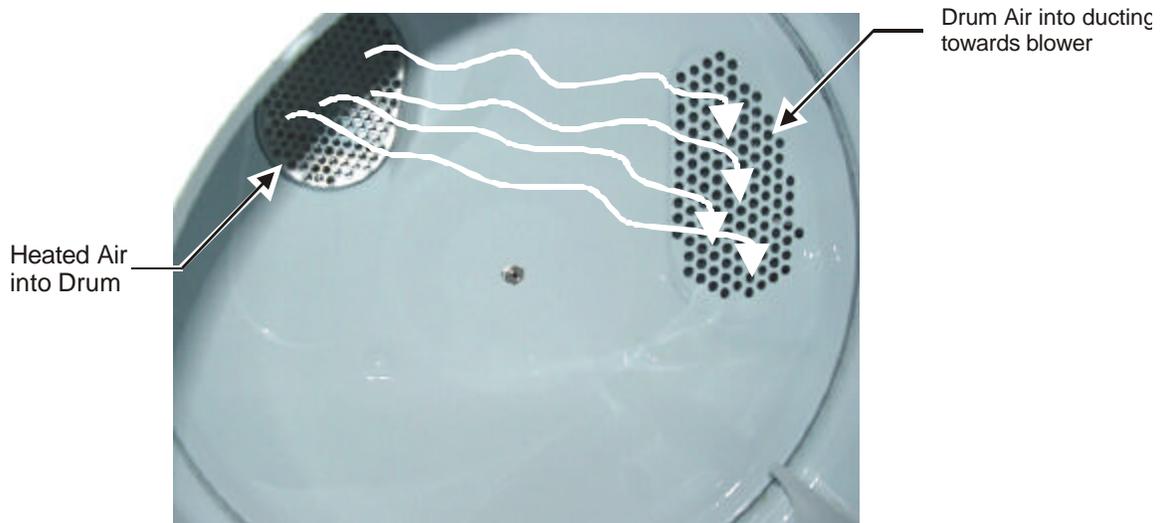
Figure 23. Tumbler Airflow Path

The airflow through the exhaust was reduced to about 1100 fpm from the average value of 1337 fpm, representing an 18% decrease. This particular model clothes dryer airflow path may explain why a greater decrease was not observed. The air enters and exits the tumbler through holes in the stationary rear wall. With an overfilled drum, the input air entered the tumbler, flowed along the rear wall, then exited to the blower, as illustrated in Figure 23. Only the portions of the towels next to the rear were dried. The remainder of the towel load stayed wet. If the dryer design had the airflow path cross from the rear to the front of the tumbler (and through a lint screen mounted in or below the dryer door), the effects on airflow caused by overfilling the tumbler airflow may have been more pronounced.

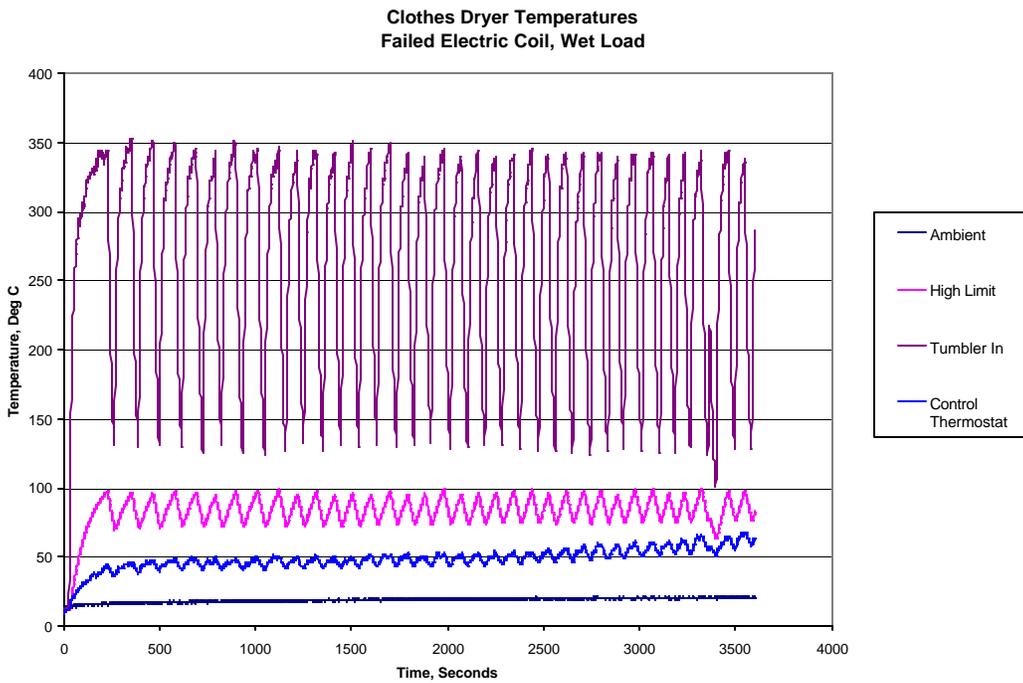
Figure 24. Modified Electric Coil Air Temperatures

This operating condition was the only one in which the current through the heating element varied from the routine 22 amperes. For this test, the current through the element was 35 amperes when energized. The modified heating element dissipated 8400 watts of heat, a 60% increase over the regular value of 5280 watts. None of the other operating modes tested had any effect on the magnitude of current through the heating element.

When energized, the modified heating element heated the air entering the tumbler very quickly to very high temperatures. At its maximum, the air at the tumbler intake exceeded 350 °C. However, the control thermostat air reached a maximum temperature of only 64 °C. The extra power dissipated by the heating element caused rapid cycling of the high limit thermostat, so much so that the control thermostat stayed relatively cool. Figure 24 shows the temperature response of the clothes dryer under these operating conditions. Figure 25 shows the corresponding current of the heating element cycling rapidly.

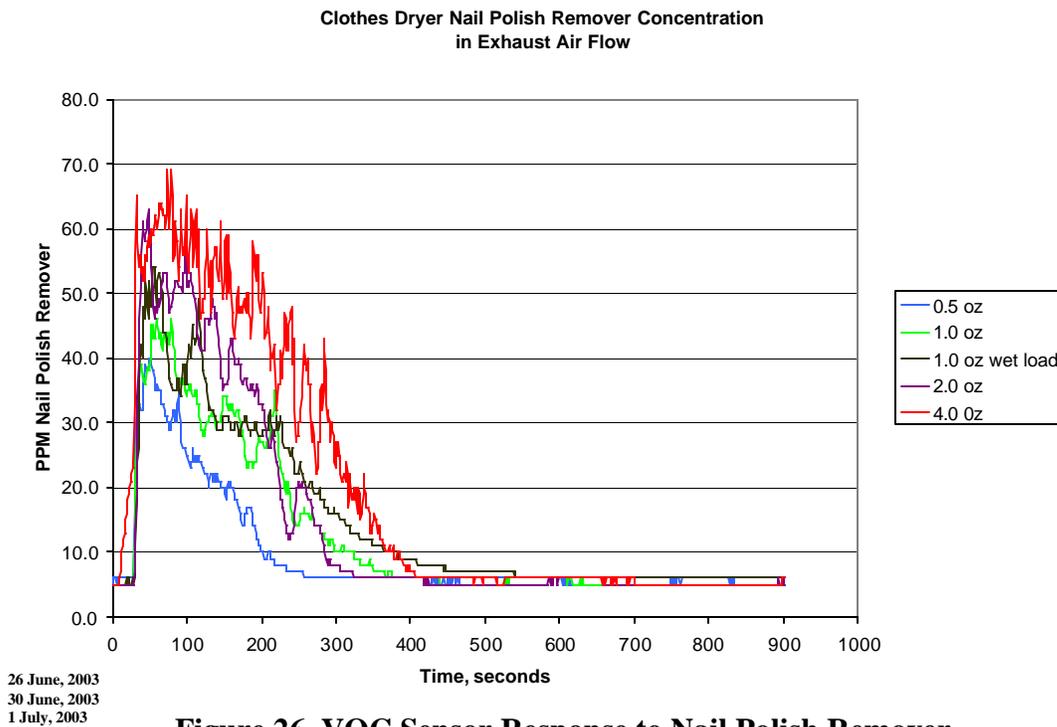
Figure 26. VOC Sensor Response to Nail Polish Remover

Figure 26 shows the VOC sensor response to nail polish remover. For the nail polish remover, the sensor response very quickly peaked, then declined. After about 7 minutes of operation, the output of the VOC detector had returned to background levels, indicating that no detectable concentrations (more than 5 ppm of nail polish remover) were in the exhaust airflow. Larger amounts of nail polish remover had a small effect on the amplitude and duration of the VOC sensor response. Wet towel loads did not seem to affect the magnitude or duration of the signal as compared to those for dry towel loads. All towel loads tested were dry except for the one wet load noted.

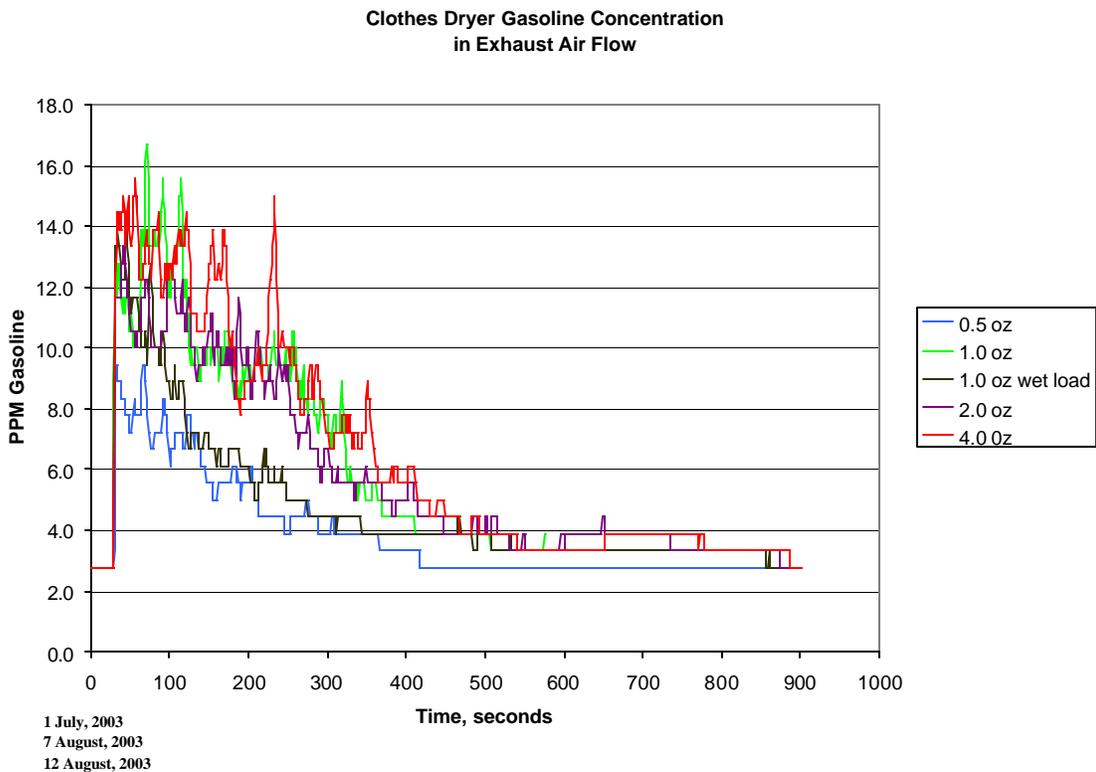
Figure 27. VOC Sensor Response to Gasoline

Unleaded gasoline was tested in a manner similar to the nail polish remover. Samples from 0.5 oz. to 4 oz. were measured out and added to a small portion of a towel. The portion was added to a dry or wet towel load, data collection was initiated, and the dryer (on the high heat setting) was started at around the 30-second mark.

Components of the gasoline were quickly detected in the clothes dryer exhaust duct. However, the amplitudes of the signals detected were small and their durations were brief. For the highest levels of gasoline tested, between 8 and 10 minutes were required for the sensor output to return to background levels. The concentration of the detected chemicals remained low throughout the tests. Figure 27 shows the VOC sensor response to gasoline. The sensor output was cross-correlated to a gas chromatograph / mass spectrometer analysis of a sample of the clothes dryer exhaust air.
