Detection of Abnormal Operating Conditions in Electric Clothes Dryers

April, 2004

**Directorate for Engineering Sciences
Randy Butturini
Arthur Lee**

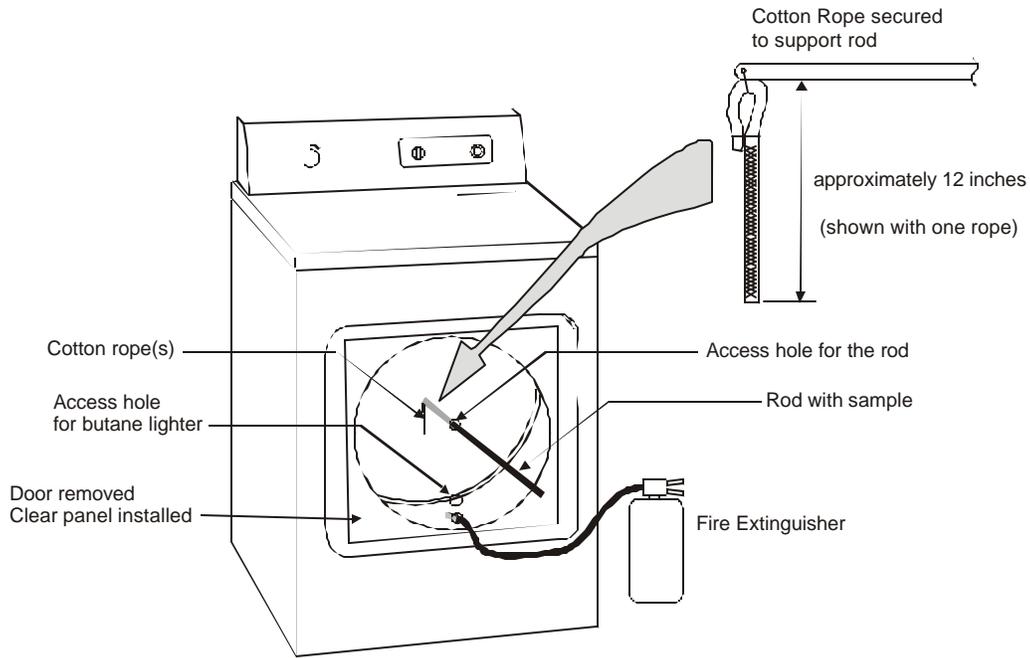
Figure 28. Test Setup for Smoldering Combustion

Samples of smoldering cotton rope were placed in the clothes dryer tumbler, as shown in Figure 28. In the first set of tests, from 1 to 4 cotton rope samples were suspended and

ignited to achieve smoldering combustion. For the second set of tests, 4 smoldering cotton rope samples were tumbled with a dry load of towels.

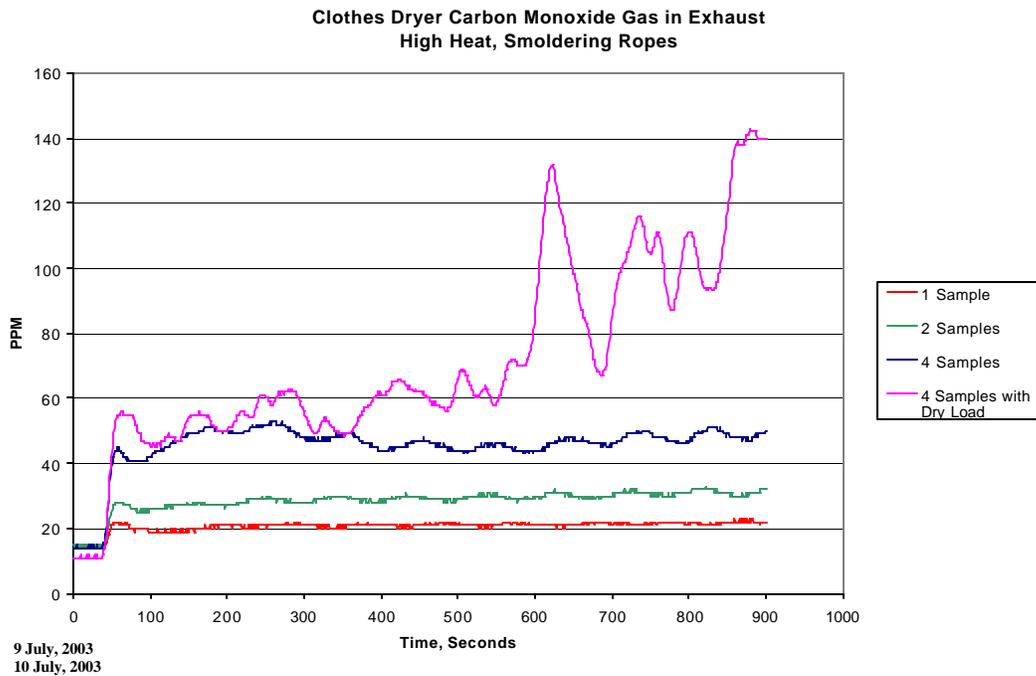
Figure 29. Carbon Monoxide Detection of Smoldering Combustion

Of the sensors monitored, the carbon monoxide (CO) and volatile organic compounds (VOC) detectors produced non-normal responses. As seen in Figure 29, increasing numbers of smoldering samples increased the amount of CO detected in the exhaust airflow. Using only one sample almost doubled the response of the CO detector over the background reading. When the dry towel load was tested with smoldering samples, the amount of CO generated increased sharply after a few minutes of operation. The sample towel set had numerous small burns on the terrycloth as a result of contact with the burning embers of the cotton rope samples.

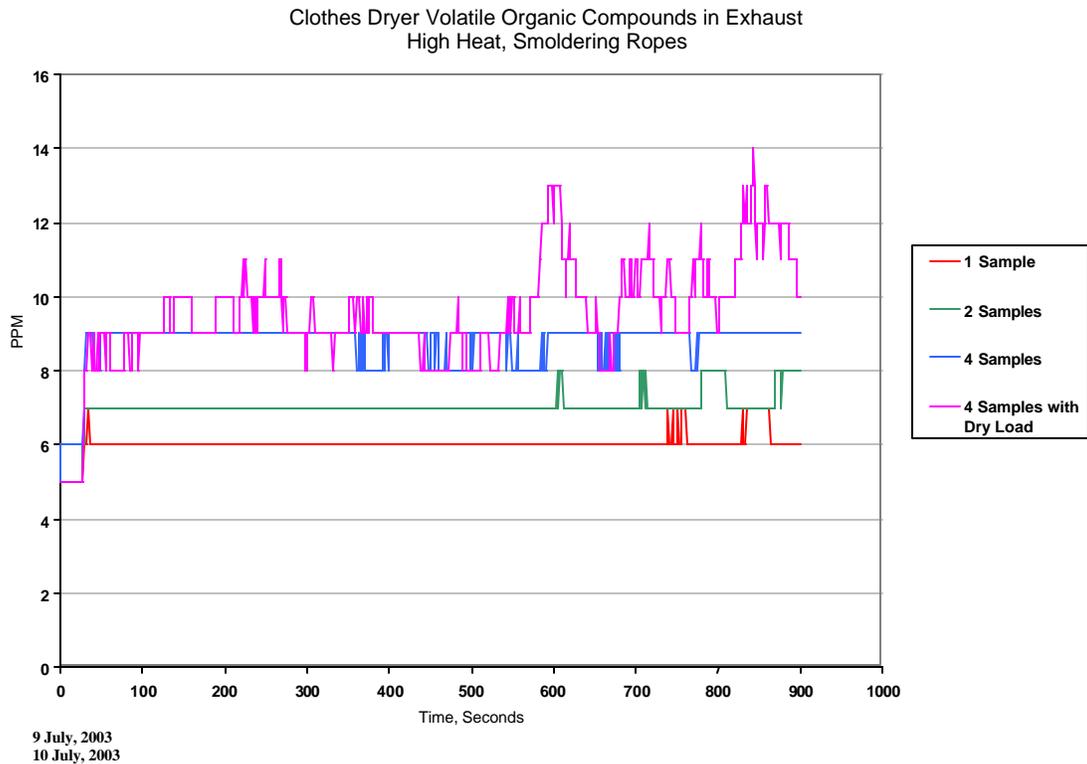
Figure 30. Volatile Organic Compound Detection of Smoldering Combustion

The VOC sensor also generated responses similar to those of the CO detector, but at a much lower level. With a background signal of about 5 PPM, smoldering samples generated small magnitude but large percentage changes. Four smoldering samples raised the sensor's response to around 9 PPM. The dry towel load test with four samples also resulted in increased VOC detection levels during the latter portion of the test. Figure 30 shows the response of the VOC sensor to smoldering combustion.

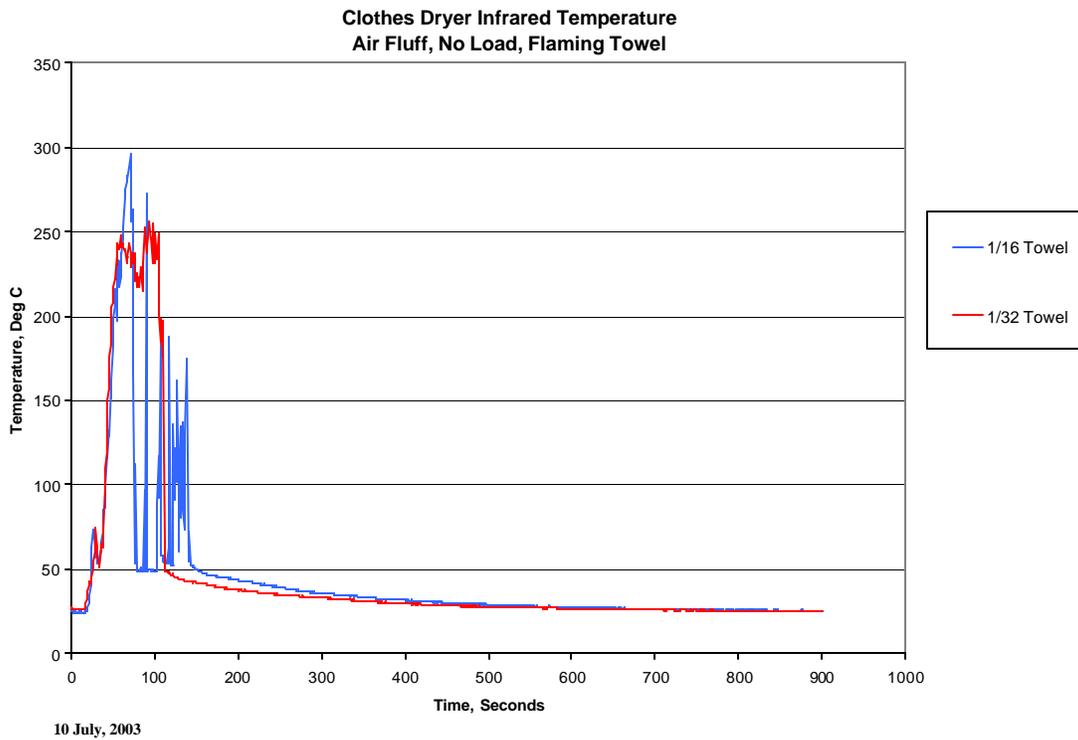
Figure 31. Infrared Sensor Response to Flaming Combustion

The ignited samples flamed brightly as they tumbled in the empty drum. The infrared sensor recorded temperatures approaching 300 °C in the drum whenever the sample passed into the sensor’s field of view. Figure 31 shows the infrared sensor’s response. There was a slight rise in the air temperature at the entrance to the blower. The maximum recorded air temperature at the blower intake was about 50 °C. By the time the air reached the exhaust duct, the air had cooled to around 38 °C.

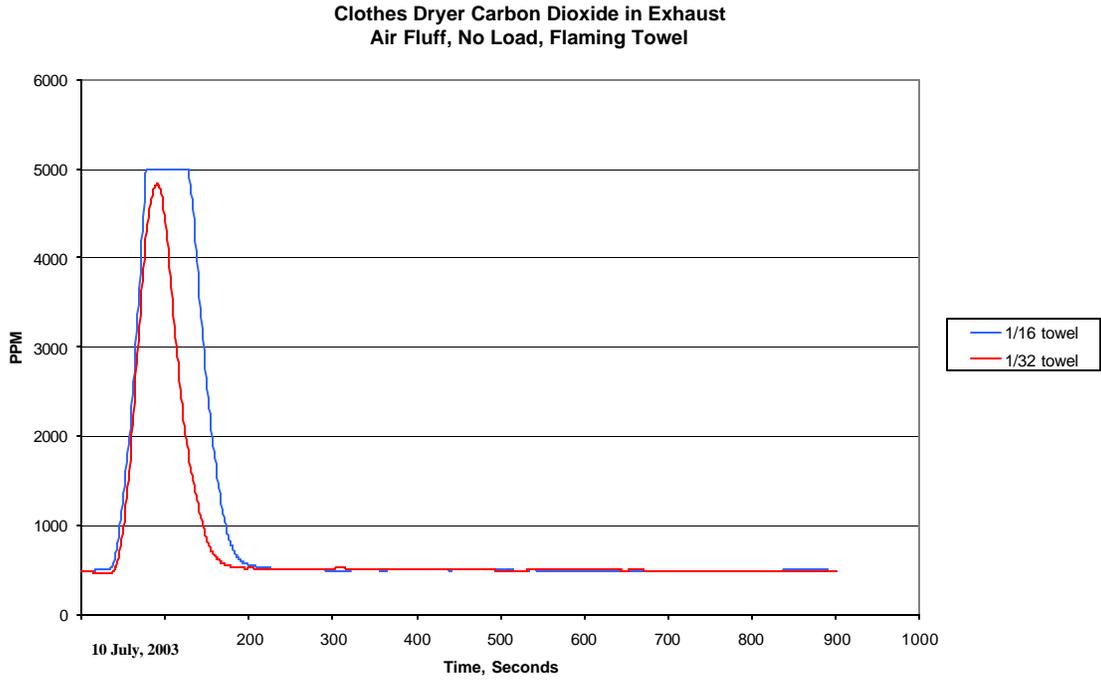
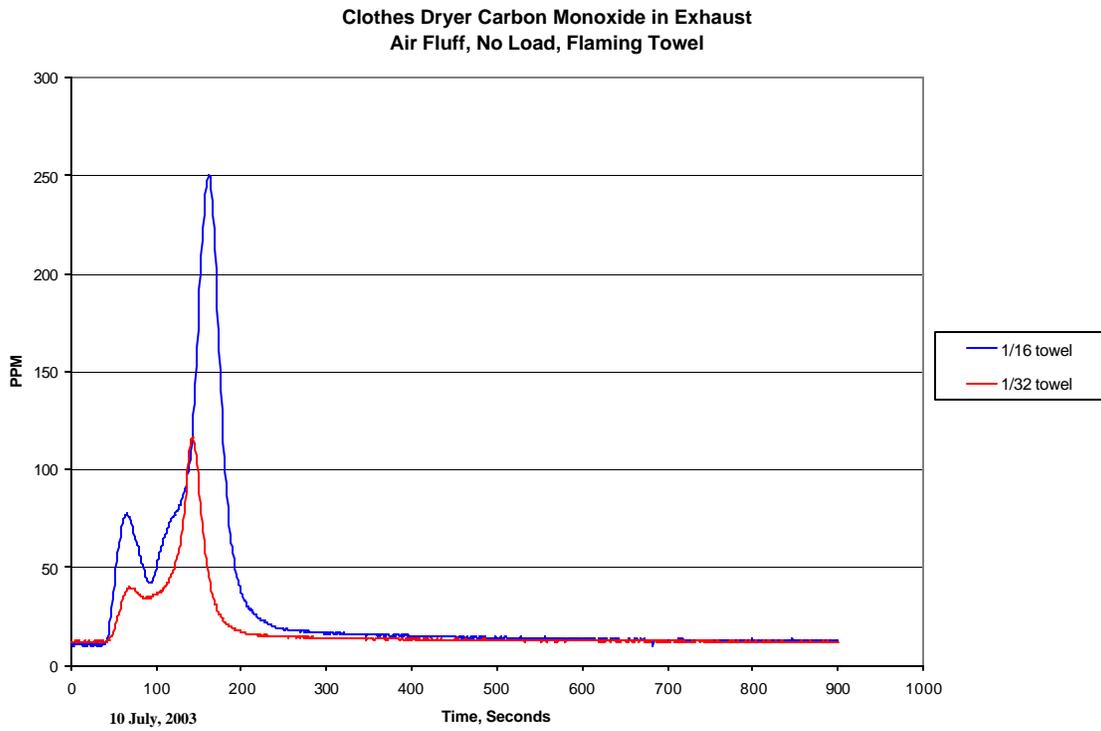
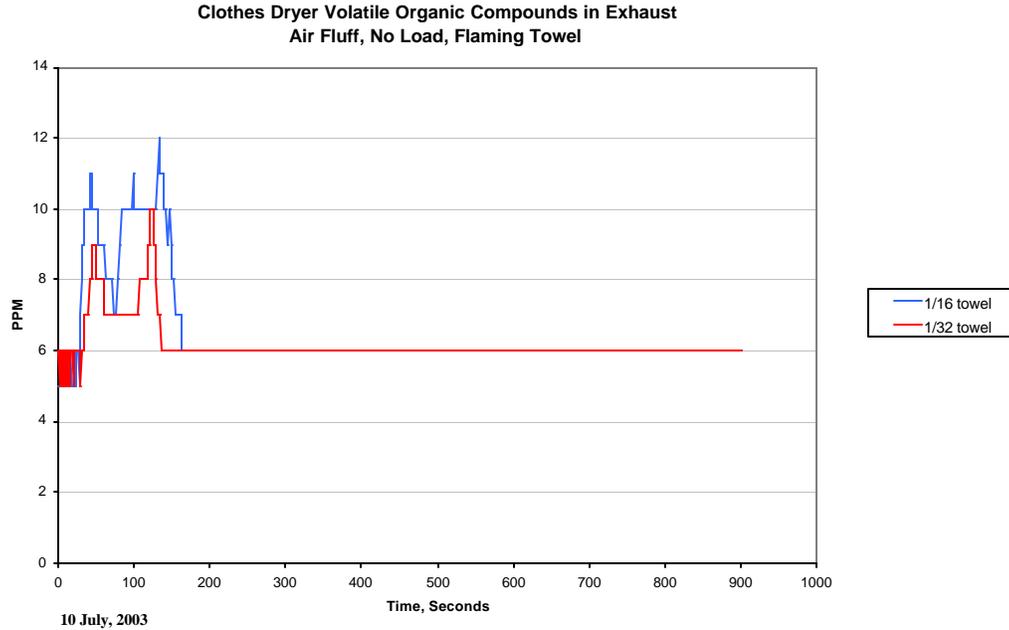
Flaming combustion generated strong signals on all the gas sensors in the exhaust duct. The 1/16th towel sample saturated the carbon dioxide sensor output at 5000 PPM. With the blower operating and no towel load to restrict the airflow, there was less carbon monoxide produced; but the peak measured levels were still 10 to 17 times the background reading. The VOC sensor also detected the combustion with a doubling of its output reading. Figures 32 through 34 show the gas sensor responses to flaming combustion in the tumbler.

Figure 32. Carbon Dioxide Sensor Response to Flaming Combustion

Figure 33. Carbon Monoxide Sensor Response to Flaming Combustion

Figure 34. VOC Sensor Response to Flaming Combustion

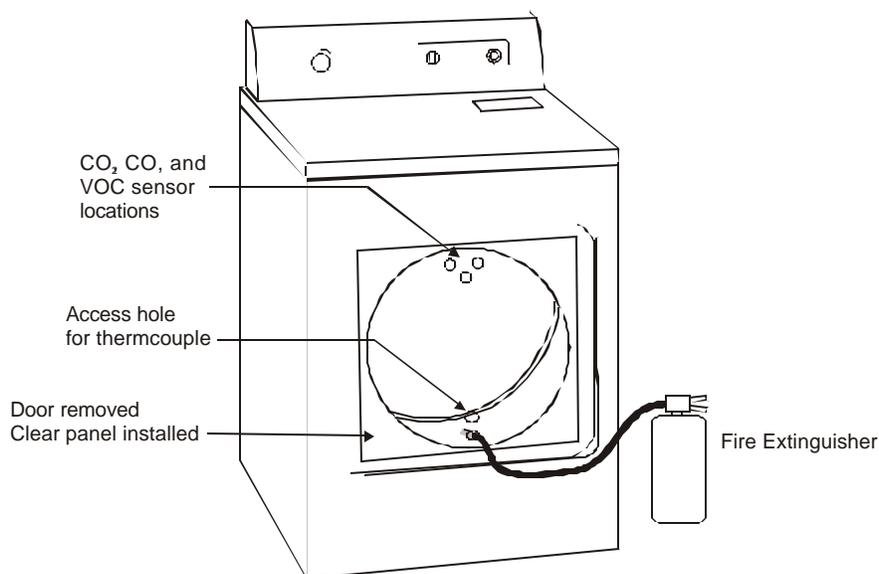
Figure 35. Test Setup for Spontaneous Combustion

For these sets of tests, the CO, CO₂, and VOC sensors were relocated from the exhaust ducting to the interior of the drum. The dryer door was removed and a clear panel was secured in its place. The three sensors were mounted on the upper portion of the clear panel, as shown in Figure 35. A thermocouple was inserted into the load to monitor the temperature inside the load after it had stopped tumbling.

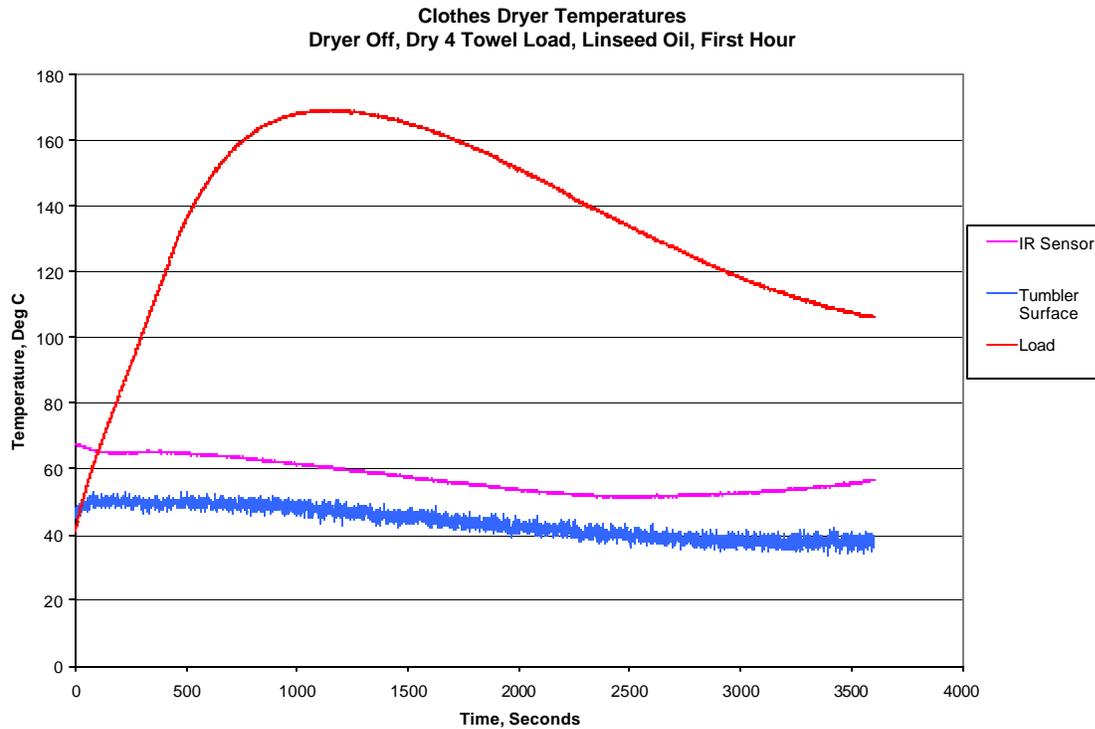
Figure 36. Linseed Oil and Towels in the Drum During the First 60 Minutes

Most of the temperatures monitored in the clothes dryer decreased smoothly towards an asymptotic value of around 40 °C. However, the temperature sensor inserted into the load rose from 45 °C to 169 °C over an 18-minute period before starting to decrease. The sensor did not reach the center of the load and, therefore, probably did not measure the hottest area. Figure 36 shows some measured temperatures over the first hour after the dryer was stopped.

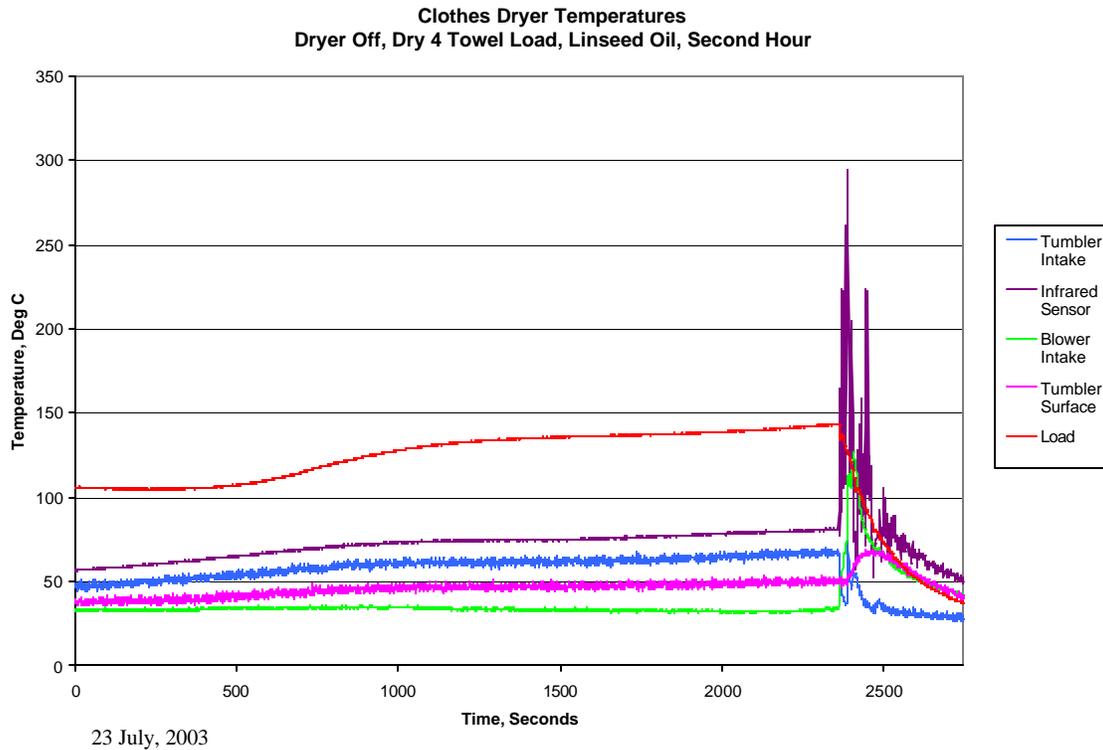
Figure 37. Linseed Oil and Towels in the Drum for the Second 60 Minutes

Thirty minutes after the dryer had been stopped, smoke could be seen leaking from the clothes dryer. The amount of smoke increased steadily during the testing. After 50 minutes, the inner rear wall of the tumbler was difficult to see through the smoke in the dryer. At about the 70-minute mark, the load temperature started to rise from a minimum of 100 °C. The infrared temperature sensor output increased due to emission from the portion of the load in the sensor's field of view.

The test was terminated at the 100-minute mark. By this time, the load temperature had risen to 143 °C, and the infrared sensor output was at 81 °C. The clothes dryer was emitting large amounts of thick smoke. The dryer was started on the air fluff cycle to determine if the load could be cooled by tumbling. The dryer load quickly ignited once fresh air was introduced into the tumbler, as shown in Figure 37 by the sudden increase in the infrared and blower intake temperatures. (The sudden decrease in temperature was caused by the release of CO₂ from the fire extinguisher.)

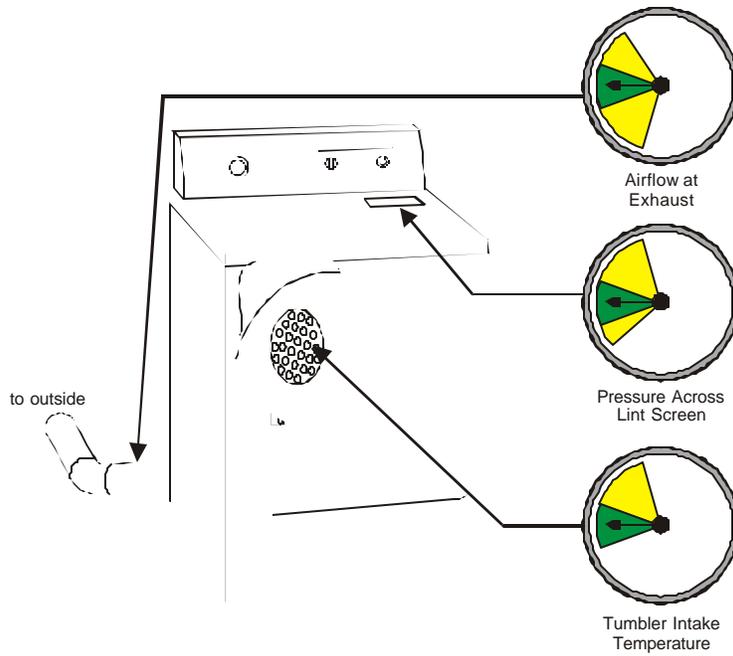
Figure 38. Sensors indicating Normal Operation

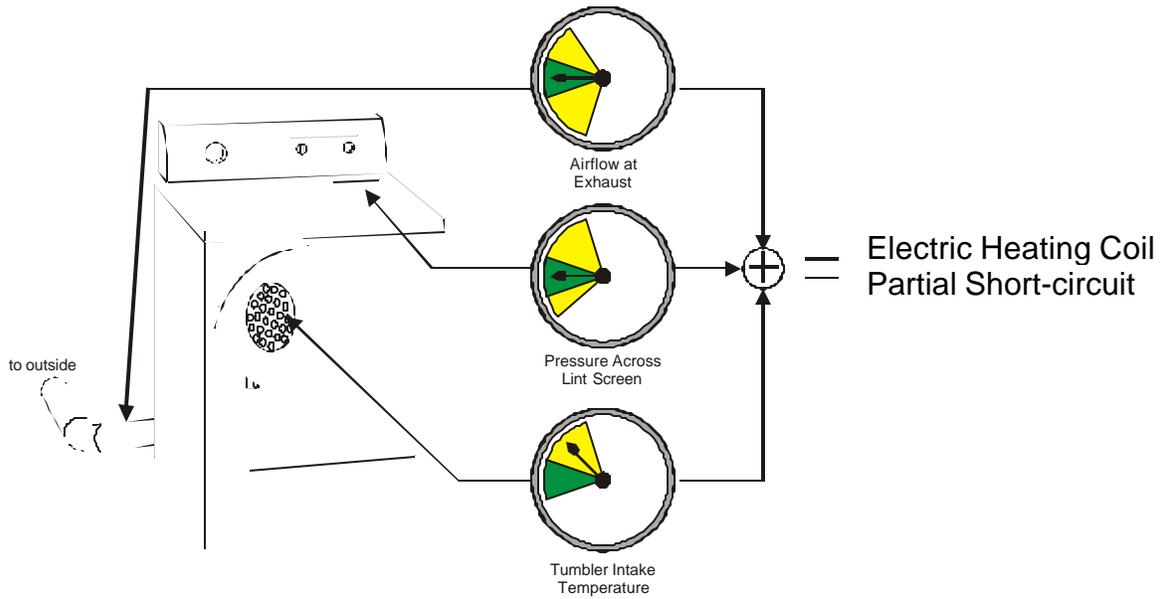
Figure 39. Sensors indicating Electric Heating Coil Partial Short-Circuit

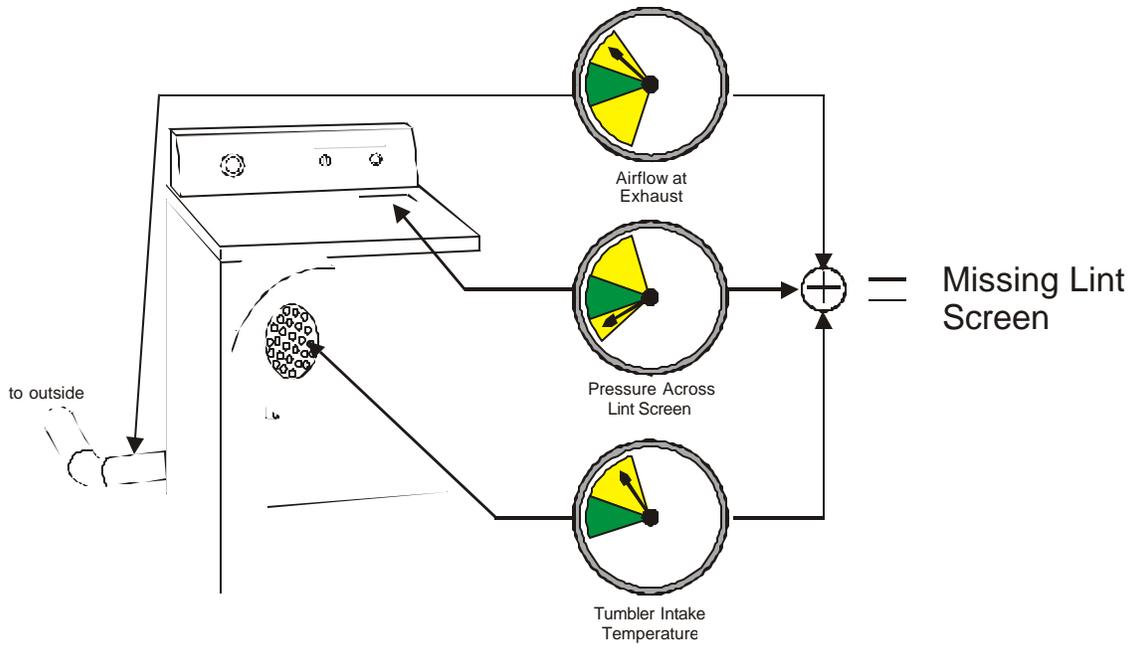
Figure 40. Sensors indicating Missing Lint Screen

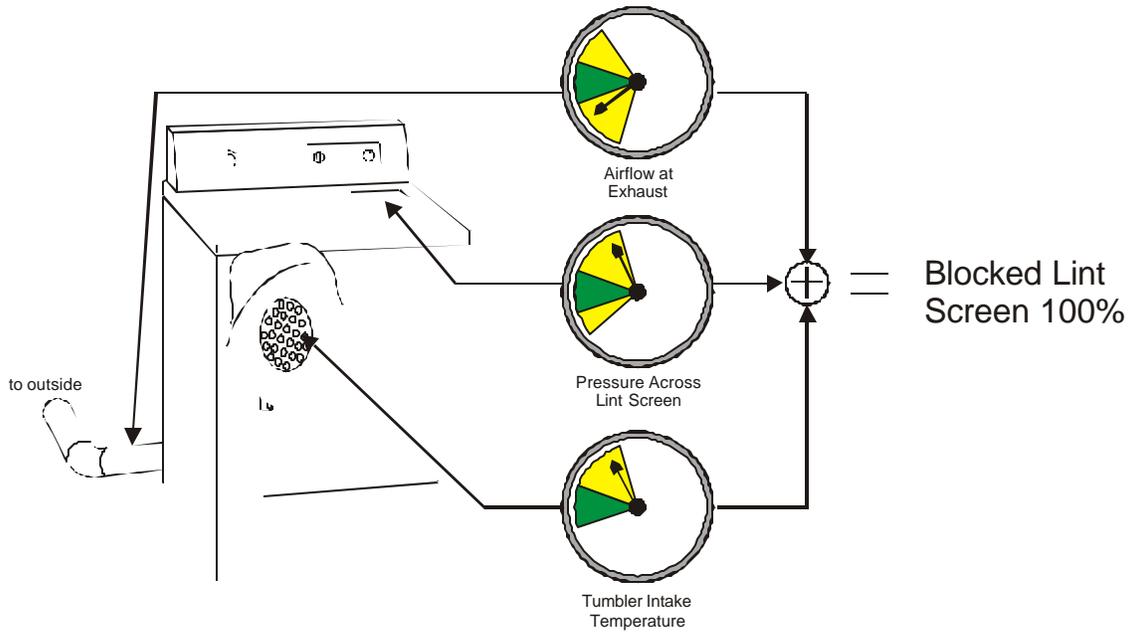
Figure 41. Sensors indicating Blocked Lint Screen

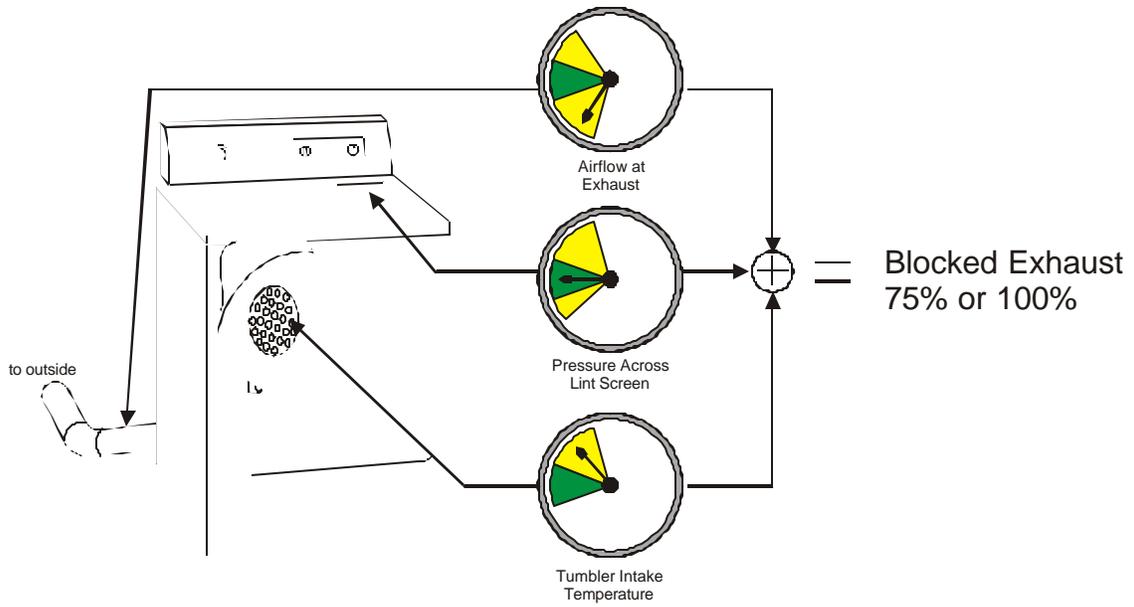
Figure 42. Sensors indicating Blocked Exhaust

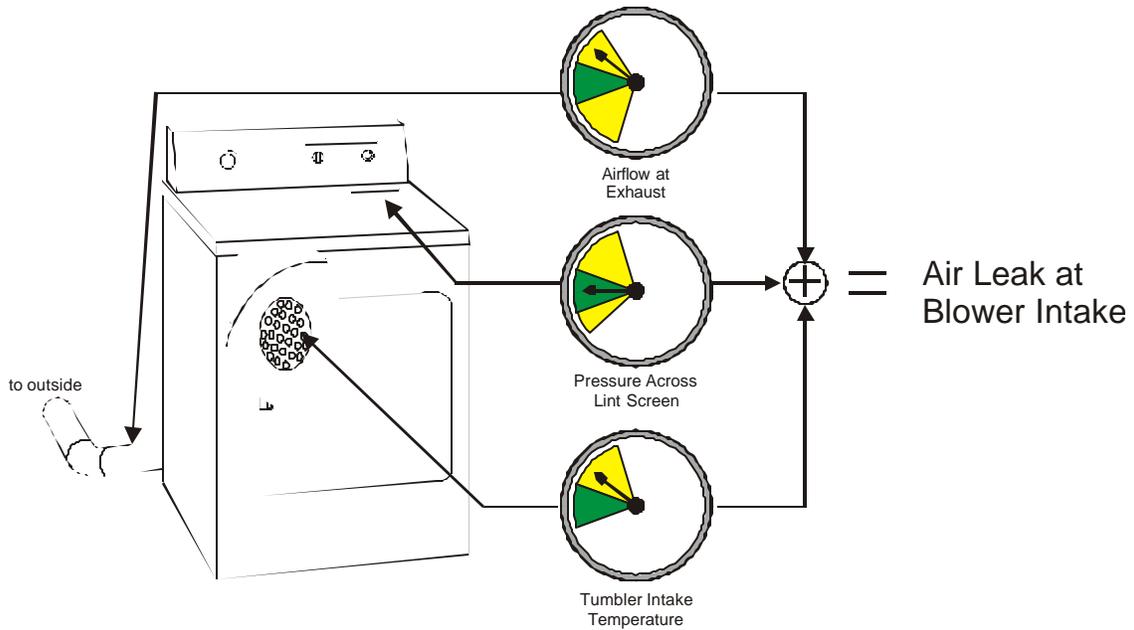
Figure 43. Sensors indicating Air Leak at Blower Intake

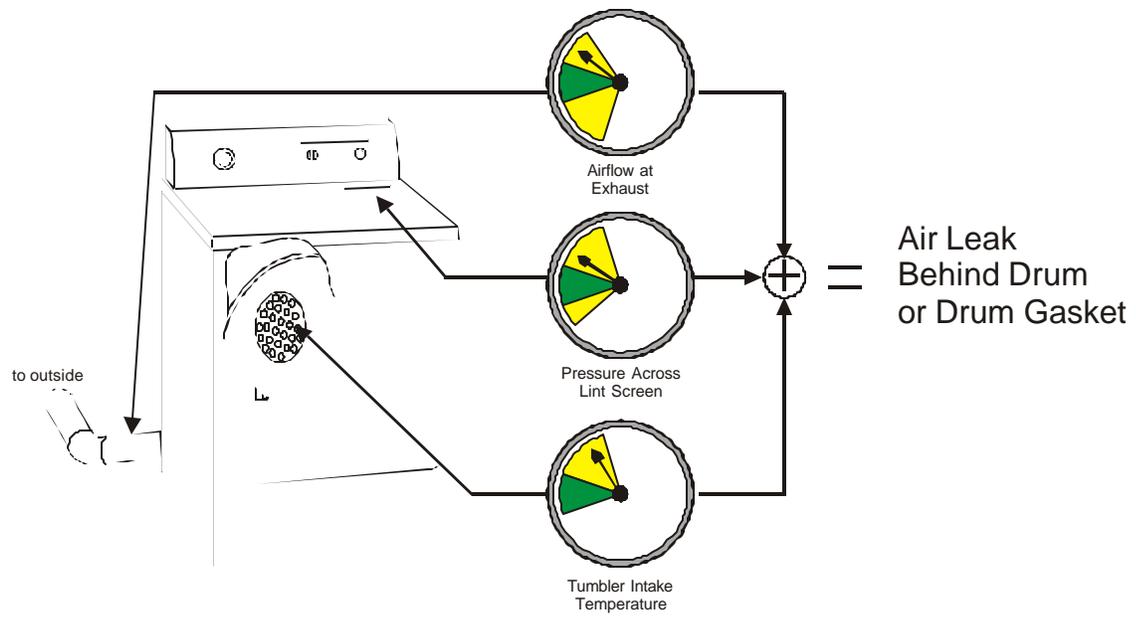
Figure 44. Sensors indicating Air Leak Behind Drum or Drum Gasket
