REPAIRING ALUMINUM WIRING

U.S. Consumer Product Safety Commission
Bethesda, MD
www.cpsc.gov
www.SaferProducts.gov

Publication 516

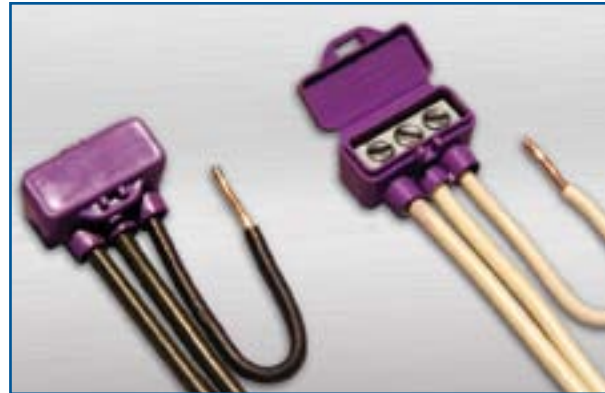
CPSC staff recognizes that copper replacement may be cost prohibitive and that the COPALUM repair may be unavailable in a locality. Based upon an evaluation that was, in part, CPSC supported,⁵ consumers are advised that, if the COPALUM repair is not available, the AlumiConn connector may be considered the next best alternative for a permanent repair. This repair method involves pigtailing using a setscrew type connector instead of the COPALUM crimp connector in the repaired connections. The AlumiConn connector has performed well in initial tests, but is too new to have developed a significant long-term safe performance history as the COPALUM repair. The repair should be conducted by a qualified electrician because careful, professional workmanship and thoroughness are required to make the AlumiConn connector repair safe and permanent.

The AlumiConn Connector
