This memorandum provides a discussion of the work done by the U.S. Consumer Product Safety Commission's (CPSC) Directorate of Laboratory Sciences (LS) staff to evaluate the sensitivity of the draft furniture flammability test protocol<sup>1</sup> and the test fixture<sup>2</sup> described in the draft protocol to various conditions and deviations from protocol requirements.

SUBJECT : Cleaning and Wear Effects on Upholstery Fabric Flammability

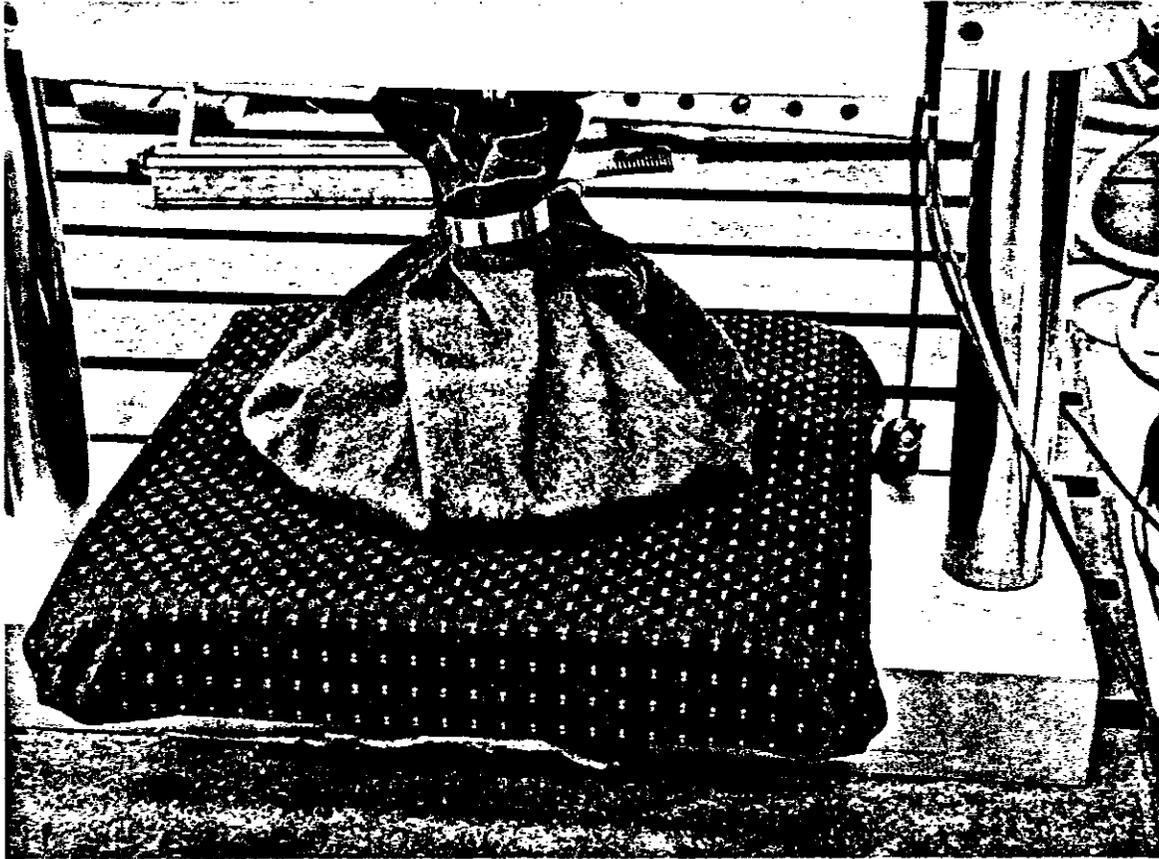
Based on the above information and to facilitate testing issues, the following test was proposed to assess the durability of flame-retardant back coating of fabrics. This test is a combination of ideas from ASTM D 3574 - 95 Standard Test Methods for Flexible Cellular Materials - Slab, Bonded, and Molded Urethane Foams - Test I<sub>3</sub> - *Dynamic Fatigue Test by Constant Force Pounding* (Sections 95 to 99), and BS 4875-85 Strength and Stability of Furniture Part 1 - Methods for Determination of the Strength of Chairs and Stools - Section 7.4 - Test 4: seat and back fatigue test, with certain modifications. Figure 1 shows the test configuration. Materials and test procedures used for the study are described below:

Figure 1. Wear Testing (Constant Force Pounding)
