REPAIRING ALUMINUM WIRING

Publication 516

ALUMINUM WIRING

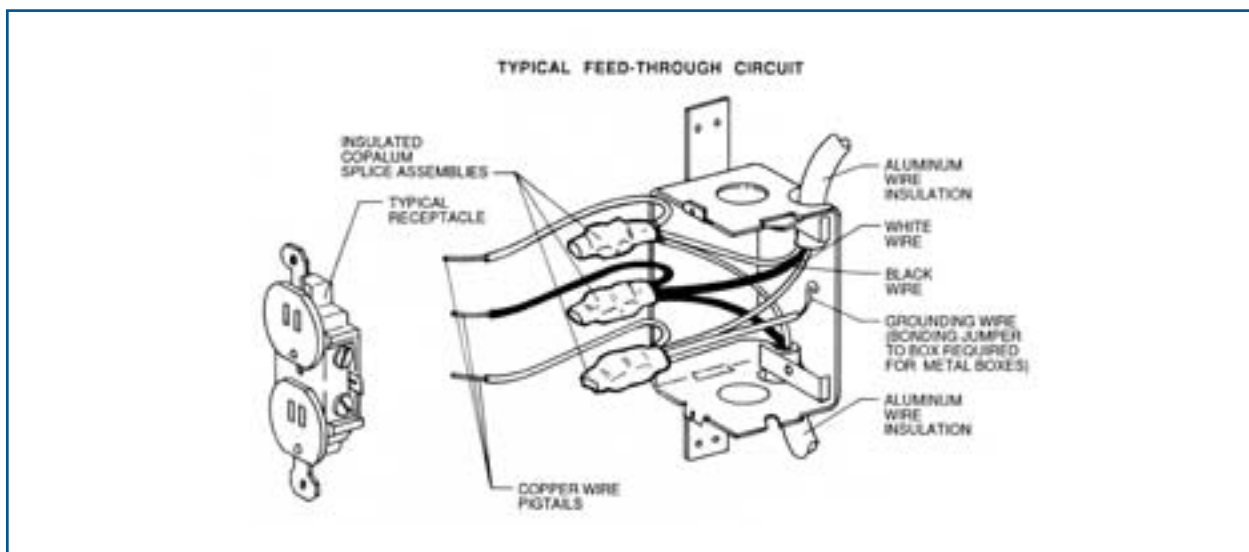
The tool is shown in the illustration below. An insulating sleeve is placed around the crimp connector to complete the repair. The copper wire pigtail is then connected to the switch, receptacle, or other termination device. An example of a repaired receptacle outlet is also illustrated below.

Recommended COPALUM Connector Repair

As an alternate to rewiring with copper, CPSC recommends attaching a short section of copper wire to the ends of the aluminum wire at connection points (a technique commonly referred to as “pig-tailing”), using a special connector named COPALUM to join the wires. CPSC staff considers pigtailing with a COPALUM connector to be a safe and permanent repair of the existing aluminum wiring. The repair should include every connection or splice involving aluminum wire in the home, including outlets, dimmers, switches, fixtures, appliances, and junction boxes. The repaired system, with short copper wire extensions at every termination throughout the home, permits the use of standard wiring devices, including receptacles and switches.

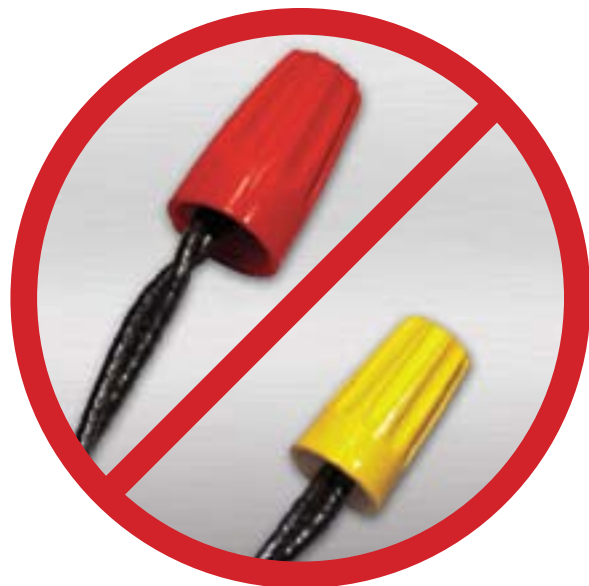
“Pigtail” with Twist-on Connectors Is Not a Recommended Repair

The first temporary repair involves pigtail with a twist-on connector. The effectiveness of “pigtail” using twist-on connectors has been evaluated by CPSC staff. In CPSC-sponsored laboratory testing and life tests, substantial numbers of these connectors overheated severely.

of twist-on connectors with aluminum wire. It is possible that some pigtail “repairs” made with twist-on connectors may be prone to even more failures than the original aluminum wire connectors. Accordingly, CPSC staff believes that this method of repair does not solve the problem of overheating present in aluminum-wired branch circuits.
