REPAIRING ALUMINUM WIRING

Publication 516

ALUMINUM WIRING

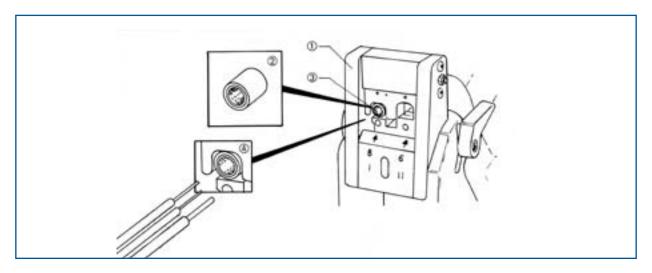
The COPALUM connector is a specially designed system that includes a metal sleeve intended to be installed only with a dedicated power tool and crimping die to make a permanent connection, that is, in effect, a cold weld (the precision dies in the COPALUM tool compress the connector and wires using upwards of 10,000 pounds of force, as required to make the permanent aluminum wire connection).

The tool is shown in the illustration below. An insulating sleeve is placed around the crimp connector to complete the repair. The copper wire pigtail is then connected to the switch, receptacle, or other termination device. An example of a repaired receptacle outlet is also illustrated below.

COPALUM Crimp Connector and its Specialized Installation Tooling

Only electricians who are trained by the manufacturer to use the tool properly are authorized to install COPALUM connectors. CPSC staff emphasizes that this training is necessary to ensure that the electrician uses the careful, professional workmanship and thoroughness required to make the crimp connector repair safe and permanent.

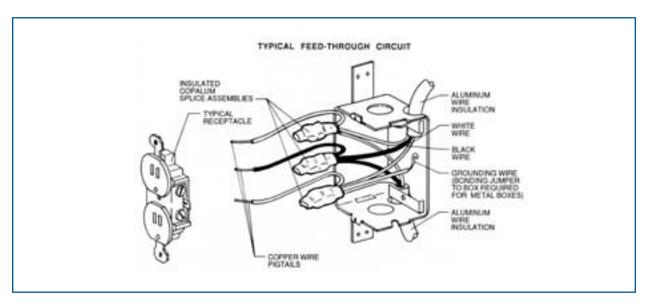
Recommended COPALUM Connector Repair

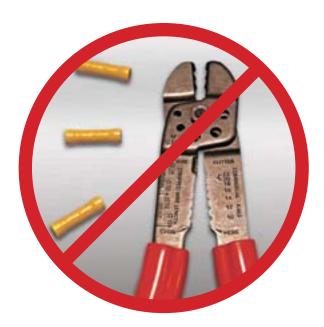
There are many other brands and types of crimp connectors — including those intended to be installed with a pliers-type of handtool — which are readily available to consumers at common retailers.

No other crimp connectors have been evaluated for connecting copper and aluminum conductors. CPSC staff strongly recommends against their use as a repair method.

Do Not Use Common Hand-Crimped Connectors with Aluminum Wire

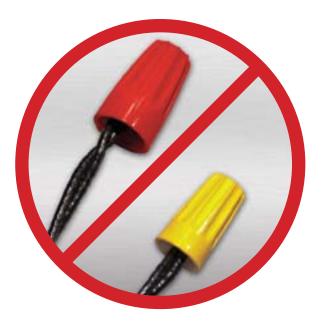
The first temporary repair involves pigtailing with a twist-on connector. The effectiveness of "pigtailing" using twist-on connectors has been evaluated by CPSC staff. In CPSC-sponsored laboratory testing and life tests, substantial numbers of these connectors overheated severely.

of twist-on connectors with aluminum wire. It is possible that some pigtailing "repairs" made with twist-on connectors may be prone to even more failures than the original aluminum wire connectors. Accordingly, CPSC staff believes that this method of repair does not solve the problem of overheating present in aluminum-wired branch circuits.

"Pigtailing" with Twist-on Connectors
Is Not a Recommended Repair

AL/CU twist-on connector pigtails or CO/ALR devices may be used as an emergency, temporary repair for a failed aluminum termination. Should such a repair be performed, CPSC staff recommends that a complete repair of the aluminum-wired system be performed using the CPSC-recommended methods as soon as possible.
