A PRELIMINARY ANALYSIS OF
HYPERTHERMIA DEATHS ASSOCIATED WITH
ELECTRIC ROOM/SPACE HEATERS

March 2019 (Updated February 2022)

U.S. CONSUMER PRODUCT SAFETY COMMISSION
Rockville, MD 20850

Arthur Lee
Electrical Engineer
Division of Electrical Engineering
Directorate for Engineering Sciences

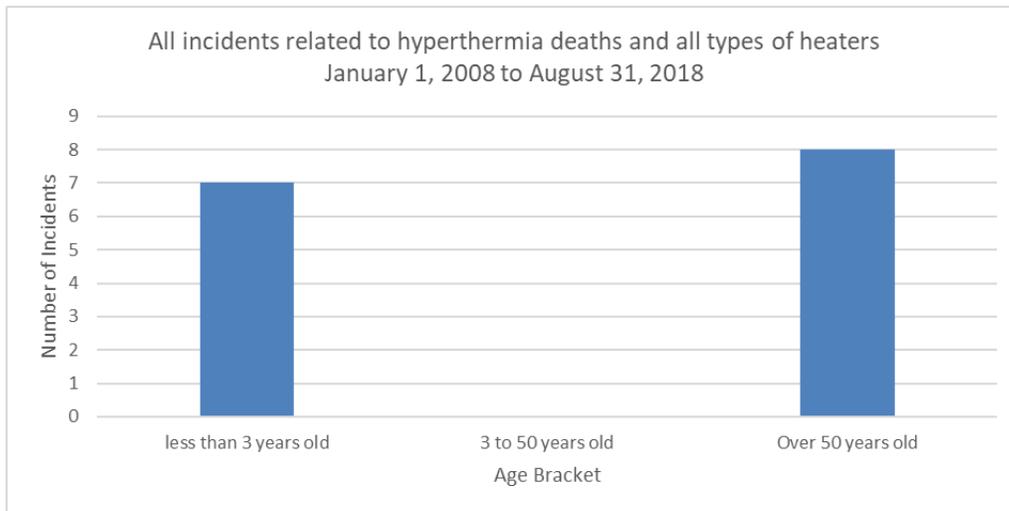
January 1, 2008 to August 31, 2018.² The search revealed 15 deaths within the search period. The incidents involved seven child deaths and eight older adult deaths, as shown in Figure 2.1. The age range of the victims was less than 3 years of age to more than 50 years of age.

Figure 2.1. Number of hyperthermia deaths related to heaters

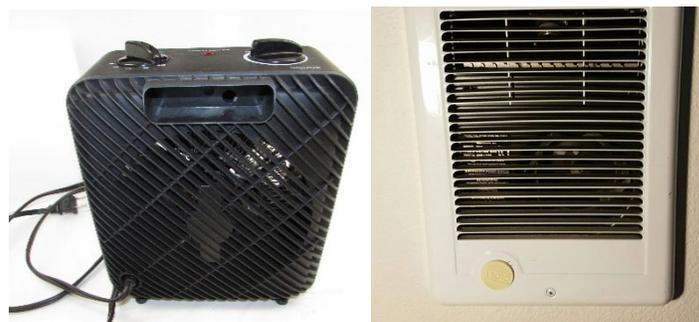
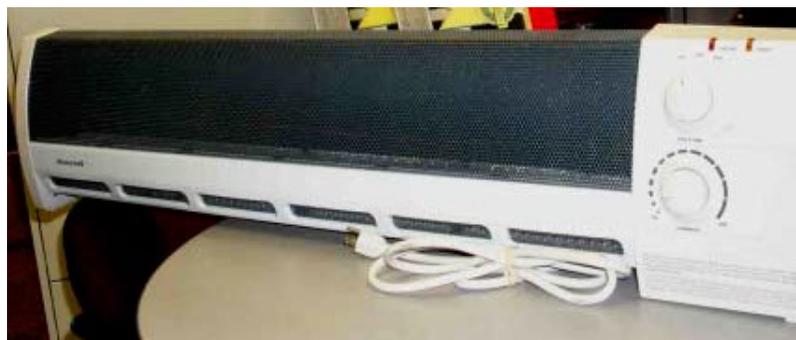
Space or room heater designs can be portable or fixed in place. Portable heaters are versatile and can be moved to heat different spaces within a structure. Fixed heaters are intended for zone heating in place of a central heating system, or to provide supplemental heat for a specific room. Baseboard heaters are unique because of their dimensional requirements. A “baseboard heater,” by definition, must have the following dimensions: the length-to-height ratio of the heater must be more than 2:1, and the depth of the heater must be less than 6 inches. Figure 3.1 shows examples of three different types of room heaters.

Figure 3.1. Some of the types of room heaters

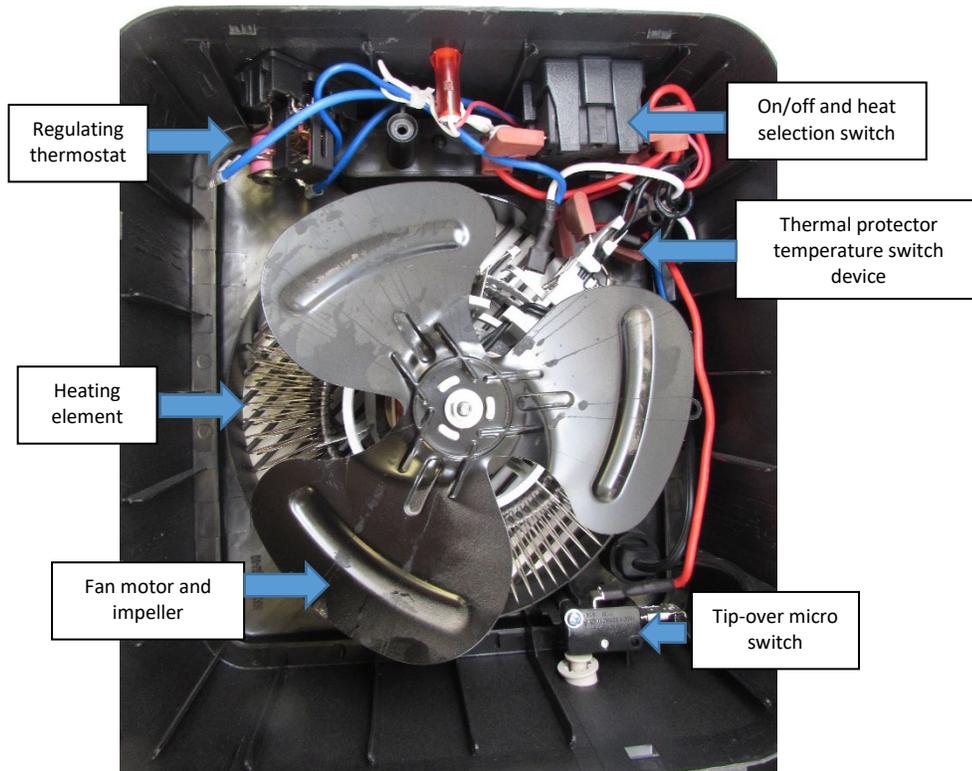
Figure 4.1 shows the various components of the heater with the rear enclosure removed. Inside the unit are the regulating thermostat, temperature-limiting control (TLC) device, heater output switch, heating element, tip-over micro switch, LED indicator light, and fan motor and metal impeller.

Figure 4.1 Components within the heater

The regulating thermostat is the automatic temperature-setting control for the heater. The TLC is the limiting control, which is located near the heating element and is intended to prevent the unit from overheating. The TLC is a self-hold type, meaning that when it reaches its set temperature, it will disconnect power from the heating element and fan motor until the user acts. When the TLC contacts are open, a temperature-sensitive bimetal holds the contacts in an open state until power is removed and sufficient time allows the TLC to cool and reset.

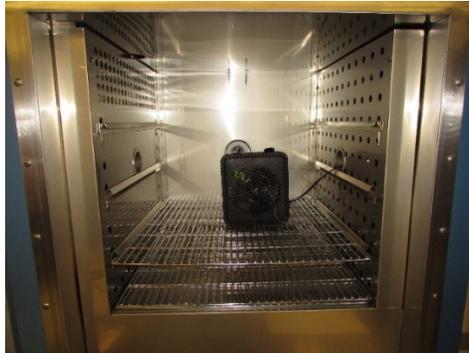
The non-energized heater was placed within the conditioning oven, as shown in Figure 4.3. Two thermocouples were placed on the heater. Thermocouple 1 measured the air temperature at the front of the heater, and Thermocouple 2 measured the air temperature at the back of the heater. The continuity between the neutral and hot-plug terminals was monitored with a digital multi-meter to determine when the regulating thermostat or the TLC activated, *i.e.*, the meter indicated an open circuit.

Figure 4.3. Heater inside the conditioning oven

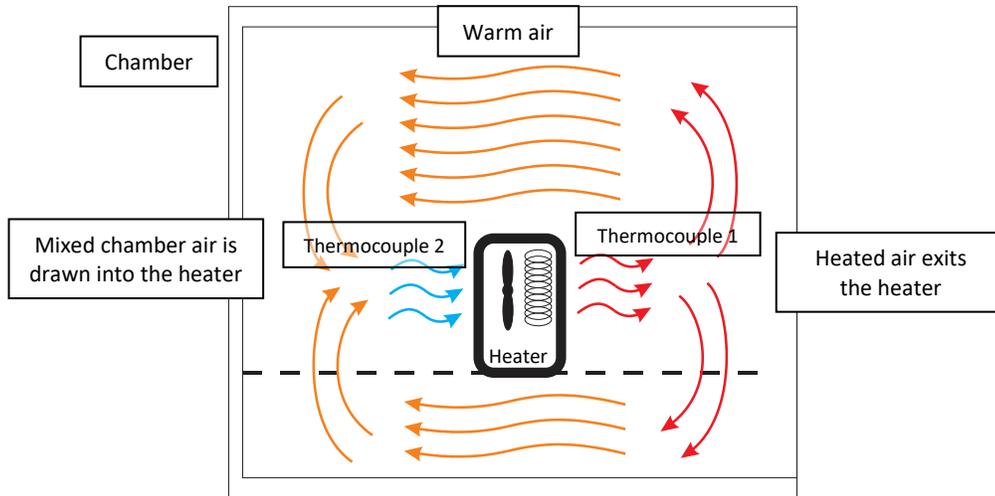
After the previous test, the oven and heater self-cooled to almost room temperature before staff started Test 2. The thermostat was set at maximum heat (MAX), and the heat setting was on the highest heat output (●). After the oven door was closed, the heater was plugged into a 120 V receptacle. Thermocouple 1 measured the air temperature exiting the front of the heater, and Thermocouple 2 measured the air temperature drawn into the heater, as illustrated in Figure 4.4.

Figure 4.4. Air flow inside the conditioning oven (heater running, oven off)

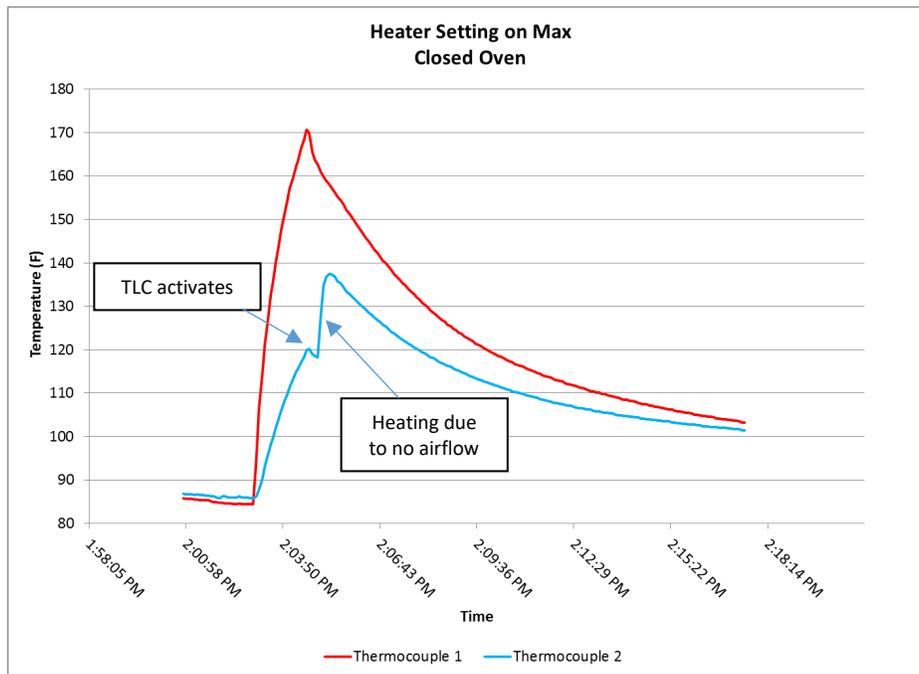
The temperatures on the heater rose quickly, as shown in Figure 4.5, because of the small chamber volume. When the rear of the heater reached about 118° F (48° C), the TLC activated, which de-energized the heater and caused the temperature to drop momentarily. After the heating element shut off and the fan stopped rotating, there was no airflow passing over Thermocouple 2, which caused the temperature to rise temporarily from residual heat from within the heater.

Figure 4.5. Thermocouple measurements during Test 2

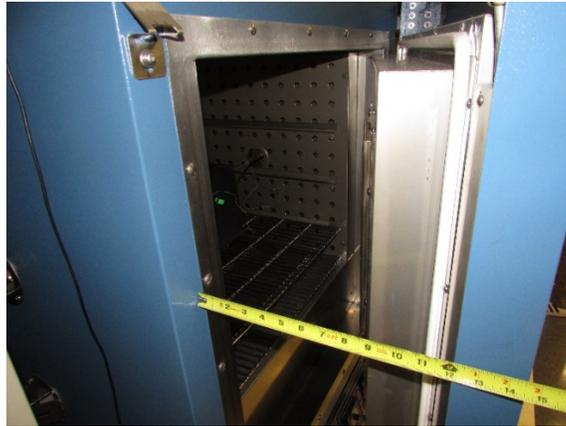
After the previous test, the oven and heater self-cooled to almost room temperature before staff started Test 3. For this test, the chamber door was partially opened approximately 9 inches (23 cm), as shown in Figure 4.6. The partially opened oven door allowed some of the heated air to exit and some of the cooler room air to enter the chamber, as illustrated in Figure 4.7. The thermostat was set at maximum heat (MAX) and the heat setting was on the highest heat output (●). Thermocouple 1 measured the front of the heater or the airflow exiting the heater, and Thermocouple 2 measured the rear of the heater, or the airflow entering the heater.

Figure 4.6. Oven chamber door partially opened about 9 inches (23 cm)

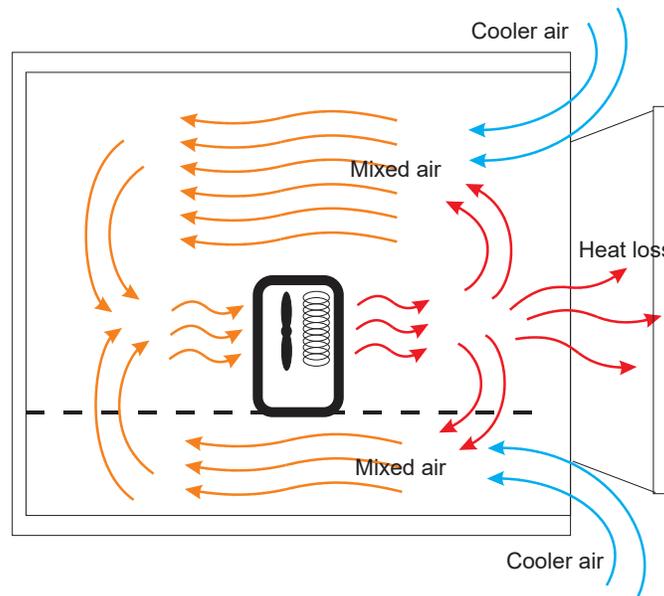
Figure 4.7. Airflow with partially opened door

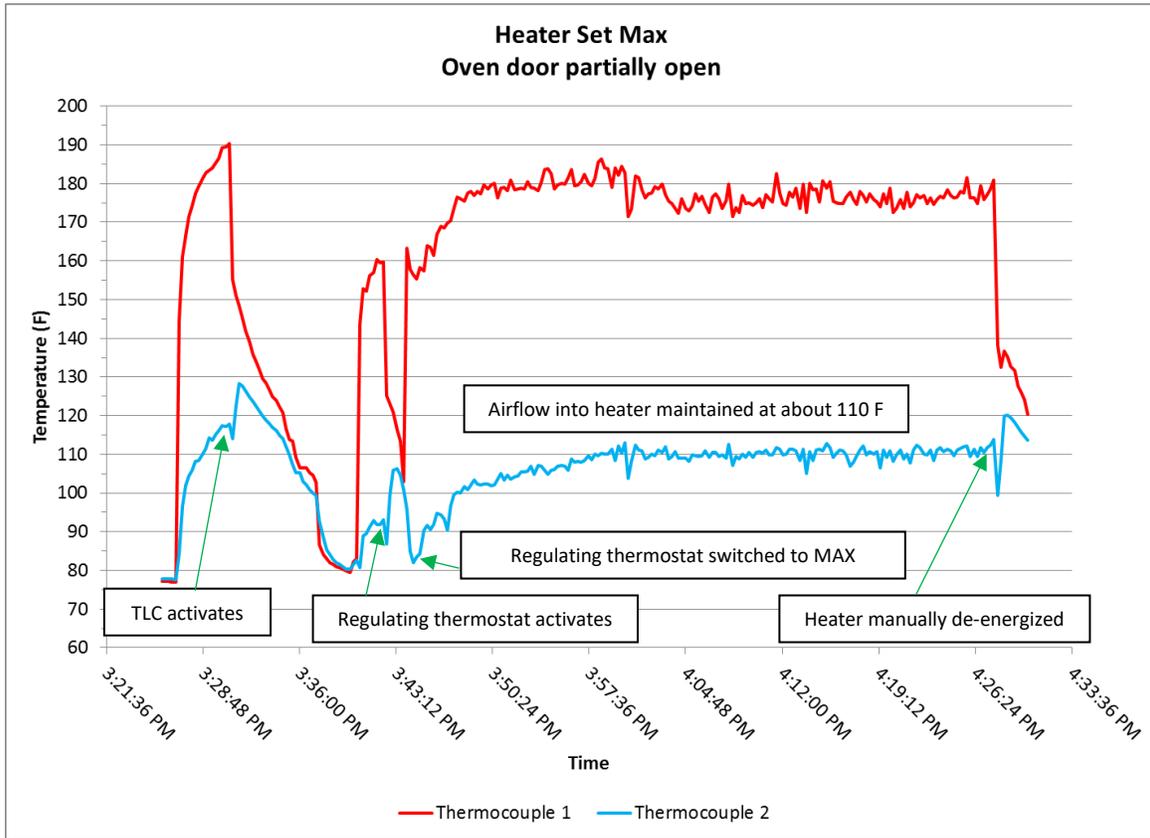
The heater was plugged into a 120 V receptacle. The temperatures on the heater still rose quickly. When the rear of the heater measured about 118.4° F (48° C), the TLC activated, which de-energized the heater, as shown in Figure 4.8, from the start of the data through approximately 3:30 p.m., as shown in the graph. The heater was allowed to cool and the TLC was reset by

unplugging the heater, as shown in Figure 4.8, through approximately 3:40 p.m., as shown in the graph below.

Figure 4.8. Thermocouple measurements during Test 3

The heater’s regulating thermostat knob was set halfway between the MIN and MAX. At this setting, the regulating thermostat contacts were still closed. The heater was plugged into the receptacle. Once the temperature on the back of the heater rose to about 93.2° F (34° C), the regulating thermostat activated (opened) and de-energized the heater at approximately 3:43 p.m., as shown in the graph above.

The regulating thermostat was changed to MAX, which caused the heater to energize from approximately 3:45 p.m. to the end of the test, as shown in the graph. To prevent the chamber from heating too quickly, an external fan was placed on the floor outside the oven chamber to remove additional heat from the chamber. This setup allowed the air that was entering the back of the heater to maintain a constant temperature of about 110° F (43° C), without causing the regulating thermostat or the TLC device to activate. The temperature stayed at about 110° F (43° C) for 30 minutes, until the test was manually terminated.

Theoretically, this temperature state of 110° F (43° C), which represents the mixed room air temperature being drawn into the heater, could be maintained for an extended period until some environmental factor, such as a change in heat loss, altered the parameters.

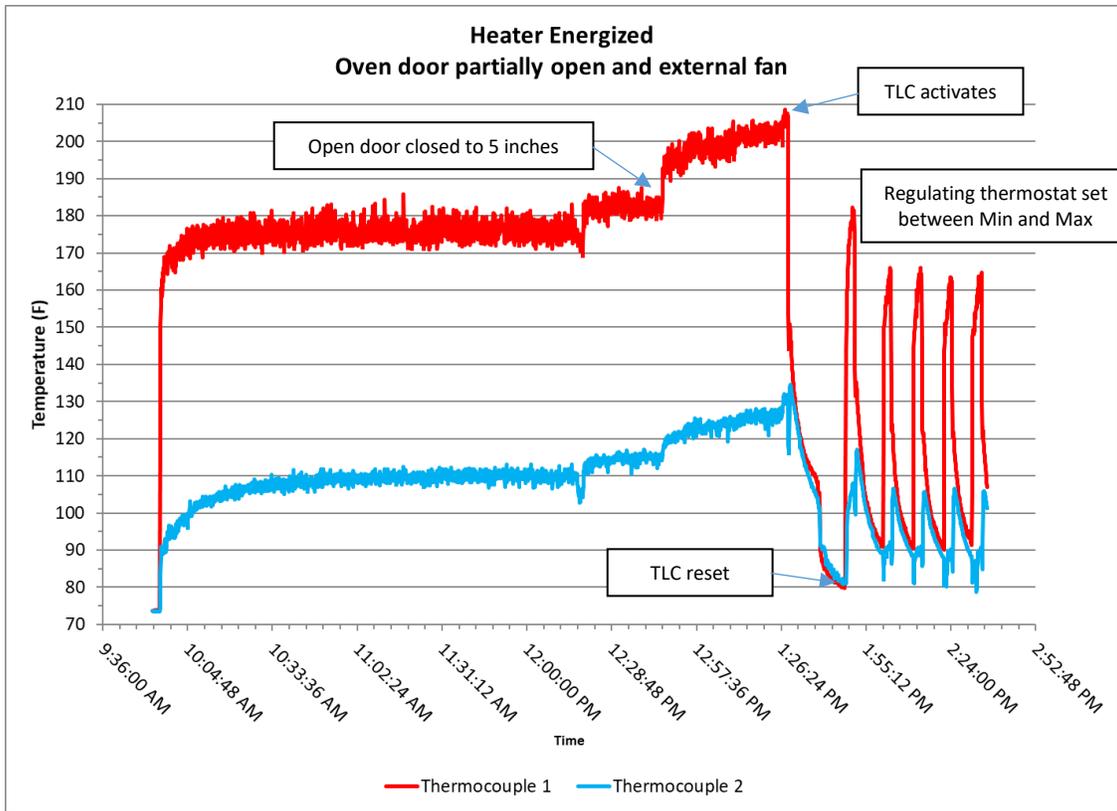
Once the heater was energized, the temperature stabilized around 110° F (43° C) for Thermocouple 2, as shown in Figure 4.9. Neither the regulating thermostat nor the TLC activated after 2 hours. After about 2 hours into the testing, the oven chamber door was closed until there was about a 5-inch (13-cm) opening. The temperature jumped up to around 118° F (48° C) for Thermocouple 2, then gradually continued to increase until the temperature rose to 122° F (50° C), which caused the TLC device to activate, as shown in the graph below.

The heater was unplugged to reset the TLC, then the heater was re-energized. The heater's regulating thermostat knob was set in the middle, between the MIN and MAX settings, which caused the heater's regulating thermostat to switch off and back on when the airflow at the back of the heater measured around 108° F (42° C) and 90° F (32° C).

Figure 4.9. Thermocouple measurements during Test 4

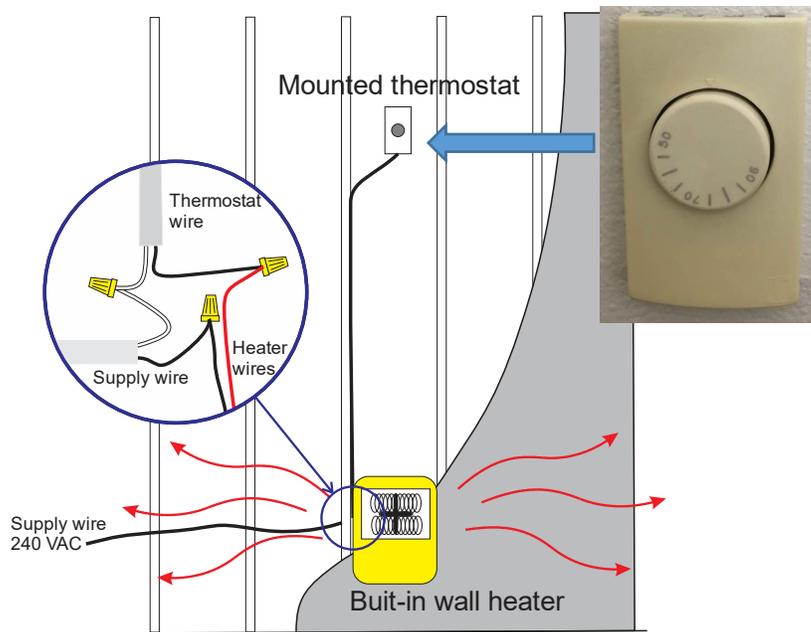
The sample used for testing was a built-in wall heater (fan/heater) that uses a separate control thermostat typically mounted on a wall. The thermostat is wired in series with one of the conductors for the heater, as illustrated in Figure 4.10. The heater unit relies on the external thermostat for regulating its output. The thermostat is a thermal-mechanical type, which uses a bi-metal element to control the switch contacts. The thermostat dial contains numbers and markings that would suggest the units are in degrees Fahrenheit, even though the units were not labeled on the dial.

Figure 4.10. Illustration of wiring for a built-in wall heater and thermostat

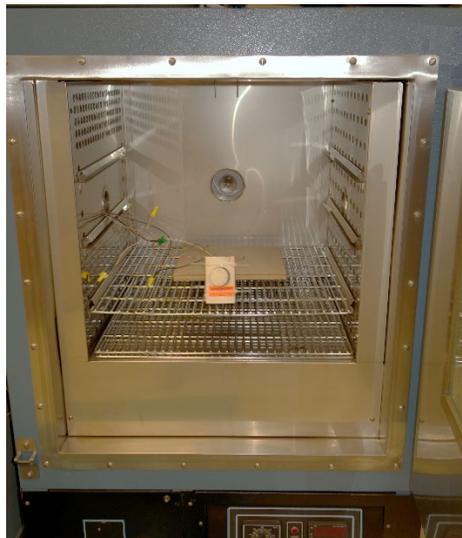
Two thermostats were tested individually, by placing each thermostat in a conditioning oven, as shown in Figure 4.11, and controlling the same heater outside the conditioning oven. The thermostat was mounted inside a single-gang plastic electrical box. Five thermocouples measured the temperature inside the oven. Four of the five thermocouples were placed inside the electrical box and one thermocouple outside the electrical box. The conditioning oven's temperature was programmed to increase 1.8°F every 2 minutes.

Figure 4.11. Thermostat in the conditioning oven

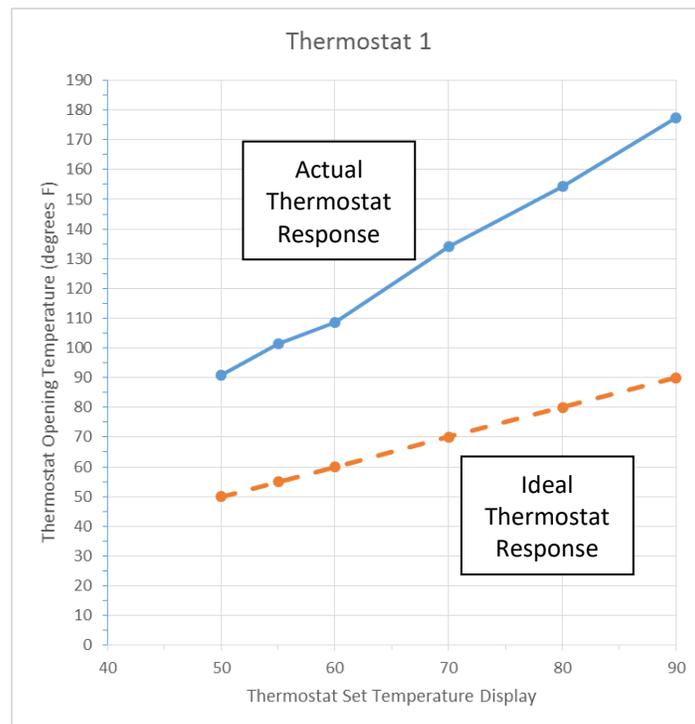
Even before the test started, turning the temperature setting dial from its minimum setting produced an “off” click below 50 on the thermostat dial. This revealed that the set/operating point was not accurate because the lab room temperature was not below 50° F (10° C). Ideally, when the thermostat’s dial is turned slightly above 70, a clicking (contacts closing and opening) sound should be heard because the room temperature was 72° F (22° C).

For the testing, the dial was set at each of the display marks 50, 55, 60, 70, 80, and 90. When the thermostat dial was set at 50, the thermostat opened when the oven temperature reached 91° F (33° C). When the thermostat dial was set at 90, the thermostat did not open until the oven temperature reached 177° F (81° C). The test results graphed in Figure 4.12 show the actual thermostat response was consistently higher than the ideal response of the thermostat. On average, the thermostat activated and de-energized the heater at about 60° F (16° C), higher than the dial setting.

Figure 4.12. Thermostat 1 conditioning oven results plot

In both of the thermostats tested, the calibration of the thermostats appeared to be shifted higher than the dial display. The inaccurate calibration of the thermostats could result in the room achieving a higher temperature than what the occupant may have intended, if the occupant was relying on the thermostat’s dial display as the set-desired room temperature. For Thermostat 1, if the dial is set at the 55 mark or above, the heater would operate until the room temperature is 100° F (37.8° C) or greater. For Thermostat 2, if the dial is set around 86 or above, the heater would operate until the room temperature is 100° F (37.8° C) or greater.

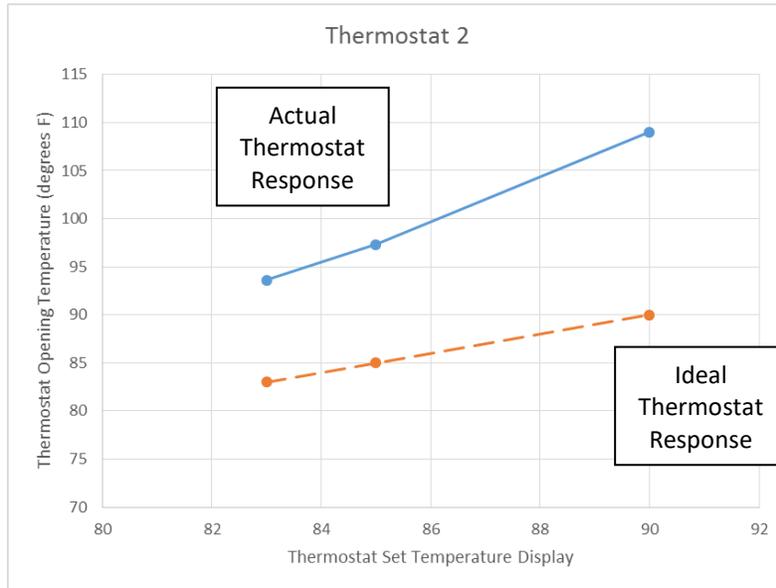
Turning the temperature setting dial before starting the testing revealed that the setting/operating point differences were off, but not as far as for Thermostat 1. The switch clicking could be heard between 80 and 85 mark on the dial display, and the room temperature was about 72° F (22° C). For this testing, the dial could only be set at around the 83, 85, and 90 mark because the thermostat would only begin to turn on above 80 on the dial. When the thermostat dial was set at around 83, the thermostat opened when the conditioning oven

temperature reached 94° F (34° C). When the thermostat dial was set at 90, the thermostat did not open until the conditioning oven temperature reached 109° F (43° C). The graphing of the test results in Figure 4.13 shows the actual thermostat response was higher than the ideal response of the thermostat, but the shift was not as pronounced as Thermostat 1. On average, the thermostat activated and de-energized the heater about 14° F higher than the dial setting.

Figure 4.13. Thermostat 2 conditioning oven results plot

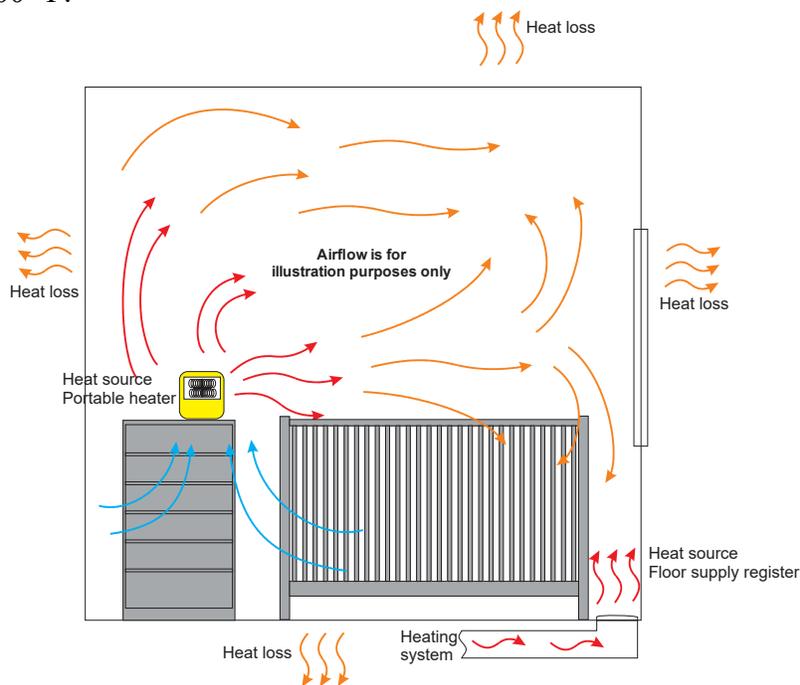
Heat can enter the room from a room heater through convection. The room and the air within the room absorb the heat, but heat is also lost by conduction through the walls, windows, doors, floor, and ceiling. As the heat is lost in the room, there is a demand from the heater to produce heat to reach the set temperature. There may be parameters where the heat lost in the room, room volume, and heater output allow the room temperature to be maintained at a stabilized temperature that is below the set point of the heater's thermostat, but is high enough to pose a risk to some occupants, if exposed for an extended period of time, particularly for occupants whose age or disabilities might limit their ability to respond to the elevated temperature.

In the incidents, a space/room heater appeared to elevate the temperatures within the room to a level that was fatal for a toddler. Staff evaluated the conditions that would be required to elevate the room temperature to such a level. The simplified illustration shown in Figure 6.1 indicates that the room temperature is determined by the amount of heat gain, minus heat loss. By considering various room sizes and starting temperatures, but keeping all other parameters the same, it is possible to illustrate that a typical room heater output may raise room temperatures to 100° F. This section examines the main variables, such as heat losses, starting temperature, and room size, to determine the room heater needed to raise the temperature to 100° F.

Figure 6.1. Illustration of heat losses and gains in a room

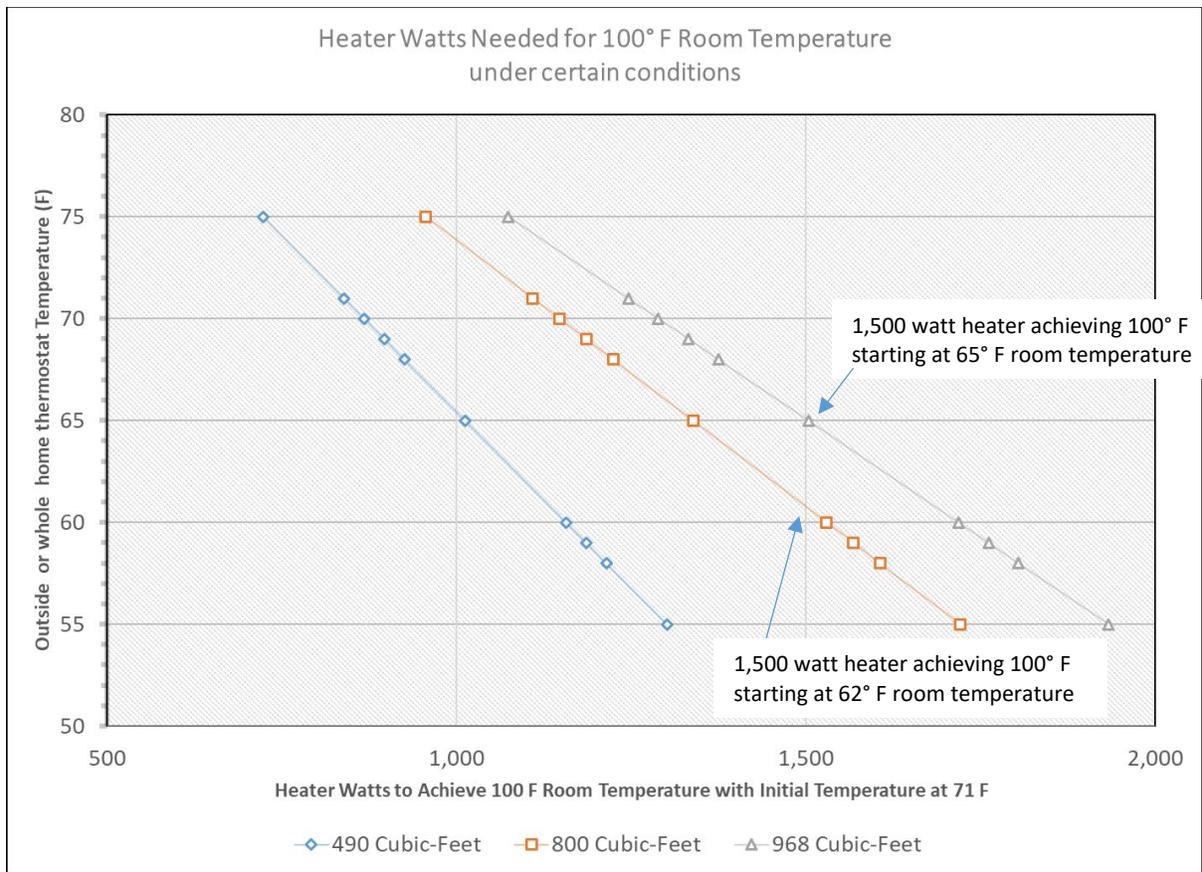
In addition to the room size changing in the calculations, another key variable that determines the heating requirement is the starting temperature, which can be the outside temperature or HVAC set temperature. Because the analysis calculated the heater watts needed to raise the room temperature to 100° F, the starting temperature would be a factor in the heater output. For example, if the outside temperature was very cold, the delta between the starting temperature and 100° F would be greater than if the outside temperature was not as cold. A sample calculation is located in the appendix that was used for the analysis. The plots shown in Figure 6.2 demonstrate that, depending on room size and starting temperature, a 1,500 watt heater is capable of elevating the room temperature to 100° F. For example, a 1,500-watt heater can raise the room temperature of an 800 cubic-foot room from 61° F (16° C) to 100° F (38° C) or a 968 cubic-foot room from 65° F (18° C) to 100° F (38° C).

Figure 6.2. Plot of heater requirement under certain conditions, such as room size
