United States  
**Consumer Product Safety Commission**

## CPSC Staff's Recommendations to UL 1278

## CPSC Staff's Recommendations to UL 1042

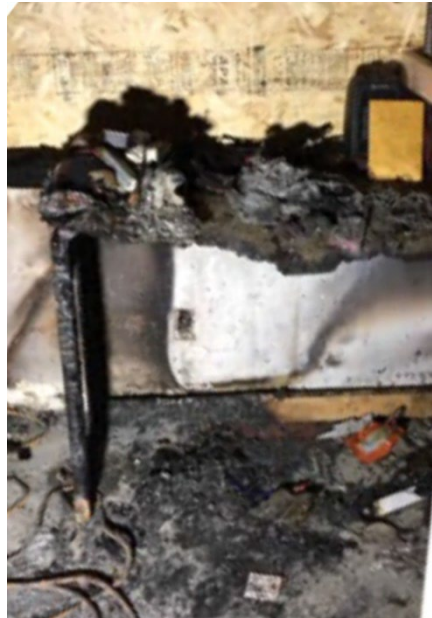
Figure 5-1. Incident scene

electrical fault that drew high current. Figure 5-1 shows the location of the heater in the laundry room after the incident.

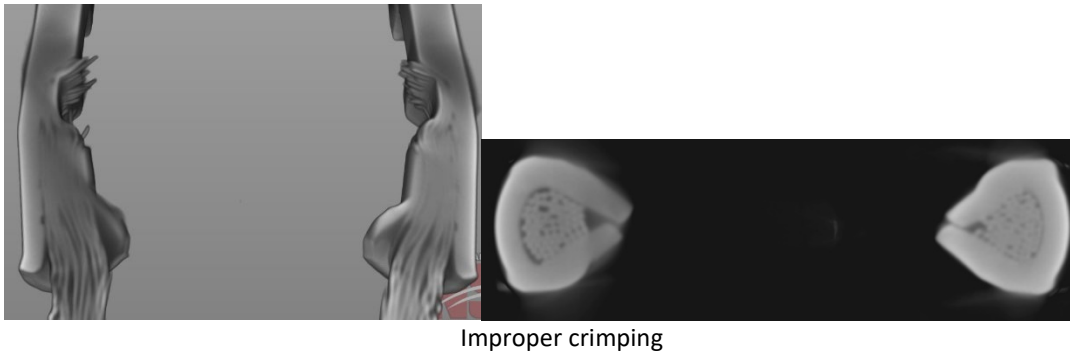
Figure 5-4. Attachment plug from exemplar new heater

Field staff also purchased a new exemplar heater sample of the same model incident heater for analysis. CT images of the heater's attachment plug show that the plug had improper crimping and voids within the crimp (Figure 5-4).

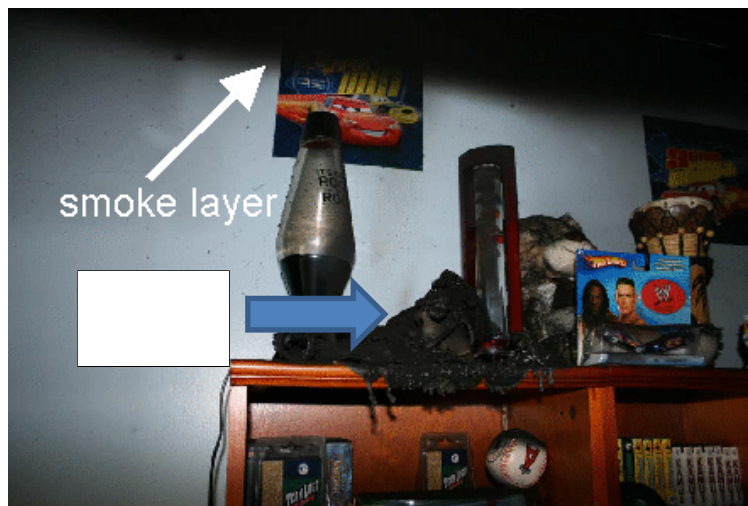
Figure 5-5. Incident scene

CPSC staff conducted an analysis of the product, which was certified to UL 1278. The investigation of the incident scene photos revealed that the heater had overheated during the night, which generated an upper black smoke layer in the room (Figure 5-5). Figure 5-5 shows the fire had not spread beyond the incident heater itself.

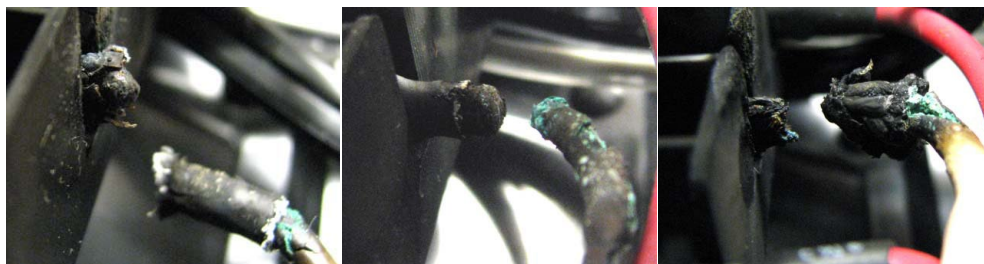
Staff conducted an analysis of three additional incidents that had occurred with the same make and model heater. These incidents did not result in the heaters igniting or melting. The analysis of the incident heaters revealed that the connection to the heating elements had overheated (Figure 5-6). The overheating at the connections suggests that high resistance connections were occurring at the heating element connectors.

Figure 5-6. Melted connections at the heating element (three additional incident samples)

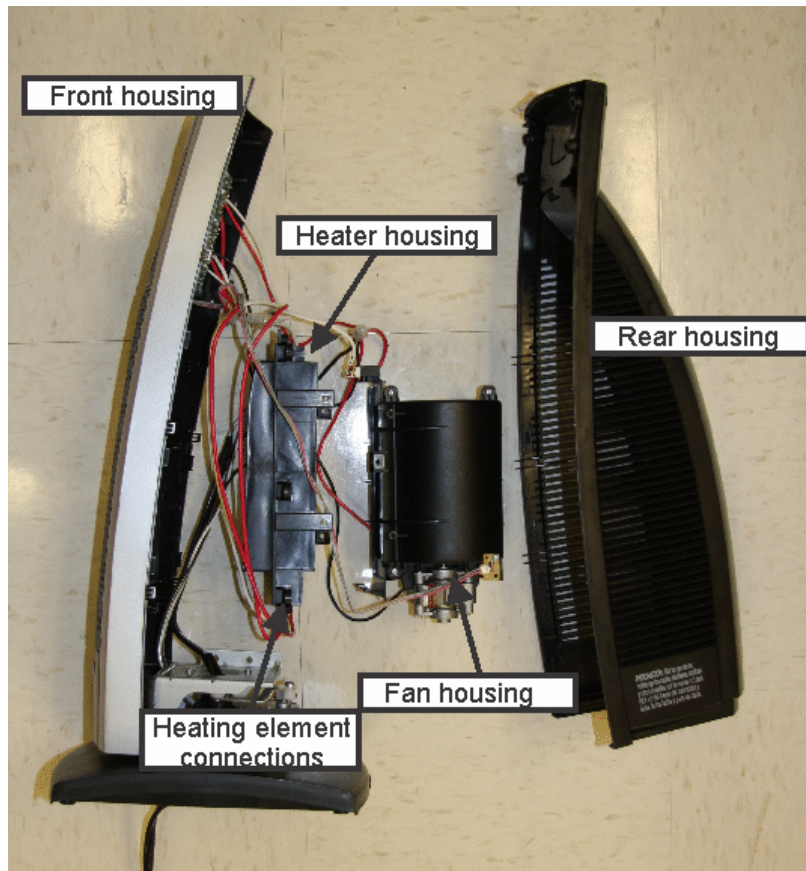
Figure 5-7. Heater components on an exemplar sample

Staff analysis of heater internal construction revealed that a portion of the fan housing was used to secure the heater element connectors in place (Figure 5-7). As part of the fan housing, three plastic tabs were used to hold and secure the heating element in place (Figure 5-8).

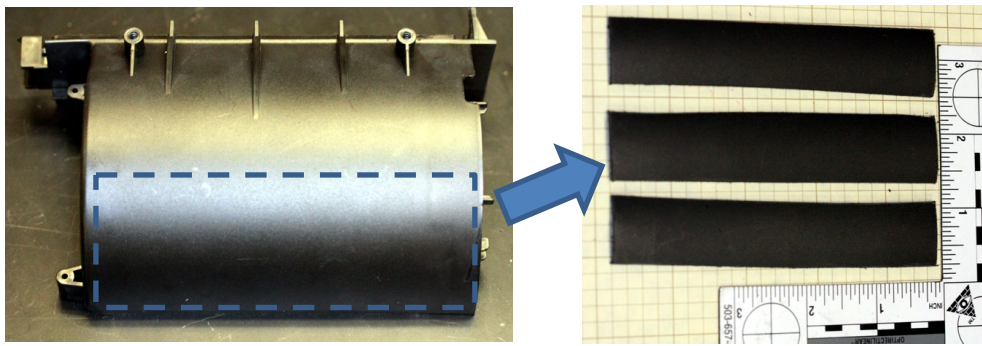
Analysis of the plastics within an exemplar heater revealed that the fan housing plastic used to hold down the heater connections can cause flaming dripping plastic if ignited.

Fan housing samples taken for open flame and glow wire testing

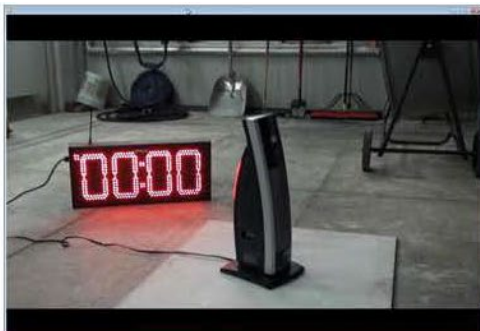
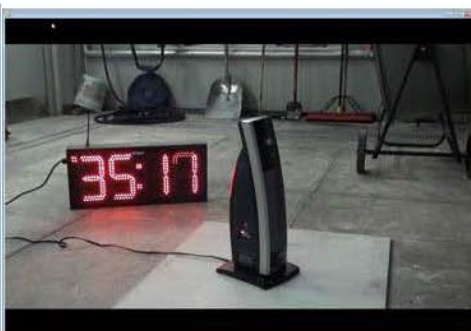
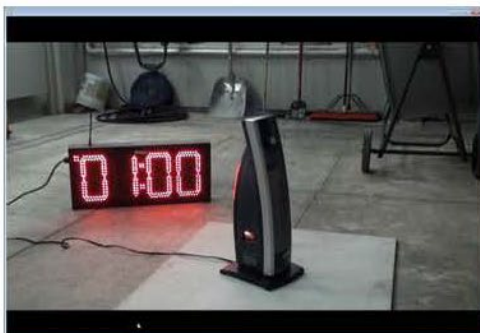
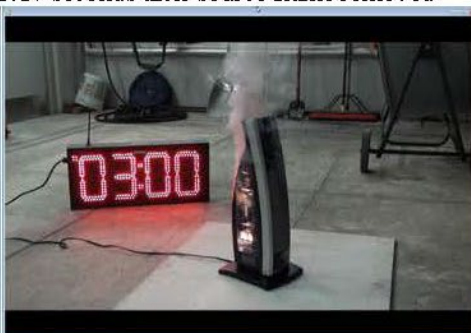
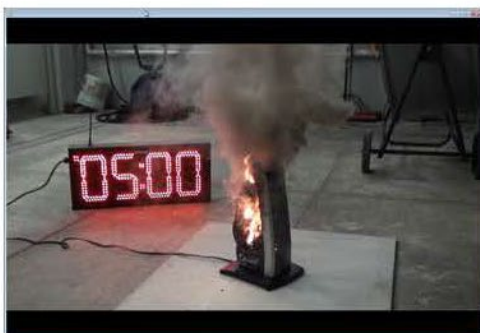
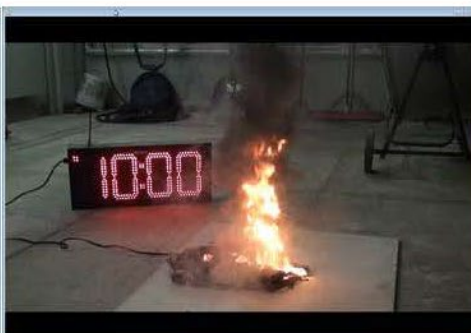
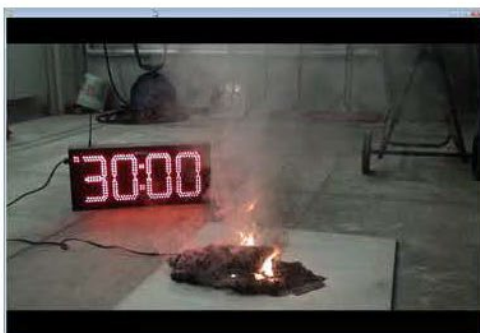
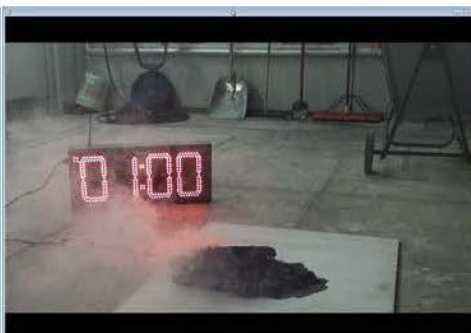
0 minutes

Time 35.17 seconds after exposed to flame  
5.17 seconds after source flame removed

1 minute after exposed to source flame

3 minutes after exposed to source flame

5 minutes after exposed to source flame

10 minutes after exposed to source flame

30 minutes after exposed to source flame  
Ignition of the fan housing in an open room

1 hour after exposed to source flame

The first test was in the large open room, which contained a ventilation hood above the test item. The ventilation hood was on during the test to prevent the room from filling up with smoke. The heater's fan housing was ignited using an external flame source. The test sequence is shown in Figure 5-10. The sample ignited and burned rapidly, producing black smoke. The product burned with open flames for about 1 hour until the plastic fuel load had been used up.

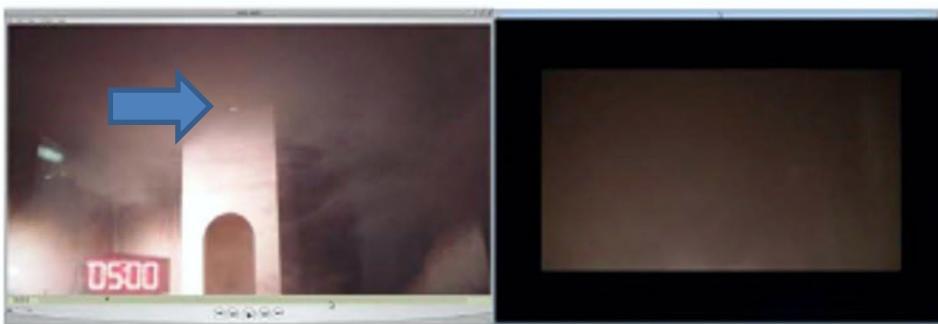
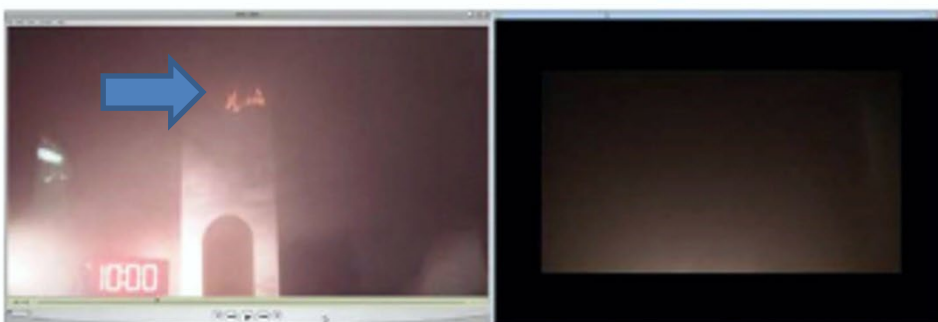
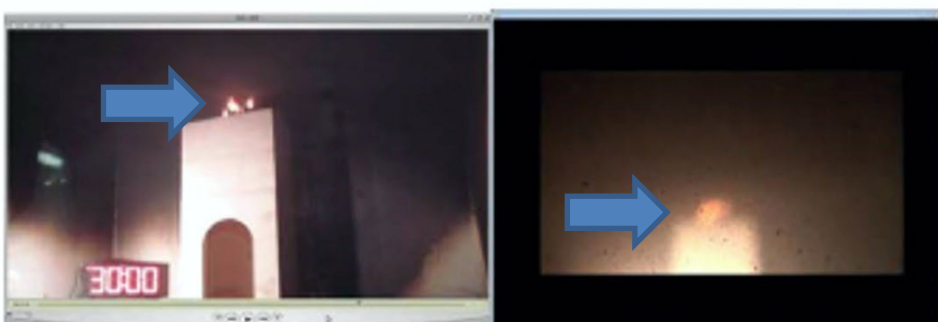
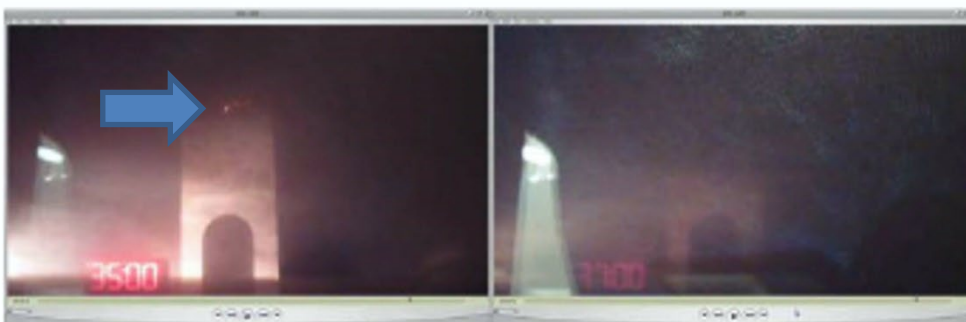
The second test was in a closed room. The heater was placed in a 10 x 12 x 8-foot room with a 36-inch doorway that had been constructed within the large burn room. The sample was placed on a 5-foot-high stand that was positioned against one of the 10-foot-wide walls. The heater's fan housing was ignited using an external flame source, and the doorway was closed. The small room test resulted in the sample burning more slowly than the sample in the open burn room. Even though the sample burned slower, the sample still appears to have melted and resulted in a significant amount of smoke that fill the room.

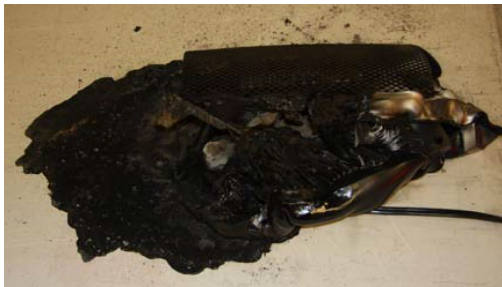
The analysis suggests that ignition of the fan housing by a failed overheated heater connection could have resulted in a fire that completely consumed the heater (Figure 5-11).

Heater sample in open room after test

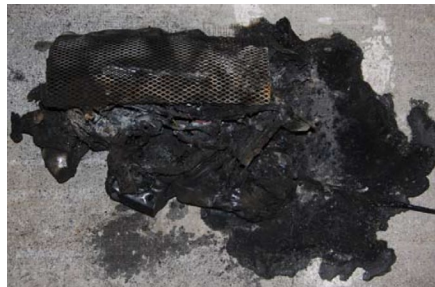
Figure 5-11. Heater samples after ignition of the fan housing

Heater sample in room after test

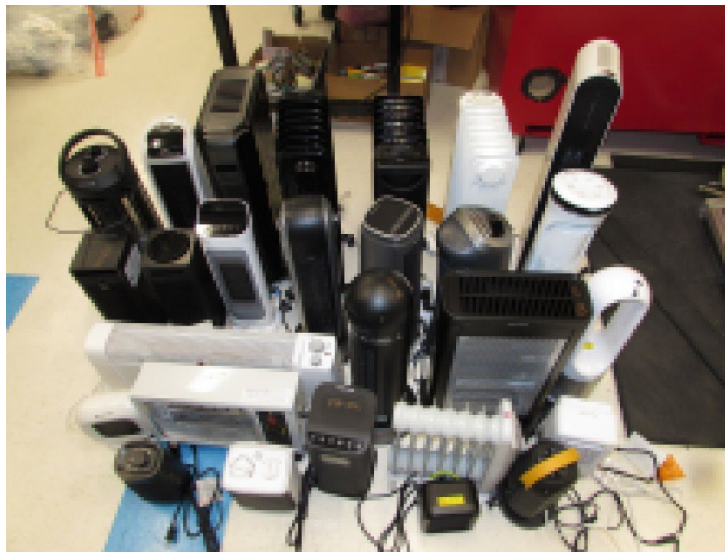
Figure 6-1. Heater Samples

Staff purchased 27 heater samples for evaluation and analysis. Staff selected the heaters to cover a variety of types, sizes and power ratings as shown in Figure 6-1. Additional details of the staff's examination are in the Appendix. Table 6-1 lists the heater samples tested.

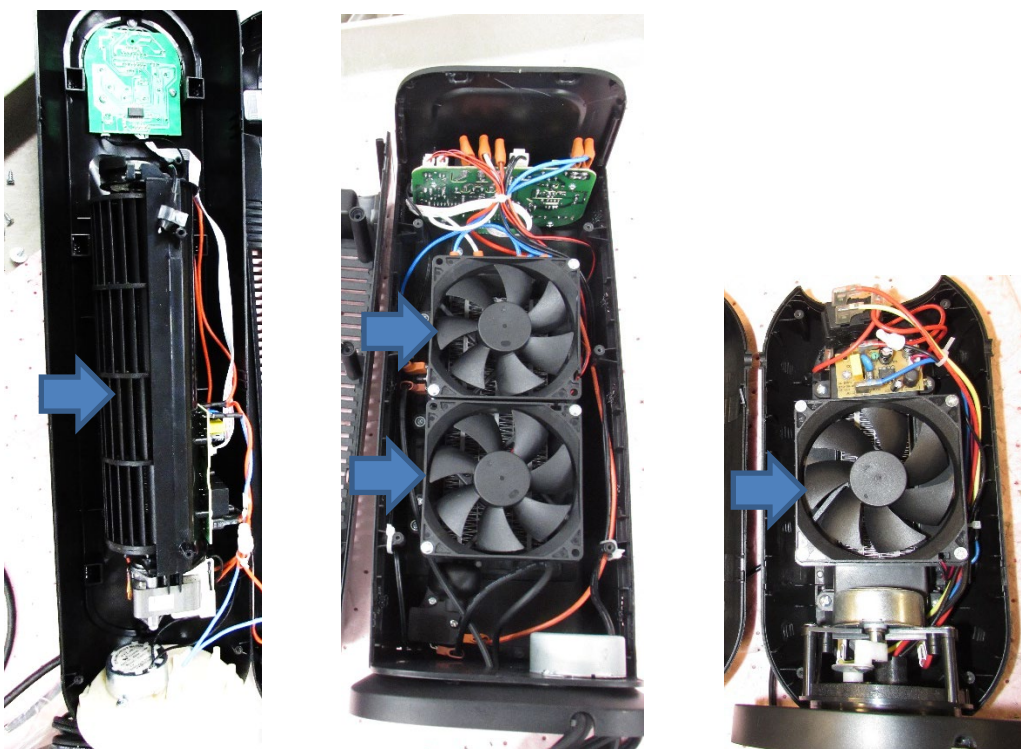
Eighteen heaters were forced-air convection heaters. The two types of fan impellers found in the samples were squirrel cage and radial blades, as shown in Figure 6-2. The squirrel cage impellers were constructed of either plastic or metal. All the radial blade impellers were plastic. For some models, two fans were used to accommodate the size of the heating element in the unit.

Squirrel cage impeller (S13)

Dual fans (S7)

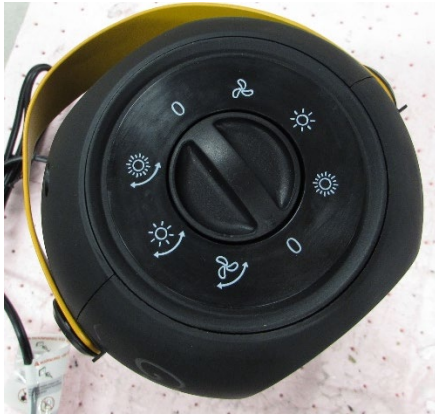
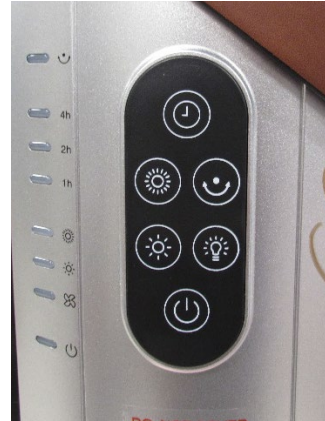
Figure 6-3. Heat selector

Mechanical heat selector switch (S24)

Digital heat selector switch (S2)

Heaters contained either a mechanical or a digital selector switch for choosing the settings, as shown in Figure 6-3. Heater S27 did not contain any controls on the unit as it could only be controlled by the remote control provided with the unit.

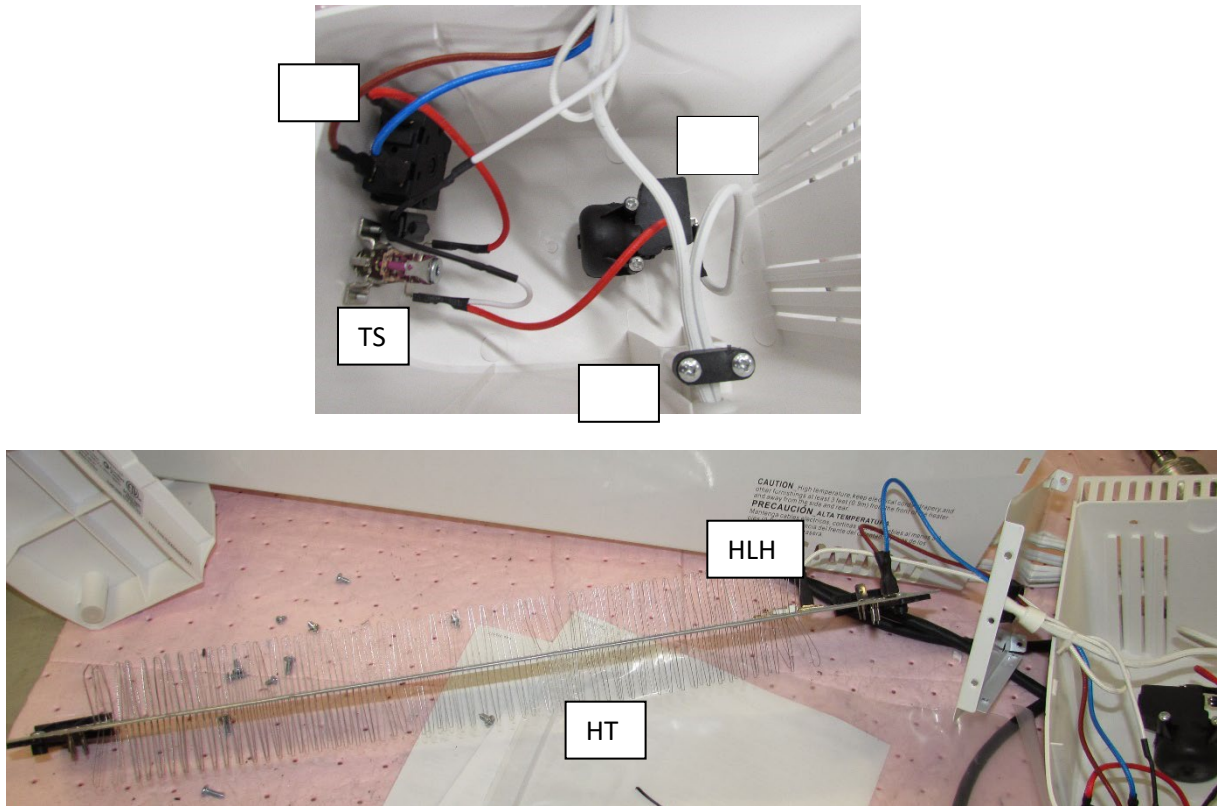
Figure 6-4. Wiring to components for S3

Staff traced and mapped out the circuits for all of the samples. Mechanical and thermo-mechanical safety control switches, such as the tip-over switch and thermal high limiters, are connected in series with the heating element, thus removing power when either device is activated. For example, as shown in Figure 6-4, S3 wire tracing was from one conductor of the power cord (PC) to the tip-over switch (TP) to the regulating thermostat (TS) to the fan heat selector switch (FS) to the heating element (HT) to the manual reset high limit (HLH) and finally to the other conductor of the power cord (PC). Heaters with digital controls may have used various temperature and tilting sensing devices that were controlled by the main circuit board. Appendix Table A-2. Wiring Connections contains additional information on the wiring of each product.

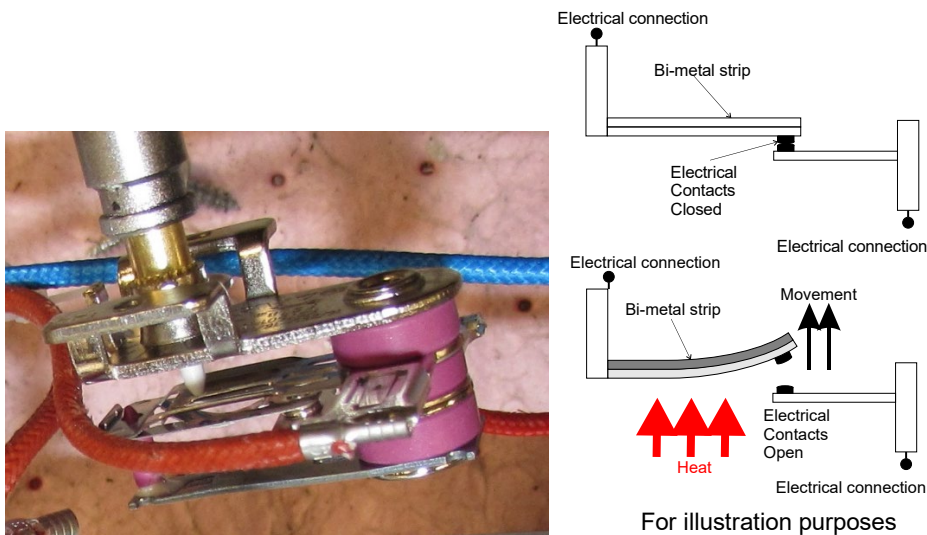
Figure 6-5. Mechanical temperature control

The heater models had either electronic or electromechanical temperature controls. An electromechanical temperature control uses a bi-metal switch to open and close the contacts as shown in Figure 6-5. When the temperature reaches the selected temperature, the bimetal component is heated and bends to make the moving contact part from the static contact, thus removing power to the heating element. When the temperature is lower than the set temperature for the bi-metal, the bi-metal bends back, and the two contacts close, energizing the heating element. For a regulating thermostat, the opening temperature to de-activate the heater can be adjusted manually by turning the dial, which adjusts the distance between the contacts.

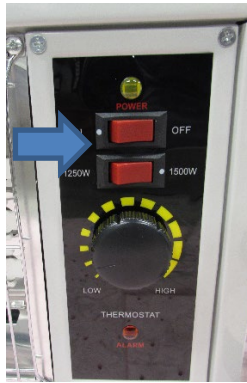
Figure 6-7. Separate power switches

S15 – front

As shown in Figure 6-7, five heaters (S2, S5, S11, S13, S25) had the power switch located at the back of the heater, thus allowing the user to disable the unit and making it more difficult to unintentionally turn on the heater from the main control panel or the remote, if provided. One heater (S15) had the power switch at the front of the heater near the controls.

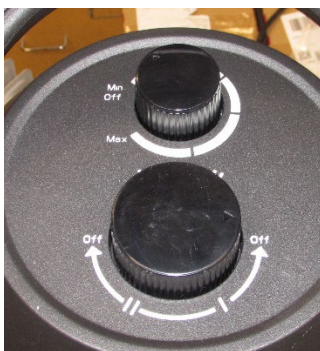
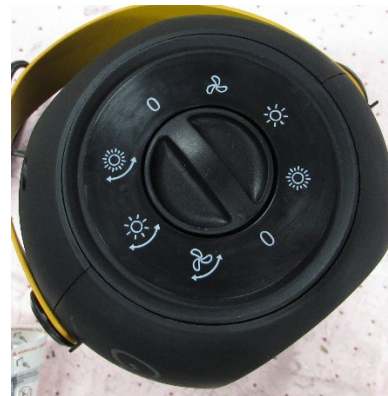
Figure 6-8. Heat select power switches

S14

S24

Ten heaters had mechanical power switches incorporated into the heat select setting as shown in Figure 6-8. These switches were multiple function switches that turned the unit on and off and selected other functions, such as the heat output.

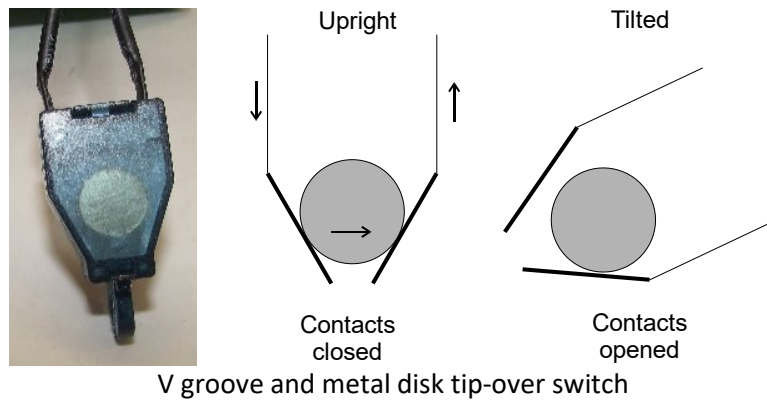
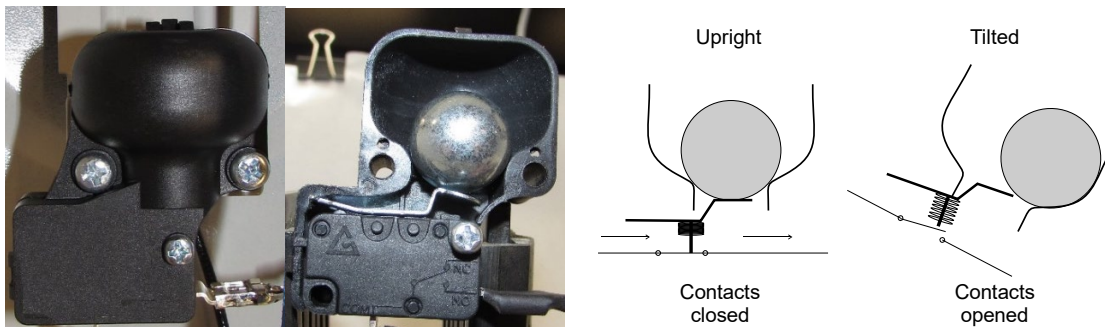
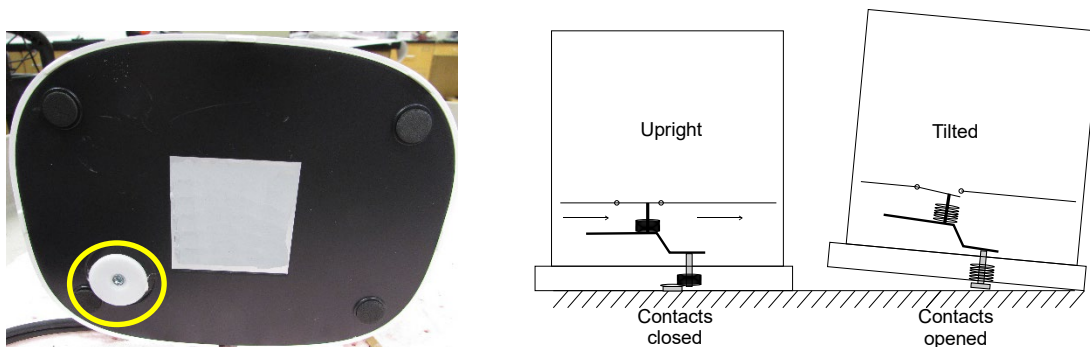
Figure 6-10. Tip-over switches

Tip-over switch type	Count
360 metal ball	14
Floor button	7
Digital	3
V metal disk	1
None	2

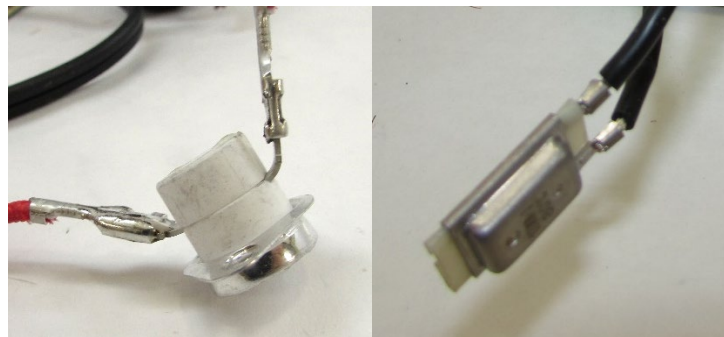
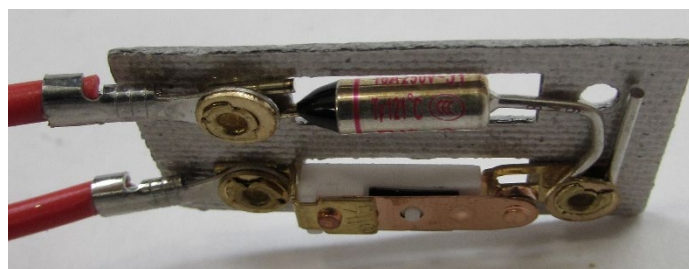
Figure 6-11. Samples of temperature-limiting controls

Automatic-reset High Limit Devices

Manual reset high limit devices

Auto reset and non-resettable limit controls

There were two types of temperature-limiting controls that were found in the heater models, non-resettable and manually resettable as shown in Figure 6-11. Both of these device types are designed to de-energize the heater when they detect abnormally high temperatures within the heater. Eleven of the heater samples have manual reset only, high-limit devices. These devices, if activated, require user interaction to reset the safety device. Eight of the heaters have high limit with auto-reset devices. These devices, if activated, will automatically reset when the temperature drops below the set point. Five of the heaters contained two safety devices, a one-shot thermal fuse and an auto-reset high limit. Typically, an auto-reset high limit has an activation temperature that is lower than the one-shot thermal fuse activation

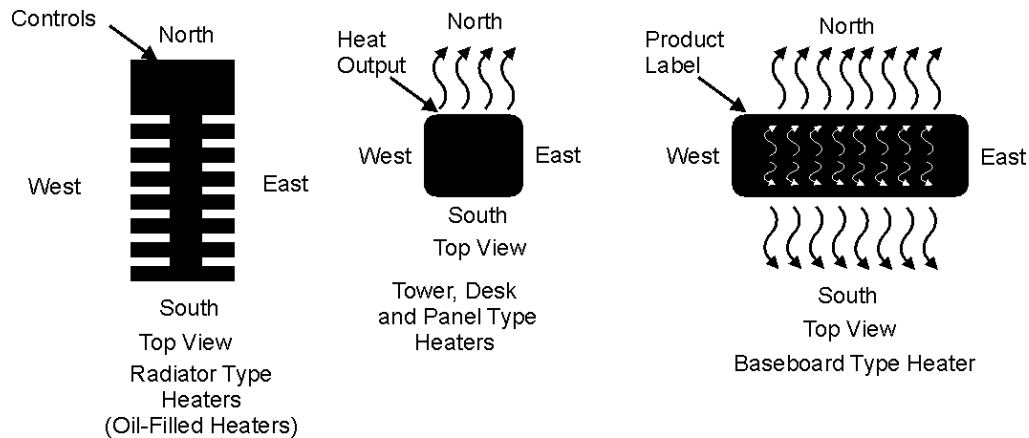
Figure 7-1. Heater orientation notation in the testing

The heater samples were tilted beyond the 10 degrees from horizontal to determine the tip angle where the heater would fall over (critical balance angle). The heaters were tested in all the orientations with “north” denoting the face or heat output as shown in Figure 7-2. The oil-filled heaters were oriented with the controls as “north.” The baseboard heater was only tested on the north and south directions because the width would make it unlikely that it could tip-over in the east or west direction. Staff used a tension test stand (Figure 7-2) to slowly raise a platform from horizontal to measure the angle at which the unit would begin to fall over (critical balance angle).

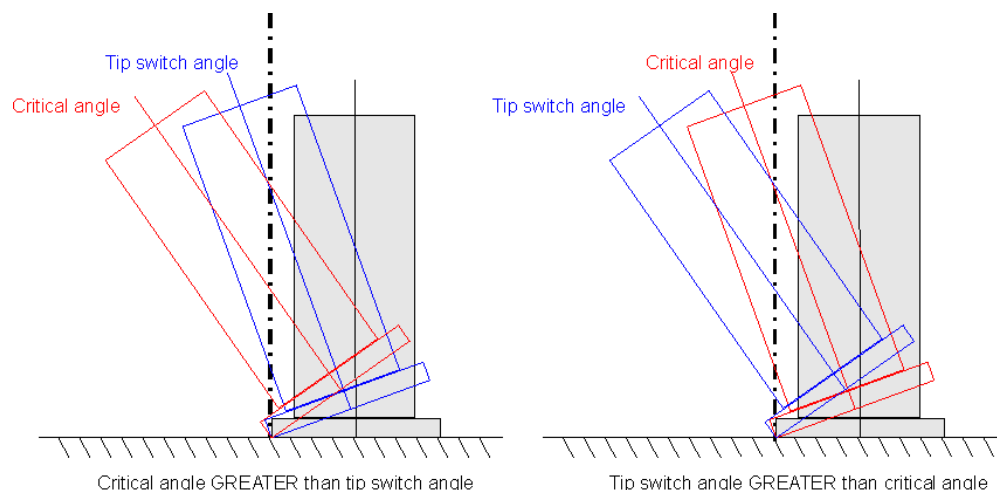
Figure 7-3. Critical balance angle and tip switch angle

Ideally, the heater tip switch should activate before the critical angle to minimize the likelihood of an energized tipped heater leaning against combustibles, such as a couch or bed. UL 1278 only requires the tip switch to activate before the critical balance angle if it was evaluated and determined that the tip switch is required to prevent a fire for the heater under evaluation. Table 7-2 summarizes the critical balance angle determination test results. Appendix Tables A-4 and A-5. Critical Balance Angles and Tip-over Switch Angles contain additional information on the testing.

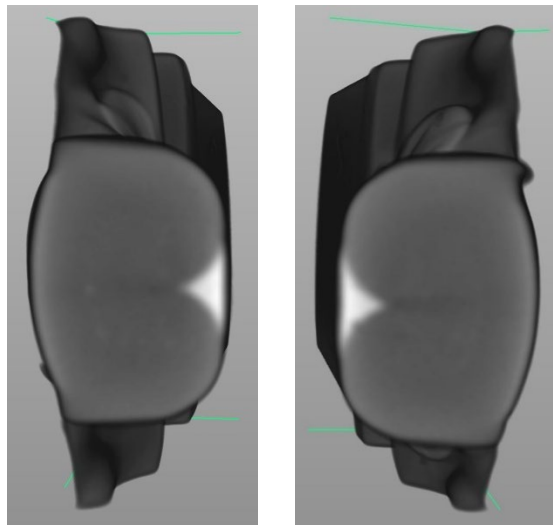
- Solder fills the gaps between the wire strands above and below the crimp
- Any voids in the crimp are filled with solder
- The valley between the crimp wings is filled with solder
- Solder is bonded to the metal

S8 – Cross section of crimps

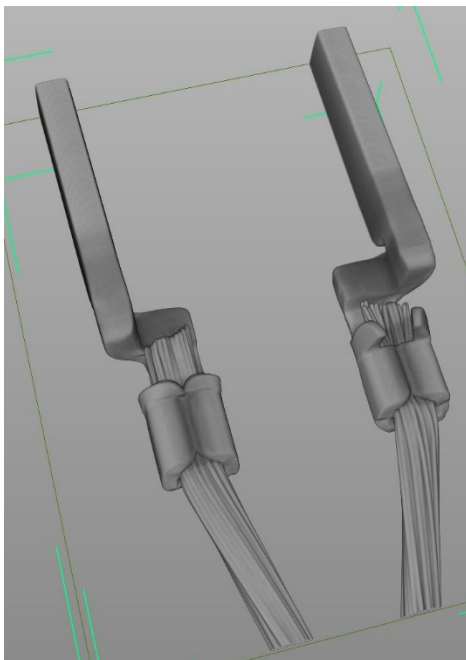
S9 – CT scan of attachment plug

- No solder or weld
- Voids in the crimp
- Uneven crimp closure
- Damaged crimp wing

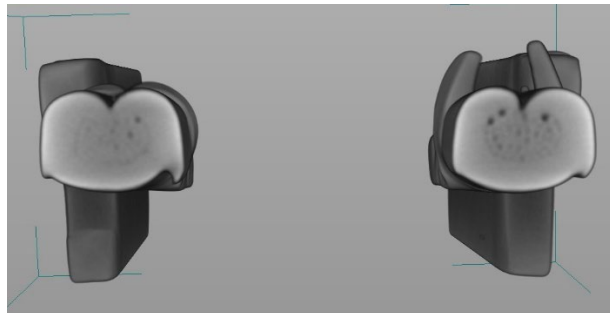
Figure 7-7. S9 CT scan of the crimp connection (no solder or welding)

S9 – Cross section of crimps

Figures 7-7 to 7-14 show examples of poor crimps, lack of soldering, or poor soldering in the attachment plug.

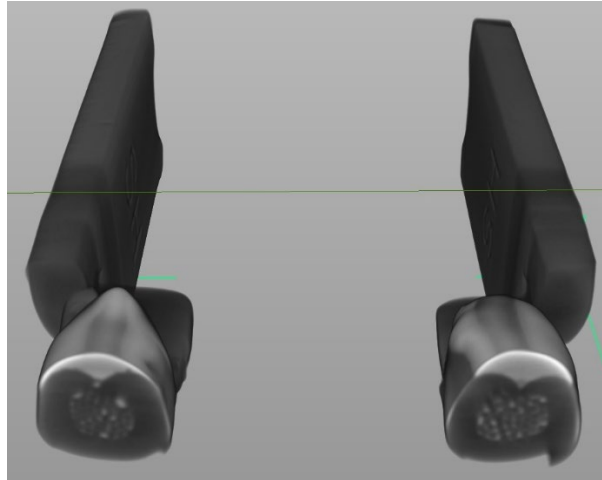
- Solder fills in the voids
- Under crimping
- Asymmetric crimps

S24 – CT scan of attachment plug

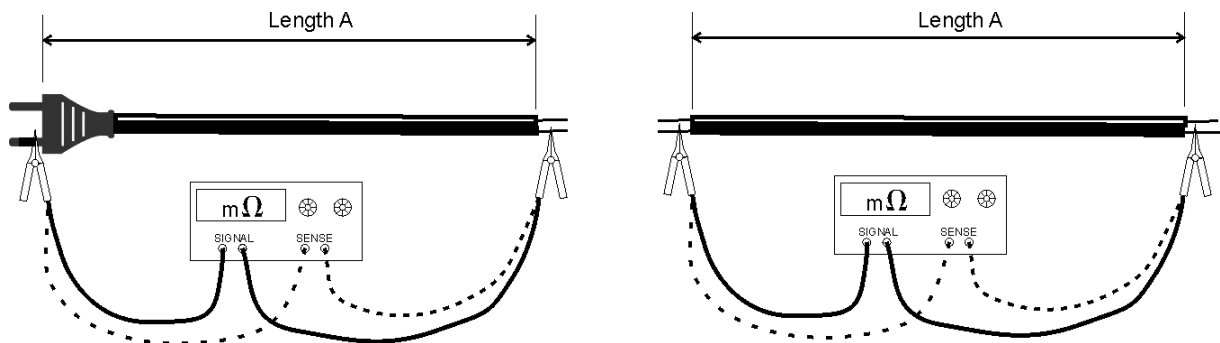
Figure 7-15. Attachment plug cold resistance measurement setup

The cold resistances of the crimp connections in the plug were estimated by taking two resistance measurements with a milliohm meter,<sup>12</sup> as shown in Figure 7-15. First, a fixed length of the cord with attachment plug was measured with the milliohm meter. After removing the plug, the same length of cord was measured with the milliohm meter as shown on the right side of Figure 7-15. By subtracting the resistance measurement of Length A of the cord-only from the resistance measurement of cord and plug, staff estimated the cold resistances of the plug connections.

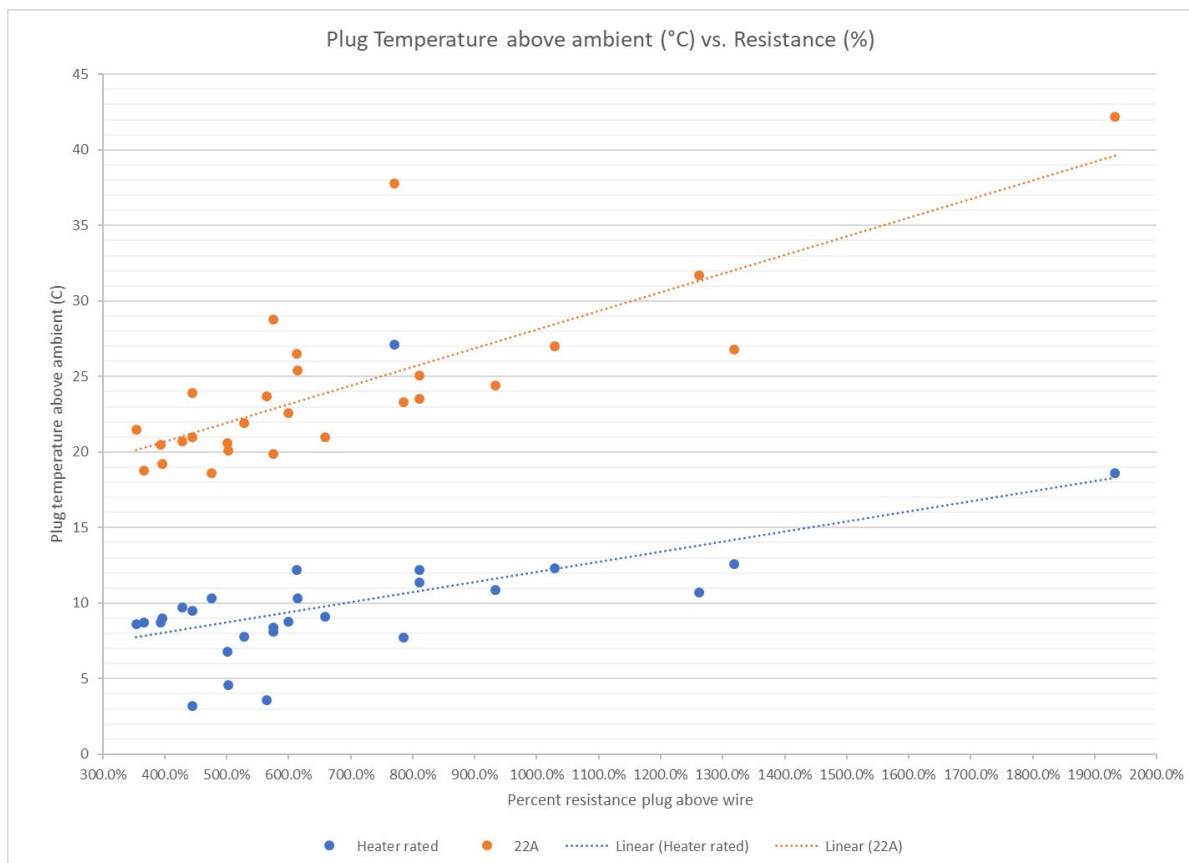
Figure 7-18. Temperature above Ambient vs. Resistance

Table 7-6 summarizes the observed temperatures over ambient. At the heater current rating (Test 1), generally temperatures increased with plug resistance. Increasing the load current to 22 A increased the change temperatures as the percent resistance increased as shown in Figure 7-18. Between Test 1 and Test 2, the highest resistance plug had a 23.6°C increase in temperature when increased to 22 A and the lowest resistance plug had a 12.9°C increase in temperature. Figures 7-19 to 7-24 show IR images of power cord samples.

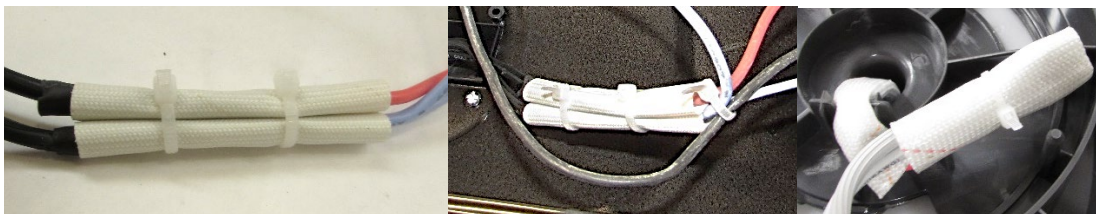
Figure 7-26. Power cord connections with minimum separation of conductors

The distance between the power cord connection conductors varied from 0.64 mm to >500 mm. The closer conductor connections were usually where the two conductors were secured parallel to each other as shown in Figure 7-26. The connections were insulated with shrink tubing and a fiberglass sleeve to prevent shorting. The power cord connections with maximum separation between opposite polarities occurred when the conductors were connected to separate components within the heater as shown in Figure 7-27.

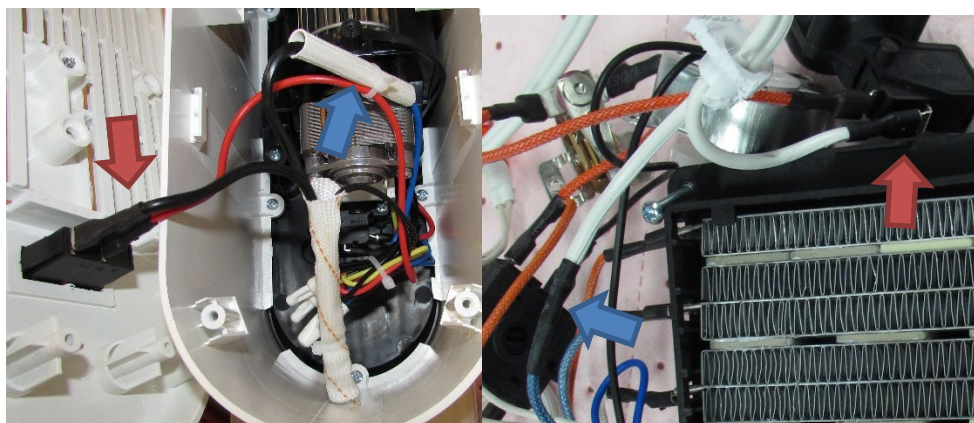
Figure 7-27. Power cord connections with maximum separation of conductors

(b) One conductor connected to power switch and other connected to internal wire

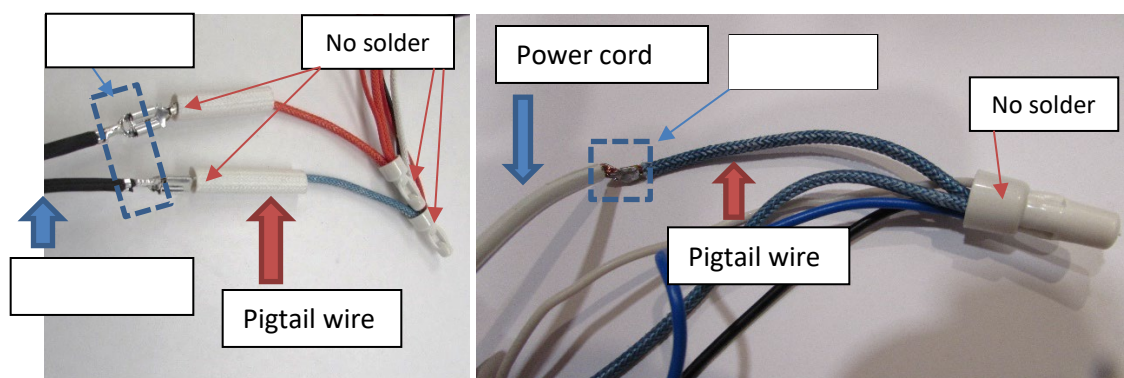
Figure 7-28. Power cord connections with pigtail wires

Some heater power cord samples contained pigtail connections from the power cord's first connection to the internal wiring as shown in Figure 7-28. These short wire connections (pigtail) are usually connected with a butt connector to the remainder of the internal wiring. This satisfies the UL 1278 requirement for soldering the first connection between the power cord and the internal wiring, but does not have the same robust construction for the remainder of the rated current carrying connections.

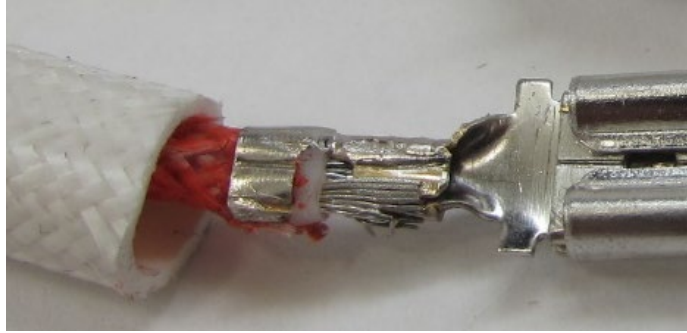
Figure 7-29. Poor crimp connection

- Poor crimping and loose wire strands (Figure 7-29)
- The internal wire connection side to the power cord was not soldered (Figure 7-30)
- Loose spade connections

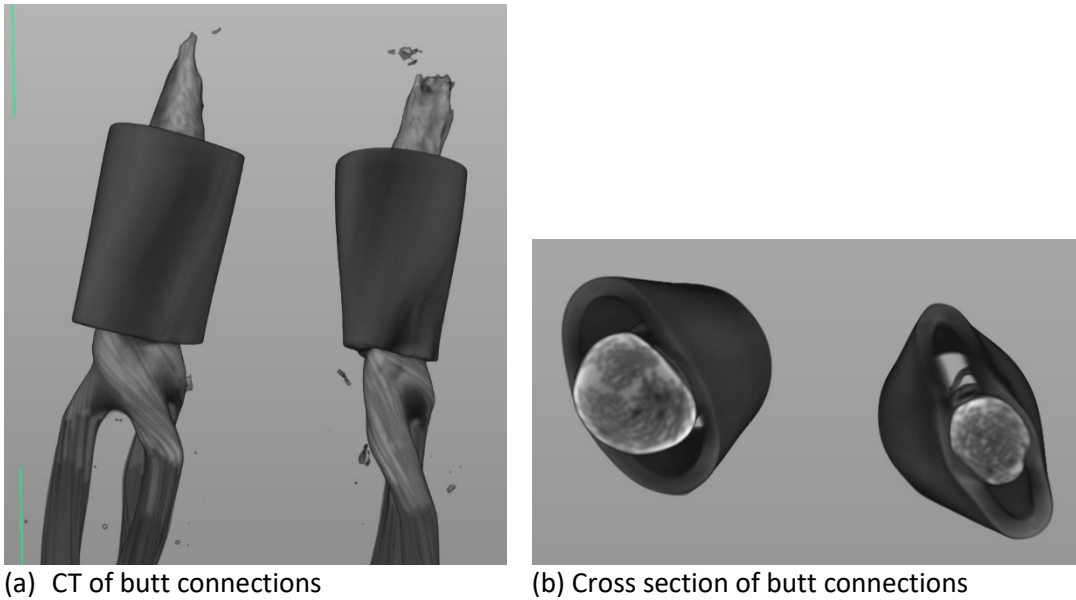
Figure 7-31. S1 CT image of butt connections

Butt crimp connectors are used for the internal wiring in some of the heater samples to join multiple conductors. Three heater samples contained butt connections where the connections were fully soldered as shown in Figures 7-31 to 7-33. These butt connections are examples of a high-quality connection.

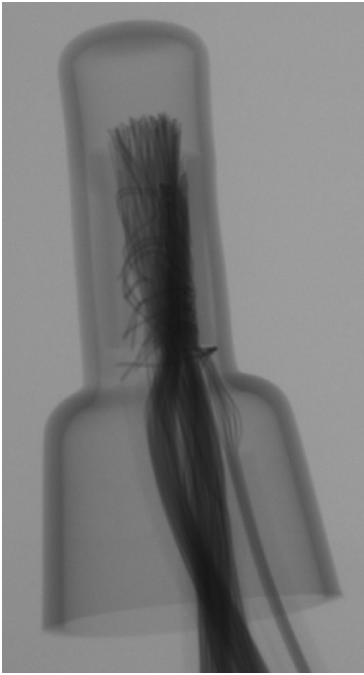
(a) X-ray image of butt connection

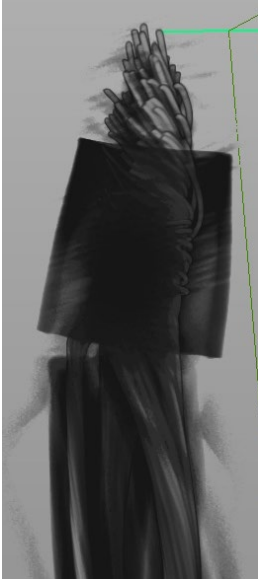
(a) CT image of butt connection

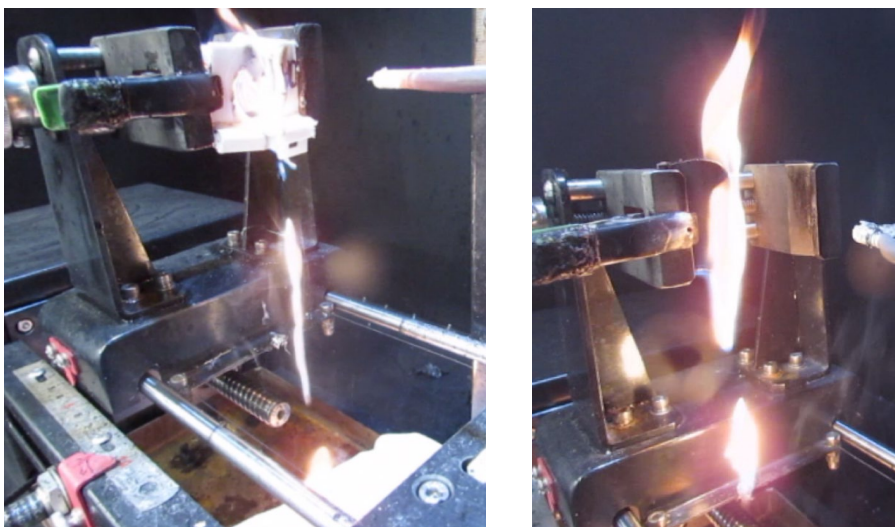
Figure 7-42. Plastic samples with flaming dripping plastic

Nine heater samples (S2, S4, S5, S17, S23, S24, S25, S26, and S27) had plastics that ignited and dripped flaming plastics that ignited the cheesecloth below. Figure 7-42 shows open flame testing where the plastic sample ignited and continued to flame after 30 seconds and dripped flaming plastic onto the cheesecloth. Flaming dripping plastics promotes the possibility of flame spread within a product and to nearby combustibles. The results of the glow wire testing are shown in Appendix Table A-12.

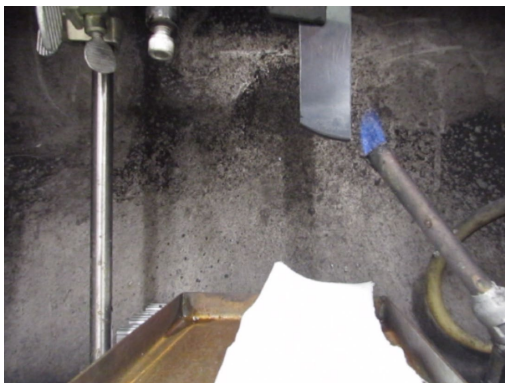
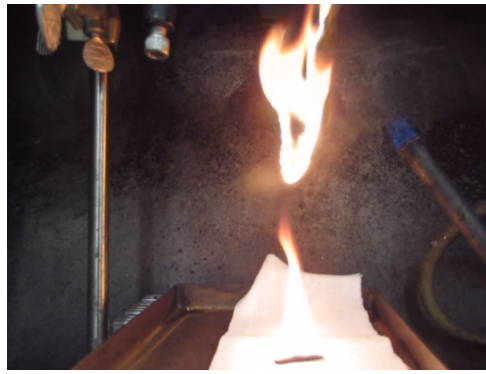
Figure 7-43. Plastic sample being tested with an open flame

(a) Open flame test

(d) Flaming dripping plastic

In some cases, the plastic sample self-extinguished immediately when the source flame was removed but caused ignition of the cheesecloth indicator when the source flame was applied during the first 30 seconds of testing. This was indicated in the data records, but not recorded as sustained flaming dripping ignition because it could not be determined if the source flame was causing by portions of the plastic melting and breaking away or it was actual flaming dripping plastic.<sup>17</sup> Once the source flame was removed, it was more obvious if the test resulted in flaming dripping plastic. Figure 7-43 shows open flame testing of a plastic.

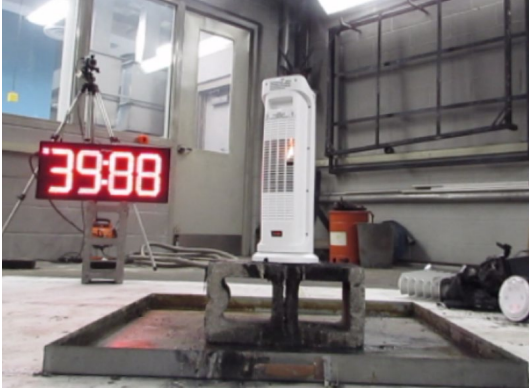
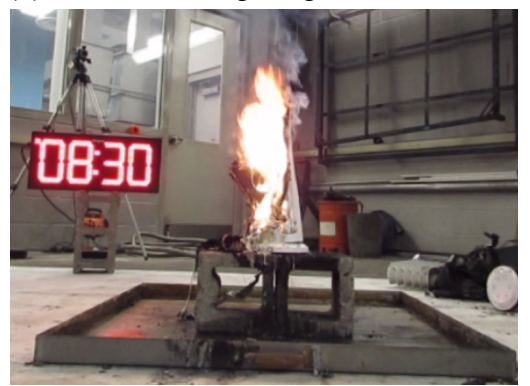
Figure 7-44. S5 1<sup>st</sup> ignition location at fan impeller

(a) 9.88 seconds after source flame removed

(d) 8min 30s from beginning of the test

During the first round, eight heater models ignited at the selected plastic component location and caused the fire to spread to other parts of the heater. The heaters continued to burn until the test was terminated by manually extinguishing the fire. Figures 7-44 to 7-51 show the testing for the heater samples that ignited during the first series of testing.

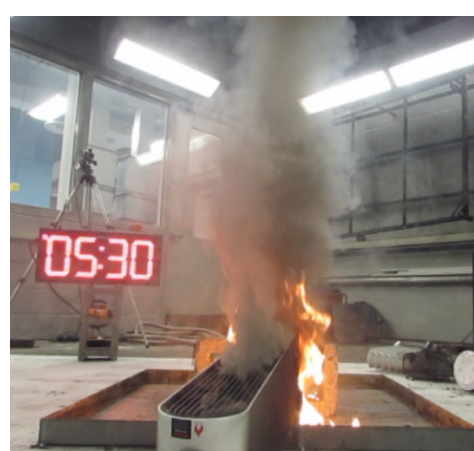
Figure 7-46. S11 1<sup>st</sup> ignition location at the base

(d) 5min 30s from beginning of the test

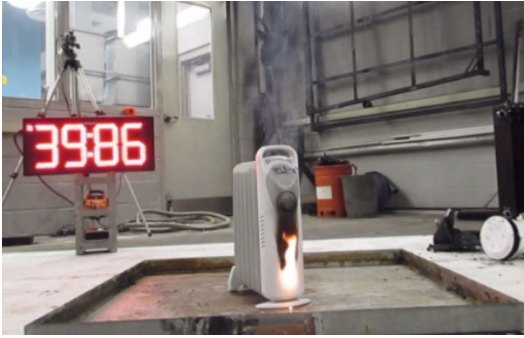
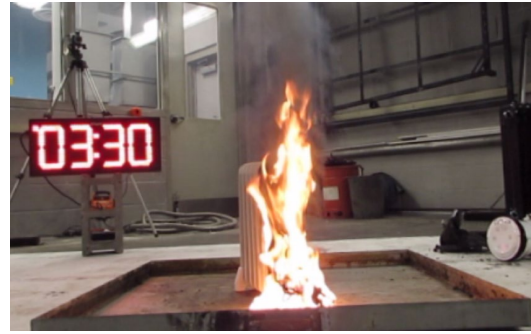
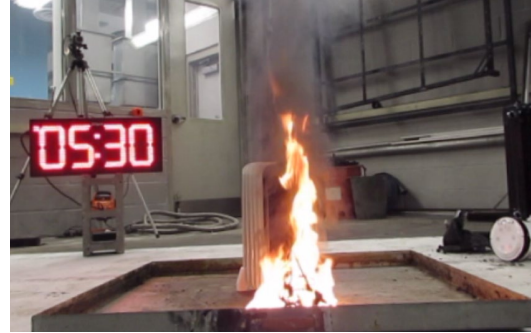
Figure 7-47. S17 1<sup>st</sup> ignition location at the end housing

(a) 9.86 seconds after source flame removed

(b) 3min 30s from beginning of the test

(d) 5min 30s from beginning of the test

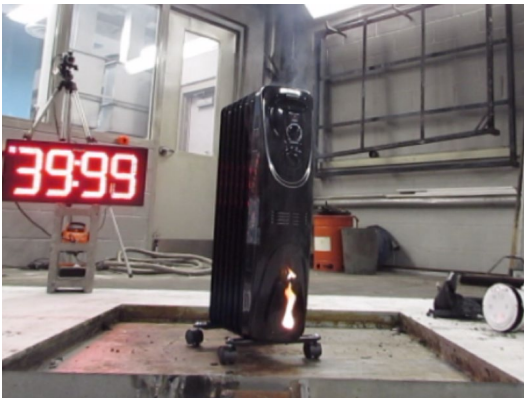
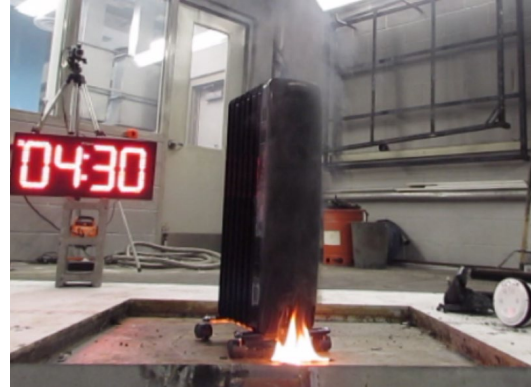
Figure 7-48. S18 1<sup>st</sup> ignition location at the cord reel

(a) 9.99 seconds after source flame removed

(d) 4min 30s from beginning of the test
