United States  
**Consumer Product Safety Commission**

## CPSC Staff's Recommendations to UL 1278

## CPSC Staff's Recommendations to UL 1042

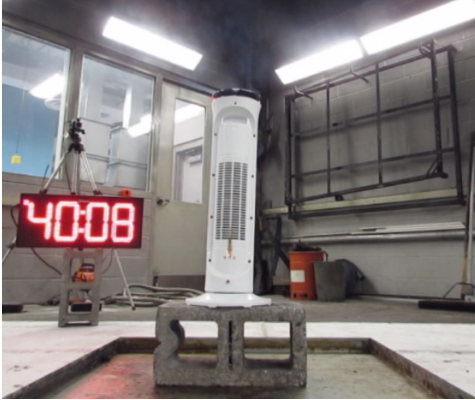
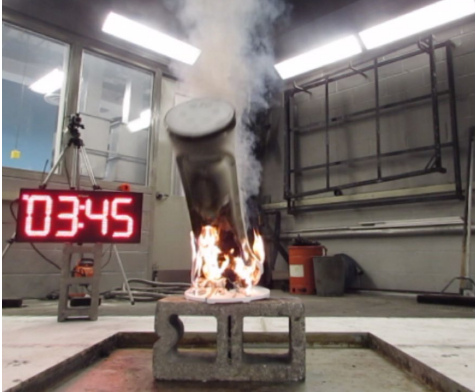
Figure 7-51. S26 1<sup>st</sup> ignition location at the rear housing

(a) 10.08 seconds after source flame removed

(c) 3min 45s seconds from beginning of the test

During the first round, eight heater models ignited at the selected plastic component location and caused the fire to spread to other parts of the heater. The heaters continued to burn until the test was terminated by manually extinguishing the fire. Figures 7-44 to 7-51 show the testing for the heater samples that ignited during the first series of testing.

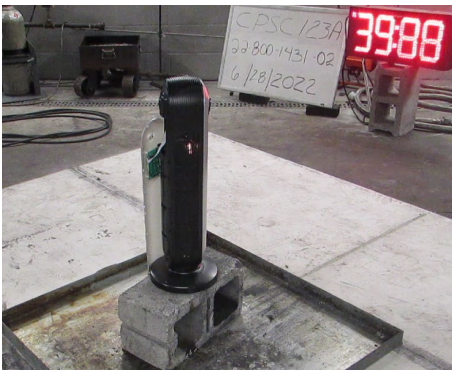
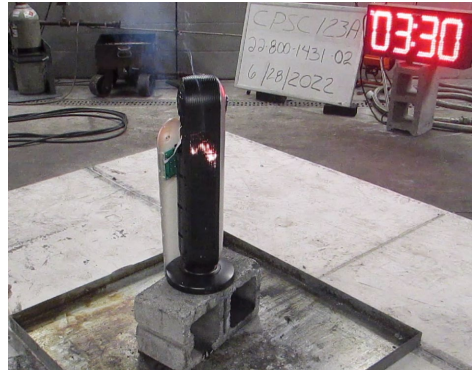
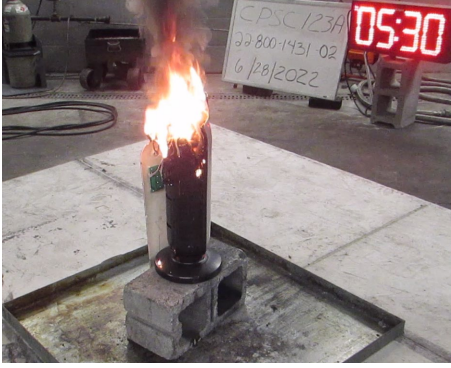
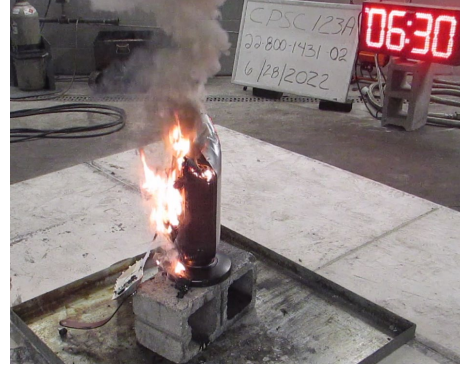
Figure 7-52. S2 2<sup>nd</sup> ignition location at the fan housing

(a) 9.88 seconds after source flame removed

(b) 3min 30s from beginning of the test

(c) 5min 30s seconds from beginning of the test

(d) 6min 30s from beginning of the test

For the second round, the 19 heater samples that did not ignite in the first round were subject to the flame being applied to a second plastic component. Three of these heaters were fully consumed. Figures 7-52 to 7-7-54 show the testing of the heater samples that ignited during the second round of testing.

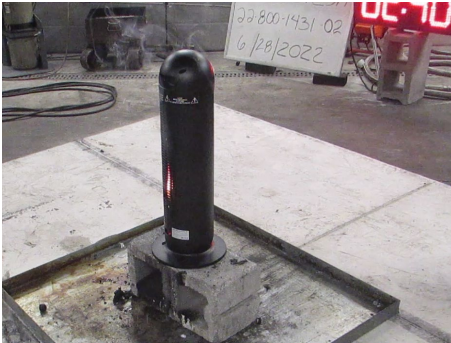
S13 ignited at the second location (the fan impeller), but after about 2 minutes it appeared the flames extinguished. A third 30 second flame application was applied to the fan impeller, which caused the heater to ignite and be consumed.

(a) 10 seconds after 2<sup>nd</sup> source flame attempt

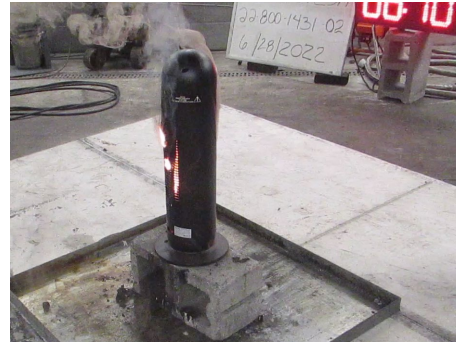
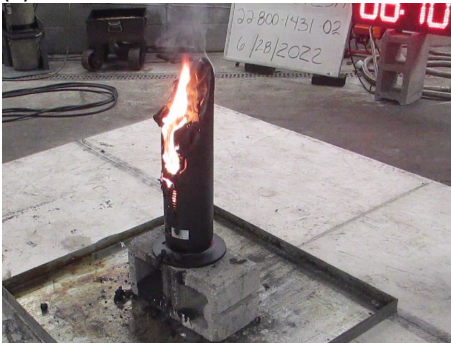
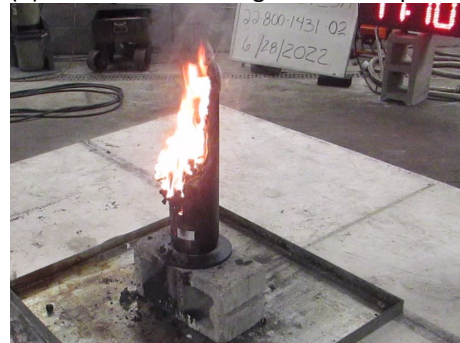
Figure 7-53. S13 2<sup>nd</sup> ignition location at the base

(b) 3min 30s after 2<sup>nd</sup> ignition attempt

(c) 5min 30s seconds after 2<sup>nd</sup> ignition attempt

(d) 8min 30s from beginning of the test

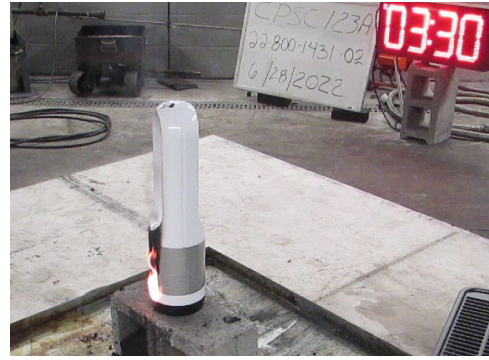
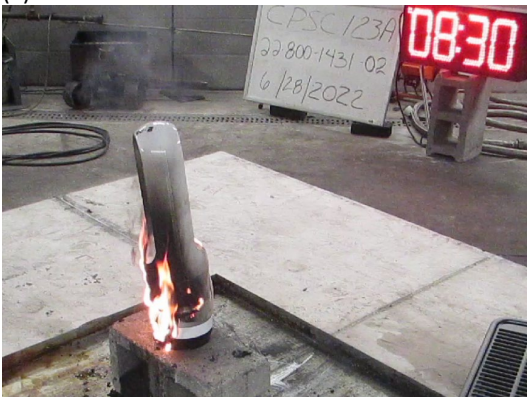
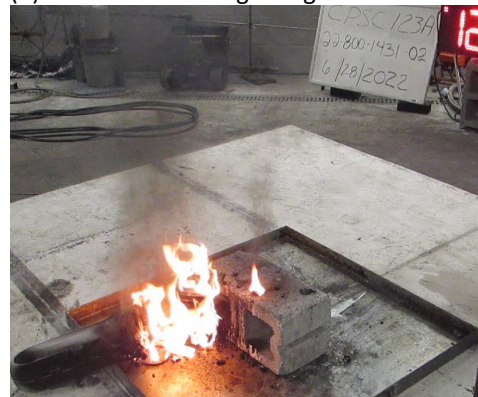
Figure 7-54. S27 2nd ignition location at the lower ring housing

(a) 10.06 seconds after source flame removed

(b) 3min 30s from beginning of the test

(c) 8min 30s from beginning of the test

(d) 12min 01s from beginning of the test

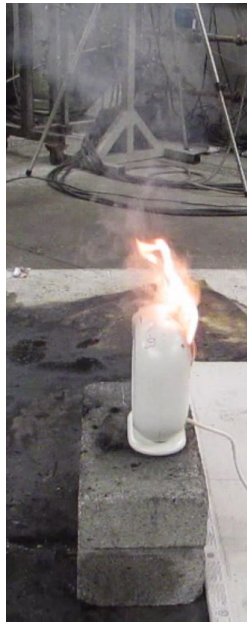
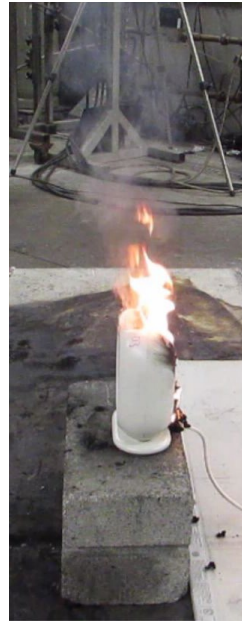
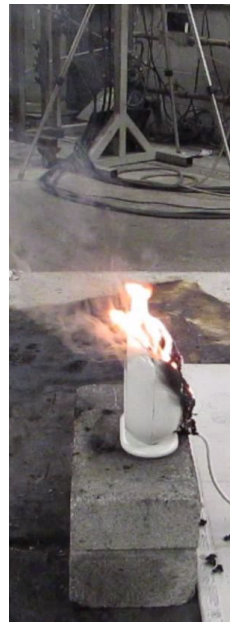
Figure 7-56. S09 2nd sample tested

The source flame application for S09 second sample was on the fan housing at the rear of the heater. Ignition required a single a 30 s source flame application. It appears ignition of the fan housing along its vertical and horizontal surfaces allow ignition on the first attempt.

(a) 3 minutes -

(b) 5 minutes -

(c) 6 min - after 1st<sup>d</sup> application of source flame

The data showed some inconsistencies in the testing and component testing that required retesting samples S05, S09, S12, S20, S21, and S25. A new sample was used for this series of tests. Four (S05, S09, S21, S21) of the 6 samples ignited. Two of the previous samples, S12 and S25, did not ignite. Figures 7-55 to 7-58 show the testing of the heater samples that ignited when a second sample was tested.

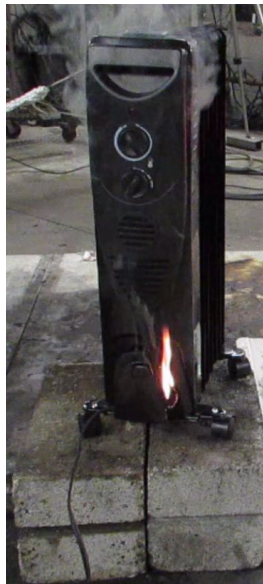
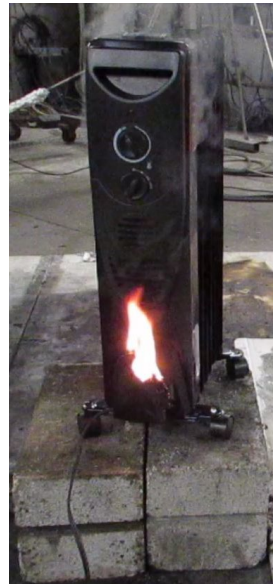
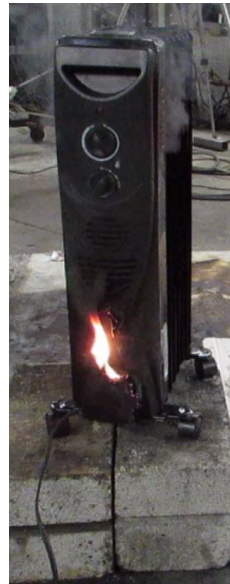
Figure 7-57. S20 2nd sample tested

The source flame application for S20 second sample was at the cord reel. Ignition required a single 14 s source flame application. During the first round of testing there was no ignition of the cord reel perhaps due to the glossy smooth surface on its external side. An unfinished surface that was not glossy, similar as located in the internal side of the plastic, allowed easier ignition of the plastic component. The flames and burning was limited to only the cord reel and did not spread to the control panel plastic housing.

(a) 3 minutes -

(b) 5 minutes -

(c) 6 min - after 1st<sup>d</sup> application of source flame

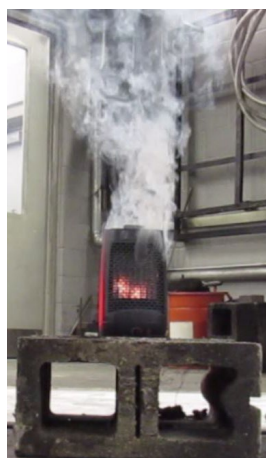
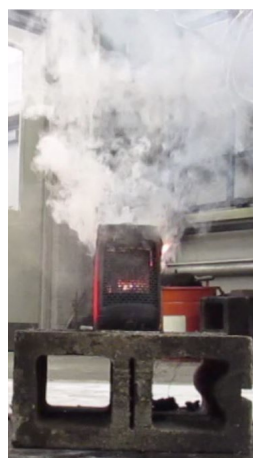
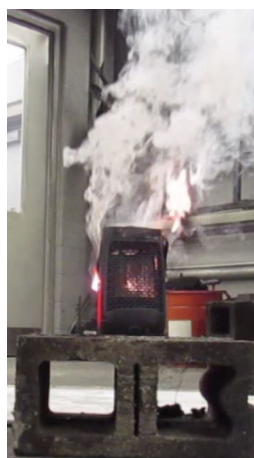
Figure 7-58. S21 2nd sample tested

The source flame application for S21 second sample was at the fan housing. The first 30 s application did not result in an ignition. A second 30 s application at the fan housing resulted in ignition of the plastic.

(a) 3 minutes -

(b) 5 minutes -

(c) 6 min - after 2<sup>nd</sup> application of source flame
