United States
Consumer Product Safety Commission

U.S. Consumer Product Safety Commission (CPSC) staff¹ conducted an assessment of portable electric heaters as documented in the February 2023 report, *CPSC Staff Assessment on Portable Electric Heaters* (available at <https://www.cpsc.gov/Research--Statistics/other-technical-reports>) In light of that assessment, CPSC staff is requesting formation of a working group under Underwriters Laboratories (UL) Technical Committee (TC) 1042 for Electric Room Heaters using the proposals in the attachment as initial topics of discussion.²

CPSC Staff's Recommendations to UL 1278

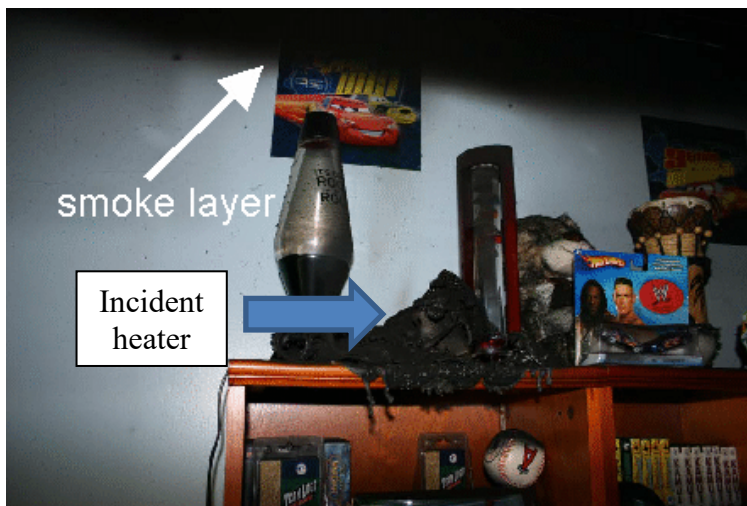
Figure 5-5. Incident scene

CPSC staff conducted an analysis of the product, which was certified to UL 1278. The investigation of the incident scene photos revealed that the heater had overheated during the night, which generated an upper black smoke layer in the room (Figure 5-5). Figure 5-5 shows the fire had not spread beyond the incident heater itself.

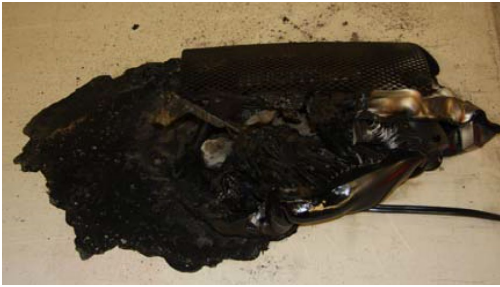
Heater sample in open room after test

The analysis suggests that ignition of the fan housing by a failed overheated heater connection could have resulted in a fire that completely consumed the heater (Figure 5-11).

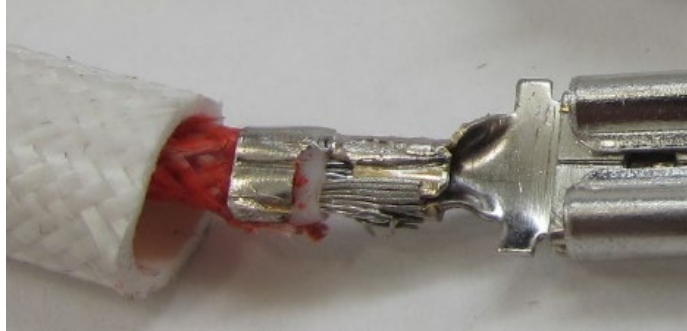
Figure 7-29. Poor crimp connection

- Poor crimping and loose wire strands (Figure 7-29)
- The internal wire connection side to the power cord was not soldered (Figure 7-30)
- Loose spade connections
