# *Circle Testing of Two Recreational Off-Highway Vehicles on a Dirt Surface*

for:  
Consumer Product Safety Commission

June 2013

Report prepared by Gary J. Heydinger, Ph.D., P.E.

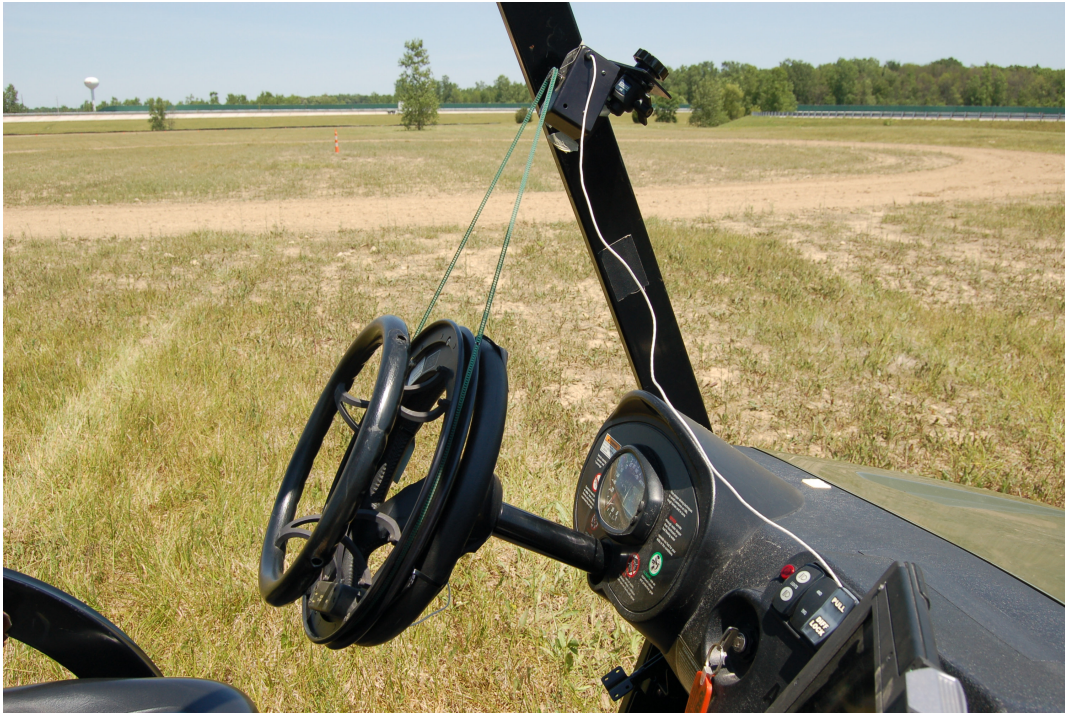
Figure 1: Steering Wheel Angle Sensor Mounted in Test Vehicle

No automated steering controller was required for this testing. A Sensor Developments, Inc., sensor was used to measure steering wheel angle for these tests. A photograph of this sensor mounted on one of the test vehicles is shown in Figure 2. A portion of the circular dirt test track can be seen in the background of Figure 2, and a more close-up view of the dirt surface is shown in Figure 3.

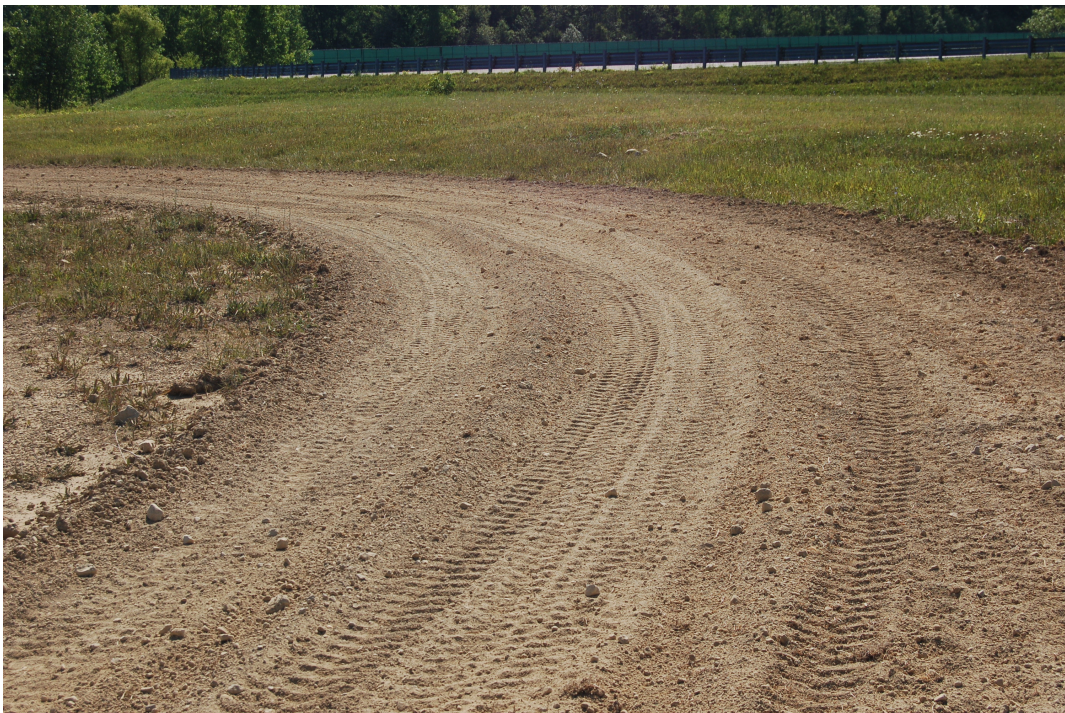
Figure 2: Prepared Dirt Surface after Several Tests were Completed

The surface used for testing was located at the Transportation Research Center, Inc. (TRC). TRC prepared the surface by cutting and removing any grass and topsoil necessary to produce a circular dirt track. The circular track had an inside radius of nominally 95 ft and an outside radius of nominally 115 ft (200 ft diameter, 20 ft wide circular dirt test track). Overall, the prepared circular track was smooth and flat.

For Vehicle F, Pages 1 through 6 of Appendix A contain results for the six sets of circle tests on dirt, and Pages 7 and 8 contains results for the two sets on asphalt. The data from the tests conducted on dirt are not as smooth or as repeatable as the data from the tests on the asphalt surface. The graphs indicate that the driver's steering inputs were more active (*i.e.*, requiring larger magnitude steering corrections) at all test speeds for the tests conducted on dirt than on asphalt. Lateral acceleration, roll angle, and yaw rate responses were also less smooth for the tests conducted on the dirt surface. As the circle tests on the dirt surface progressed, slight ruts and ridges formed along the wheel paths of travel. These ruts and ridges likely contributed to the less smooth vehicle responses and driver steering inputs.

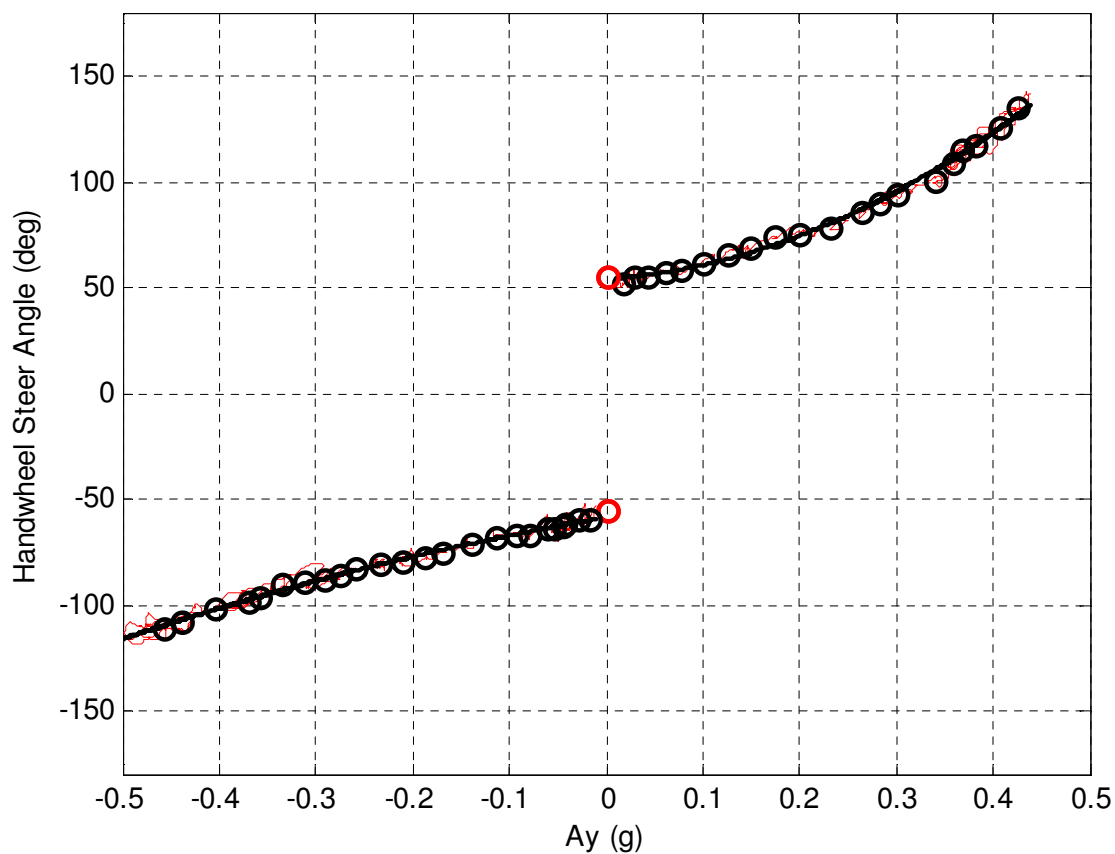
Vehicle G - Tests on Dirt - Set #1

Page 7 of Appendix B shows results from Set #1 tests on dirt and Set #1 tests on asphalt for Vehicle G. The red lines are the underlying data, the black lines are the second-order polynomial curve fits to the data, and the black circles are discrete points from averaging 0.5 second intervals (500 samples) of handwheel angle and lateral acceleration. The discrete points are generally scattered around the curve fit lines; but again, the scatter is greater for the tests on the dirt surface than for the tests on asphalt.
