# CPSC Safety Alert

## Certain Older Gas Connectors May Be Dangerous

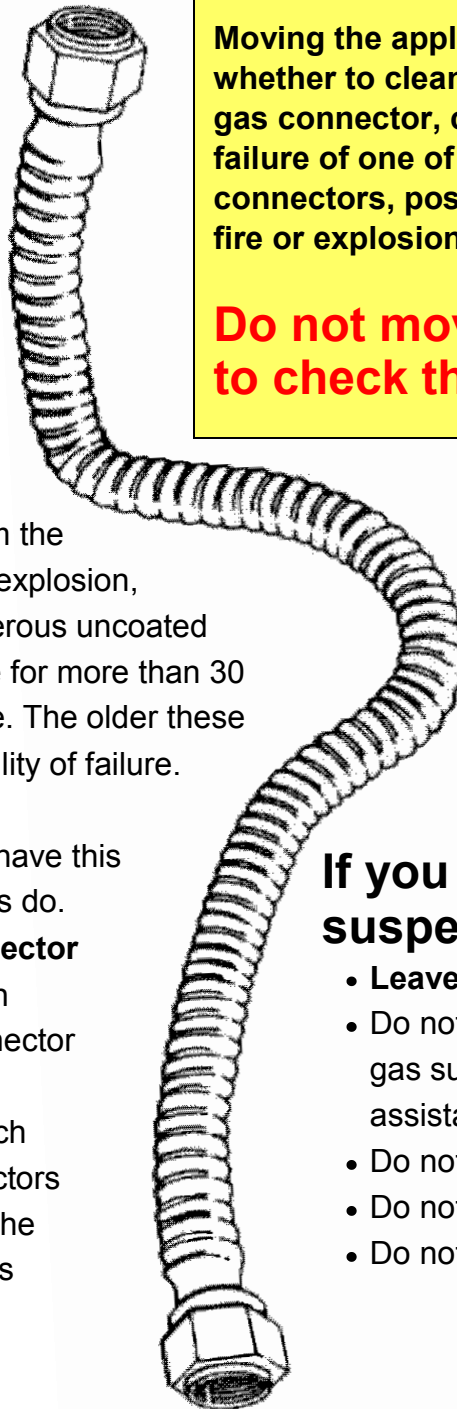
Gas connectors are corrugated metal tubes used to connect gas appliances in your home to fuel gas supply pipes. Some older brass connectors have come apart, causing fires and explosions resulting in deaths and injuries.

These older brass connectors have a serious flaw in how their tubing was joined to their end pieces. Over time, the end pieces can separate from the tubing, and cause a serious gas leak, explosion, or fire. To our knowledge, these dangerous uncoated brass connectors have not been made for more than 30 years, but many of them are still in use. The older these connectors get, the greater the possibility of failure.

Although not all uncoated connectors have this flaw, it is very difficult to tell which ones do. Therefore, **any uncoated brass connector should be replaced immediately** with either a new plastic-coated brass connector or a new stainless steel connector. Connectors can wear out from too much moving, bending, or corrosion. Connectors should always be replaced whenever the appliance is replaced or moved from its location.
