# PURAFIL ENVIRONMENTAL CORROSION REPORT

CCC Panel #: P68018

<b>CCC Panel # P68018</b>
<b>ISA Class G1</b>
Mild

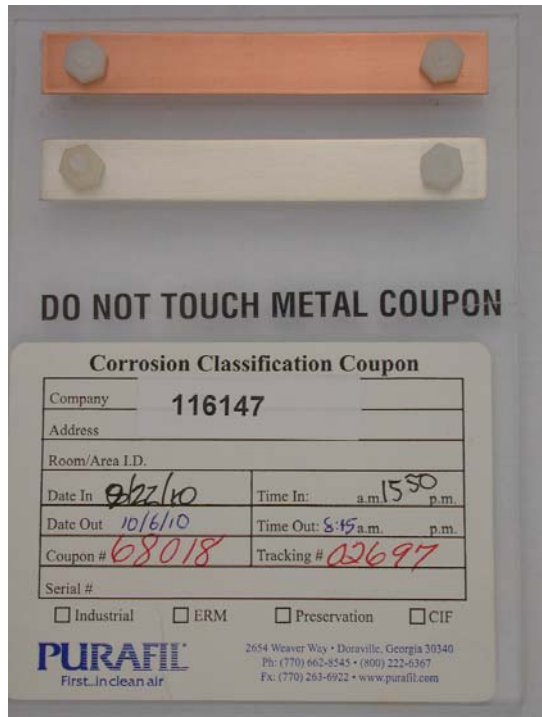
**Corrosion Classification Coupon**

<b>Copper Corrosion</b>
257 Å/30 Days
<b>Silver Corrosion</b>
220 Å/30 Days

The electrolytic reduction analysis on Corrosion Classification Coupon #P68018 shows the presence of only very low concentrations of contaminants in the environment tested. The hydrogen sulfide level is not expected to exceed 3 ppb and the sulfur dioxide level should be less than 10 ppb. Corrosion is not a factor in determining equipment reliability in this environment.

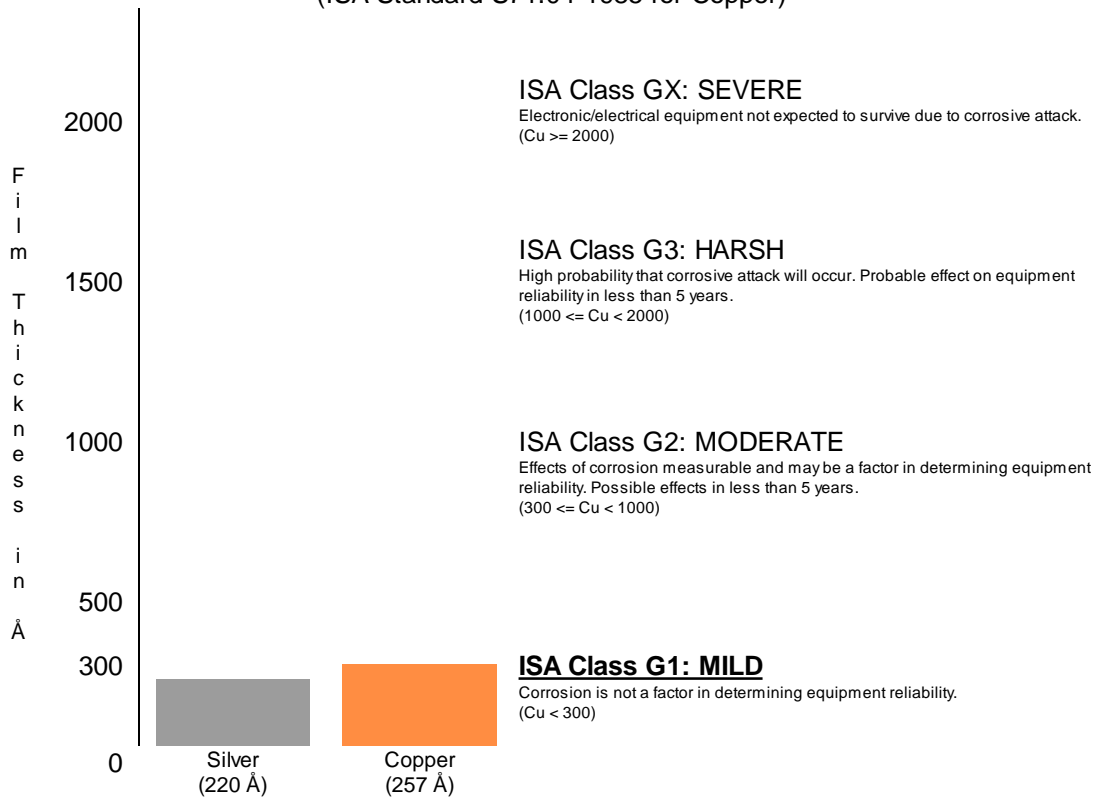
**Equipment Reliability Correlation**  
 (ISA Standard S71.04-1985 for Copper)

<b>Corrosion Film Composition</b>				<b>Gold Coupon - Magnified 20x</b>
	Projections			
	<u>30 Days</u>	<u>1 Year</u>	<u>5 Year</u>	
<b>Copper Films</b>				
Cu <sub>2</sub> S	0 Å	0 Å	0 Å	
Cu <sub>2</sub> O	257 Å	343 Å	449 Å	
Unknowns	0 Å	0 Å	0 Å	
Totals	257 Å	343 Å	449 Å	
<b>Silver Films</b>				
AgCl	0 Å	0 Å	0 Å	
Ag <sub>2</sub> S	220 Å	2684 Å	13421 Å	
Unknowns	0 Å	0 Å	0 Å	
Totals	220 Å	2684 Å	13421 Å

**Gold Pore Corrosion:**  
 Note: 1000 Å = 0.1 micron
