# PURAFIL ENVIRONMENTAL CORROSION REPORT

Sales Order #: C002726  
CCC Panel #: P68789  
Date In: 15-Nov-2010  
Date Out: 29-Nov-2010  
Days In Service: 14

**CCC Panel # P68789**

## Summary for PURAFIL CCC # P68789

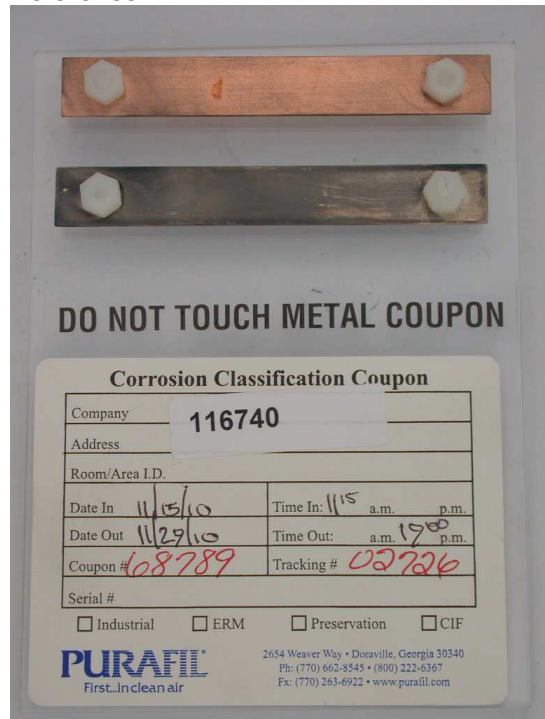
**Corrosion Classification Coupon**

**ISA Class G2**  
Moderate

**Copper Corrosion**  
515 Å/30 Days

**Silver Corrosion**  
4249 Å/30 Days

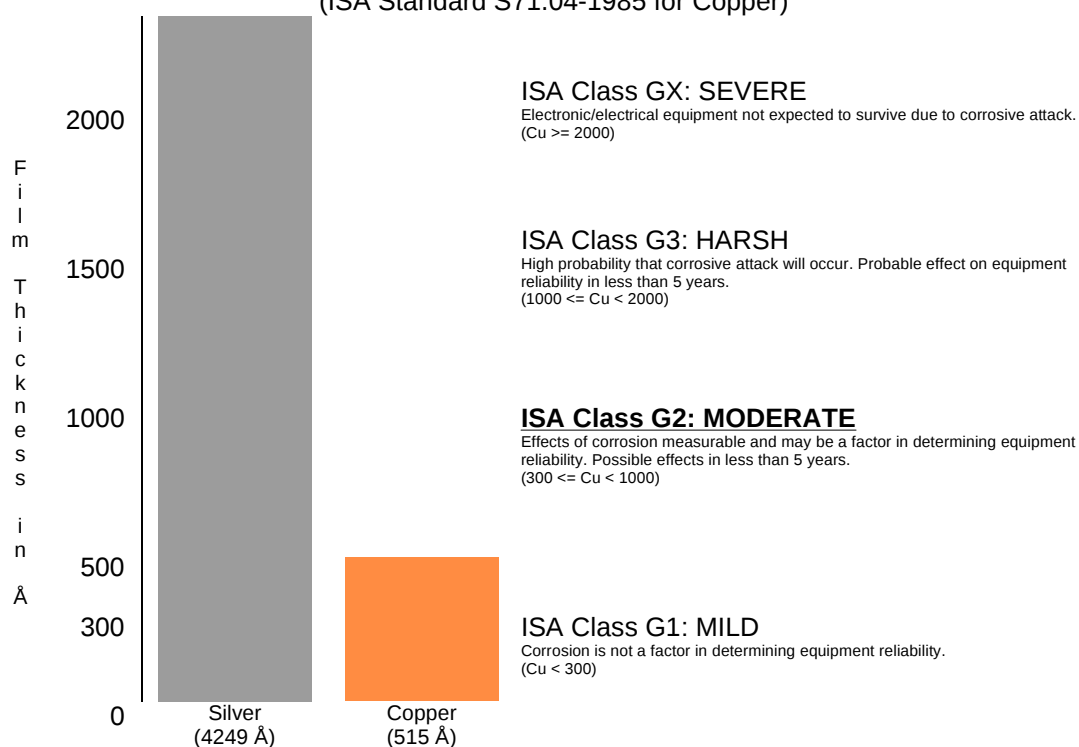
**Equipment Reliability Correlation**  
(ISA Standard S71.04-1985 for Copper)

The electrolytic reduction analysis on Corrosion Classification Coupon #P68789 shows the presence of moderate concentrations of contaminants in the environment tested. The hydrogen sulfide level is expected to range between 3 and 10 ppb and the sulfur dioxide level between 10 and 100 ppb. The effects of corrosion are measurable and may be a factor in determining equipment reliability.
