# PURAFIL ENVIRONMENTAL CORROSION REPORT

CCC Panel #: P68811

CCC Panel # P68811

ISA Class G1  
MildCopper Corrosion  
265 Å/30 DaysSilver Corrosion  
324 Å/30 Days(see next page for complete  
analysis)

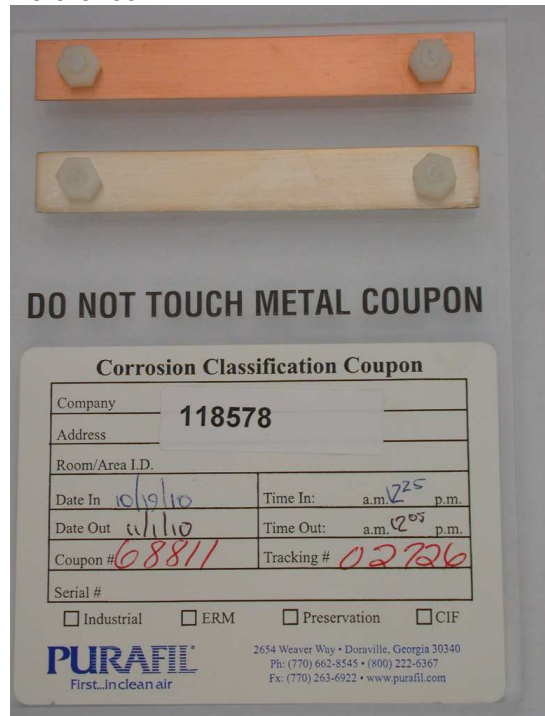
**Corrosion Classification Coupon**

| Coupon # <b>68811</b> | Tracking # <b>02726</b> |

The electrolytic reduction analysis on Corrosion Classification Coupon #P68811 shows the presence of only very low concentrations of contaminants in the environment tested. The hydrogen sulfide level is not expected to exceed 3 ppb and the sulfur dioxide level should be less than 10 ppb. During the test period, corrosion, as shown by the copper coupon, is not a factor in determining equipment reliability.
