LOG OF MEETING

SUBJECT: Twist-On Wire Connectors for Aluminum Wire,
Presentation by Dr. Jesse Aronstein and a General
Discussion.

DATE: September 28, 1995

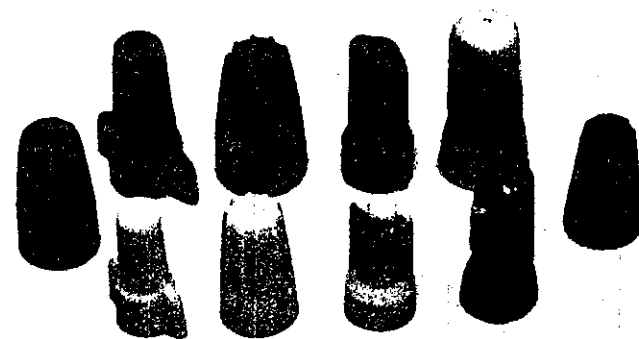
2. PRIOR TO 1985 most twist-on connectors on the market were listed by UL as suitable for the purpose. The actual performance in this application varied widely, however, depending on construction and installation method.

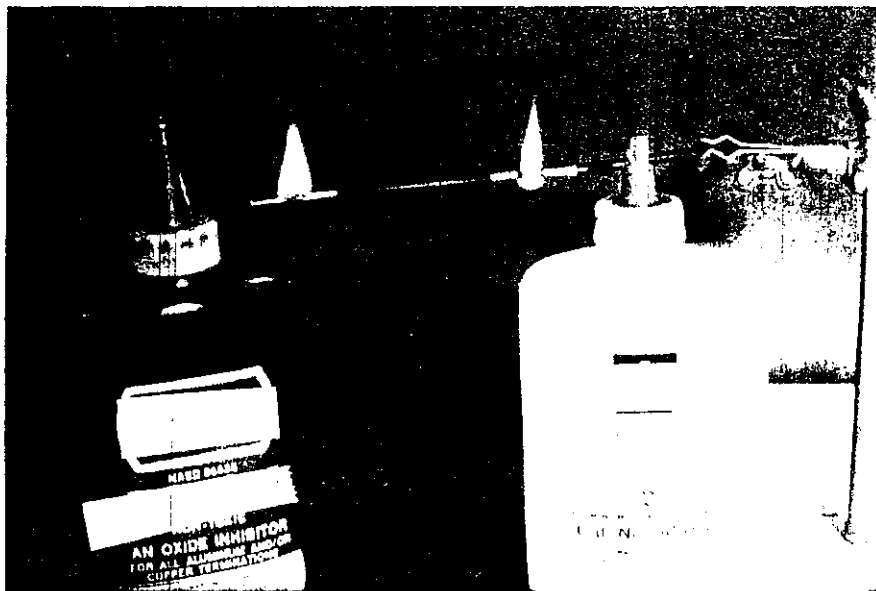
38. OTHER BRANDS. INCLUDING THE ONE MADE BY AND USED IN THEIR CONNECTOR, IGNITE READILY AND BURN VIGOROUSLY.
